LiDAR Quality Assurance (QA) Report
San Francisco Bay LiDAR Project
NOAA Coastal Services Center
April 21, 2011

Submitted to:
NOAA Coastal Services Center

The following LiDAR quality assurance report documents Dewberry's 3rd review of LiDAR data and derived products for the San Francisco Bay LiDAR Project. The data was flown by Fugro EarthData, Inc (FEDI) for the NOAA Coastal Services Center. The delivery of the data includes portions of seven California counties: Alameda, Contra Costa, Marin, Napa, San Francisco, Solano, and Sonoma.

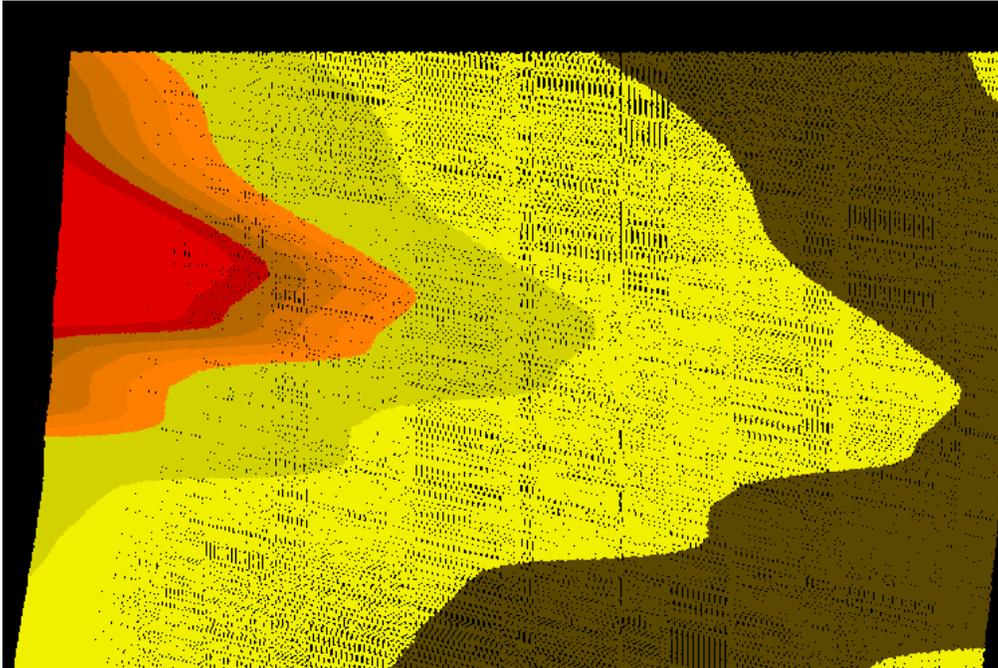
- 76 tiles have a scan angle from nadir greater than 20°. Tile C5445_42150 has the greatest scan angle at 29° and Dewberry loaded this tile to identify if this high scan angle adversely affected the quality of the LiDAR data. No visible flight line ridges or noise artifacts were visible in the data as a result of the high scan angle within this tile. Figure 3 to Figure 5 show the area in tile C5445_42150 that has the high scan angle and documents how this high scan angle does not have a noticeable effect on the ground model.

Figure 3 - Point cloud from TerraScan with points colored by scan angle. The red points are where the scan angle is near or above 25° off from Nadir. The yellow and brown colors are scan angles under 20°.

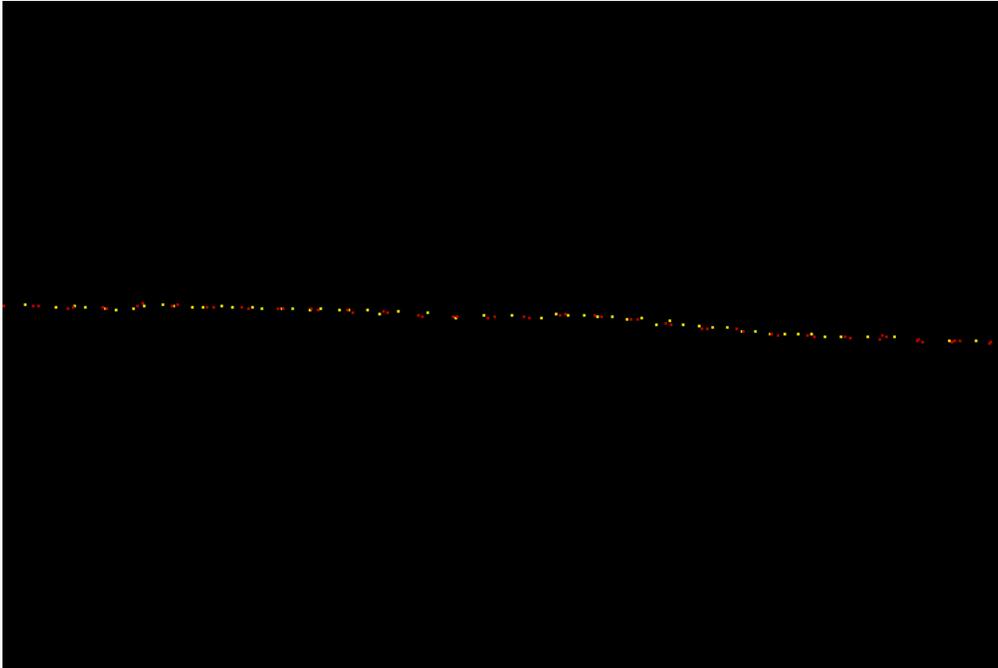
Figure 4 - Profile of point cloud from TerraScan. The yellow points are from another flight line with a scan angle around 10°. The red points have a scan angle of 25° and no identifiable discrepancies between the two flight lines are visible.

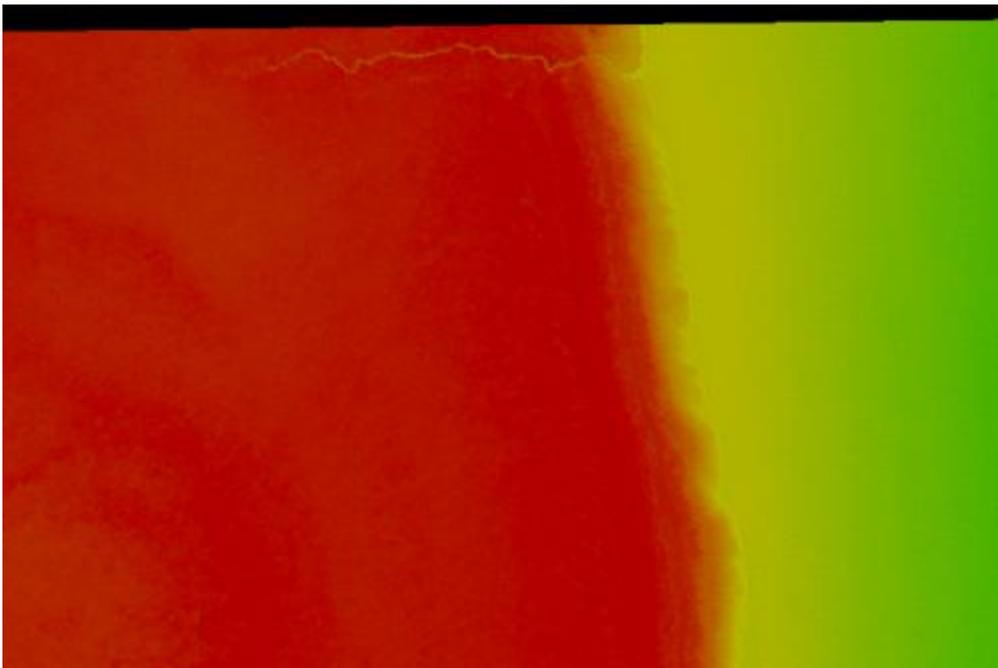
Figure 5 - Ground model from QT modeler colored by elevation showing the same general area as the figure above. No visible noise or flight line ridges are present as a result of the high scan angle.

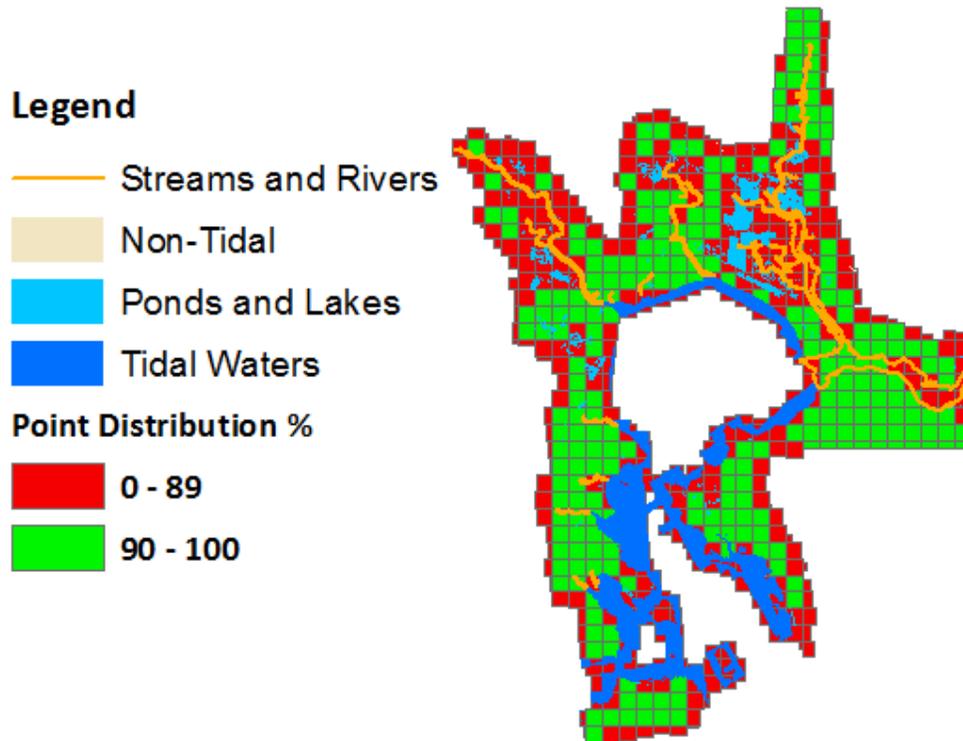
Figure 6 - Results of point density analysis. Only 1st return points were used in the analysis.

Although, it appears that approximately half of the tiles do not meet the project specification, the majority of these tiles either contains large/numerous hydrologic features or are on the project boundary. Tiles along the project boundary will fail because the analysis assumes all tiles are full tiles.. After determining that tiles along the project boundary and tiles containing large/numerous hydrologic features did meet or exceed the required 90% point distribution, Dewberry investigated 5 tiles that could not be explained by the two aforementioned reasons in the initial QA/QC of the 1st delivery. Dewberry determined these tiles failed because of flooding.

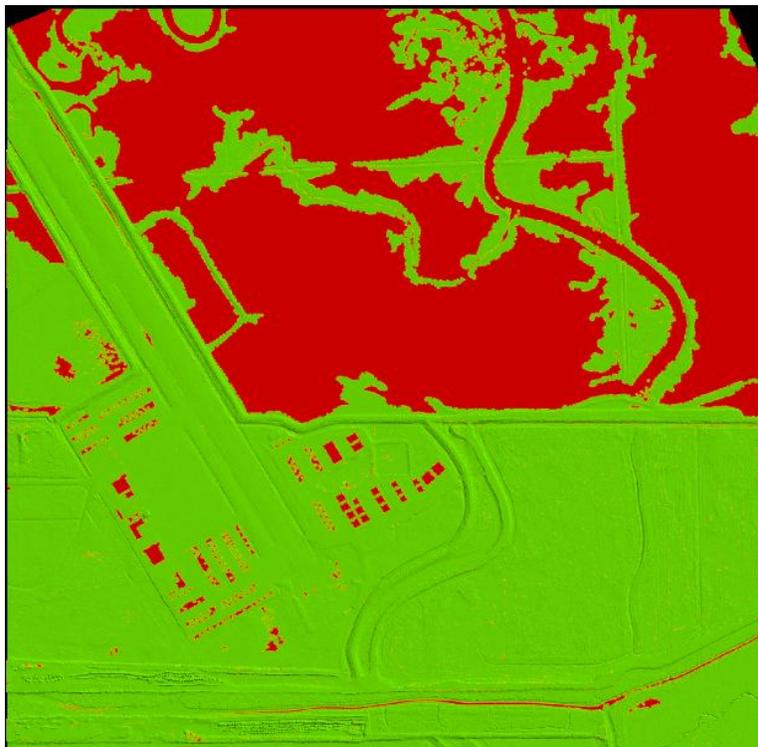
The issue of flooding still exists within 5 of the tiles (C5520_42285, C5370_42210, C5370_42195, C5385_42195, and C5385_42210). FEDI states that because the LiDAR was flown with the tidal window it does not require fixing. Dewberry provides examples below of this issue to make the end-client aware of the issue. FEDI also outlined several of the flooding areas as water bodies in the breaklines and therefore the images below are updated to reflect these changes.

Figure 7 - Ground density model of Tile C5385_42210. The area in red in the northern half of the tile is believed to flooded and in the 2nd delivery is outlined by a break line as a water body.

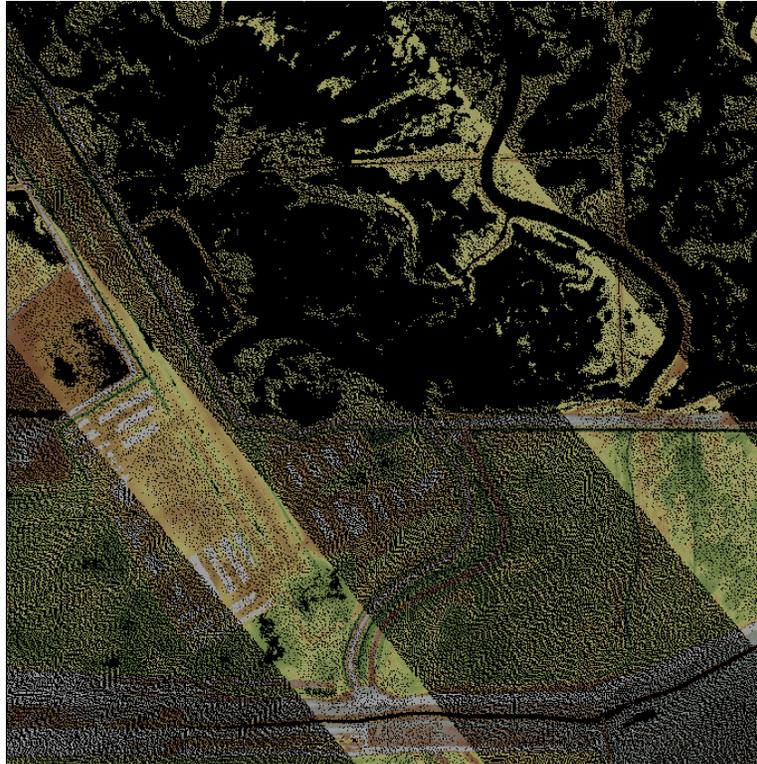
Figure 8 - Full point cloud of tile C5385_42210 colored by elevation. Note the voids of data where the flooding exists.

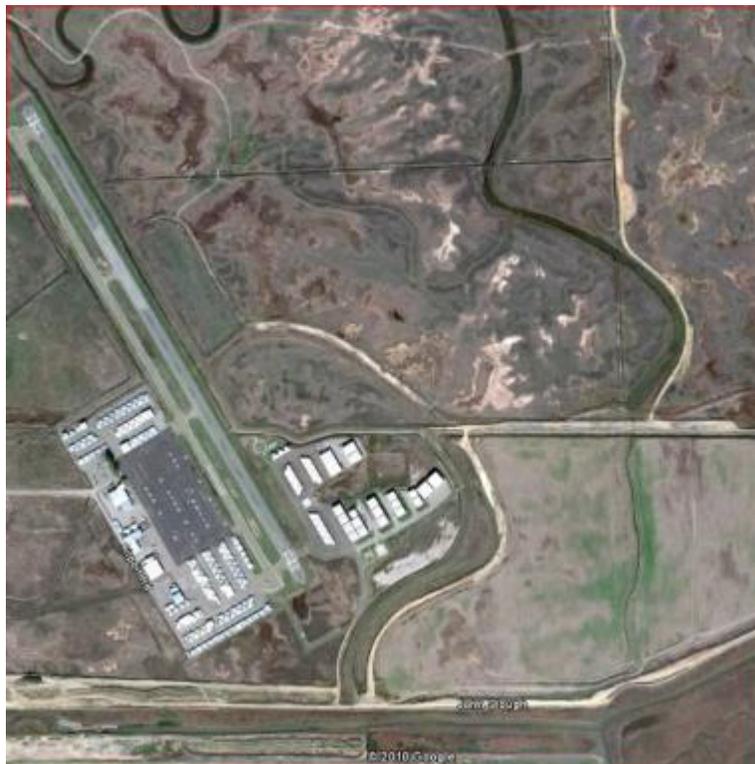
Figure 9 - Aerial image from Google Earth covering the same areas as Tile C5385_42210. In this image there is no water present but the land cover suggests this area is prone or capable of flooding, leading to the assumption that when the LiDAR was collected, this area was flooded.

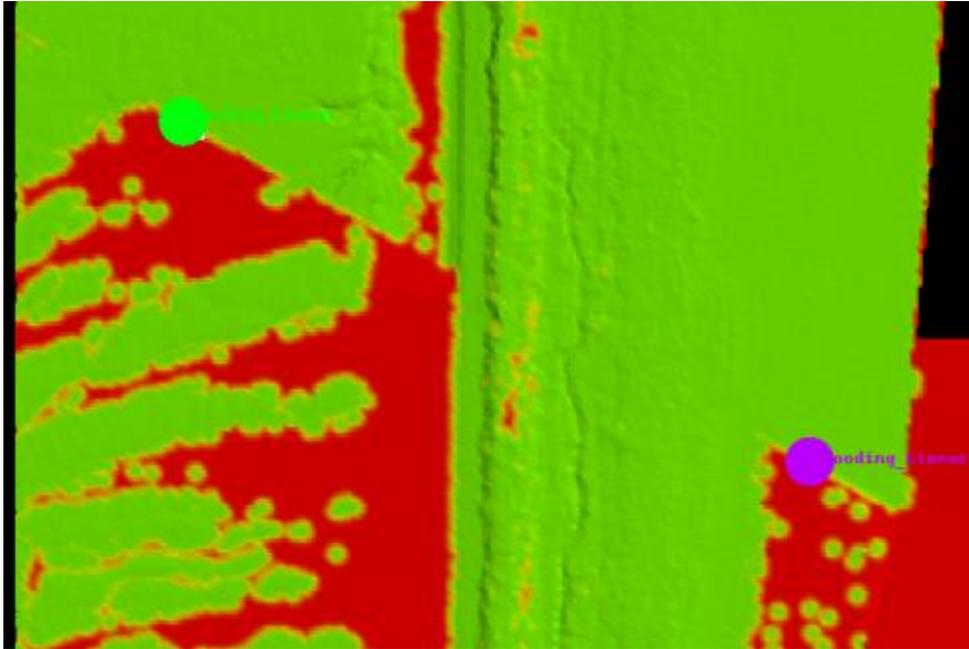
Figure 10 - Ground density model of tile C5625_42195 that shows a linear feature created by two different flight lines. This image is from the 1st delivery and is fixed in the 2nd delivery shown below.

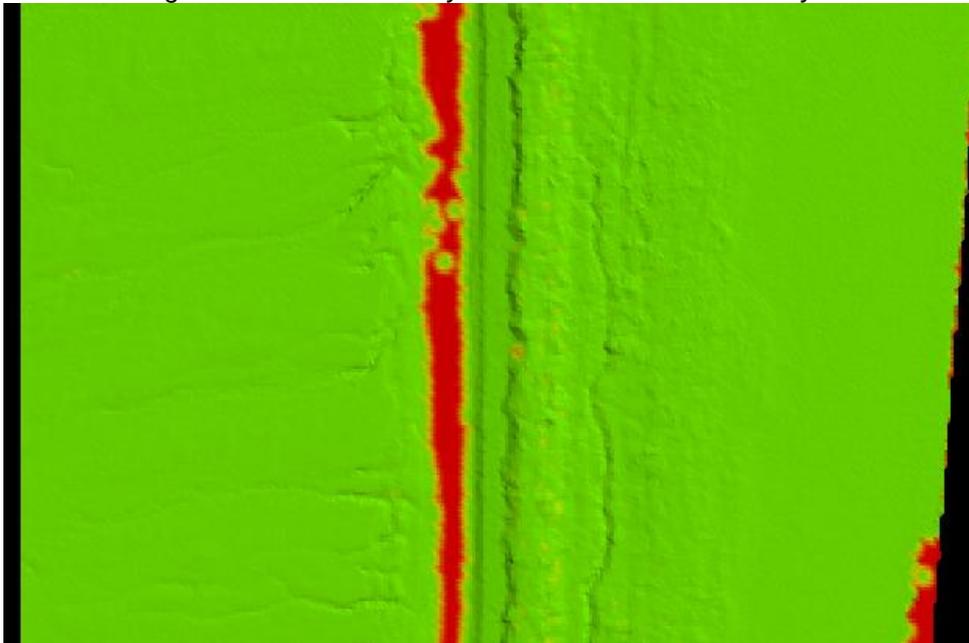
Figure 11 - Ground density model of tile C5625_42195 that shows the linear feature no longer exists in the 2nd delivery.

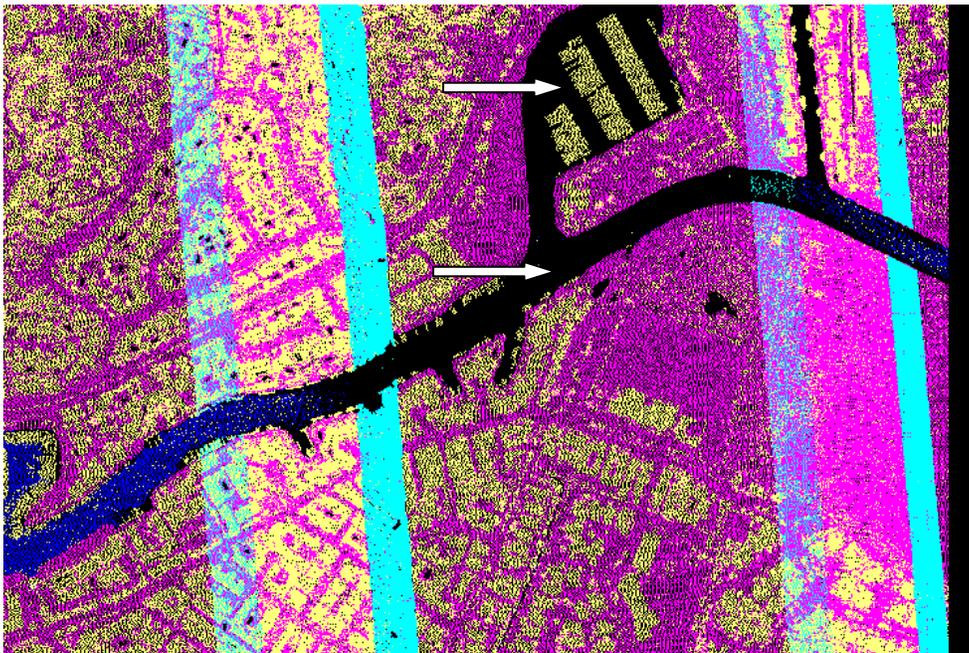
In the initial QC of the delivery, Dewberry identified some areas that seem to be missing points (that are classified as water) within a single flight line. In the 2nd delivery, FEDI commented that this swath has no returns from the water and is therefore not an error. The image and description is provided to make the end-client aware of this anomaly, but Dewberry agrees that there is no issue here. Figure 12 shows tile C5430_42015 as a full point cloud within Fugro Viewer. The points are colored by classification (ground points are purple, unclassified points are yellow, overlap points are light blue, and water points are dark blue). The overlap points show the general direction of the flight line (north-south) and as evident from the black void within the river and harbor (highlighted by white arrows) there are no water points within one flight line.

Figure 12 - Full point cloud classified by color in Fugro Viewer of tile C5430_42015. See text above for description of figure in detail. Ground points are purple, unclassified points are yellow, overlap points are light blue, and water points are dark blue.

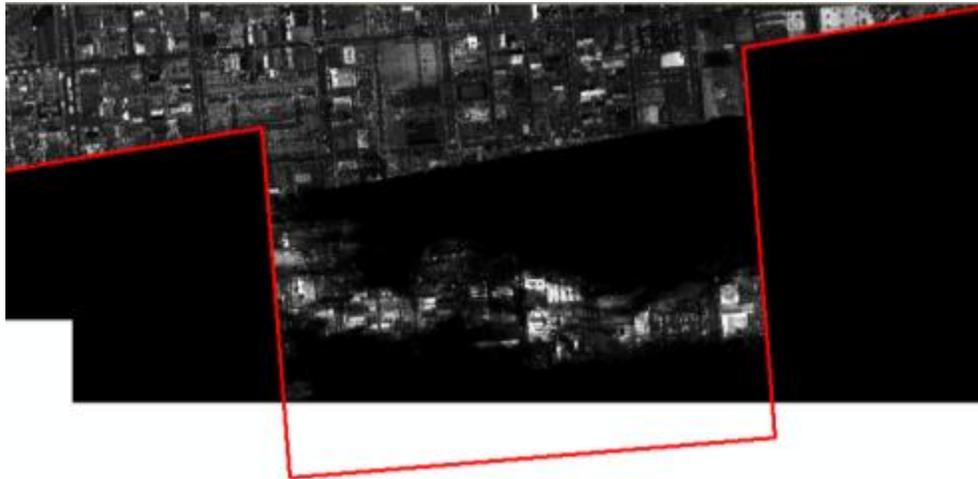
image (see Figure 13). This void still remained in the 2nd delivery. In the 3rd delivery, FEDI responded that they discussed this issue with NOAA and that “this area contains data from a cross-tie and [was not] QC’d as a production line. A data extents shapefile “SanFran_DataExtents_UTM10_NAD83_NSRS2007_m.shp” was provided with delivery identify the accurate coverage area. The intended project area has been covered and no loss of valuable data has occurred” (From San_Fran_Geodatabase Call_FEDI_REPLY_041411.doc, Dewberry assumes the delivery relates to a shapefile provided to NOAA). Based off this response, Dewberry no longer considers this to be an issue.

Figure 13 - Full point cloud intensity image of tile C5505_41790 that shows a data void. The red line is the project boundary as provided by NOAA on March 4th, 2011.

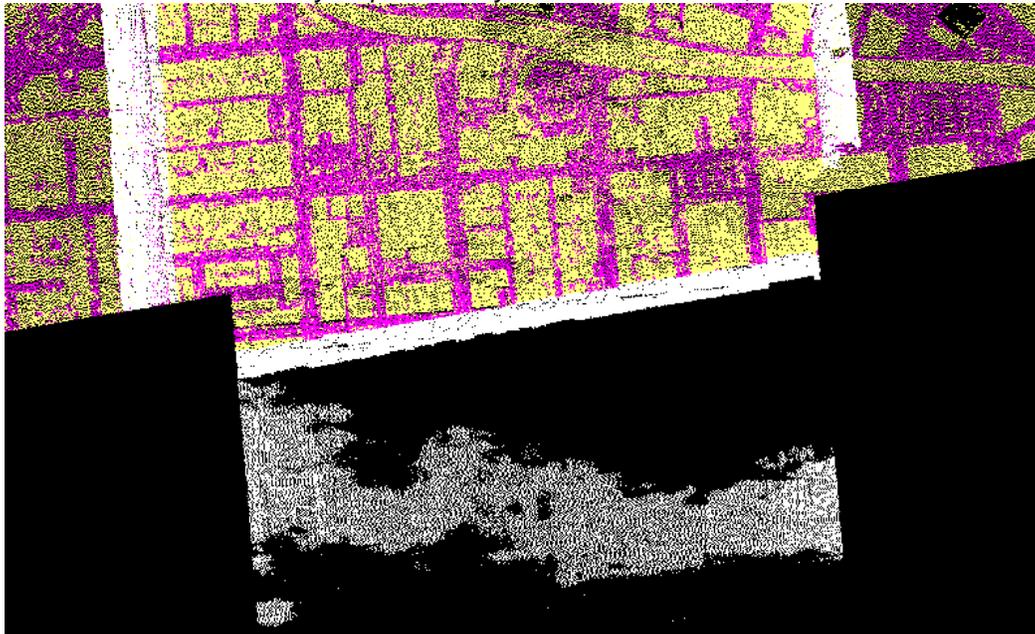
Figure 14 – Map view of full point cloud from Fugro Viewer of tile C5505_41790 colored by classification. The purple points are classified as ground (class 2), the yellow points are unclassified (class 1), and the white points are overlap (class 12).

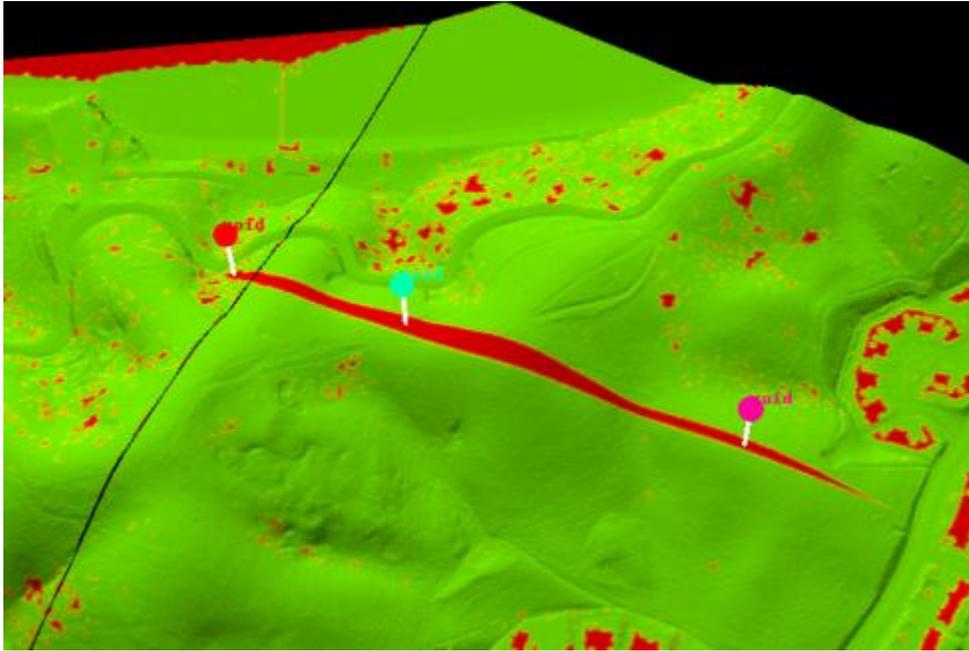
In the 1st delivery, Dewberry noted three other tiles (C5430_42045, C5445_42045, and C5460_42045) that contain a thin strip where no ground/unclassified points exist. In the 2nd delivery, FEDI has fixed these tiles. Figure 15 to Figure 18 show examples of the corrections.

Figure 15 - Ground density model of tile C5460_42045 showing a linear feature where no ground points exist. This has been fixed in the second delivery.

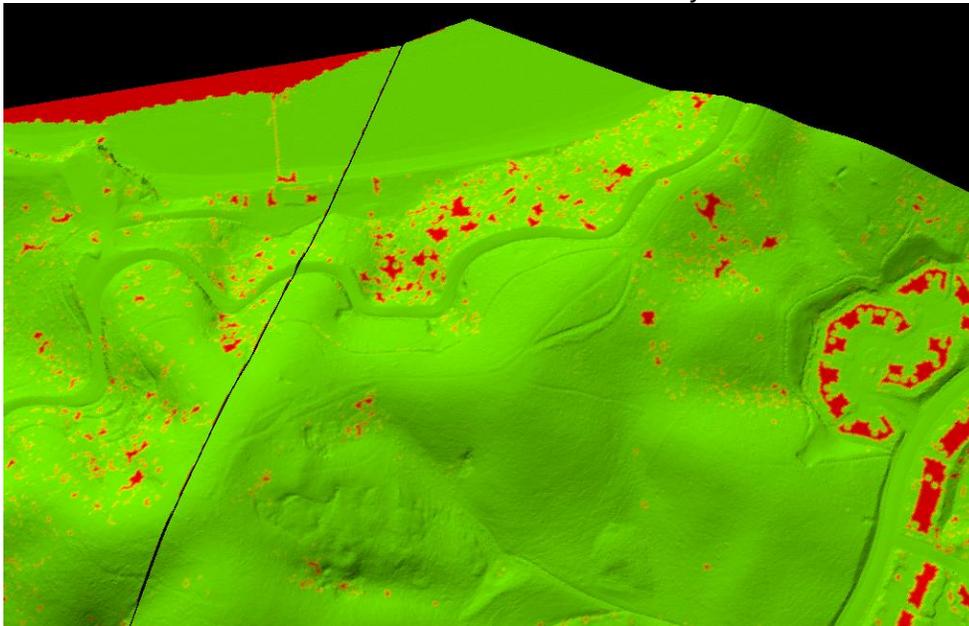
Figure 16 – Ground density model of tile C5460_42045 showing that the linear void in the image above has been fixed in the 2nd delivery.

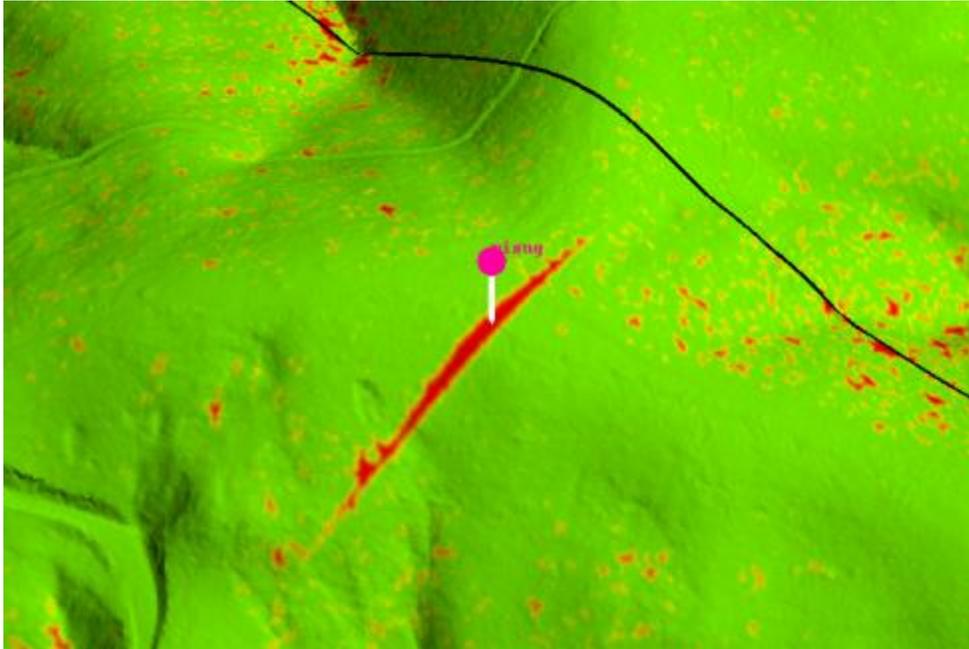
Figure 17 - Ground density model of tile C5445_42045 from the 1st delivery showing a linear feature where no ground points exist. This has been fixed as shown below.

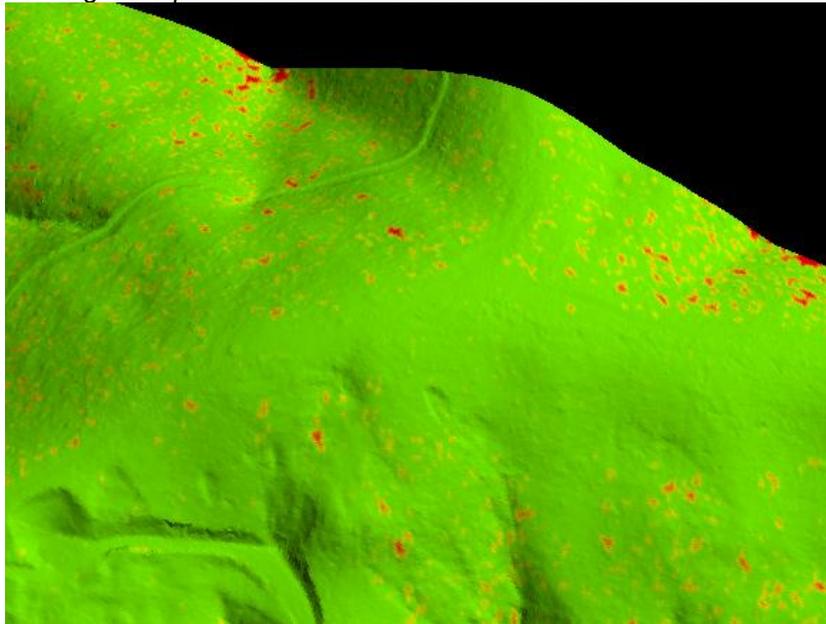
Figure 18 - Ground density model of tile C5445_42045 showing that in the 2nd delivery the data void in the image above is not present.

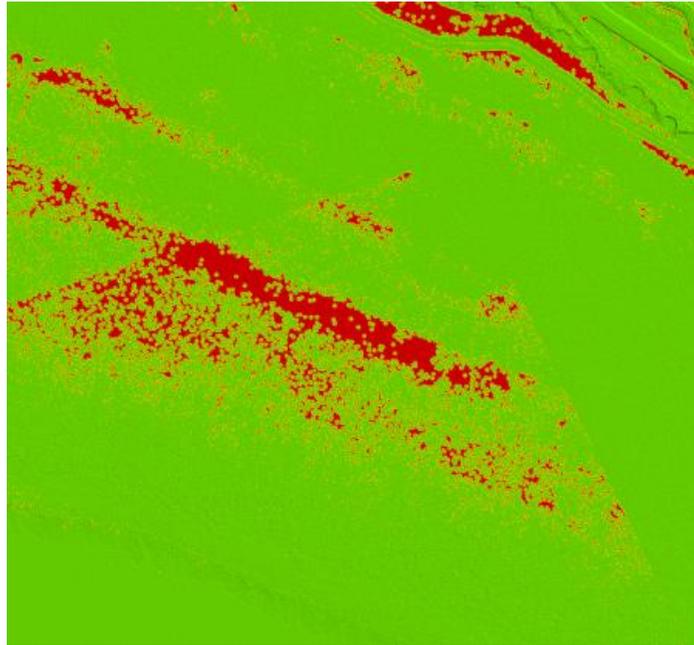
In the initial QC of the data, several areas were identified where ground points on the bank of a hydrographic feature or a road embankment had been aggressively classified. Aggressive classification happens when features that legitimately should be left in the ground are partially removed. FEDI addressed all calls in the 3rd delivery and no issues remain. Two examples of fixed aggressive classification calls are shown below in Figure 19 to Figure 22.

Figure 19 - Ground density model of tile c5535_42210 from the 1st delivery showing ground that was aggressively classified. This is fixed in the second delivery as shown below.

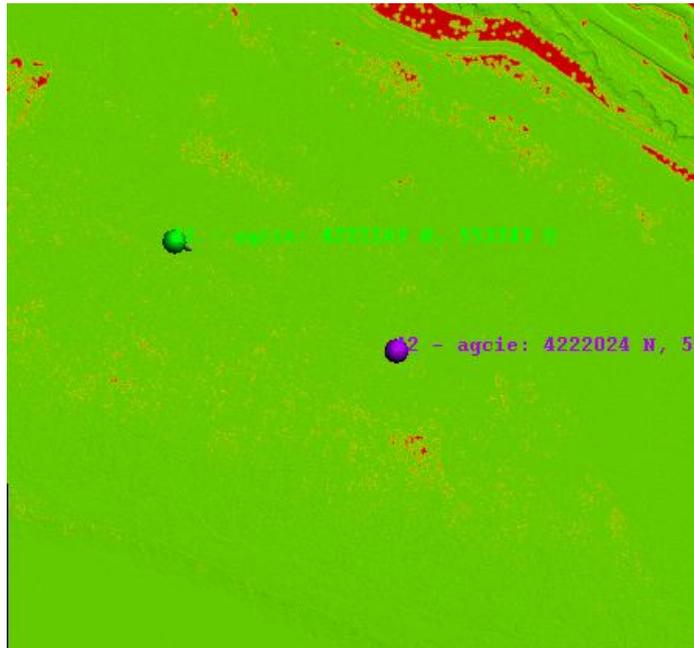
Figure 20 - - Ground density model of tile c5535_42210 showing that numerous legitimate ground points were put into the ground model.

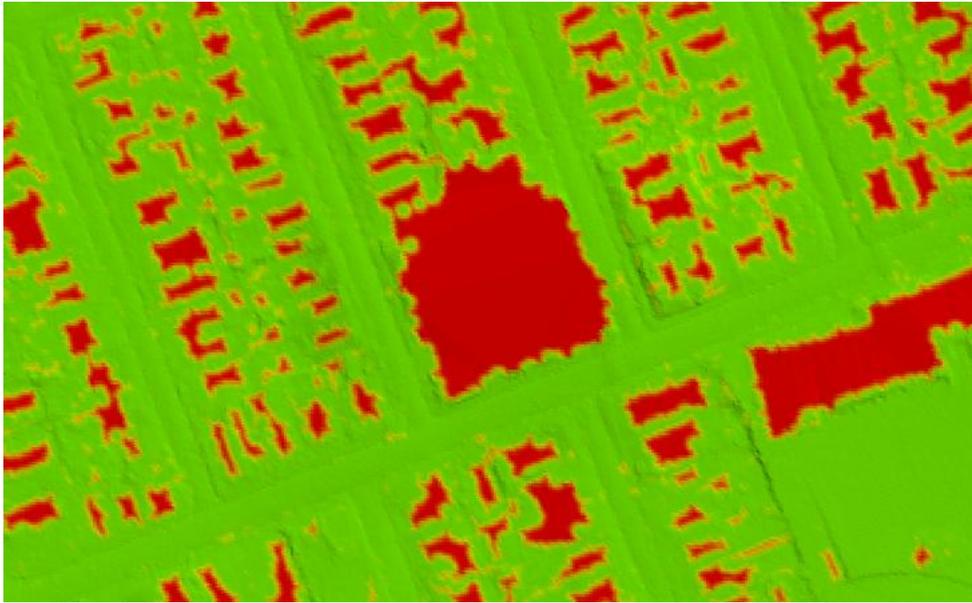
Figure 21 - Ground density model of tile C5610_41940 that shows an area with a city block that has been aggressively classified.

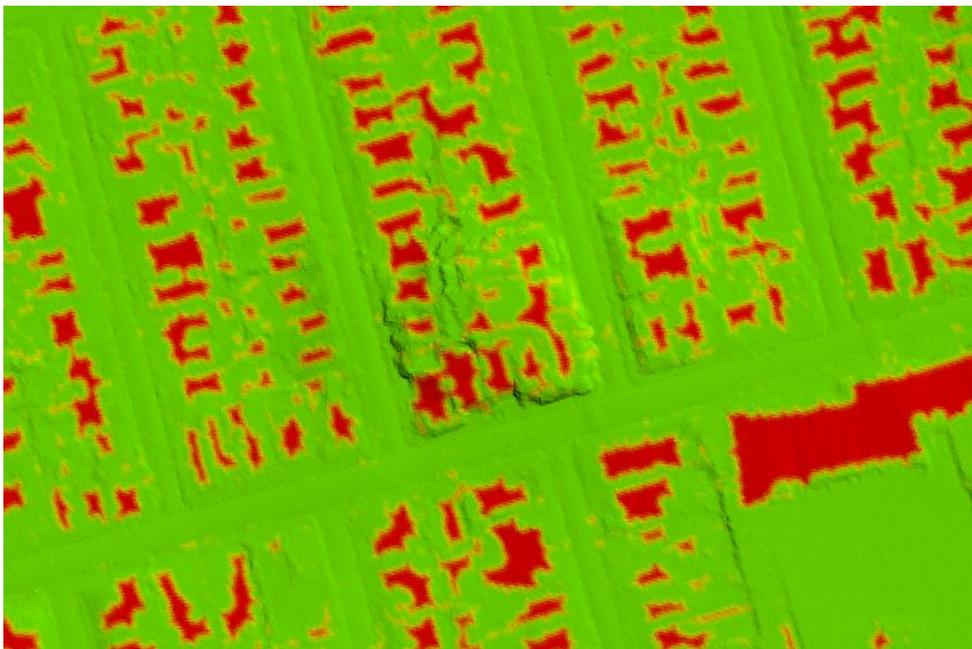
Figure 22 – Ground density of tile C5610_41940 from 3rd delivery showing all available ground points are added and the aggressive classification has been addressed.

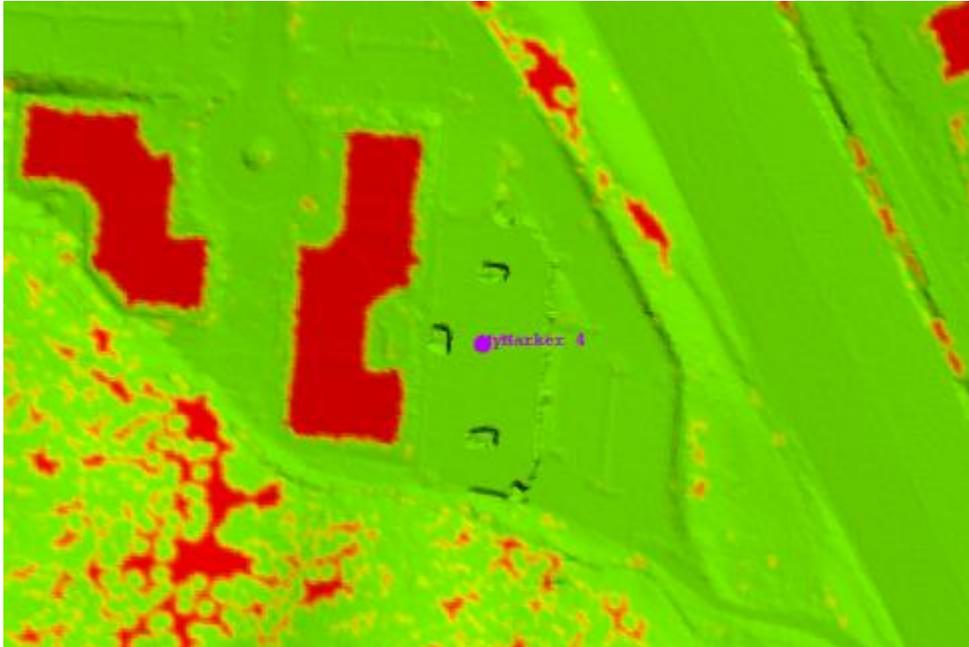
These classification issues are caused by ground points that are left in the dataset that should be removed. In general these are buildings, bridges, vegetation, or docks/piers. FEDI addressed and corrected all artifact calls identified by Dewberry in the 3rd delivery. An example of a correction is provided below in Figure 23 and Figure 24.

Figure 23 - Ground density model of tile c5400_42135 showing a building artifact from the 1st delivery.

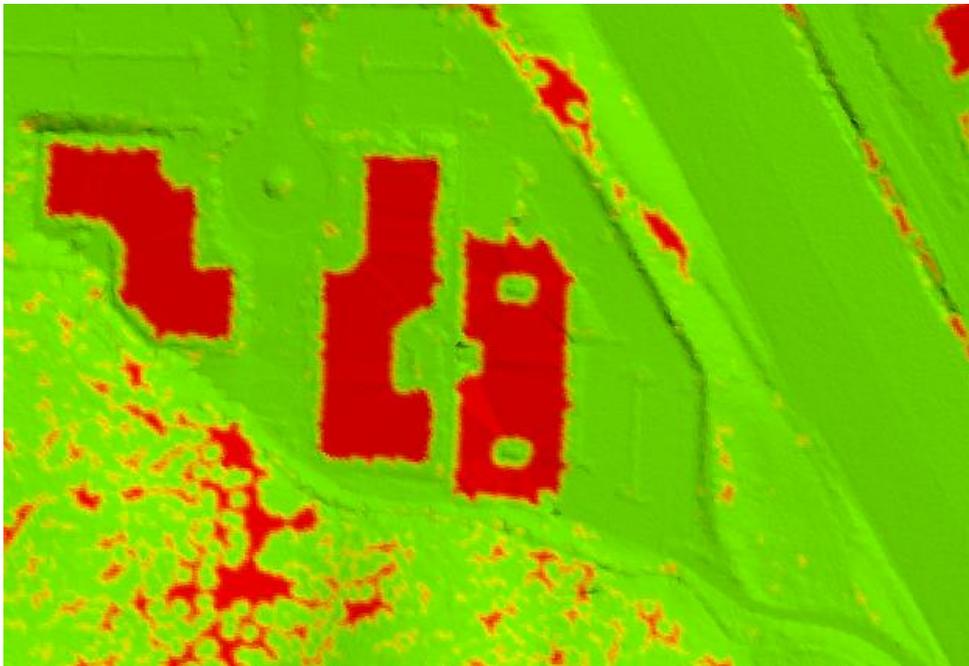
Figure 24 - Ground density model of tile c5400_42135 showing that the building is removed in the 2nd delivery.

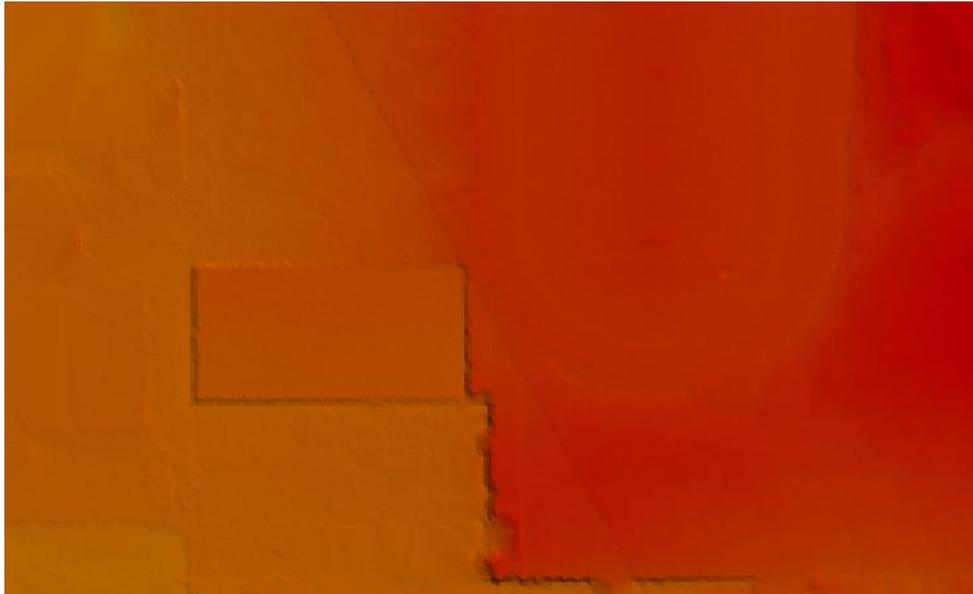
Figure 25 - Ground Model of tile c5565_42000 from the 1st delivery showing a flight line ridge. This is fixed in the 2nd delivery as shown below.

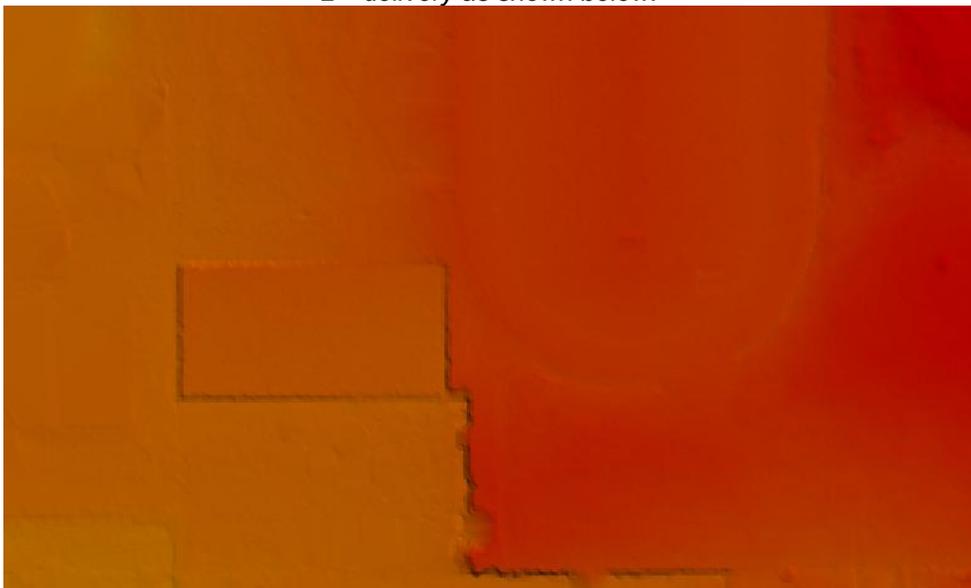
Figure 26 - Ground Model of tile c5565_42000 from the 2nd delivery showing that the flight line issue is fixed.

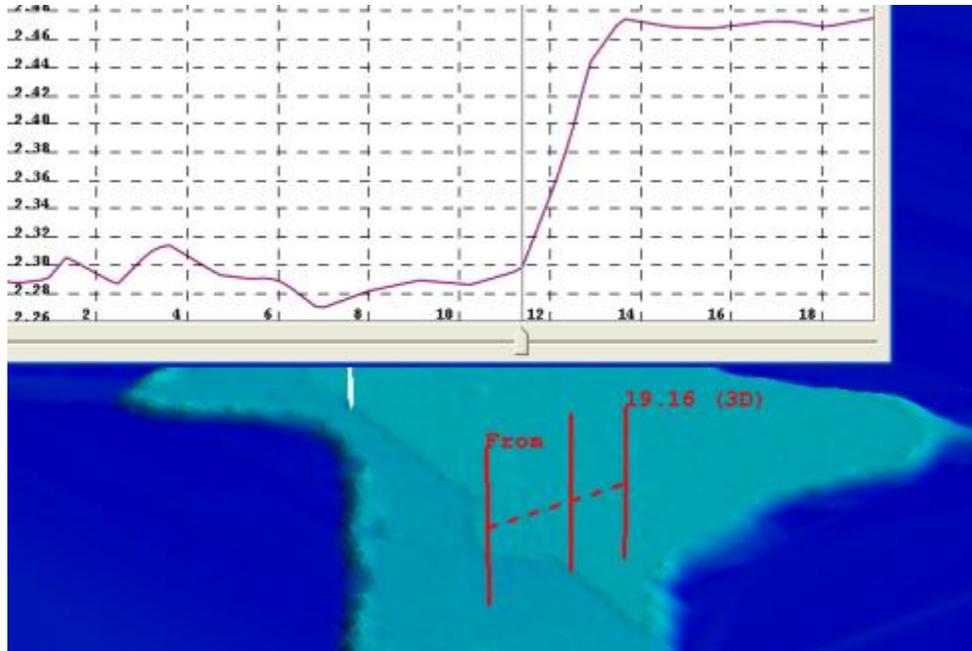
Call_FEDI_REPLY_041411.doc provided to Dewberry by FEDI on April 14th, 2011, the flight line ridge in question is due to a temporal change in the surface (Figure 27 and Figure 28).

Figure 27 - DTM model colored by elevation of tile C5610_42270 showing a flight line ridge that is ~18 cm. The profile and distance units are in meters. This flight line ridge is temporal and there is no issue.

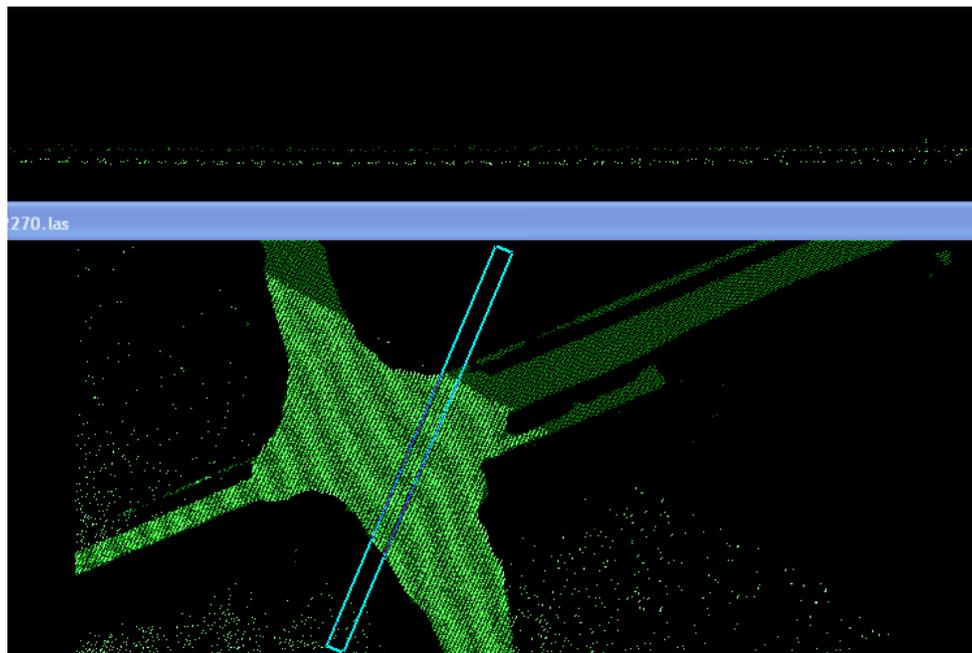
Figure 28 - Image from Fugro Viewer of tile C5610_42270 showing, on the top half, a profile of the points colored by flight line source ID and, on the bottom half, a map view of the points colored by flight line source ID. As visible in profile view the two flight lines are offset from each other by ~18 cm (distance measured in the program).

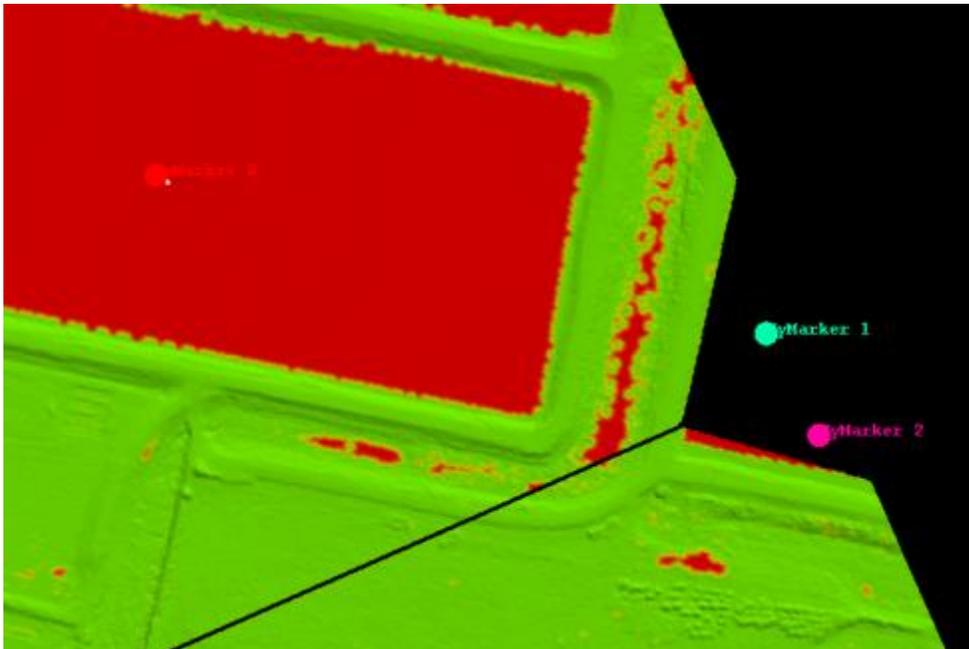
Figure 29 - Ground density model of Tile C5355_42300 that shows two areas of voids that are in class 1 (unclassified). It appears that the intensity image reveals that there is ground in these two areas and is therefore misclassified. The image below shows this issue is fixed in the 2nd delivery.

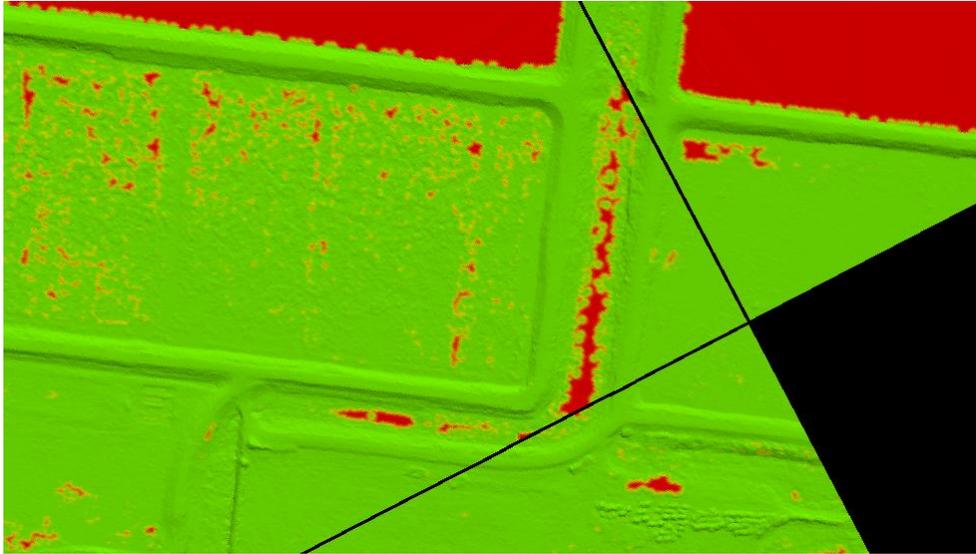
Figure 30 - Ground density model of Tile C5355_42300 that shows the two areas of misclassifications that have been fixed in the 2nd delivery.

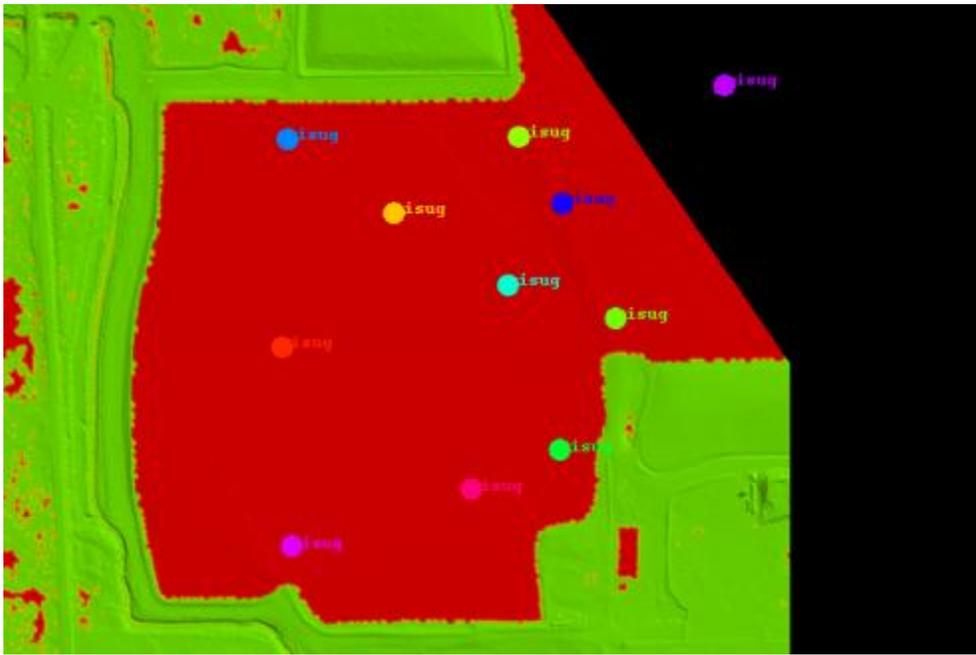
Figure 31 - Ground density model of a large area of no ground points in tile C5535_42000 from the 1st delivery. Each call indicates a feature that should be in the ground. In the 2nd delivery all these features were brought back to ground.

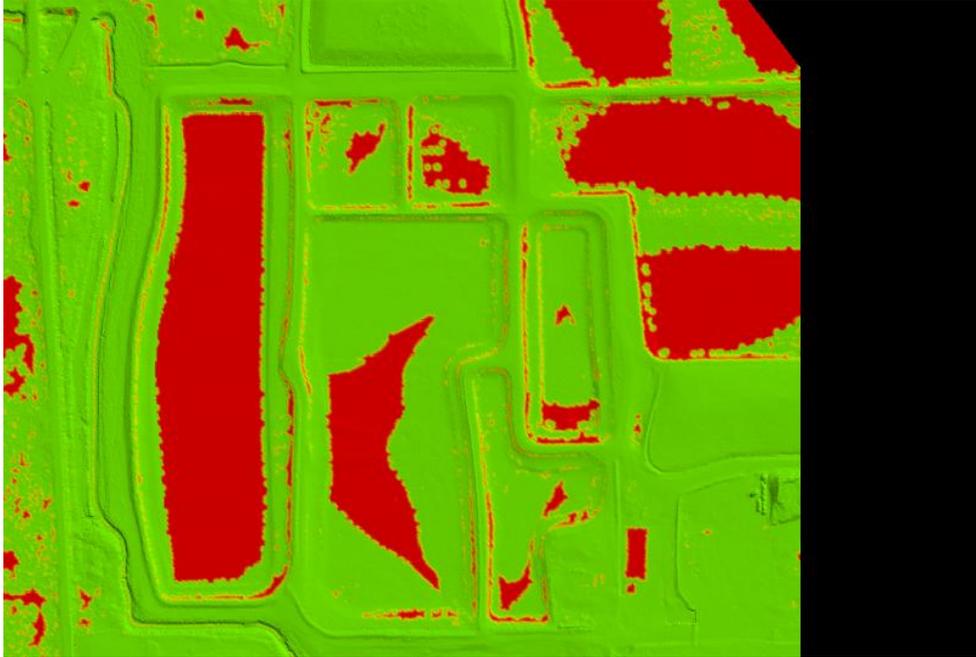
Figure 32 - Ground density model of tile C5535_42000 from the 2nd delivery. The issue of misclassification was addressed in the 2nd delivery.

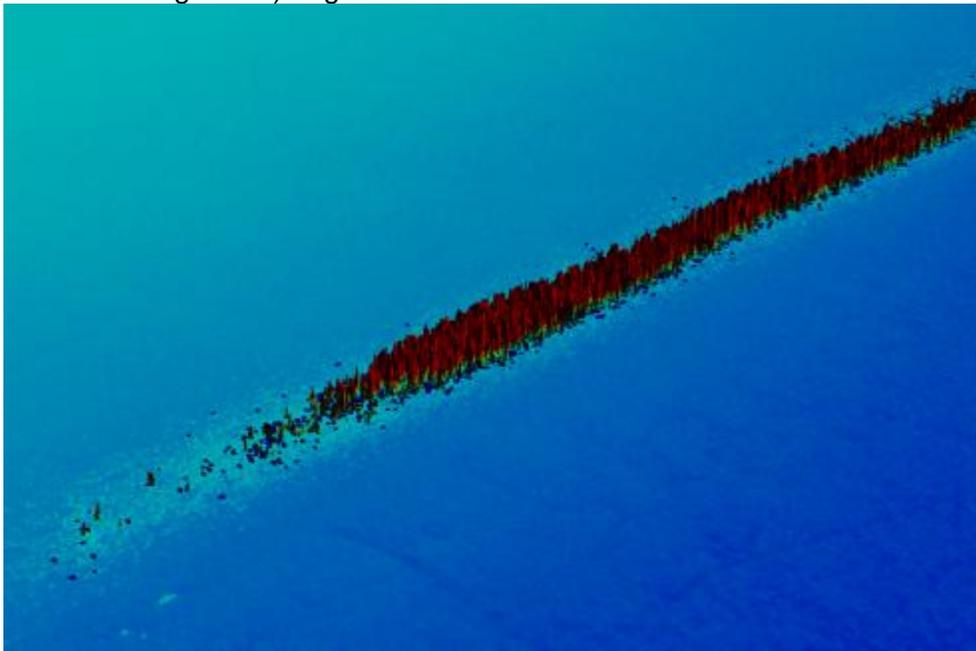
The intensity image in tile C5445_42165 reveals high intensity values at nadir which will sometimes cause what look like elevation spikes in the full point cloud. The “nadir spike” streak is caused by anomalous readings from the LiDAR sensor. There are two images showing the issue from previous deliveries (Figure 33 and Figure 34). Figure 35 shows that the issue is addressed in the 3rd delivery.

Figure 33 - Full point cloud DTM model colored by elevation of tile C5445_42165 showing the elevation spikes along nadir.

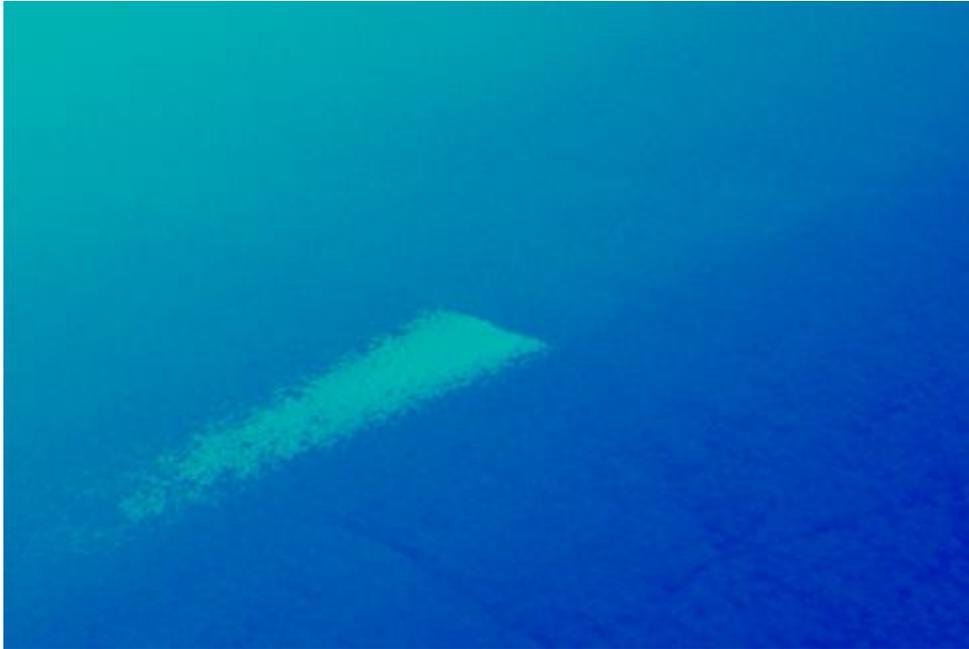
Figure 34 - DTM model of ground points colored by elevation of the same area as figure above in tile C5445_42165 showing the affect the sensor anomaly has on the ground model.

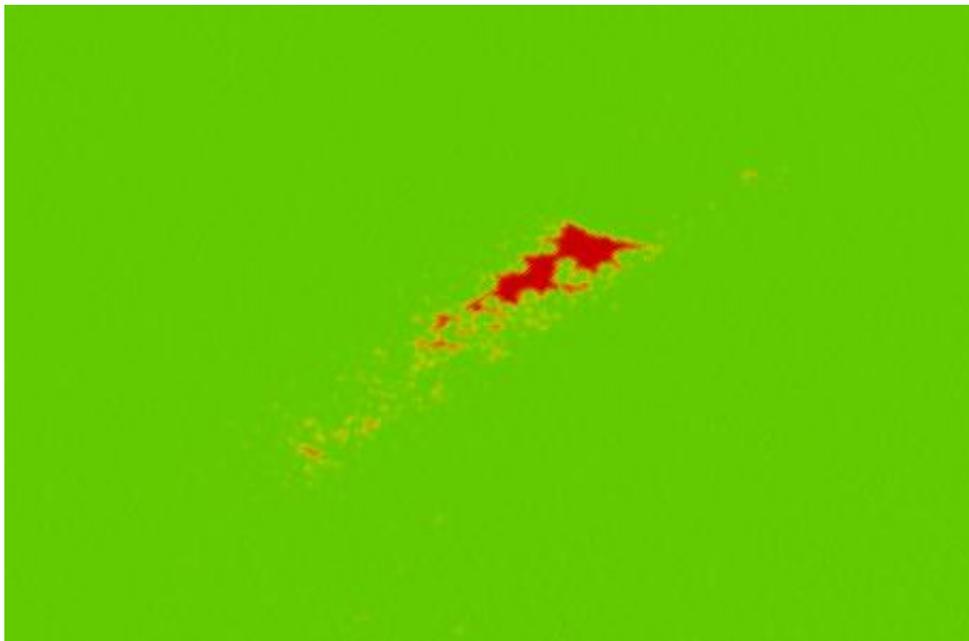
Figure 35 – Ground density model showing that the artificially high ground points are removed from the ground model.
