LiDAR Quality Assurance (QA) Report
San Francisco Bay LiDAR Project
NOAA Coastal Services Center
April 21, 2011

Submitted to:
NOAA Coastal Services Center

The following LiDAR quality assurance report documents Dewberry's 3rd review of LiDAR data and derived products for the San Francisco Bay LiDAR Project. The data was flown by Fugro EarthData, Inc (FEDI) for the NOAA Coastal Services Center. The delivery of the data includes portions of seven California counties: Alameda, Contra Costa, Marin, Napa, San Francisco, Solano, and Sonoma.

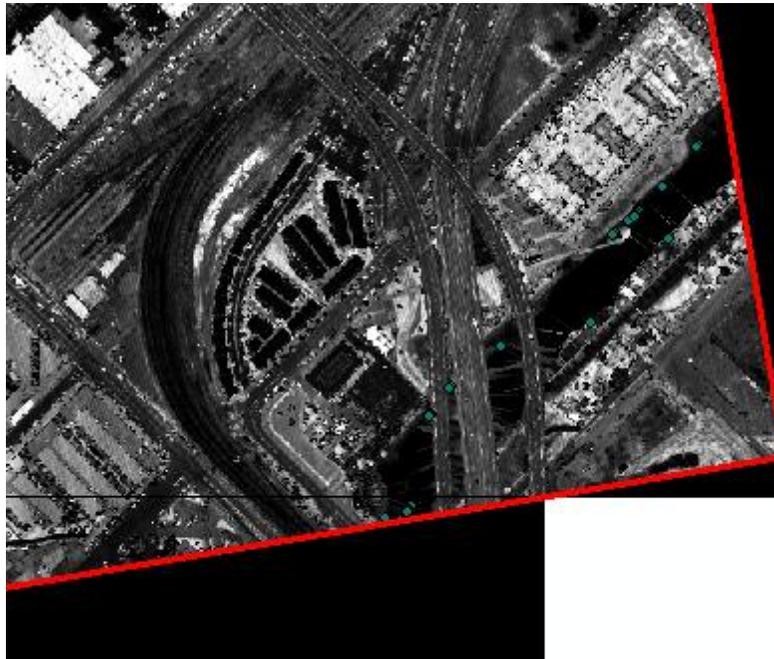
Figure 37 - Full point cloud intensity image of tiles c5520_41790 & c5520_41805. The blue dots are LiDAR points classified to water. There are no hydrographic breaklines in this area.

In the 2nd delivery, Dewberry noticed that tiles c5520_41790 and c5520_41805 have points classified as water, but there are no breaklines covering those points. Dewberry recommends adding breaklines in this location to match the classification of points for consistency. An image is provided below in Figure 37

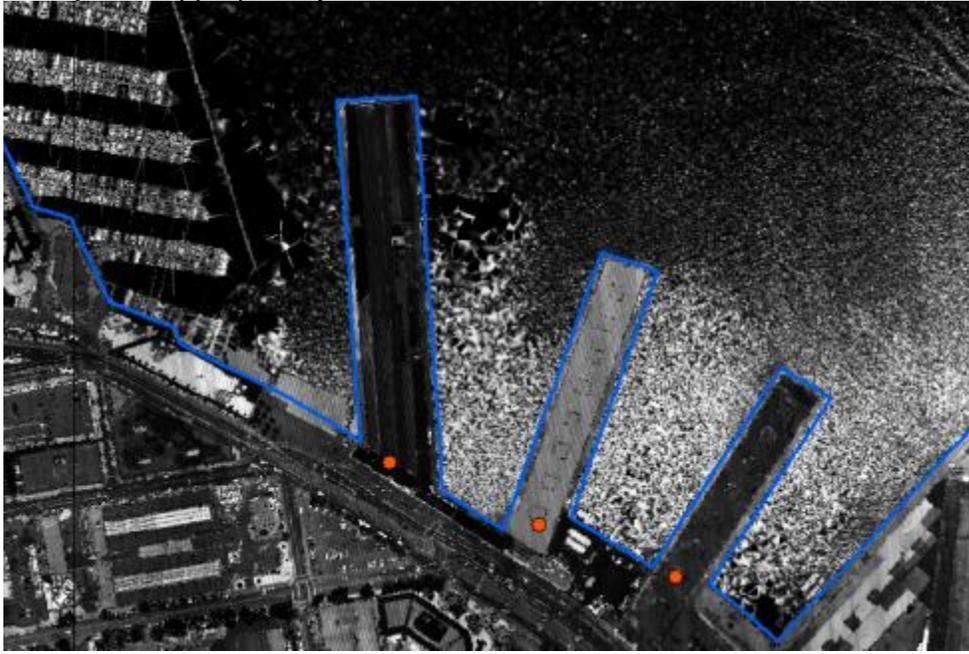
Figure 38 - Full point intensity image of tile C5520_41835 showing that piers are not removed by the tidal waters breakline (the blue line). These features should be removed because it can reasonably be determined where the edge of the water most probably falls beneath the piers.

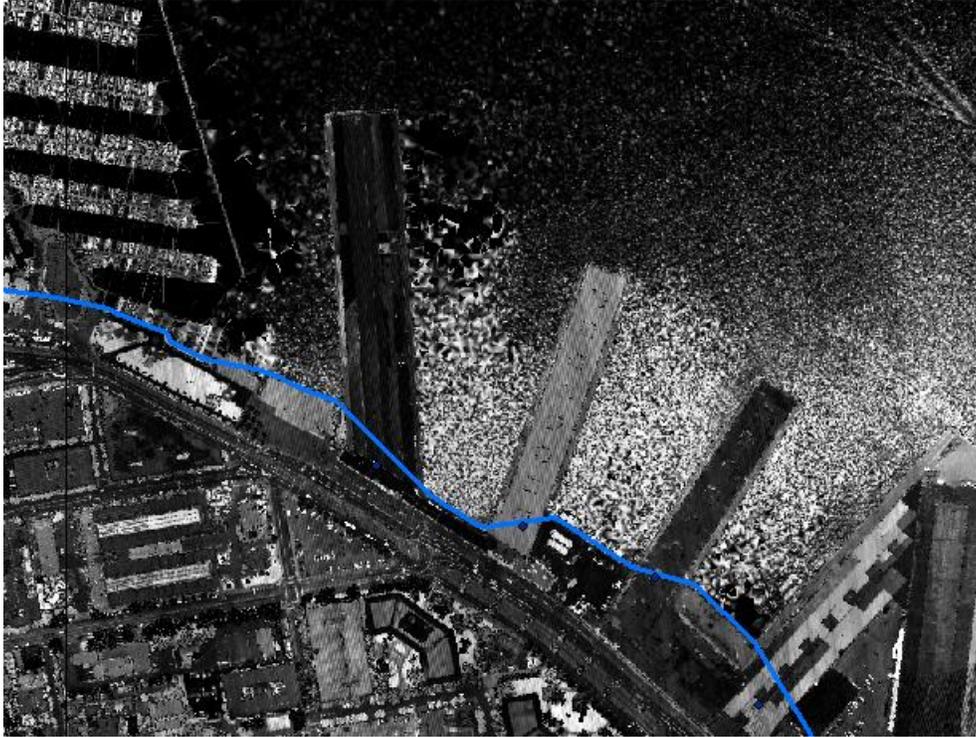
Figure 39 - Full point cloud intensity of tile C5520_41835 from 3rd delivery. The breaklines are adjusted and the piers removed from the ground model.

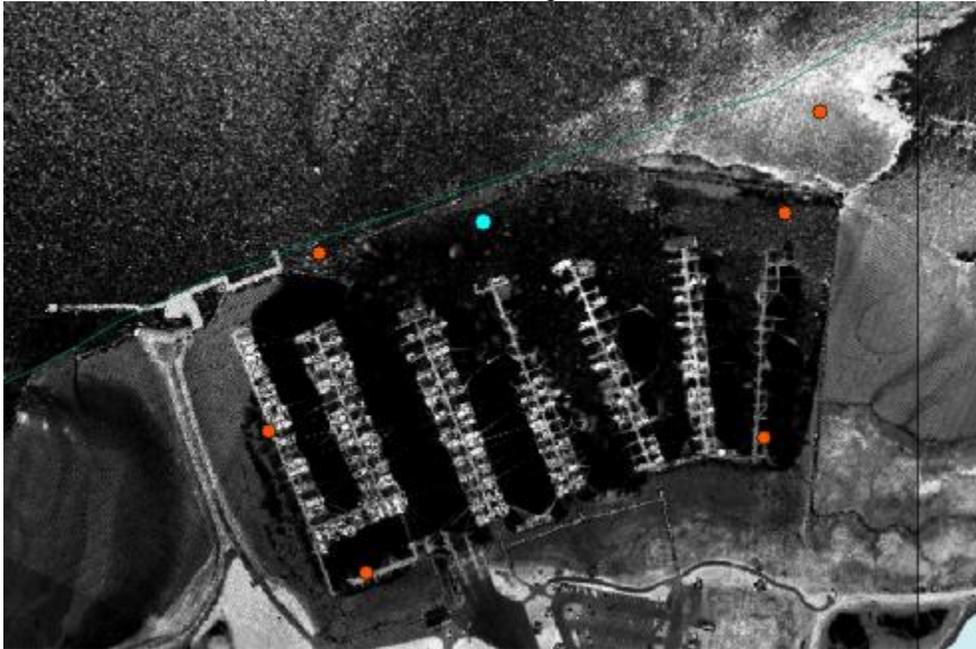
Figure 40 - Full point cloud intensity image of tile C5745_42090 showing that an inlet is not captured by the tidal waters breakline (the aqua-blue line) as well as inaccurate placement to the north. This image is from the 1st delivery and is corrected in the 2nd delivery as shown below.

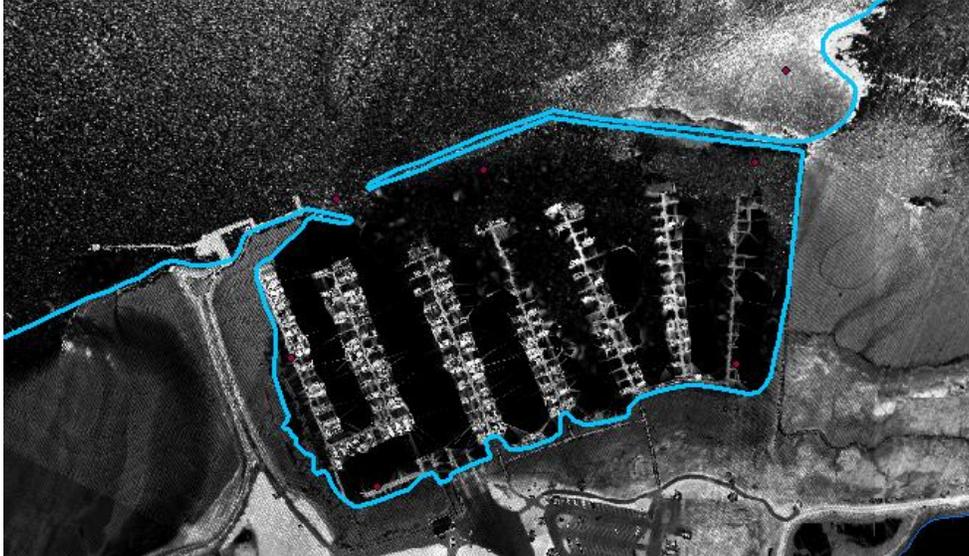
Figure 41 - Full point cloud intensity image of tile C5745_42090 showing that in the 2nd delivery all the calls are addressed and correctly fixed.

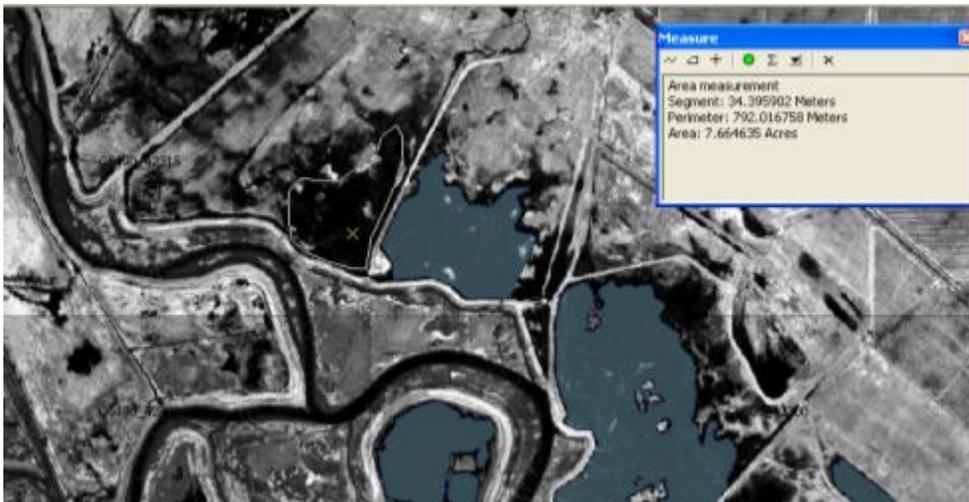
Figure 42 - Full point cloud intensity image of tile C5490_42315 that shows a water body feature that is over 2 acres in size that is not captured by the Lakes and Ponds feature class in the 1st delivery. This issue is resolved in the 2nd delivery as shown below.

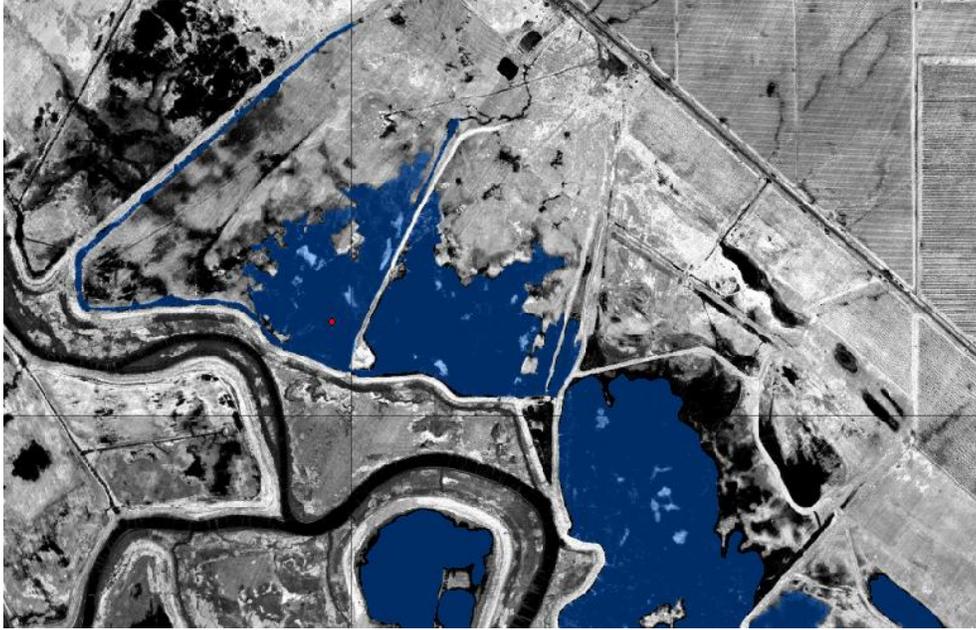
Figure 43 - Full point cloud intensity image of tile C5490_42315 that shows the water body is captured in the 2nd delivery.

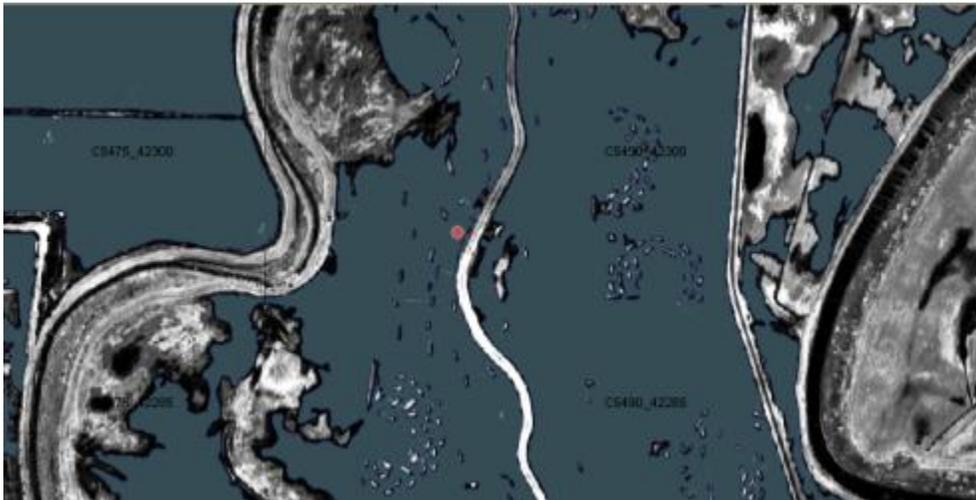
Figure 44 - Full point cloud intensity image of numerous tiles (identified in picture) that show numerous small islands captured and extracted out of the tidal waters polygon in the 1st delivery. This issue is addressed in the 2nd delivery as shown below.

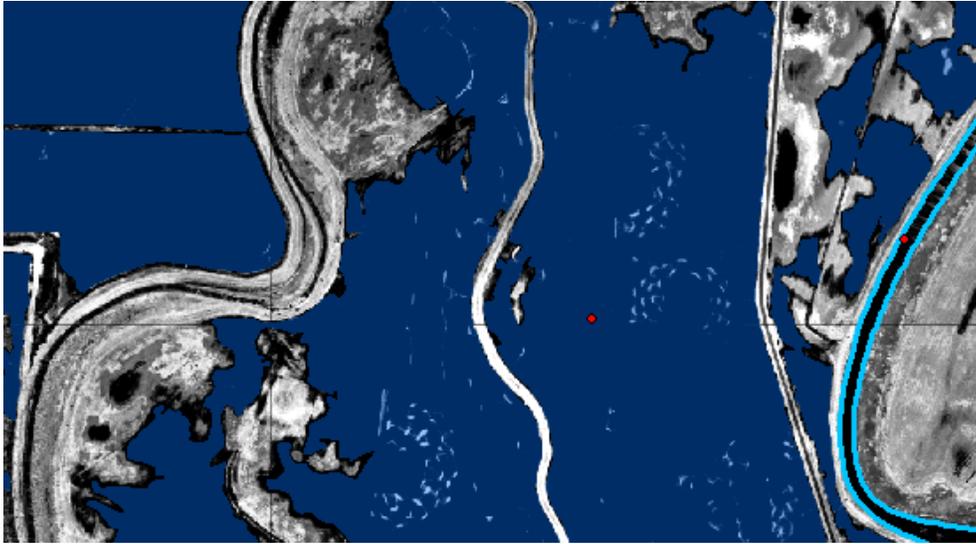
Figure 45 – Full point cloud intensity image of numerous tiles (identified in picture above) showing that the island are removed in the 2nd delivery.

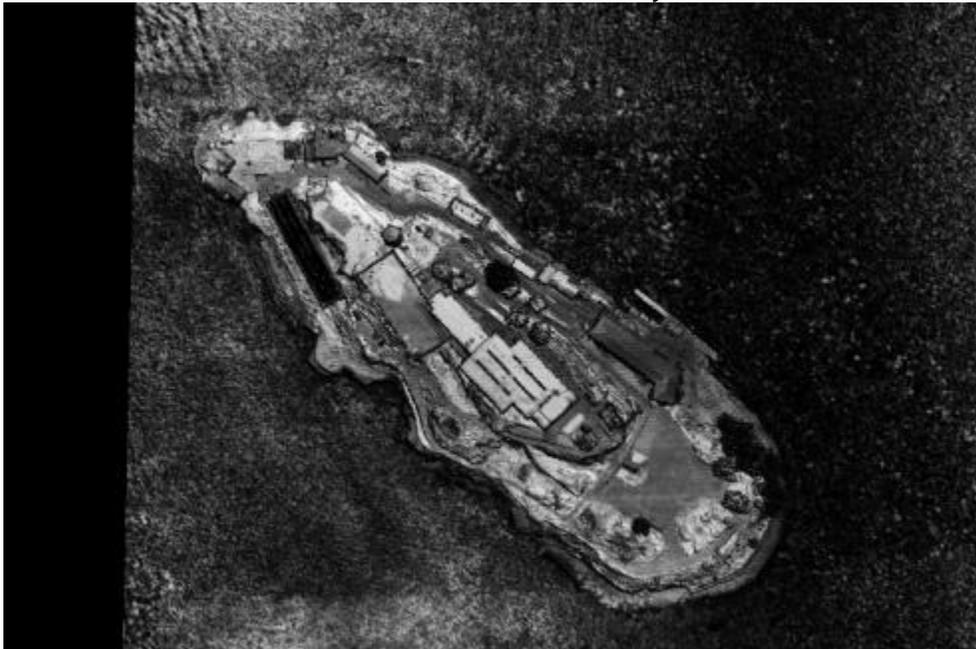
Figure 46 - Full point cloud intensity image of tile C5505_41865. In the 1st delivery this was not captured by the breaklines and did not appear in the ground model. This is fixed in the 2nd delivery as shown below.

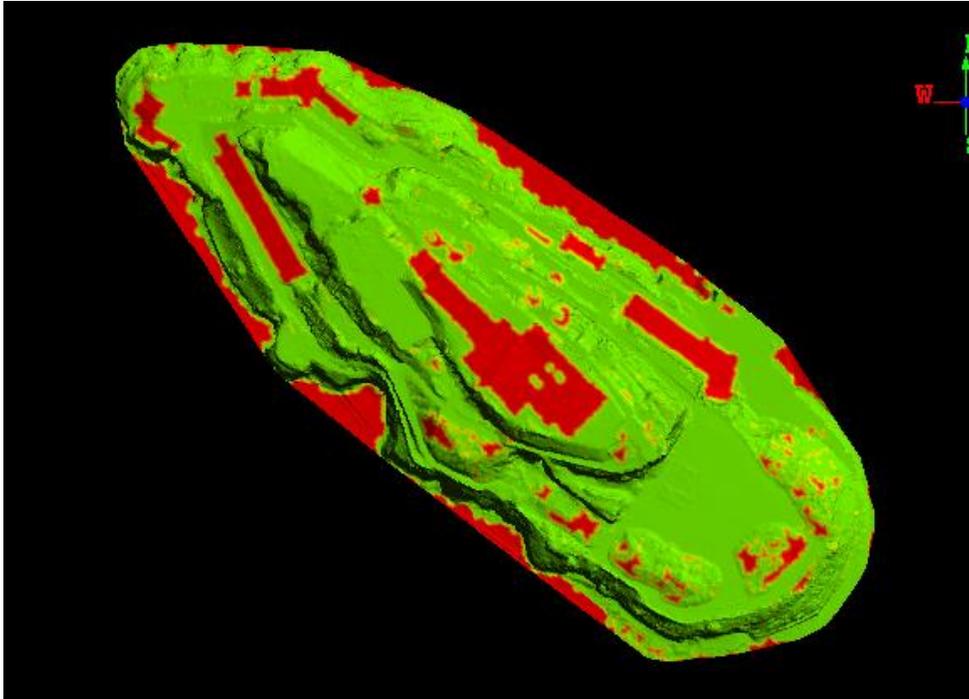
Figure 47 – Ground density model of tile C5505_41865. Alcatraz island is now incorporated into the ground.

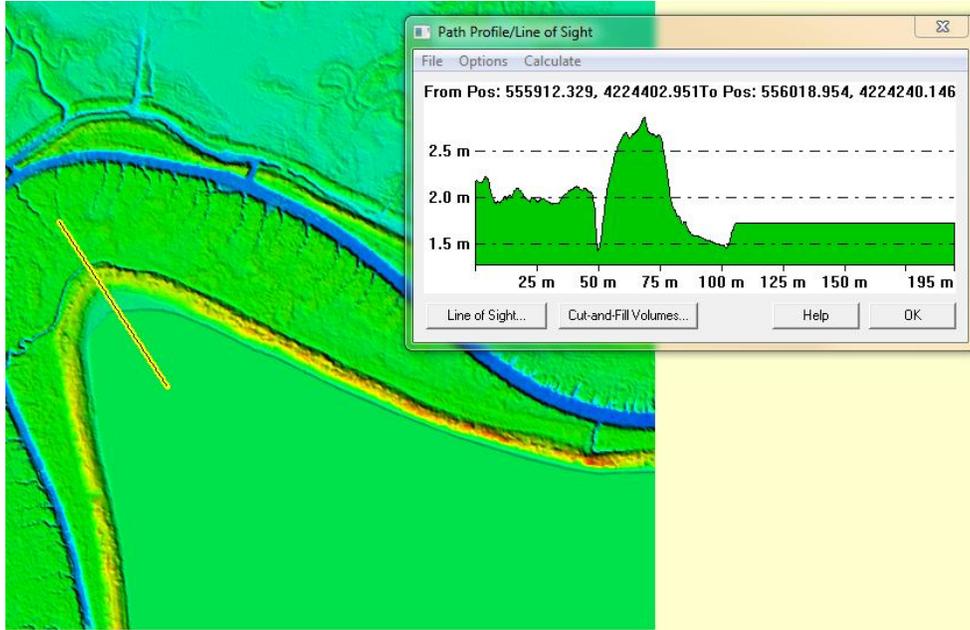
Figure 48 - DEM colored by elevation in Global Mapper of tile c5550_42240 showing a floating Tidal hydrographic feature.

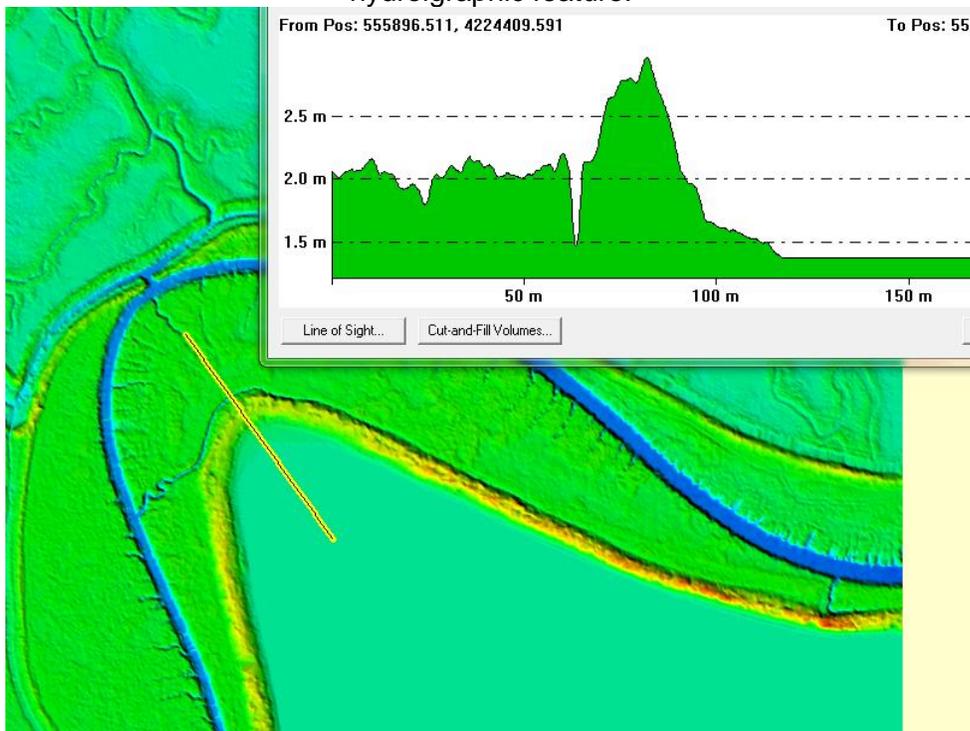
Figure 49 – DEM colored by elevation in Global Mapper of tile c5550_42240 from the 3rd delivery showing that the water body no longer floats.

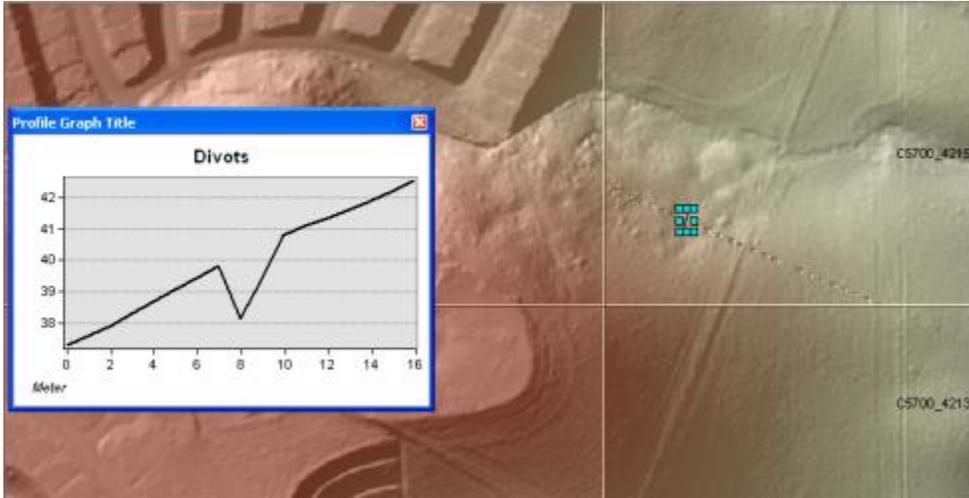
Figure 50 - DEM of tile C5700_42150 from the 1st delivery that shows numerous divots creating a linear feature that is not reflected in the LiDAR.

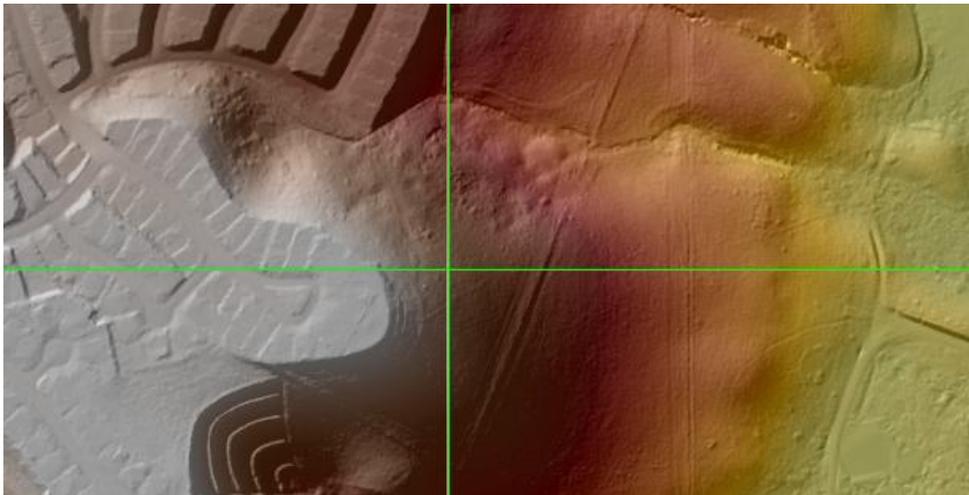
Figure 51 - DEM of tile C5700_42150 from the 2nd delivery that shows the linear artifact are no longer present in the DEM.
