LiDAR QA/QC
– Quantitative and Qualitative Assessment Report –
Jefferson County FL
May 6, 2008

**Dewberry**
Fairfax, VA

EXECUTIVE SUMMARY

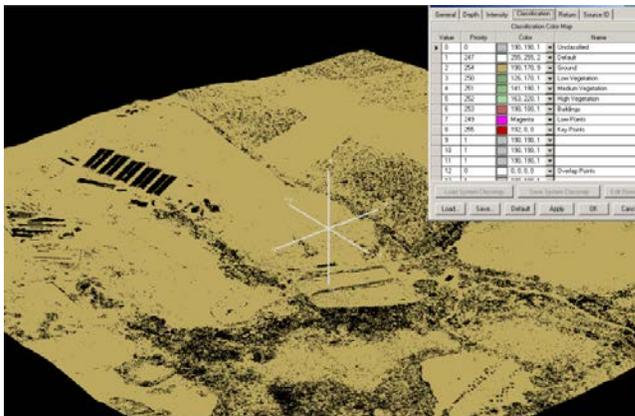
The class review allowed us to identify a tile (22405850) with all the points in class 2 (see Figure 9). A visualization confirmed that this tile was correctly classified as far as the ground is concerned (buildings and vegetation are removed) and would be correct to create a bare earth model. However, all the other classes are missing.

Figure 9 – Tile 22405850; only ground class is present in the file

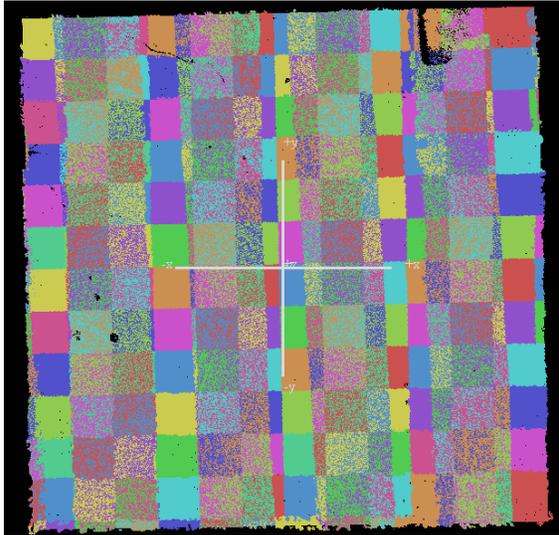
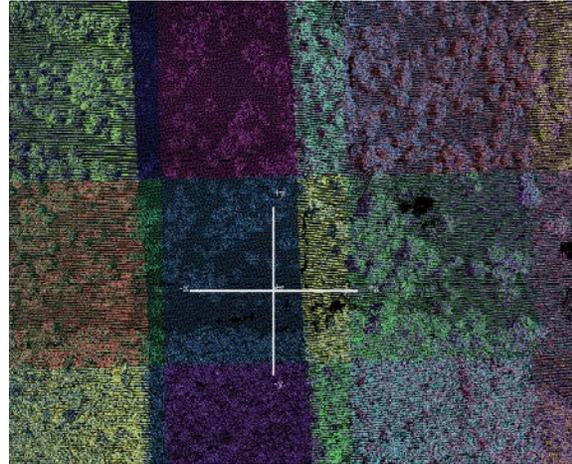
Statistics on the Point Source Id parameter, usually holding the flight line number, extracted 23 files having only one flightline number equal to 1, whereas it was clear that several flightlines were stored in the file (see Figure 12, right), this is a minor issue as no explicit specification was made for this parameter. Another tile (22156000) exhibits an unusual pattern for the flightline id with sections (squares) within a flight line being classified as different flightlines (Figure 11).

Figure 11 – Tile 22156000 with mosaic of Flightline numbers

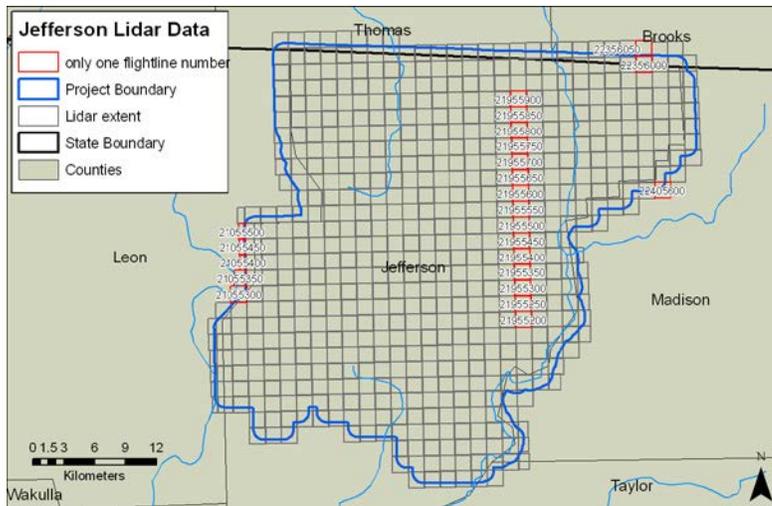
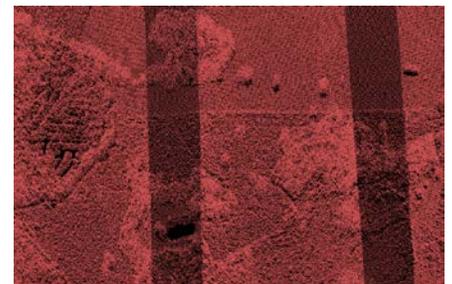
Figure 12 – Tiles with only one 'Point Source ID' or flight line number

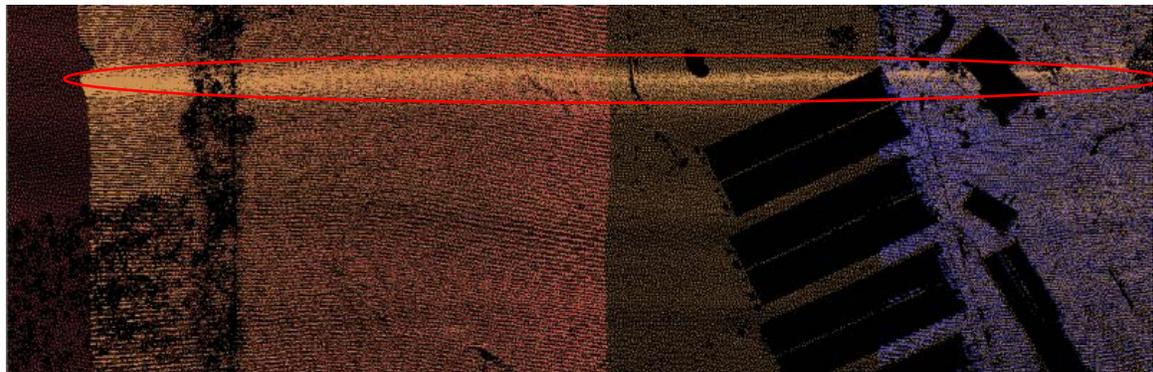
When considered over an entire tile, the point density meets the specifications of 0.7m and is even better in overlapping areas. However in the sections where only one pass was acquired, which correspond to the middle of each flightline (nadir), the point spacing may be wider (1.2m along scan, 1 to 1.2m along track at nadir).

Figure 17 – Point “bunching” in the yellow flightline

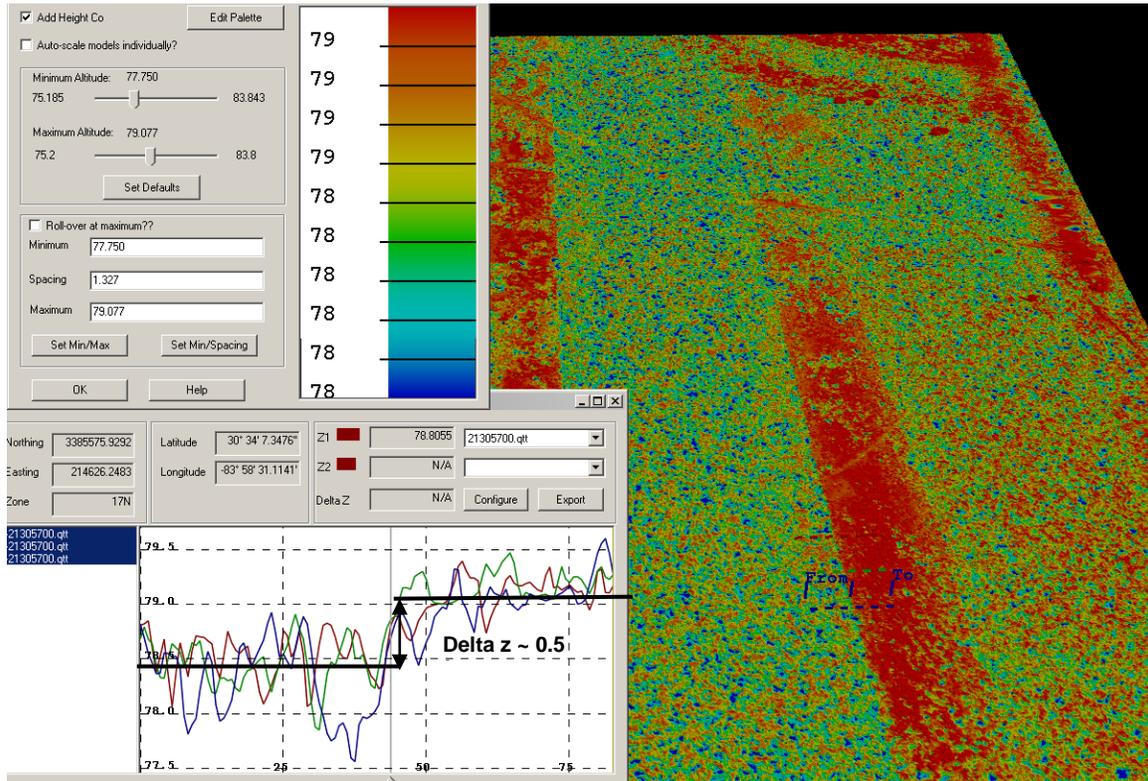
The fact that the flightlines do not completely overlap and that the far edges were not clipped results in recurrent issues in the bare earth model. Indeed, we found a lot of false ridges located exactly along these edges as illustrated in Figure 18. Actually, the central sections of the flightlines (where there is no overlap) sometime exhibit a delta z from 0.25 to 0.5 foot compared to the overlapping sections. If we examine the full point cloud using a cross section as in Figure 19 and Figure 20, we can clearly see that this is due to the fact that more points were available where two flightlines have been acquired and that points located at the edge of a flightline (larger scan angle) were lower than points acquired at nadir. It could be due to a better penetration in the vegetation at a large angle or due to a mirror speed anomaly when it changed direction at the end of a scan.

Figure 18 – Tile 21305700; Bare earth model colored by elevation. The 3 profiles illustrate a ridge along the flightline edge; actually all the central sections of each flightline (where there is no overlap) exhibit a deltaz of 0.5 foot compared to the overlapping sections.

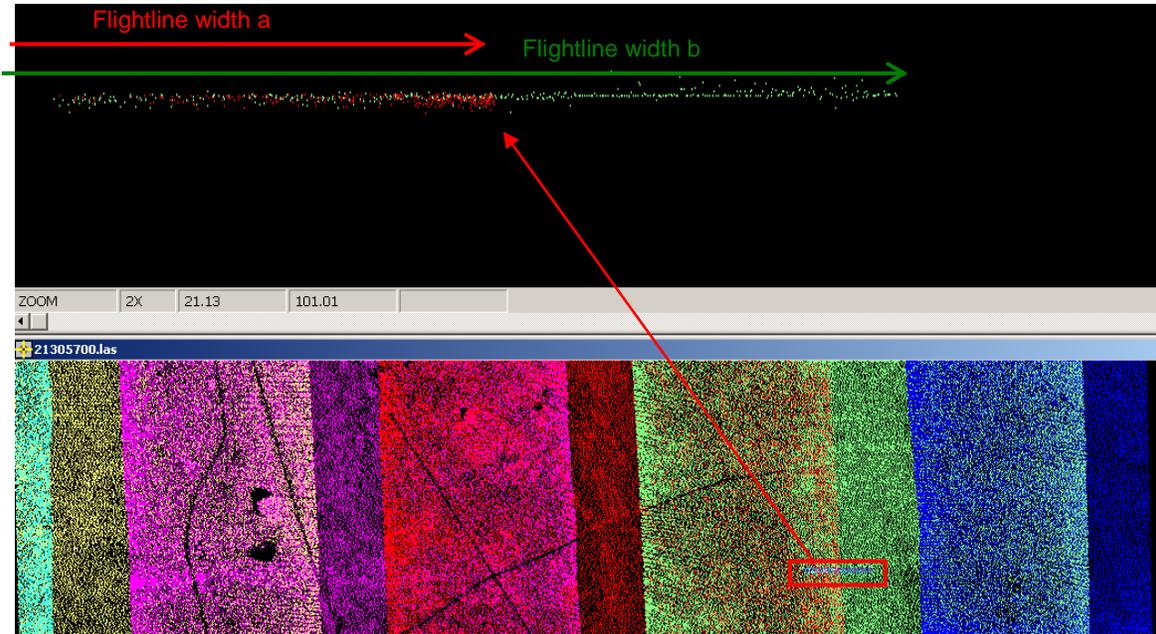
Figure 19 – Tile 21305700; Full point cloud colored by flightline number, the top cross section shows the point elevation at the edge of a flightline. At the edge of the red scan, a majority of the lower points are red.

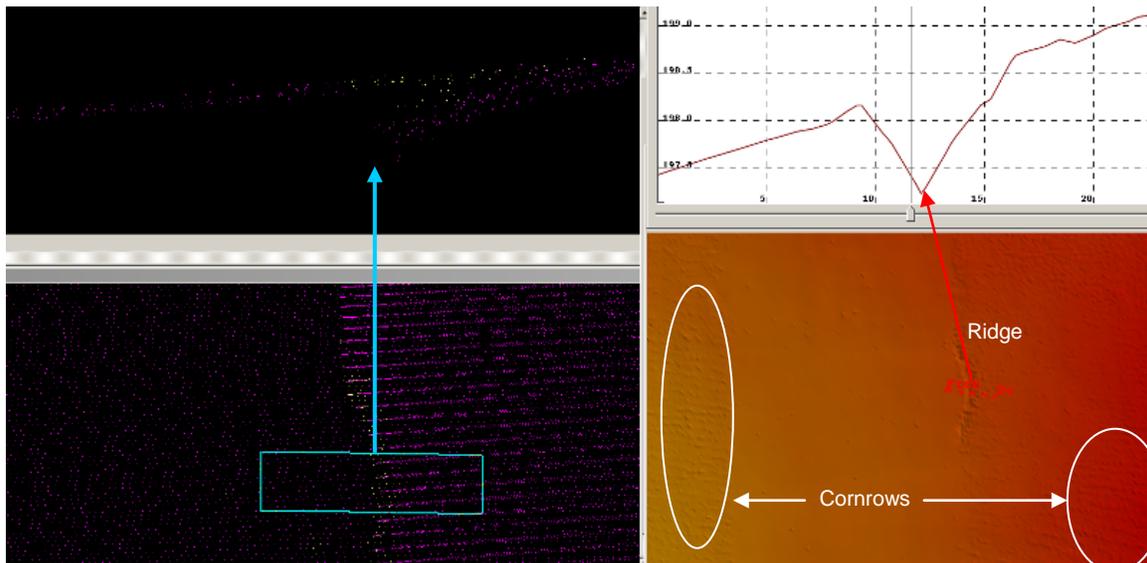
Figure 20 – Tile 21305100; Full point cloud colored by class, the top cross section shows the point elevation at the edge of adjacent flightlines. Ground points are colored in pink, showing that ground points are higher when only one flightline is available.

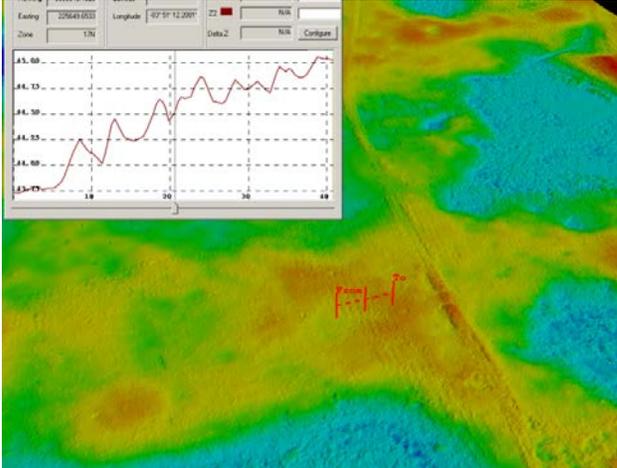
Cornrows were typically seen throughout the project. There are multiple reasons as to why this happens but the end result is that adjacent scan lines are slightly offset from each other. This will give the effect that there are alternating rows of higher and then lower elevations. Although this is common with LiDAR data, as long as the elevation differences are less than 20 cm and the occurrences are minimized, it is acceptable

because it is within the noise and accuracy levels. We think that these cornrows are a side effect of the previously mentioned ridges between overlapping flightlines as the cornrows mainly occur along the edges of these flightlines (see Figure 20). Our review found several negligible instances of the cornrow effect as in Figure 21 and the remainder of this effect was within acceptable limits.

Figure 21 - Cornrows under the acceptable limit (0.25feet)

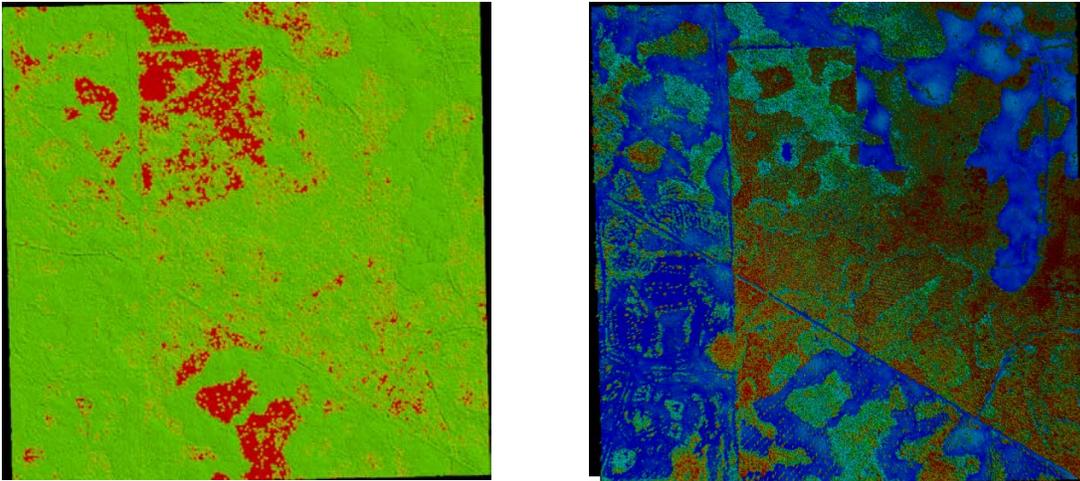
Another problem that we often found is patches with lower density of ground points. When the vegetation is very dense, the LiDAR may not penetrate the canopy all the way to the ground, therefore only a few ground points remain after classification of the vegetation. Nevertheless, as soon as a few points are present, a 3D model can be built with an acceptable reliability, especially in flat areas. However, the smoothness of the surface is often of less quality since low understory vegetation that completely blocks the pulse may be classified as ground resulting in a rather noisy surface. This is illustrated in Figure 22 and Figure 23. Figure 24 shows the corresponding bare earth DEM raster that exhibits the same kind of noisy features and a cross section of the full point cloud clearly proving that dense bushes are blocking the LiDAR.

Figure 22 – Tile. Sparse density and noise in ground surface due to poor LiDAR penetration in really dense vegetation.

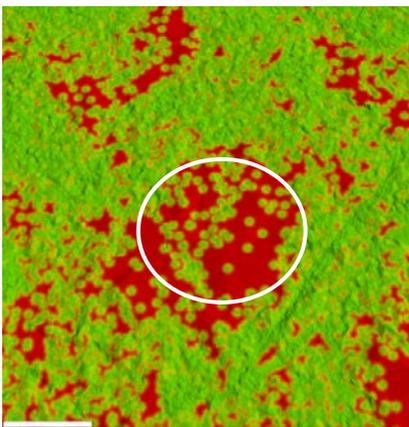
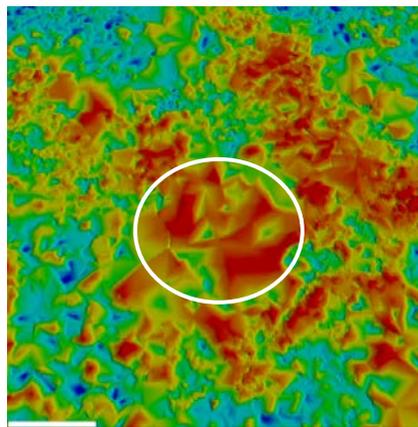
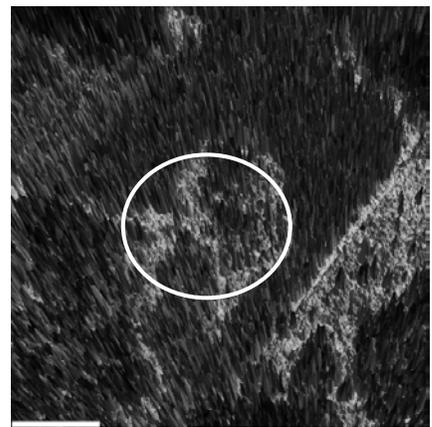
Figure 23 – Tile 21704700, detail. Sparse density and noise in ground surface due to poor LiDAR penetration in really dense vegetation. The white circle pinpoints the same area in the three images.

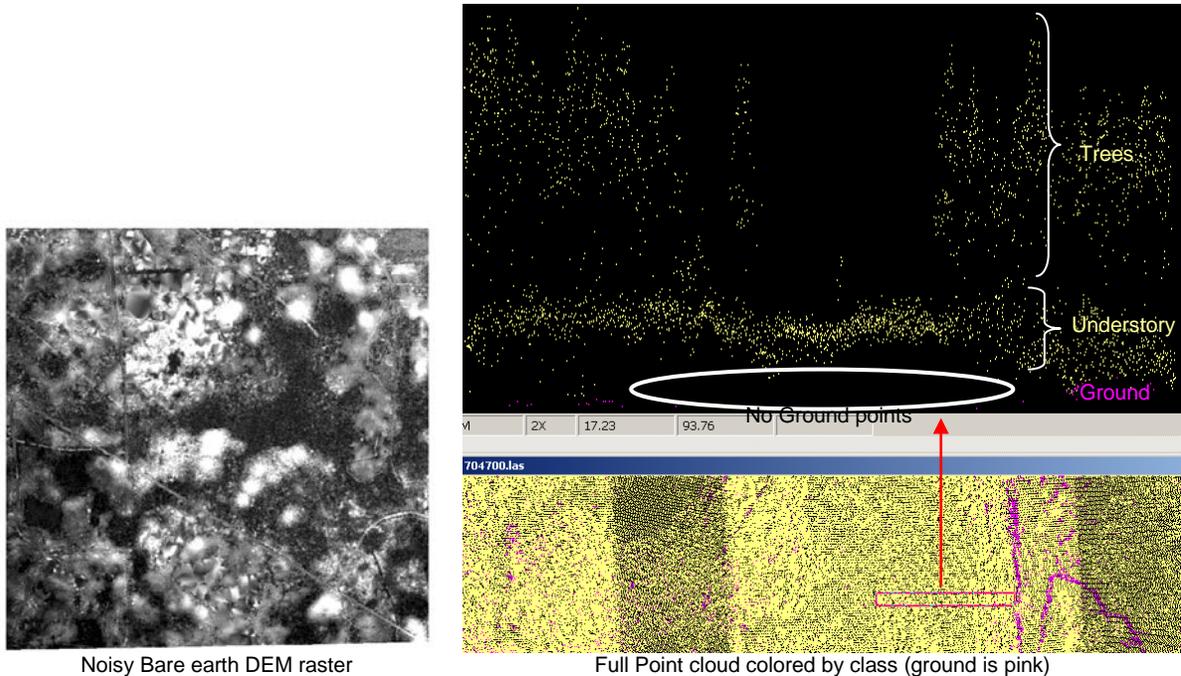
Figure 24 – Tile 21704700. Poor LiDAR penetration in dense brush areas

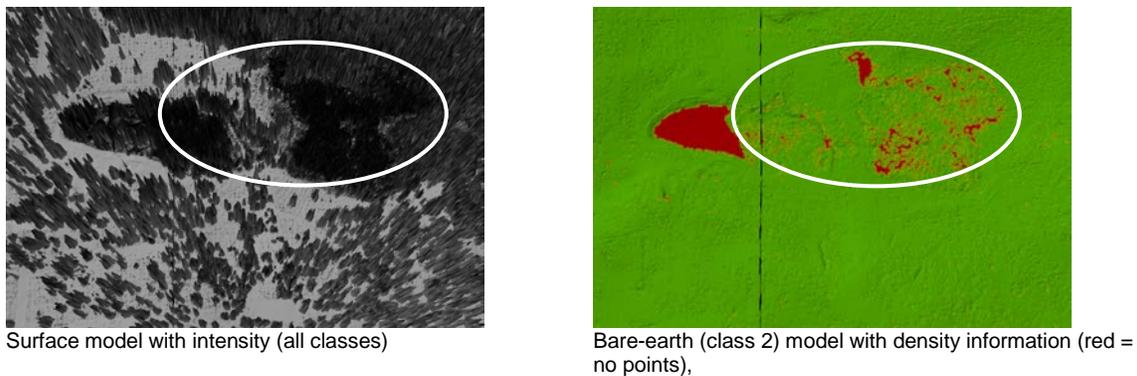
We did find some isolated spots of sparse density of points in the bare earth model with no apparent change in the vegetation density at these locations; however the intensity image is characterized by a darker tone. After carefully inspecting the full point cloud, which really shows presence of LiDAR points inside the vegetation but fewer at ground level and based on the dark coloration of the intensity images we assumed that these are swamp areas where the LiDAR is not reflected by the wet ground surface. Indeed, except at angles close to nadir, the Near Infrared LiDAR beam is usually not reflected by water (Figure 25).

Figure 25 - Poor LiDAR reflection in swamp area, the LiDAR do not seem to be reflected by the underlying surface.

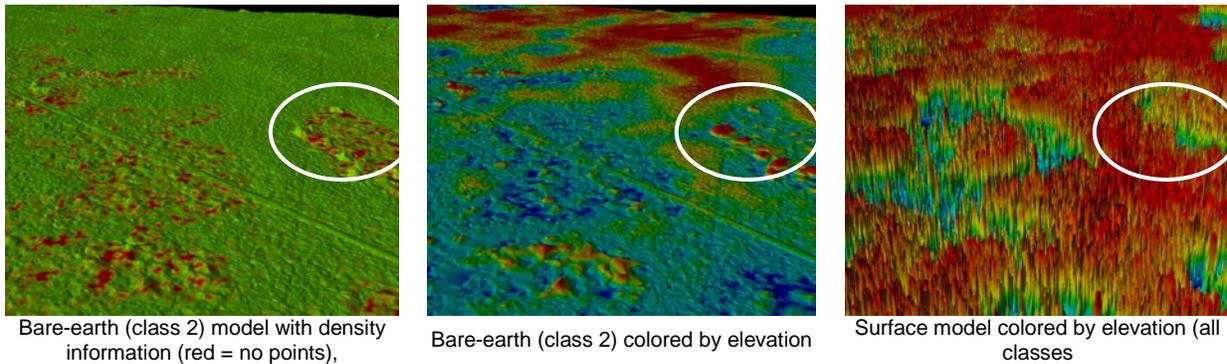
Another classification issue that we encountered is the presence of vegetation artifacts (see Figure 26). Although it is conceivable that the soil exhibits natural small relief, we believe that they are vegetation remains as they occur in areas where we also notice a sparse density of the ground points. These two types of issues are actually linked together; if LiDAR is blocked by the understory vegetation it is more likely that the classification routine treats these last points over vegetation as ground. These artifacts are limited in height but add to the general noise of the bare earth model.

Figure 26 – Tile 21404850. Poor LiDAR penetration, possible vegetation artifacts

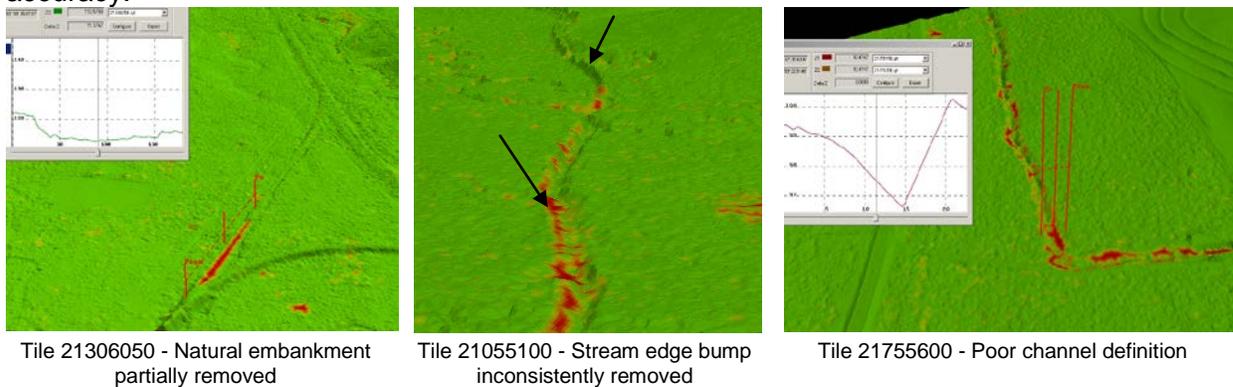
The other classification issues that were observed are inconsistencies in the processing of stream banks or natural elevated embankments. Portions of these features were removed from the ground whereas others are kept. Along stream edges, we also noticed possible aggressive classification; as a result, cross sections of the channel may lose accuracy.

Figure 27 – Inconsistencies in classification (Bare-earth-class 2 model with density information, red = no points)
