LiDAR QAQC Report
Hawaii TO12: Molokai, Maui, Lanai islands
March 2008

**Dewberry**
Fairfax, VA

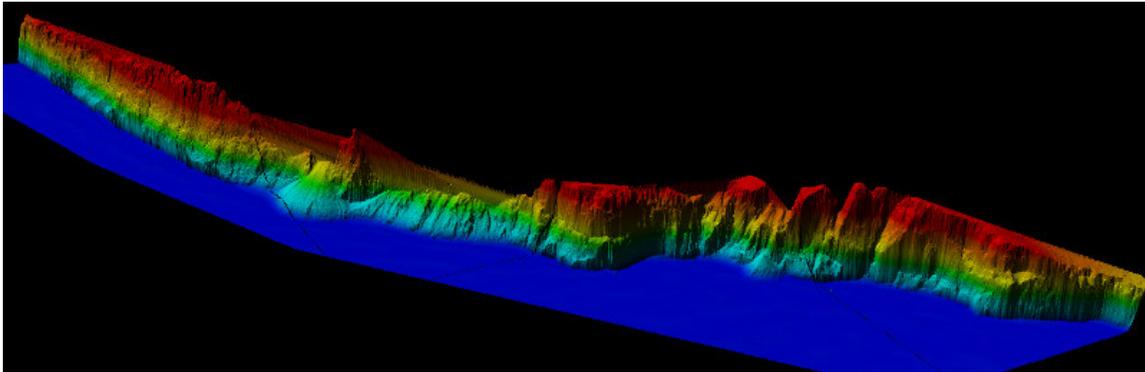
Figure 9 – High Zmax on cliff, the project boundary is very close to the shoreline

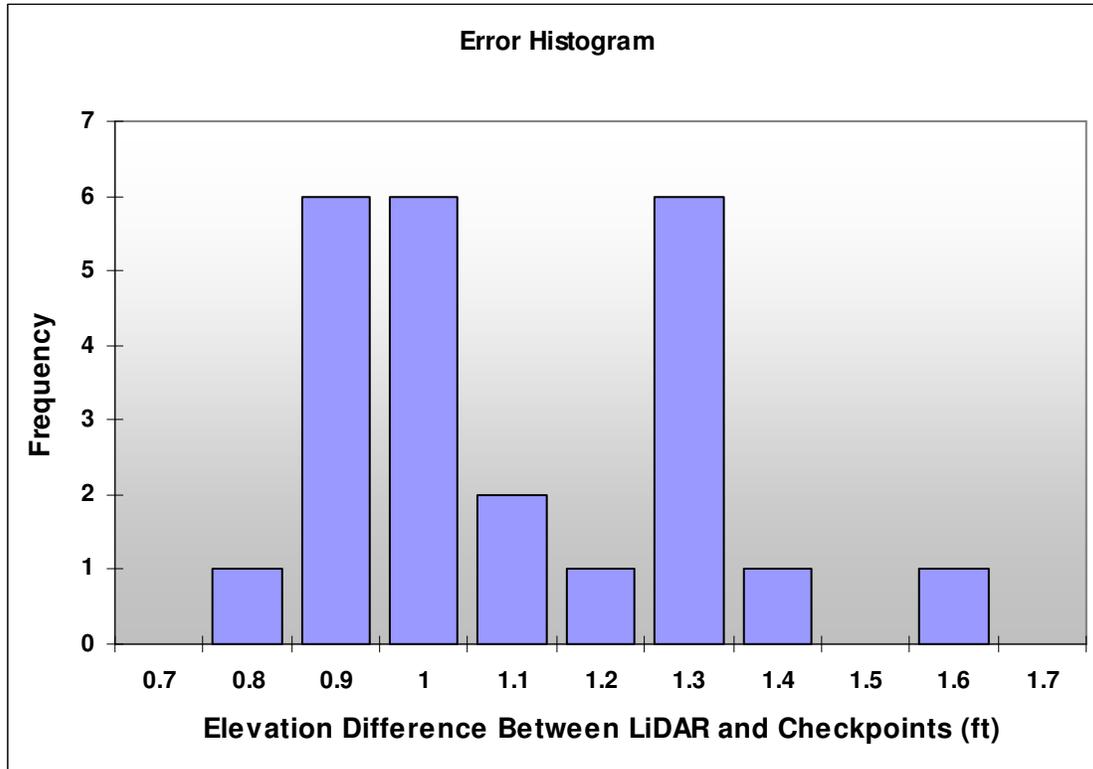
Figure 10 – Histogram of the elevation differences between LiDAR and Checkpoints

By reviewing the distribution of the errors in Figure 10, it was apparent that there was a systematic positive bias in the data. Based on what we know of the islands and the lack of an official vertical datum, it was conceivable that Airborne 1 used different vertical values for their control and the processing of the LiDAR data. Due to our knowledge of vertical control issues on this island we suggested that the data be reexamined by Airborne1 to investigate the cause of this discrepancy.

After review by Airborne 1 the data was vertically adjusted based on utilizing the same control as the checkpoints and resubmitted to us. The survey report by McGee Surveying clearly outlines how the vertical control was derived for the checkpoints and why these values take precedent over other local vertical datums for this area (see Appendix B. By utilizing the same control values and recomputing the RMSE, the Airborne 1 data meets the specifications as shown in Table 1.

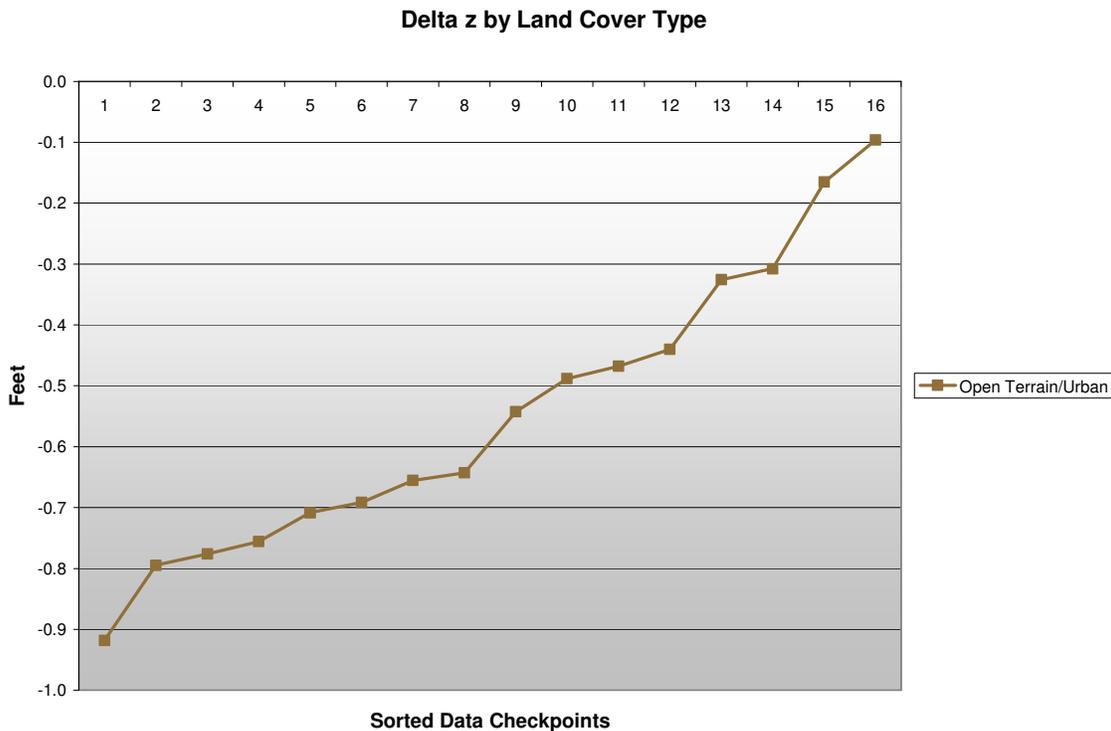
The consolidated RMSE meets the NSSDA standard. We noticed that all the errors are negative as seen in Figure 13 indicating that a bias exists in the data.

Figure 13 – Elevation errors (sorted)

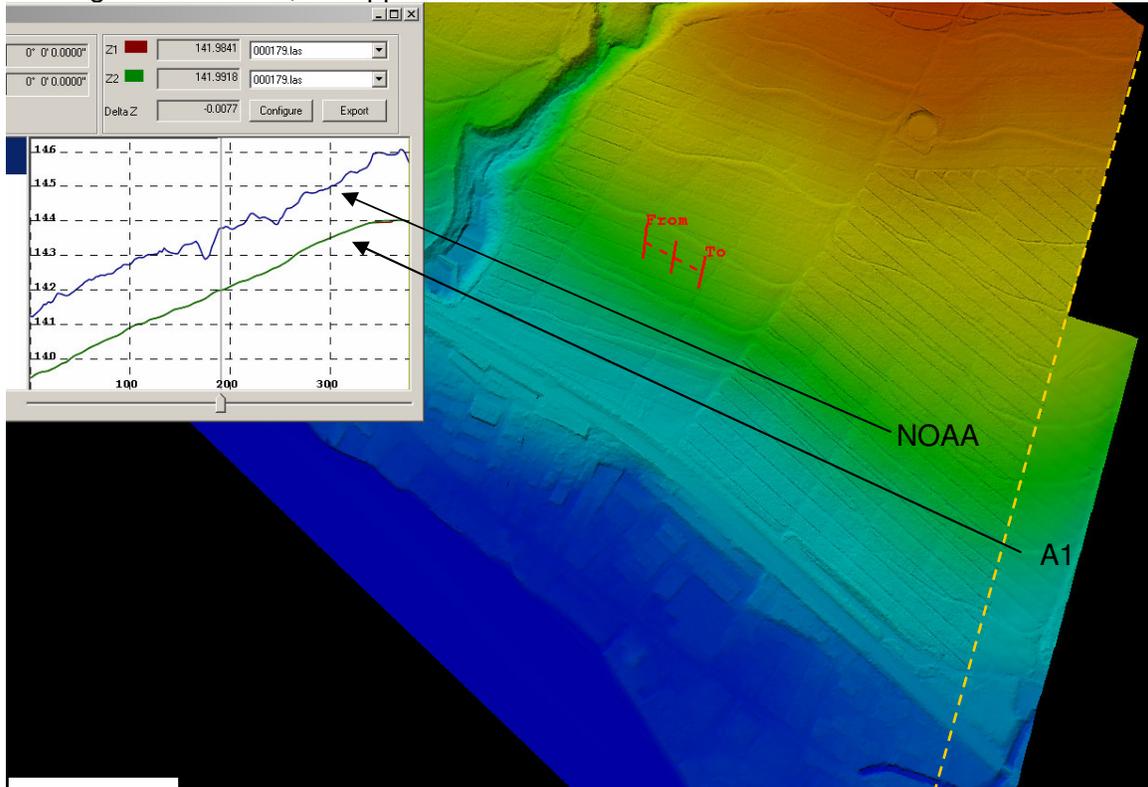
We checked the elevation matching between the two sources and found about 1 feet discrepancy between NOAA and A-1 data (NOAA data is generally above the A-1 data as shown in Figure 14). When computing the RMSE over a mixed dataset, we noticed that, except for one point, the NOAA data fit our survey points (see check point error

Figure 14 – 3D models of ground LiDAR data from NOAA (left from the yellow dashed line) and Airborne 1. The cross section has been drawn where the 2 datasets are overlapping. (Tile Number 000179)

graph in Figure 15) confirming that the Maui data might have a bias. However, in order to merge the datasets, we applied a -1ft correction to the NOAA data.

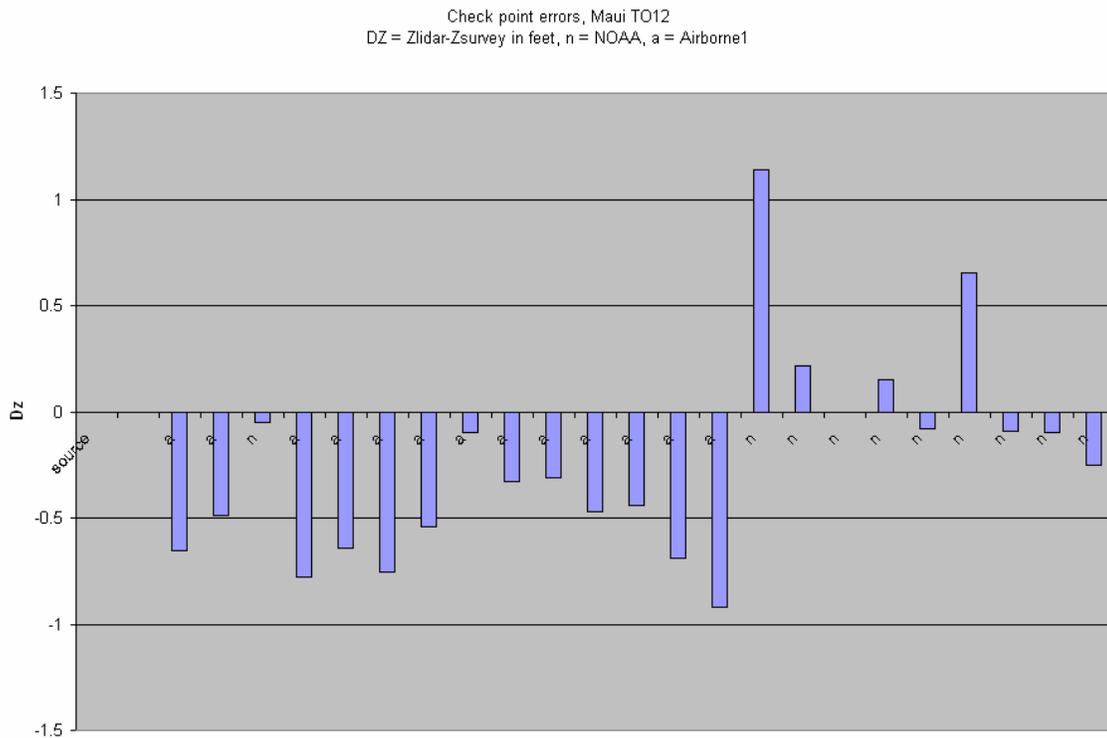
Figure 15 – Check point errors separated by LiDAR dataset (a= Airborne 1, n=NOAA)

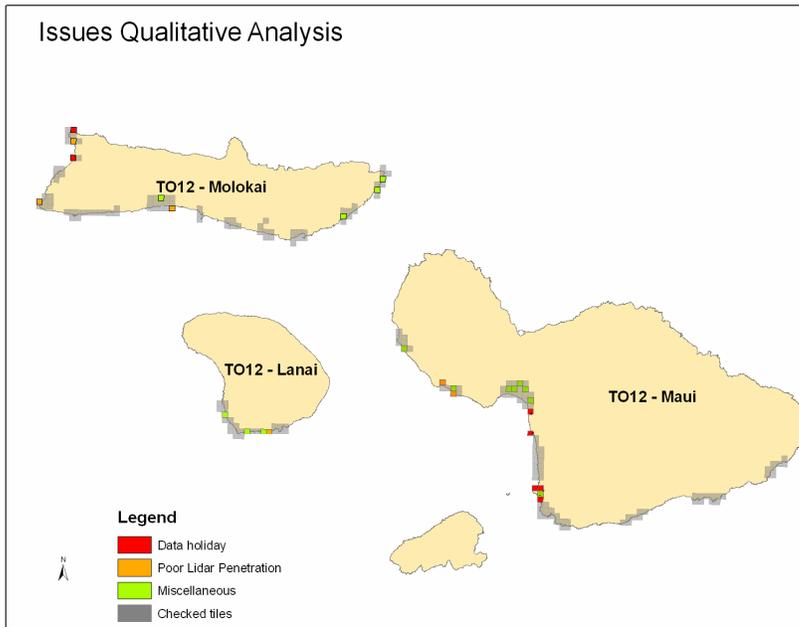
1. Poor LiDAR penetration in dense vegetated areas and/or aggressive removal of vegetation, causing bare earth model to have no point left
2. Cleanliness of artifacts (noise, vegetation or building remains)
3. Spikes in full point cloud data
4. Small divots in ground models
5. Holes in data (Figure 17 shows the gaps with reviewed tiles)

Figure 17 – Gaps in Molokai and Maui.

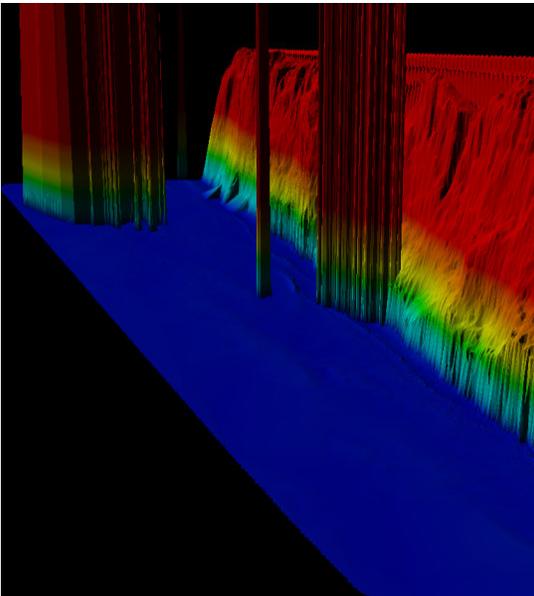
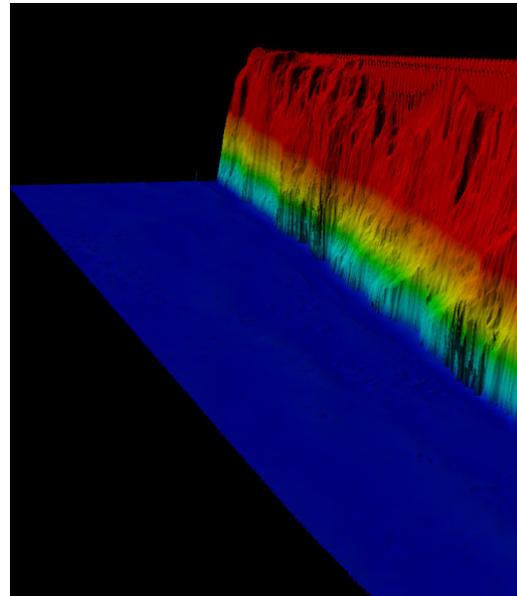
Figure 19 – Spikes in the extracted feature product (left), they have been eliminated from the ground file (right)

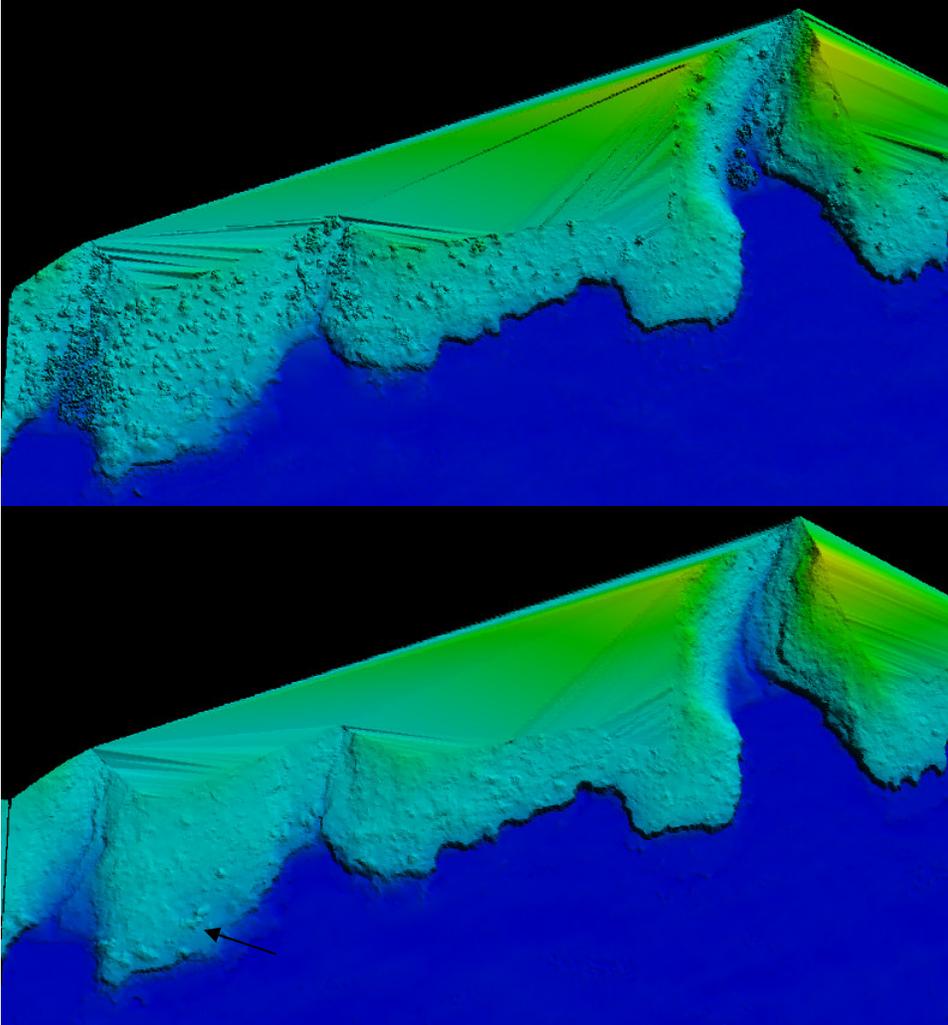
The east part of the project area (south facing shoreline) exhibits a slightly smoother topography. On this area, well defined stream channels were noticed. The only types of issues we faced were possible remains of vegetation and one instance of poor LiDAR penetration in highly vegetated area (this issue is documented in the next section).

Figure 20 – Extracted feature model (up) and bare earth model (down). Well defined stream channel and possible vegetation remains on the slopes. (Tile 0441)

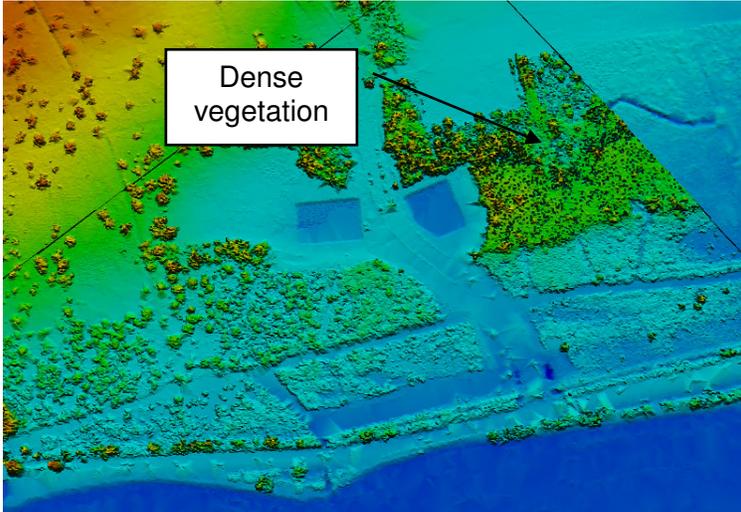
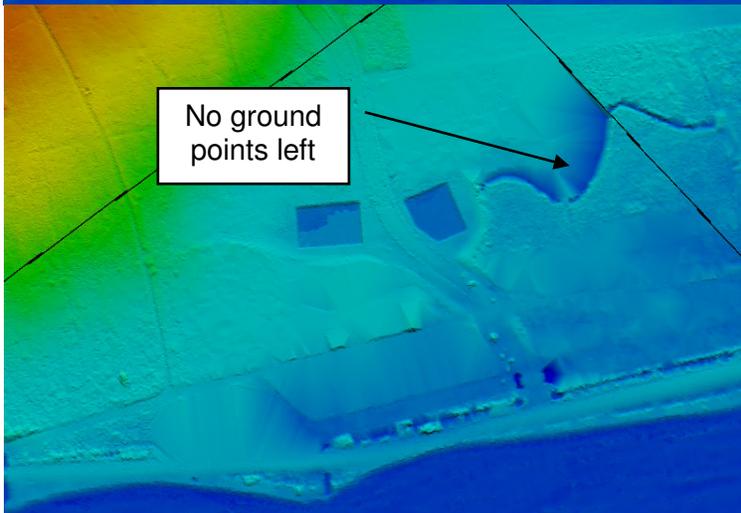
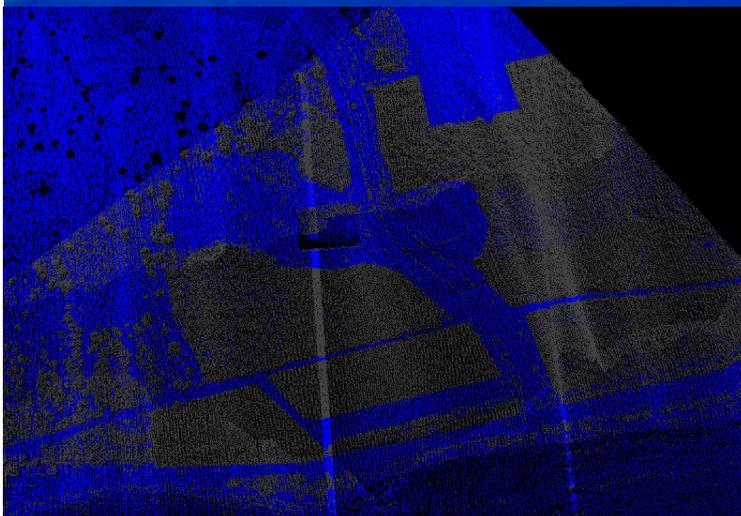
Nevertheless, we have also often encountered more problematic tiles during our review of Maui. First, we have faced a recurring (over all three islands) issue of dramatic low density of points in really densely vegetated areas (see Figure 23 and Figure 26, upper right corner). It is believed that this may be caused by a poor penetration of the LiDAR beam between the leaves and branches because of their density.

Figure 23 – Poor LiDAR penetration in dense vegetation. (Tile 1045)

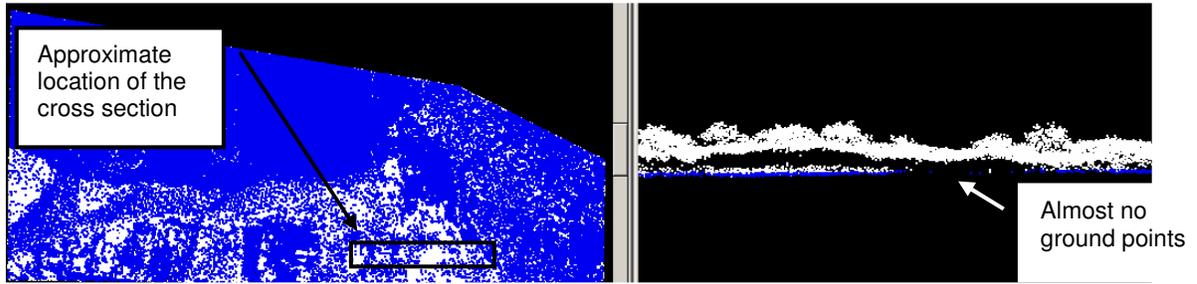
Figure 24 – Full point cloud colored by class (blue = ground, white = extracted features). (Tile 1045)

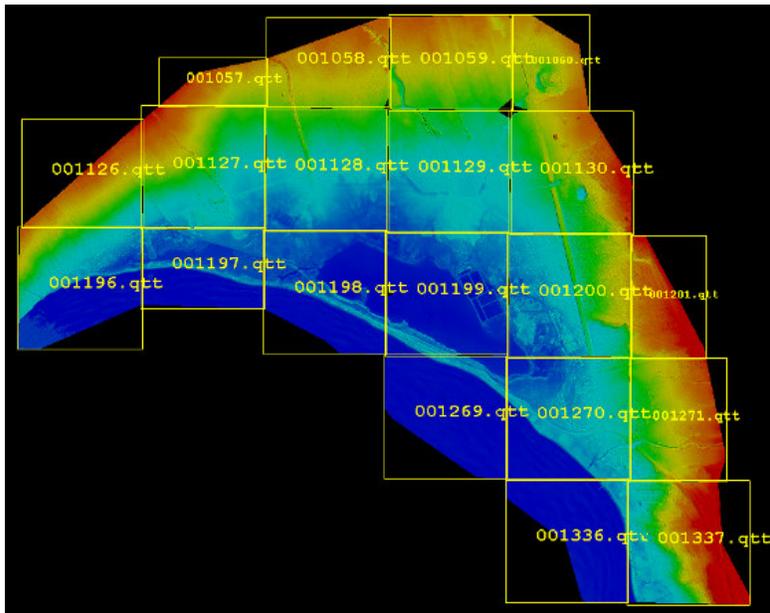
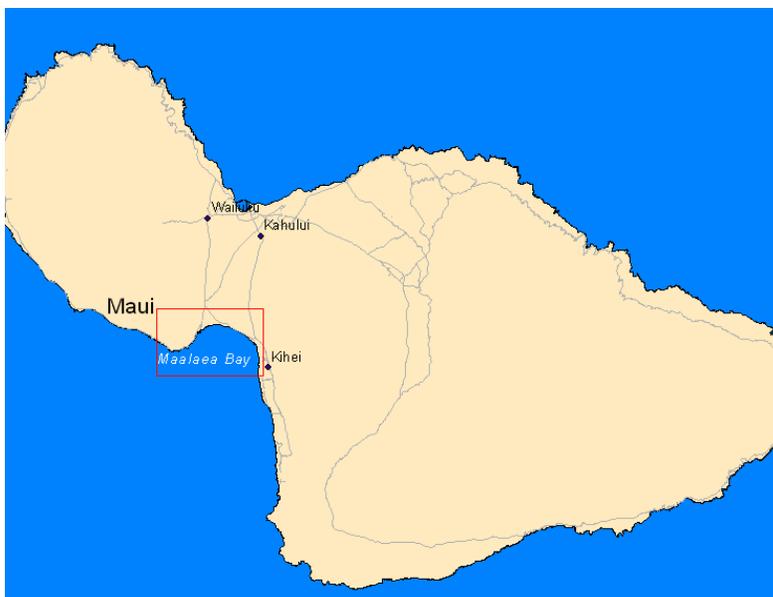
In addition, the Maalaea Bay Area especially catches our attention as significant classification issues were found there. Its location is given in Figure 25. In this case, instances of low density of ground points seem to be caused by an overaggressive classification of vegetation. Indeed, processing discrepancies were noticeable between two adjacent tiles as illustrated Figure 27 and Figure 28. Moreover, a few divots were found along roads (Figure 29).

Figure 25 – Maalaea Bay. Problematic area

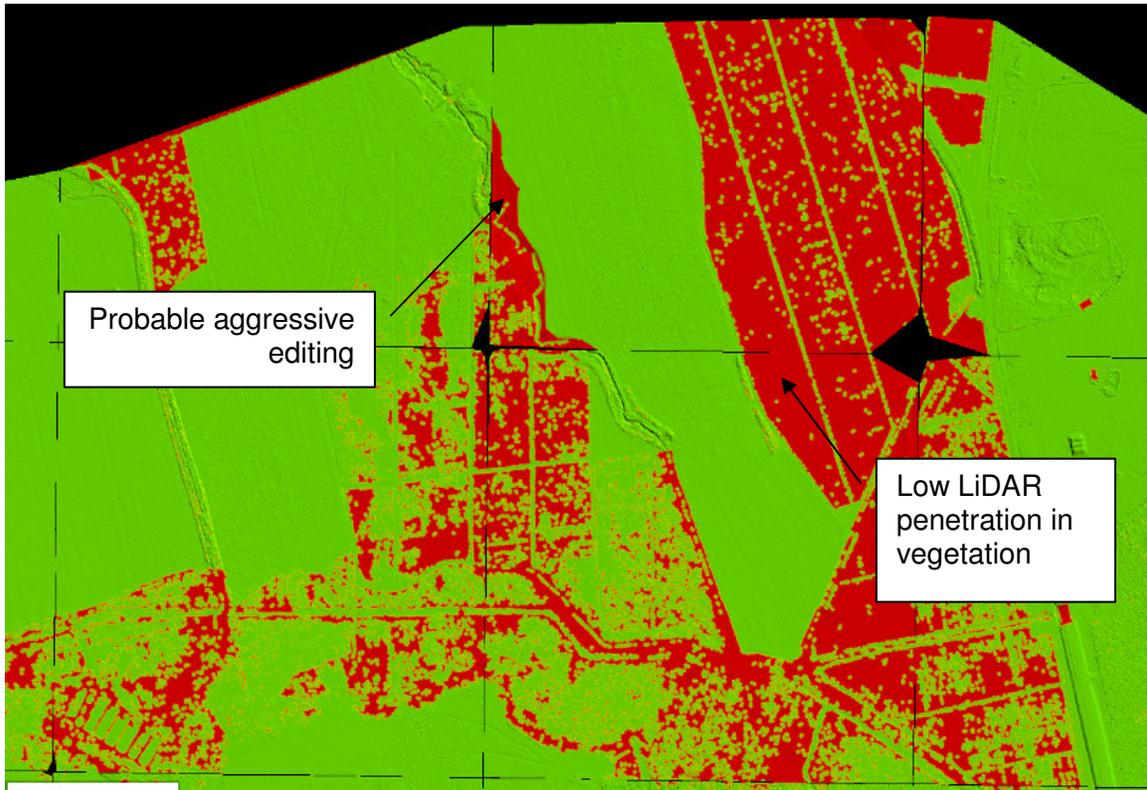
Figure 26 – Point density on bare earth model. Red indicates low density areas. Black holes in corners of adjacent tiles are caused by the absence of ground points at this location. (Tile 1059)

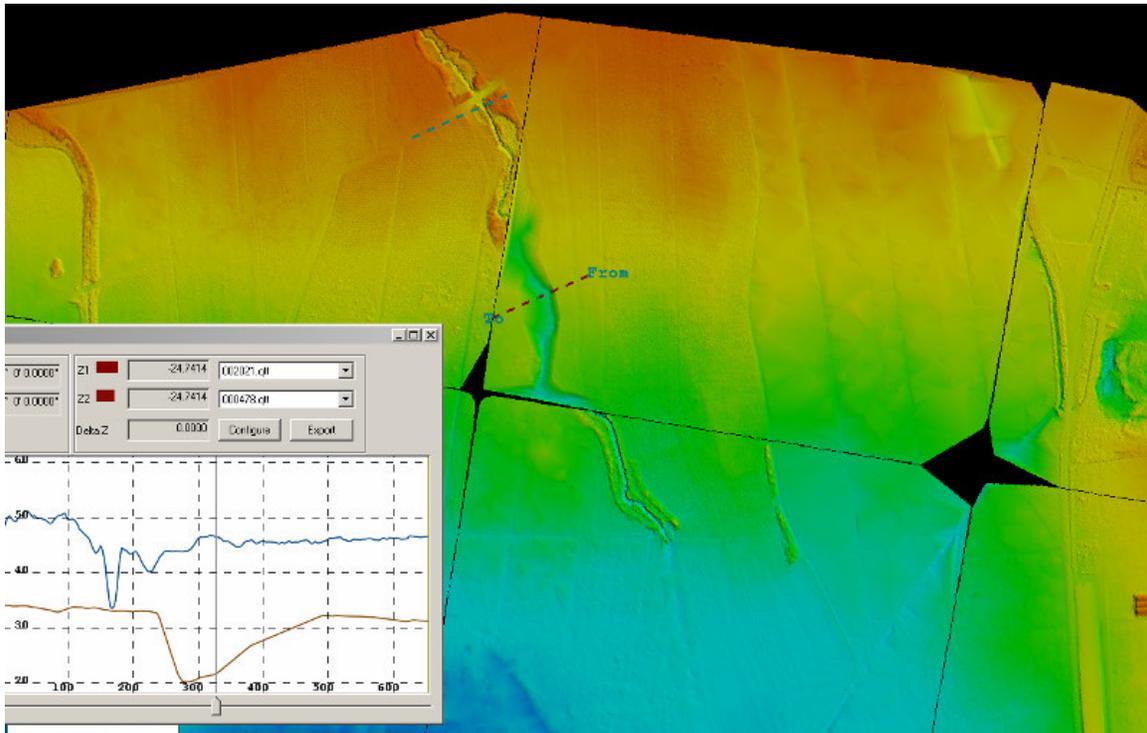
Figure 27 – Bare earth model, different level of processing between two tiles. The blue profile shows a well preserved stream channel whereas the dark red profile computed in the other tile is oversimplified (elevations in feet). (Tile 1059)

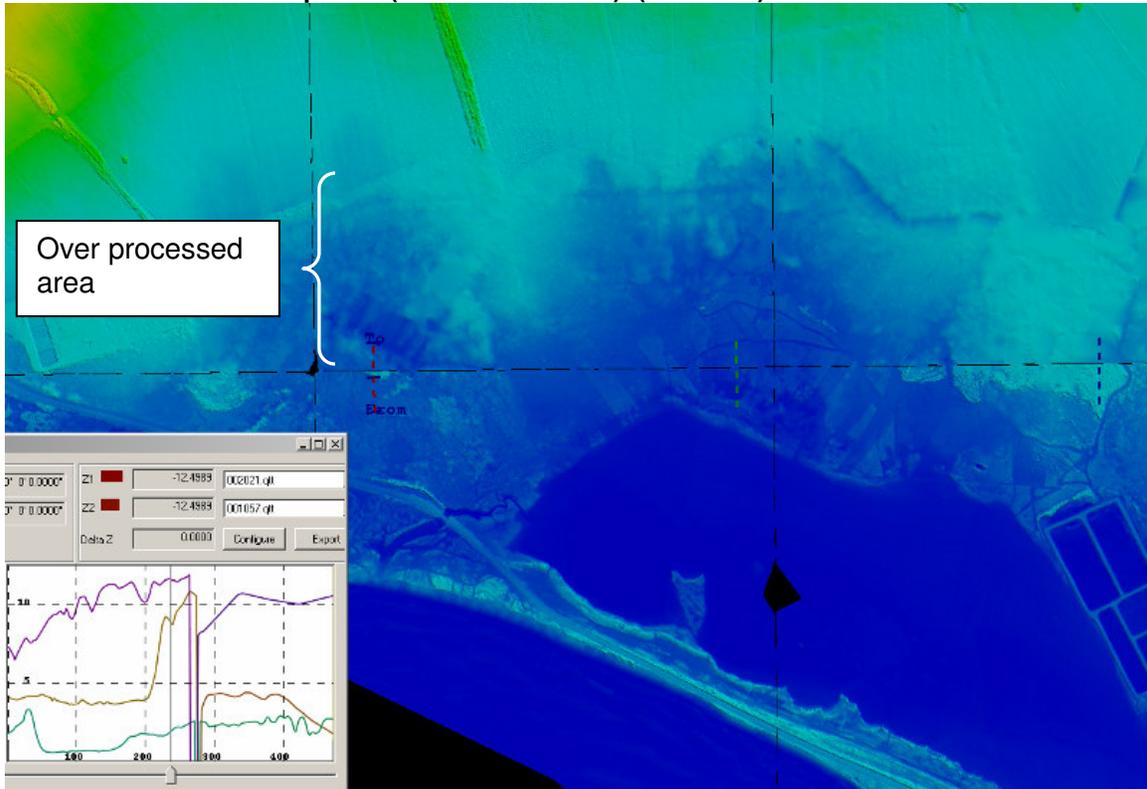
Figure 28 – Ridge between two tiles (Maui, Tile 1128)

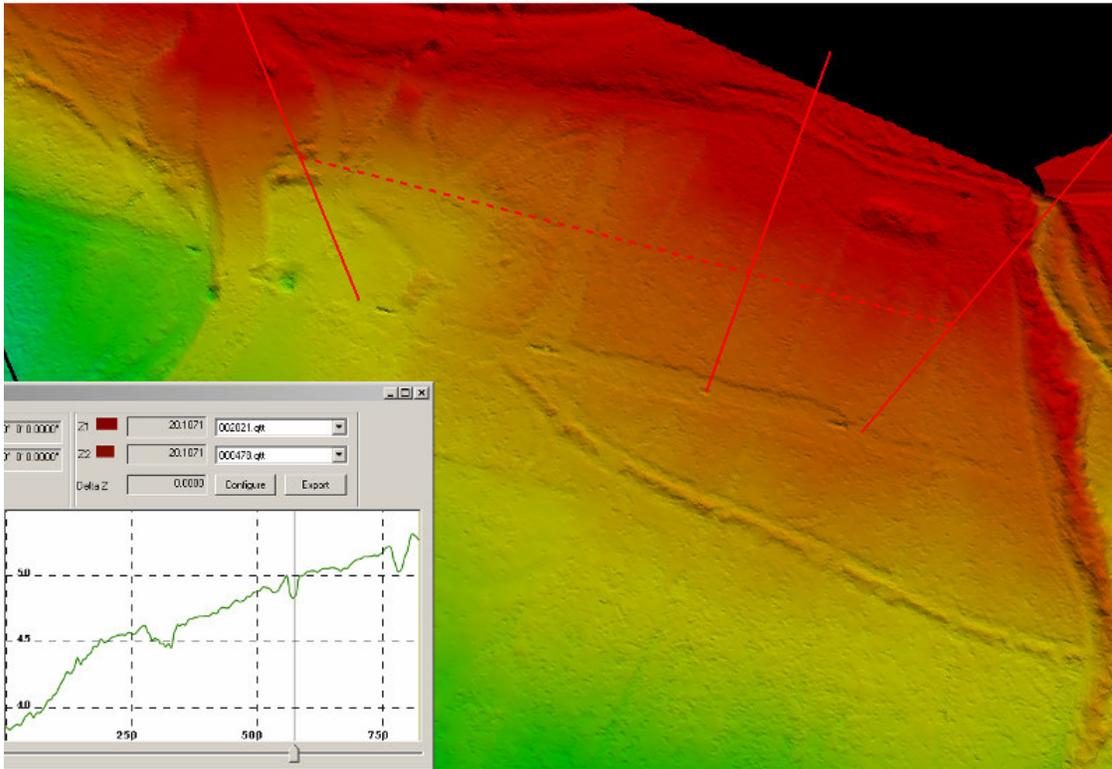
Figure 29 – Divots along a road (Maui, Tile 1117)

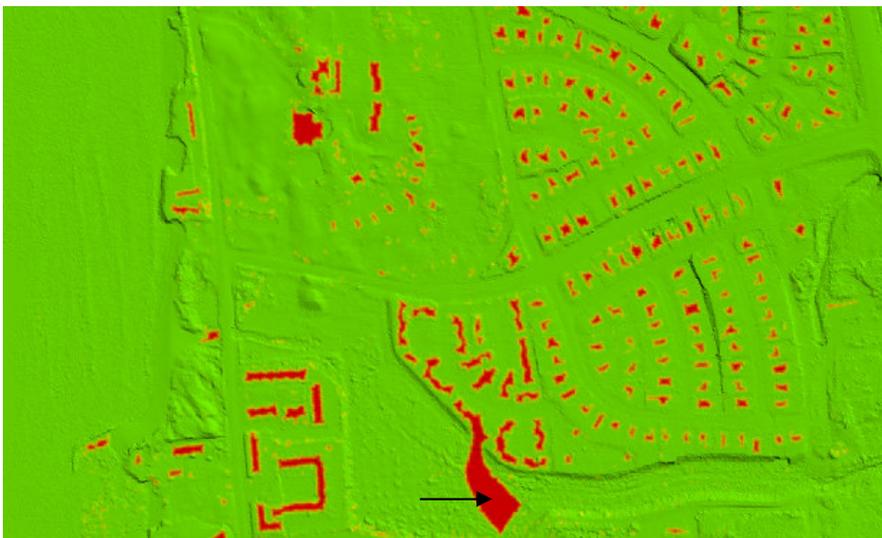
Finally, Airborne 1 stated to us in a letter that there were multiple data gaps found in the Maui tiles. On average, these gaps have an area of 1 acre or less (see example Figure 30).

Figure 30 – Gap in data (point density of ground model, red indicates no data), the small rectangular red shapes are legitimate removed building footprint (Maui, Tile 1398)

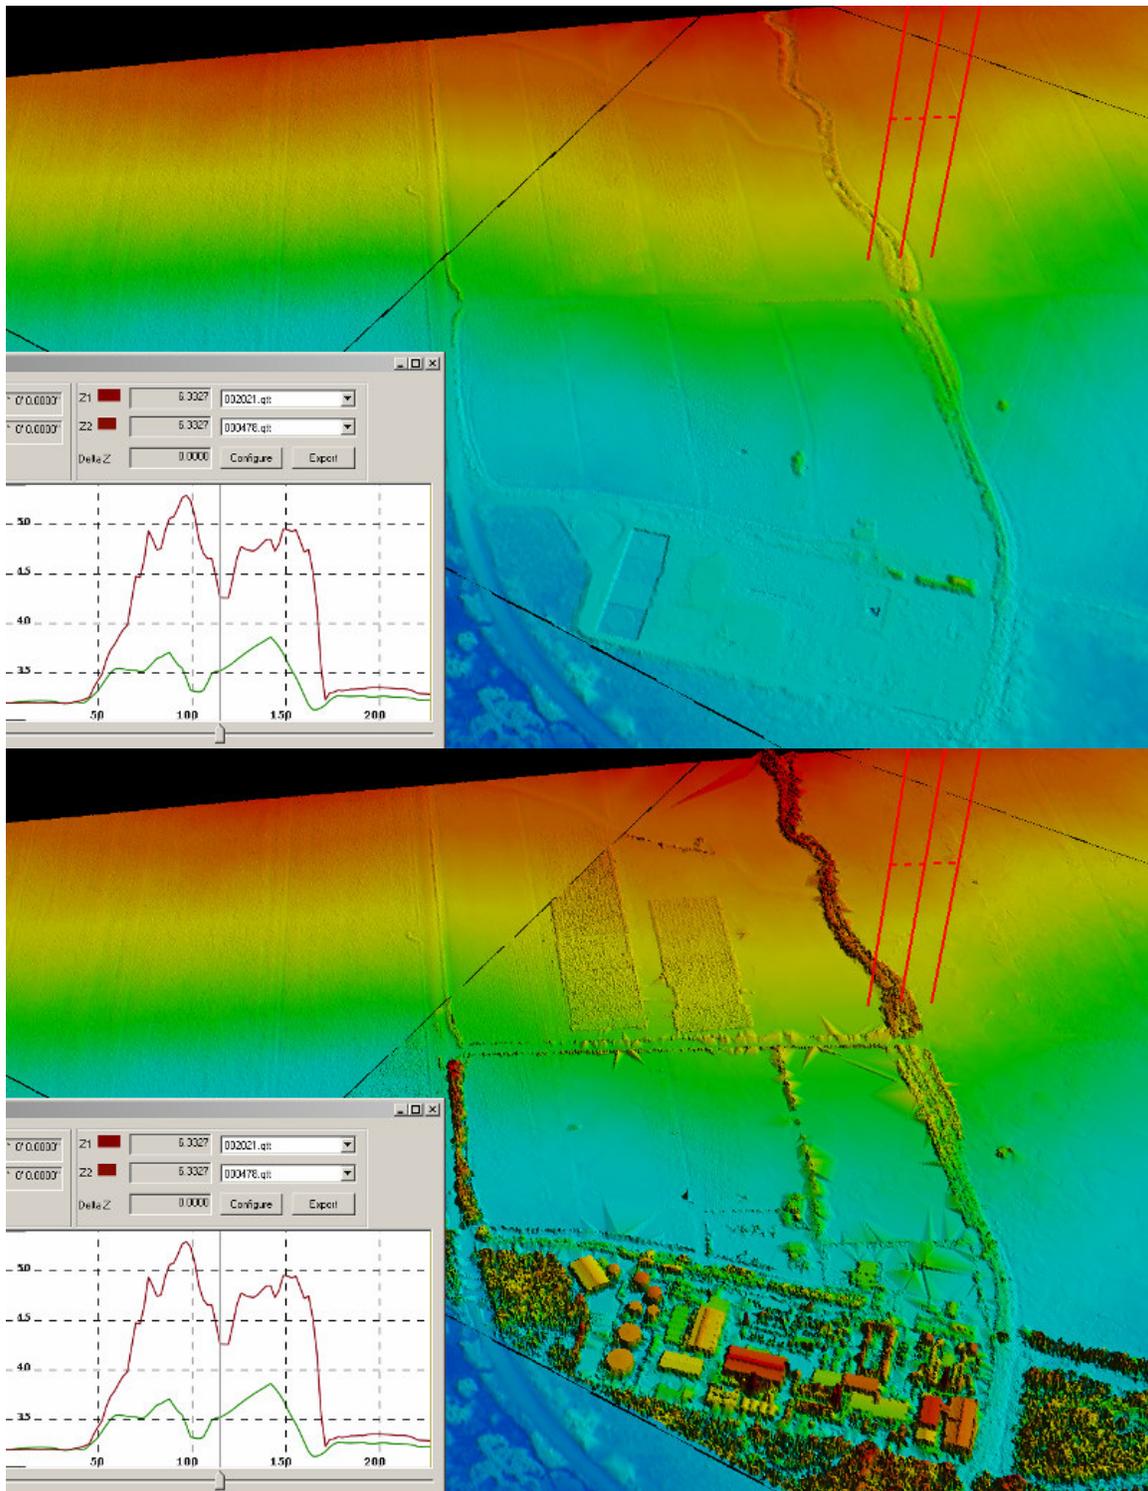
Figure 31 – Possible vegetation remains (Maui, Tile 1127)

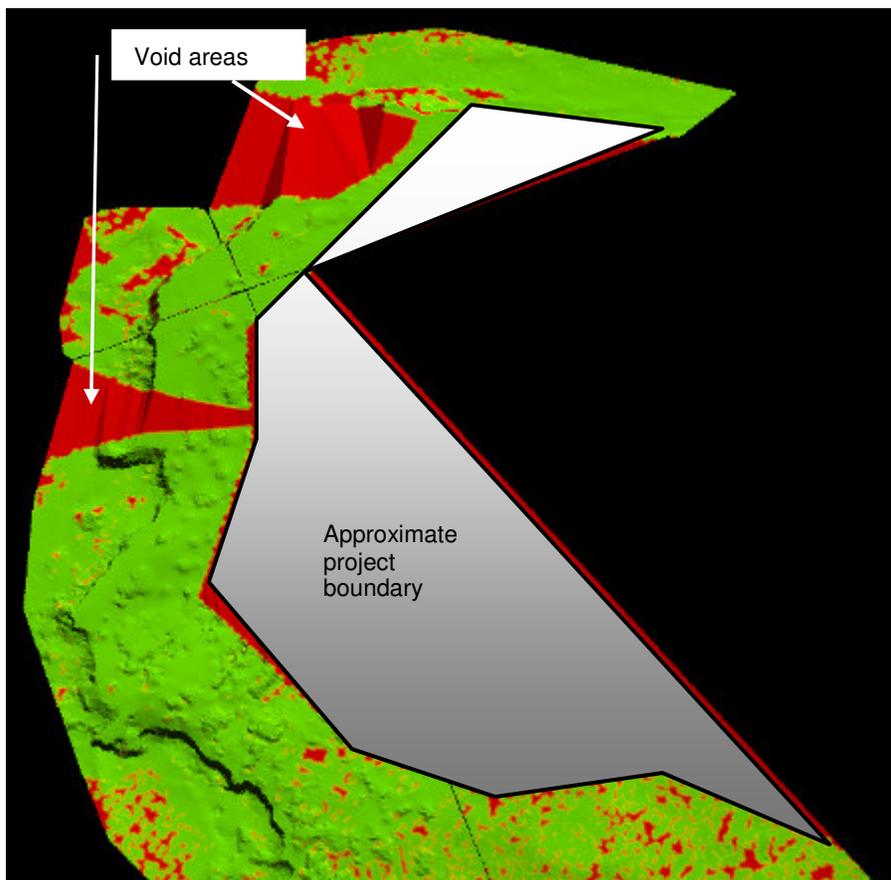
In addition, instances of holes in the data were found, especially in the upper west side of the project area as illustrated in Figure 32 and Figure 33. Another specific issue for this island was a cornrow effect visible in several adjacent tiles (Figure 34). There are multiple reasons as to why this happens but the end result is that adjacent scan lines are slightly offset from each other. This will give the effect that there are alternating rows of higher and then lower elevations. Although this is common with LiDAR data, as long as the elevation differences are less than 20 cm and the occurrences are minimized, it is acceptable because it is within the noise and accuracy levels. However this also can be an indication that the sensor is mis-calibrated, or offsets exist between adjacent flight lines so each area identified is analyzed.

Figure 32 – Hole in data - Ground point density (Tile 002)

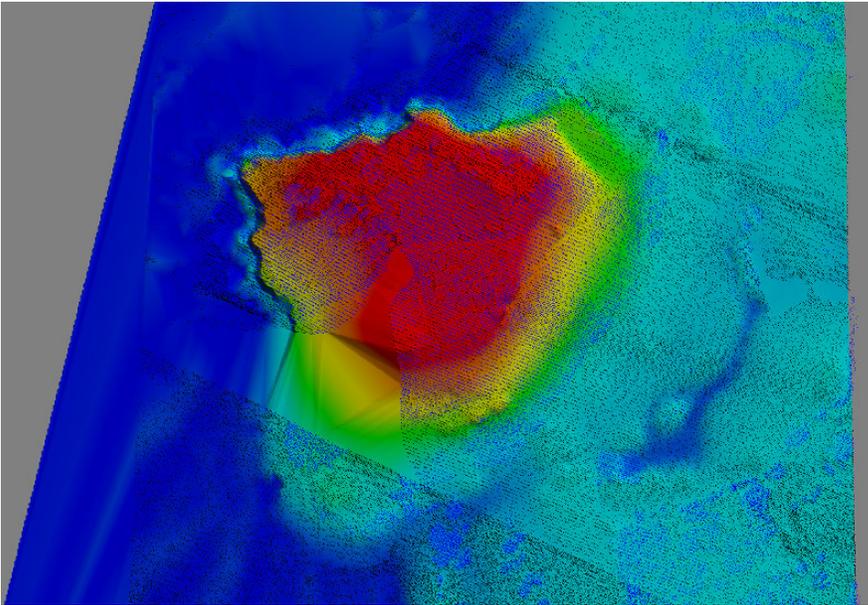
Figure 33 – Hole in data (ground model, full point cloud)

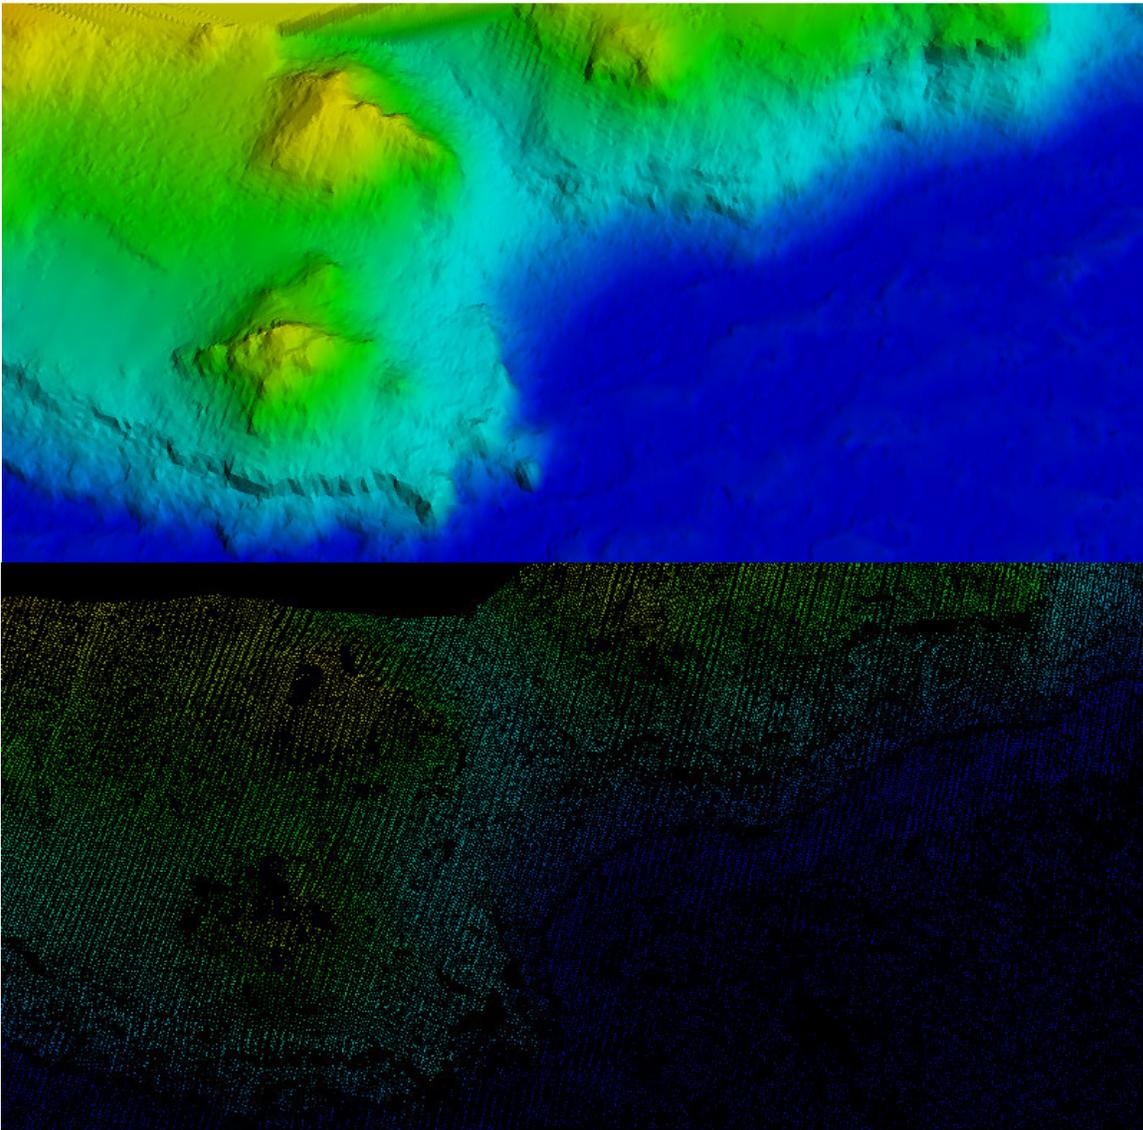
Figure 34 – Cornrow effect (up: bare earth model, down: ground point cloud)
