LiDAR QA/QC
- Quantitative and Qualitative Assessment Report -
Northwest Florida Water Management District
July 17, 2008

EXECUTIVE SUMMARY

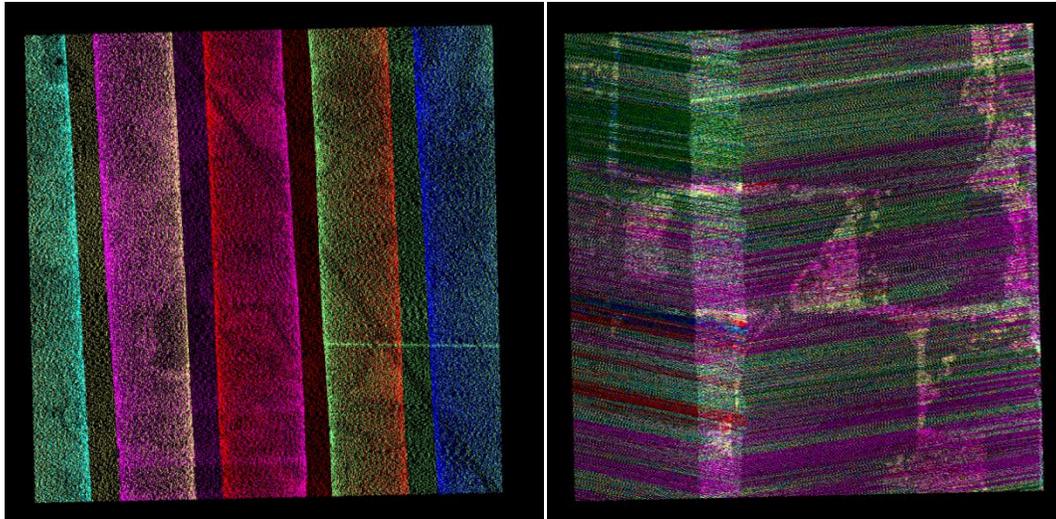
Only 78 masspoint shapefiles were delivered compared to the 2004 LAS and DEM tiles. Also missing was the flightline information which is usually stored in the Source ID field. This information aids in the quality assurance process by identifying where the overlap

between flightlines is located in case there is an offset between flightlines. Figure 7 shows two LiDAR tiles classified by Source ID. The tile on the left is classified by Source ID and shows distinct flightlines. The Jackson Blue tile on the right is also classified by Source ID although the flightline information is clearly missing.

Figure 7 - LAS files classified by Source ID. File in left image displays the LiDAR points by flightline, this information is missing in Jackson Blue LiDAR tile on right.

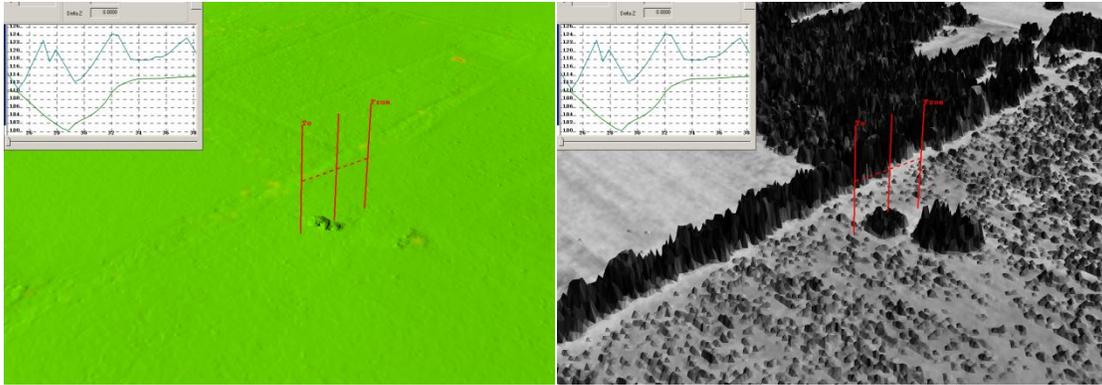
Divots were found throughout the dataset although most were found in areas of dense vegetation. Figure 12 displays a typical example of the type of divots that we found.

Figure 12 – Tile 32588. The bare earth image on the left depicts a possible divot and cross section. The full point cloud image on the right shows that this divot is located in dense vegetation.

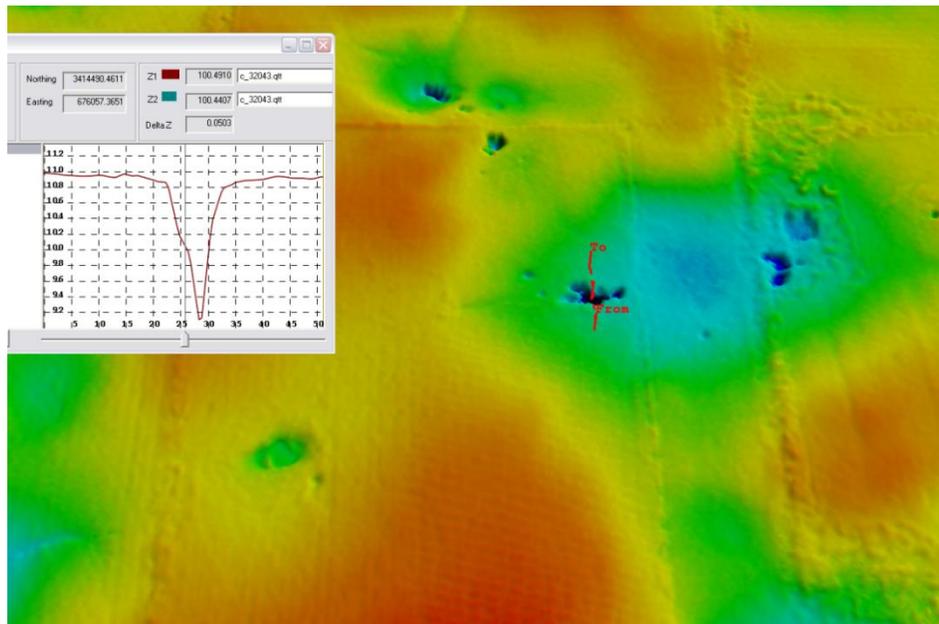
A couple of these divots appear to be legitimate upon finding corresponding imagery where these “holes” are visible (Figures 13 & 14). Although considered common for these types of sensors, these anomalies should be re-examined based upon the scale of analysis performed on the area in question. While these divots will not have a significant effect on the overall quality of the data, they could affect small scale analysis.

Figure 13 – Tile 32043. Ground LiDAR Image displaying a possible divot of almost 18 feet.

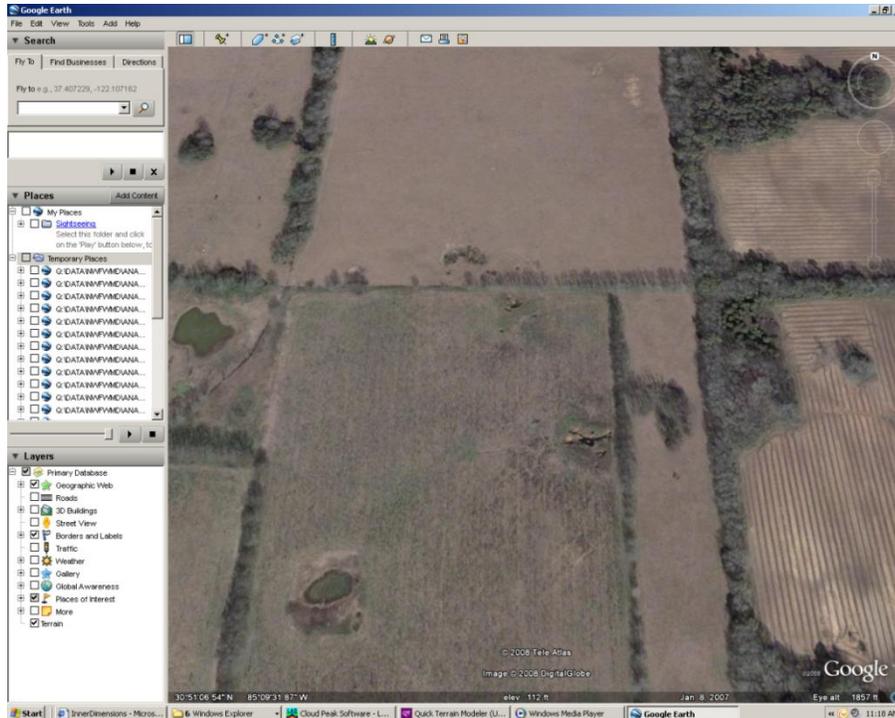
Figure 14 - Google image of possible divot shown above. From this image the low points seem to be legitimate as this is a true ground formation.

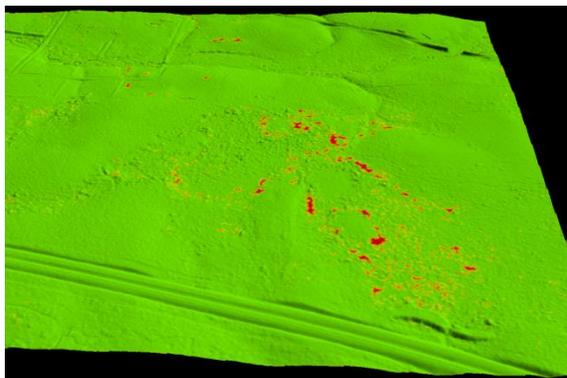
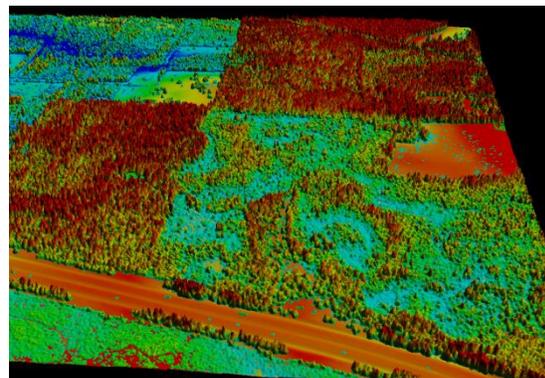
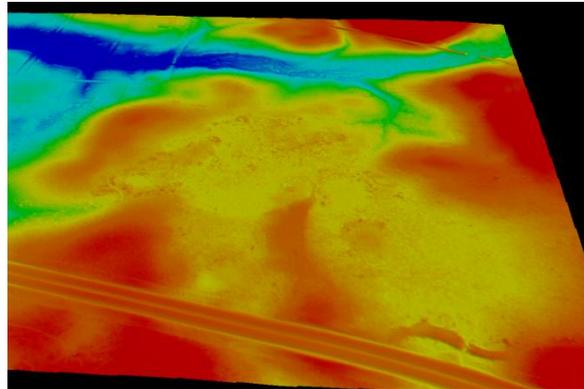
Figure 15 – Tile 36902

Another problem that we often found was patches of sparse data. This is illustrated in Figures 15-17. Figure 15 is a density image of tile 36902 where red indicates missing data and green indicates dense data. Figure 16 is a full point cloud image of the same area showing dense vegetation. The image in Figure 17 displays bare earth where the LiDAR did not get to the ground and vegetation was left in.

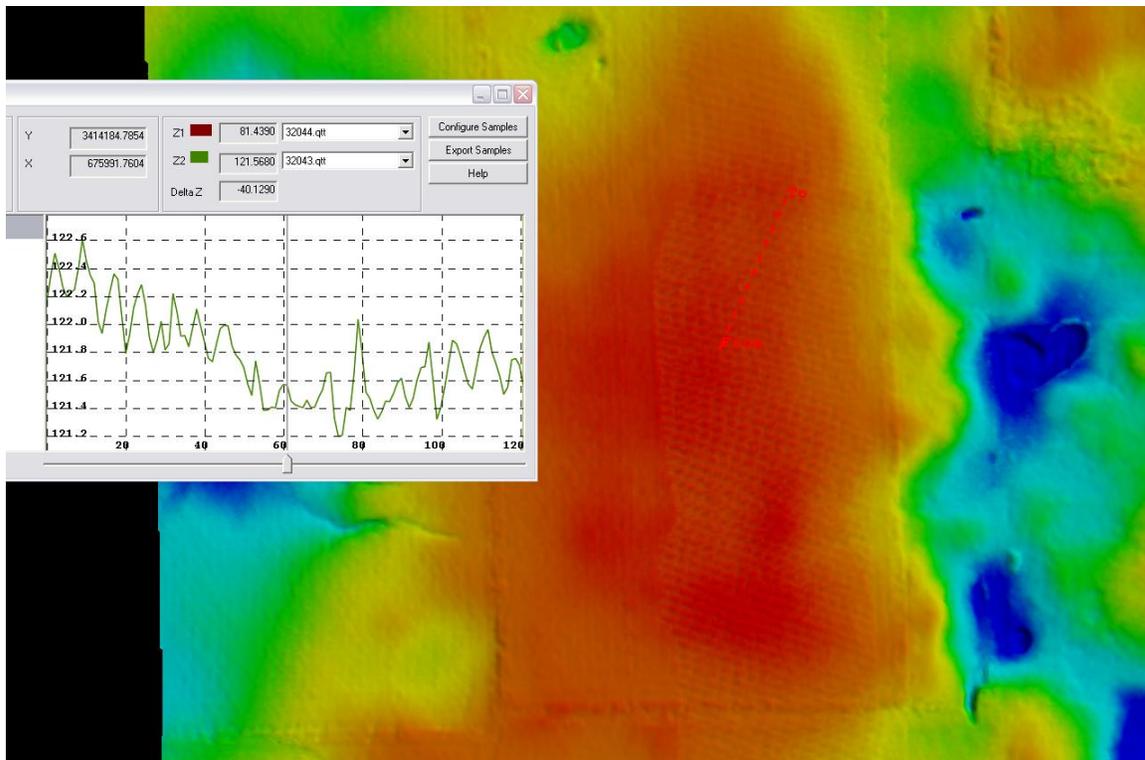
Although this phenomenon is found frequently throughout the dataset, the differences in elevation are not large enough to have a significant effect on any anticipated modeling. Figures 18 and 19 display examples of cornrows found in the data.

Figure 18 – Tile 32043. Bare earth image of edge of scanline and corresponding cornrows.

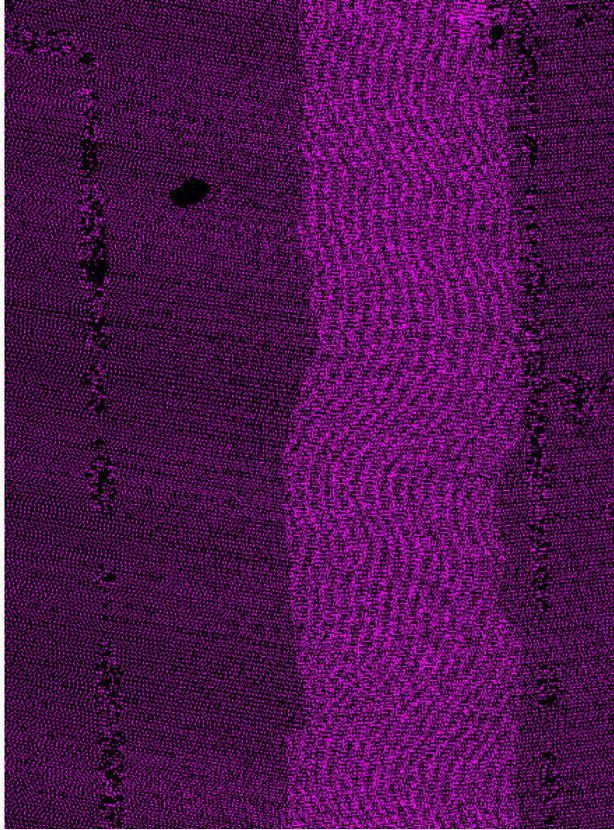
Figure 19 – Tile 32043. Ground points showing the edge of the scanline.

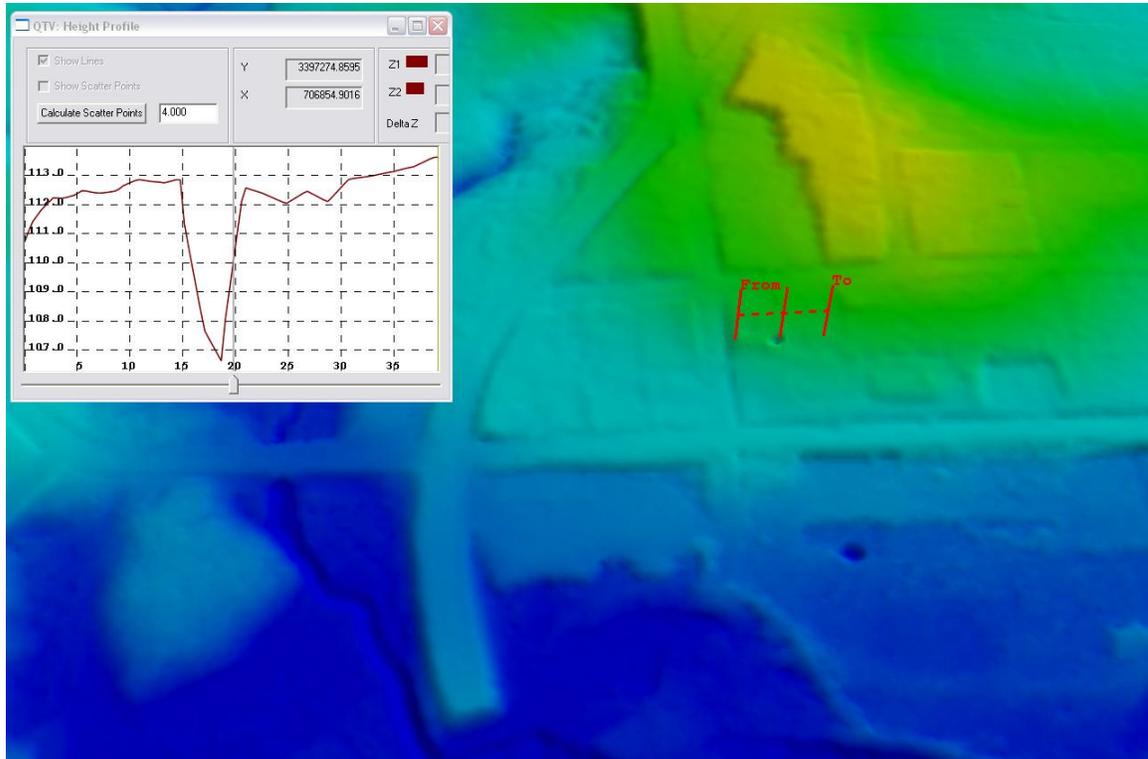
There were very few divots seen in the data the most noticeable of which occurred in urban areas where the points are more likely to bounce off of hard surfaces. Figure 26 illustrates an example of this.

Figure 26 – Residential area of tile 38543. The low point is approximately 6 feet below the surrounding LiDAR points.

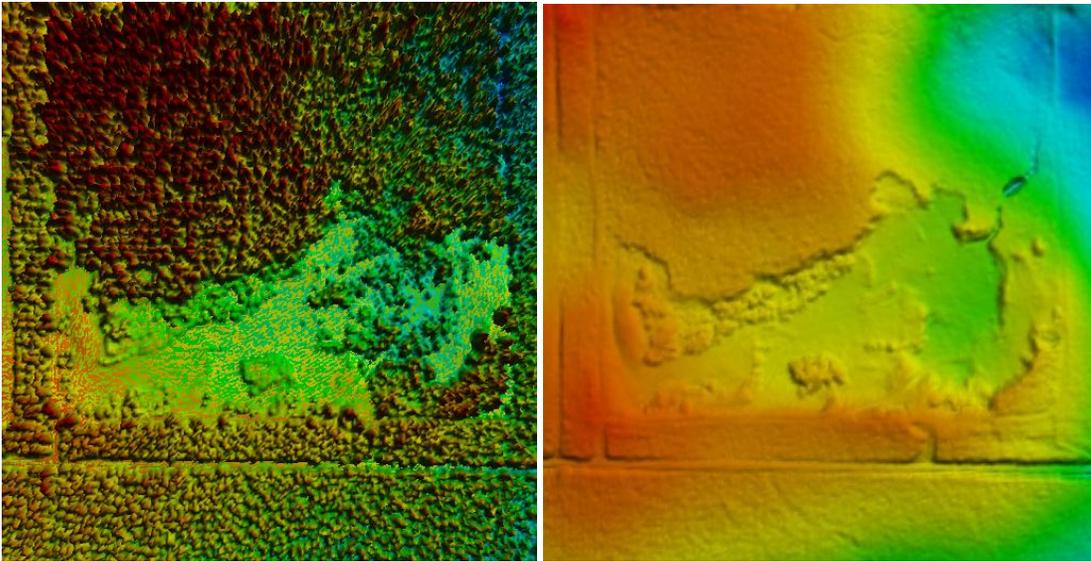
There were a couple areas where the vegetation removal process was not completely successful. We did not consider this to be a significant issue considering it was not widespread as well as the fact that the dense, swampy terrain makes classification difficult in some areas.

Figure 27 – Tile 42853. Left image is full point cloud of tile showing the dense vegetation. Right image is the same tile showing ground points. The changes in vegetation density make classification difficult.

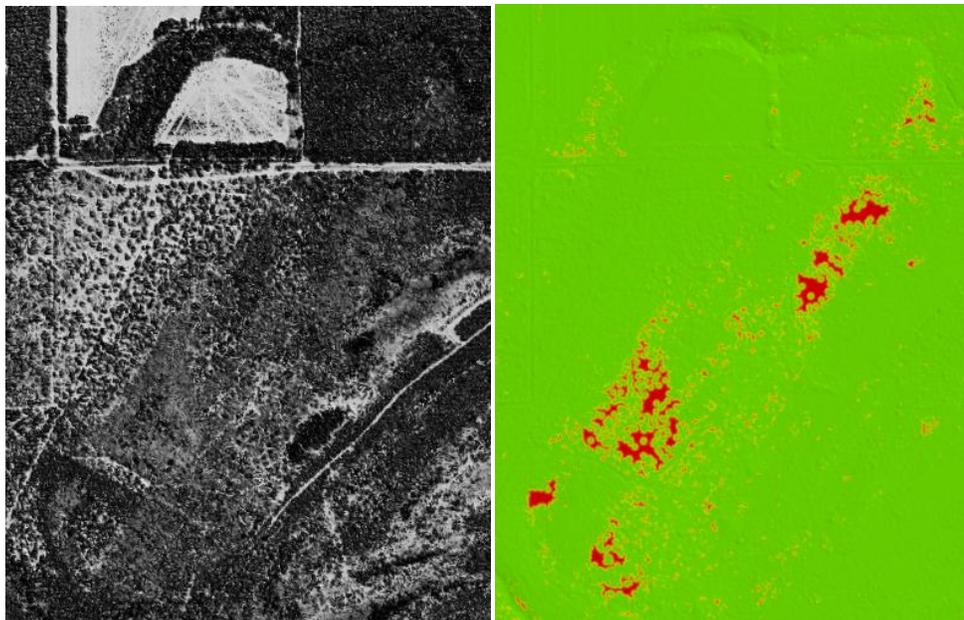
Patches of sparse data were also found. The images in Figure 28 are a typical example of this problem in the Apalachicola dataset although this can be expected due to the swampy terrain.

Figure 28 – Tile 57428. Left image is full point cloud representation, right is density image. The red in the density image indicates areas of no data.

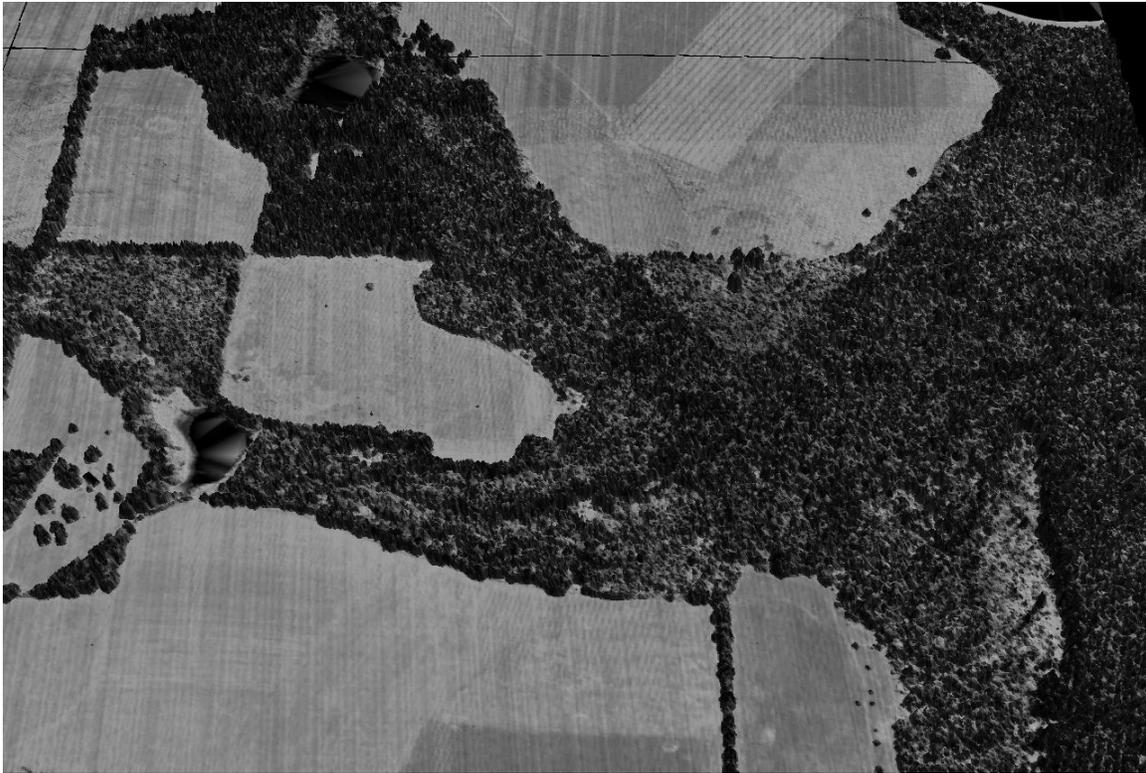
As seen in the decimated image of the Gadsden LiDAR data in Figure 36, the terrain in Gadsden County is extremely swampy and includes a lot of water. As a result, the LiDAR data had a hard time penetrating to the ground. The images in Figures 37-39 are representative of the many areas of poor penetration that were see throughout this dataset.

Figure 36 – Tile 42870. Full point cloud intensity image of densely vegetated stream channel.

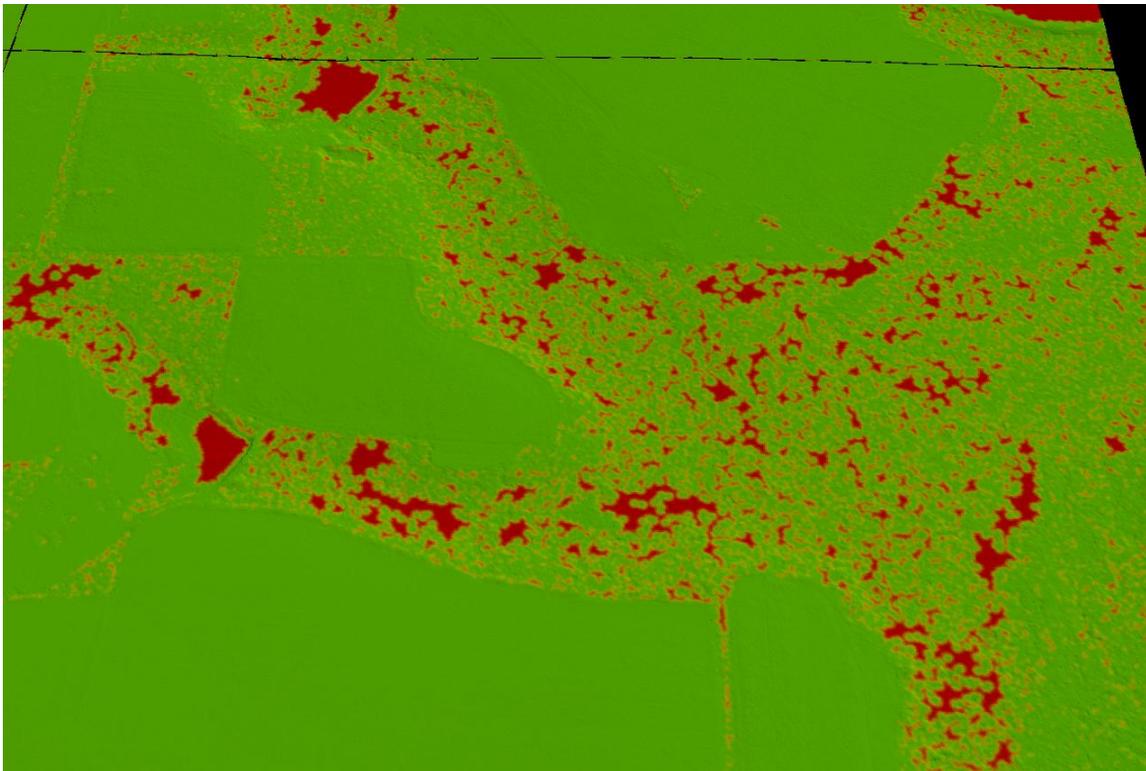
Figure 37 – Ground density image of same area. The red indicates areas of no data where the LiDAR was unable to penetrate the vegetation.

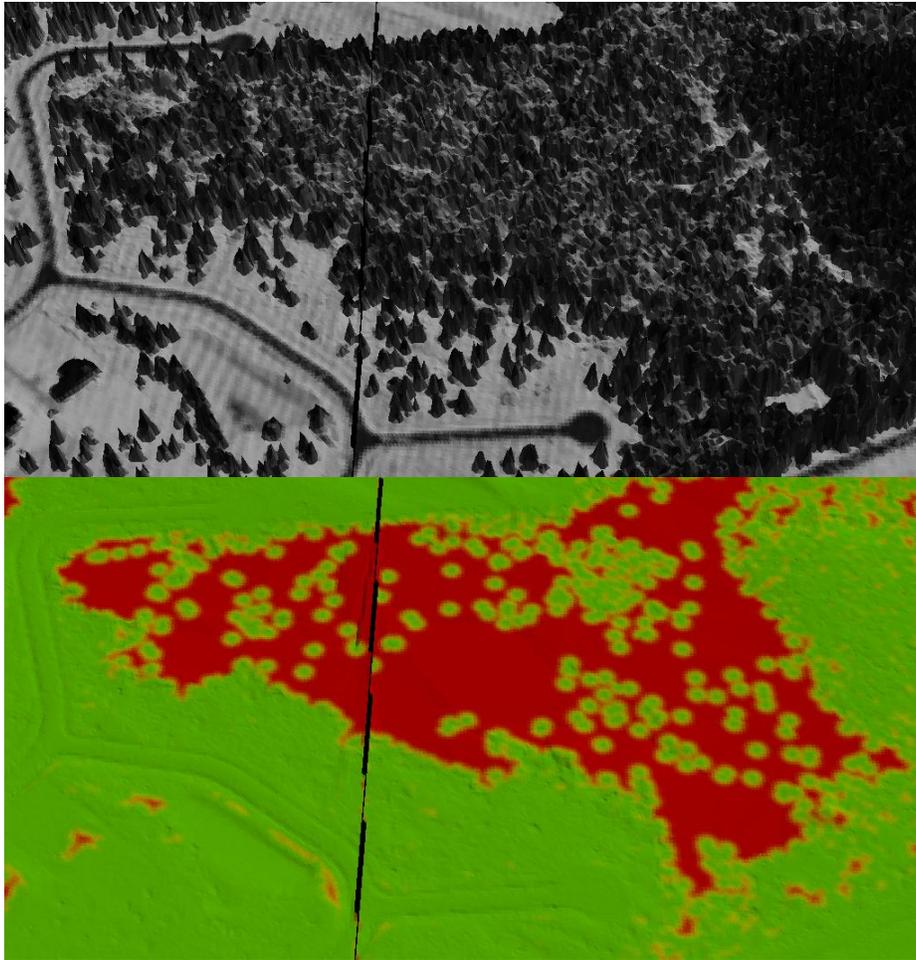
Figure 38 – Tiles 40730 and 40731. Top image is full point cloud intensity. Bottom is ground density image. Very few points penetrated here.

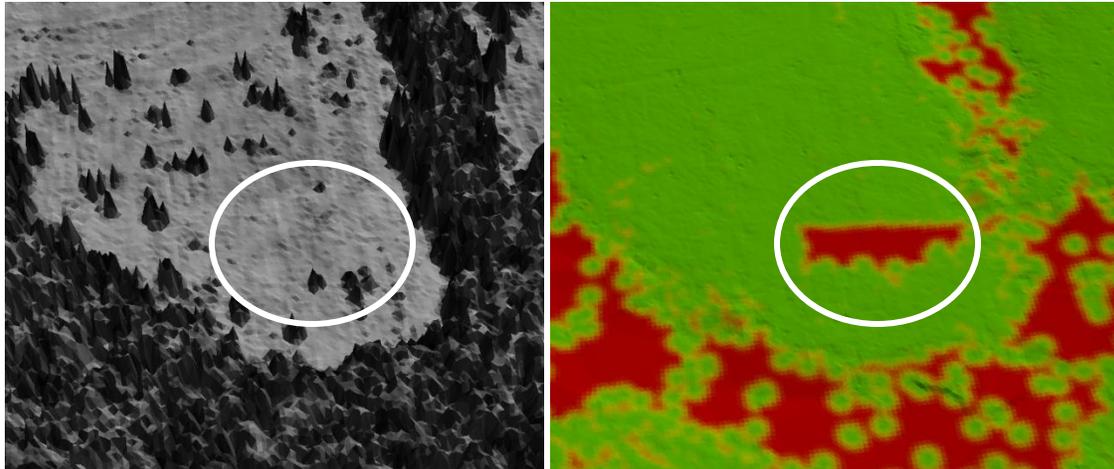
Figure 39 – Tile 41270. Left image is full point cloud with intensity. Right image is ground density and shows a gap in the data created during the classification process.

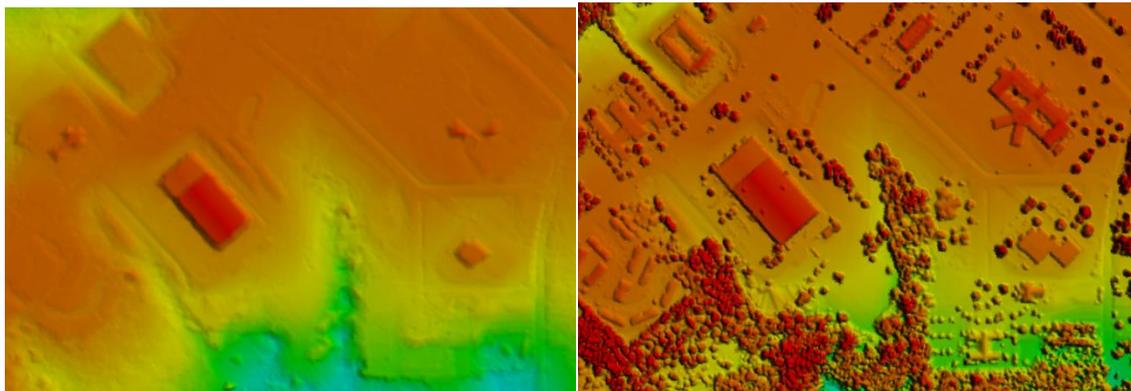
During the review of the Gadsden LiDAR data many instances were found where vegetation or buildings were left in. The building artifacts (Figure 40) seemed to be rather isolated incidents while the vegetation artifacts proved to be rather rampant throughout the dataset.

Figure 40 – Tile 42881. Left is ground image where remnants of buildings are visible. Right image is full point cloud.

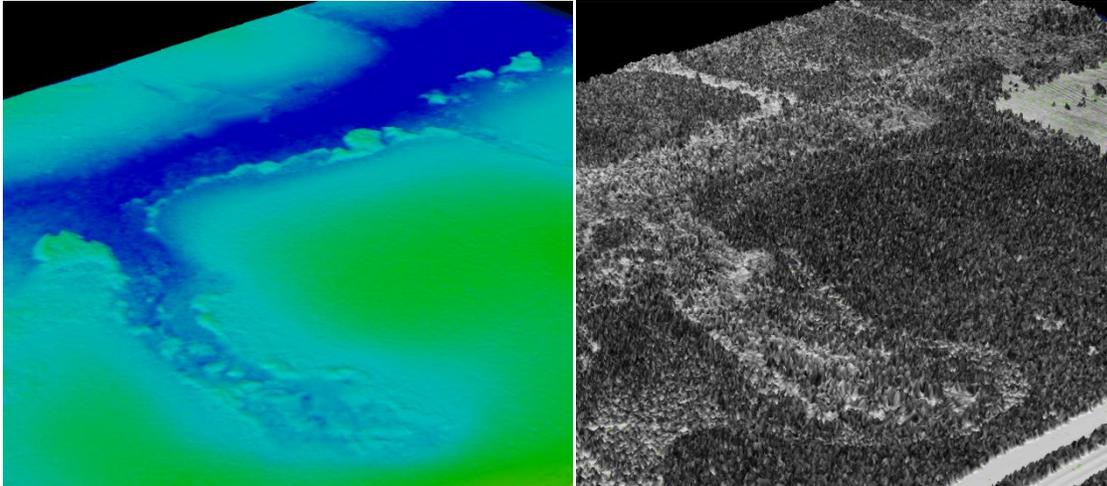
Figure 41 displays an area where the vegetation removal process was not fully successful resulting in noisy data.

Figure 41 – Tile 45568. Left is ground image with vegetation left in. Right is full point cloud image with intensity.

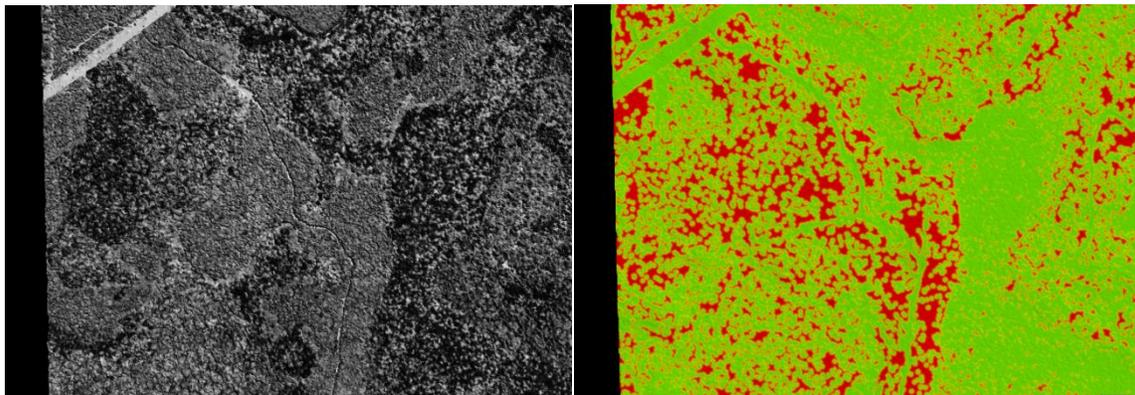
Large patches of sparse data were found. Figure 47 below displays a typical example of this problem in the Large Area dataset.

Figure 47 – Tile 34598. Left image is full point cloud image showing lots of vegetation. Right is ground density image showing areas of sparse data.

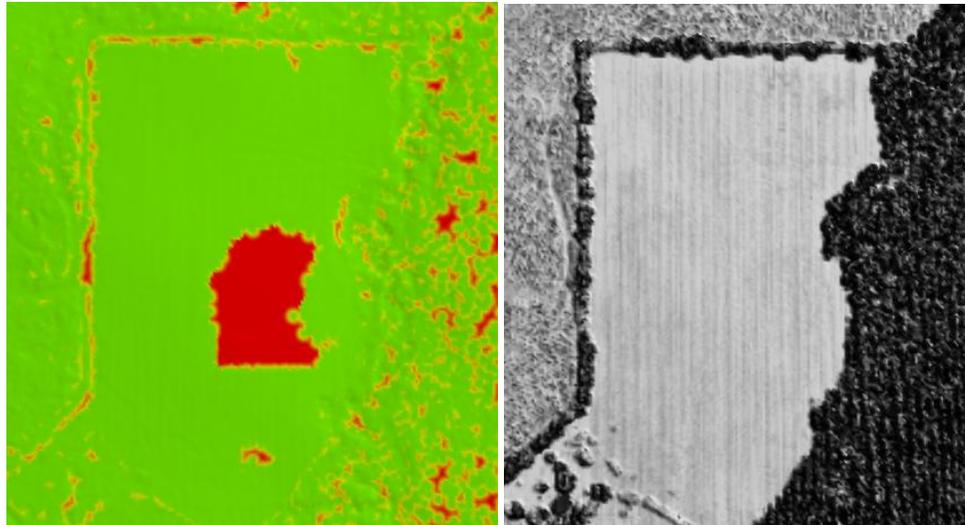
There were a few areas of missing ground points that seem to be the result of aggressive editing during the classification process. Figures 48 and 49 display missing patches of data within a small field. These points should not have been removed from the ground class.

Figure 48 – Tile 27671. Left image shows area of missing data in red. Right image is full point cloud with intensity.

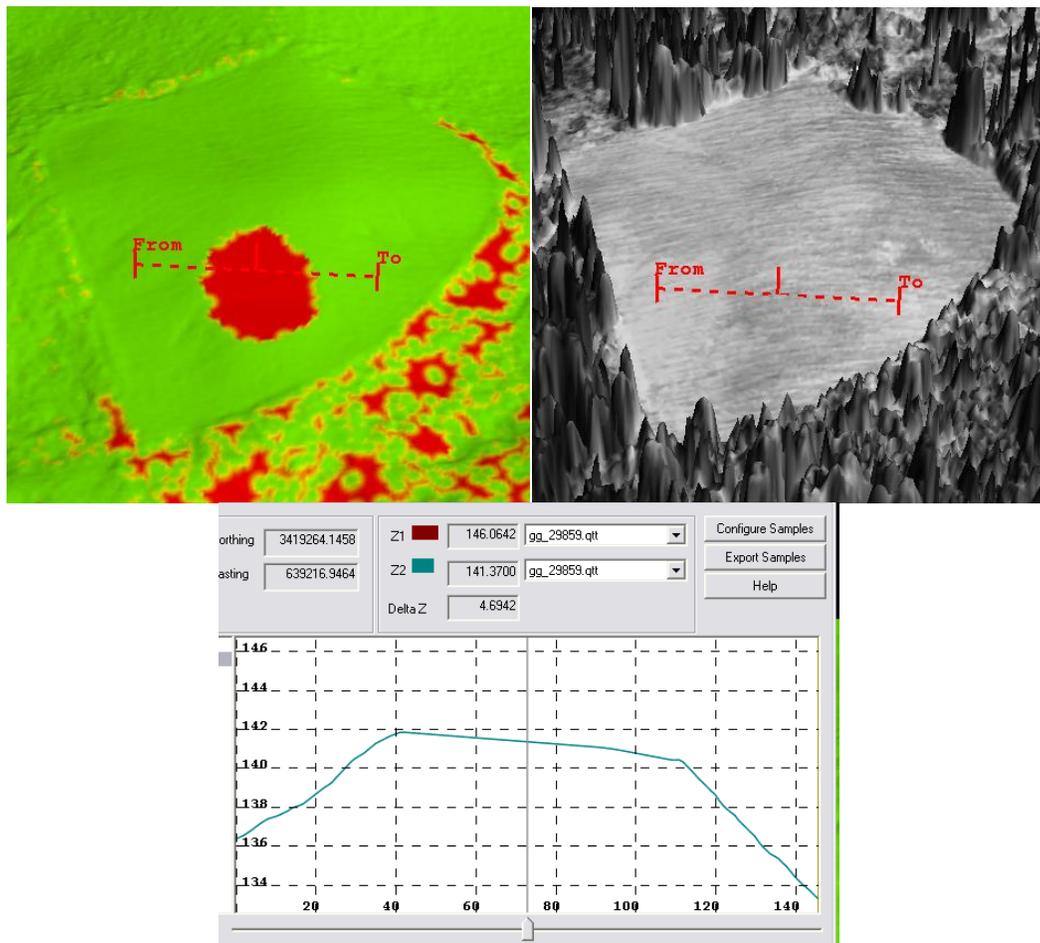
Figure 49 – Tile 29859. Top left ground density image with missing data in red. Top right full point cloud intensity (exaggeration x2) shows small field surrounded by trees. Bottom image is cross section showing a flat area where the data much jump across missing points.

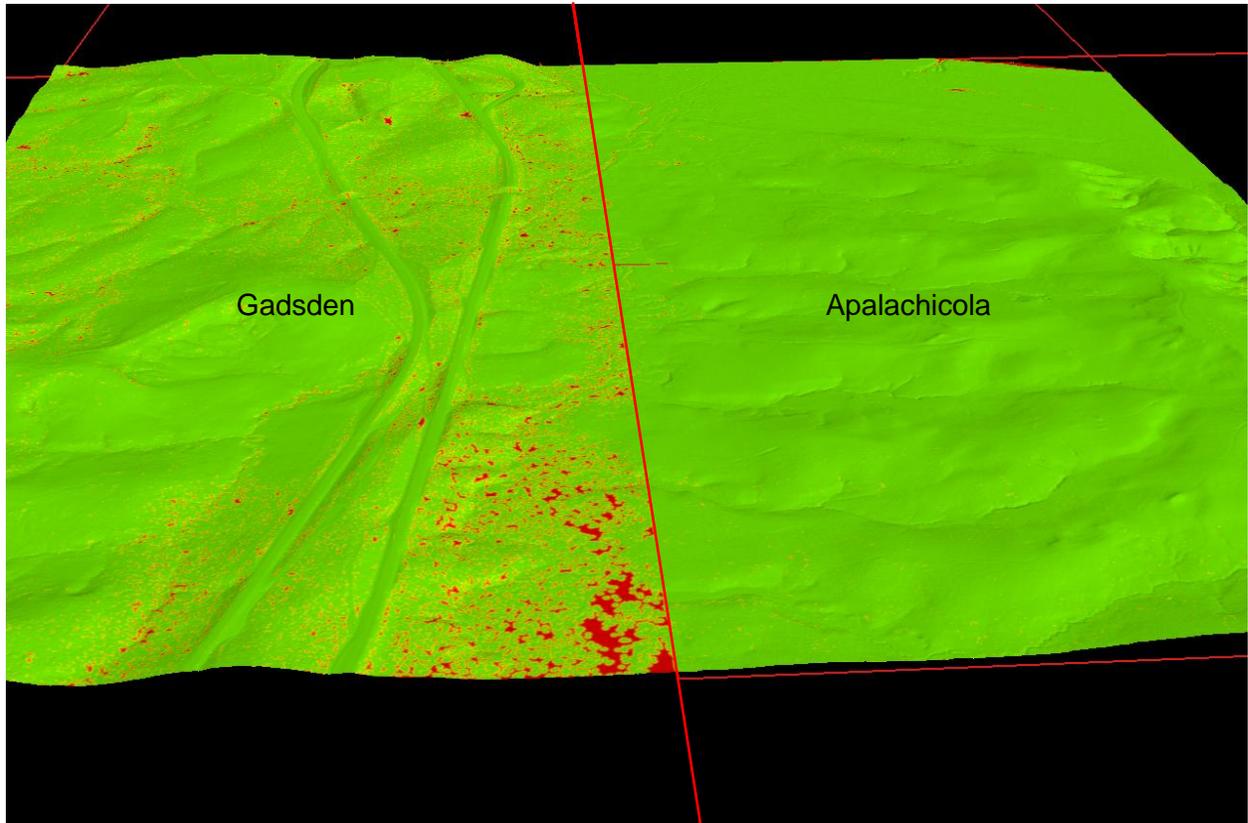
Figure 51 – Tiles 40701 and 40161. Visible change in penetration across dataset lines.

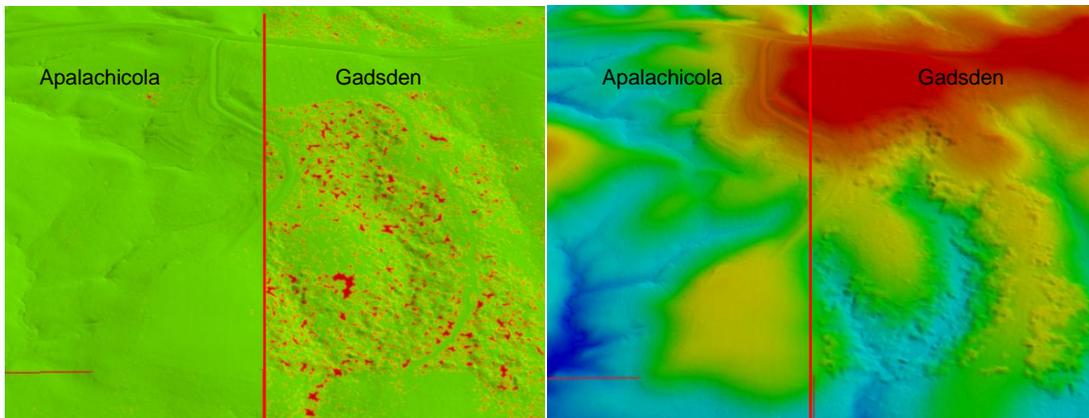
Figure 52 – Tiles 38004 and 38005. Contrast between noisy Gadsden data on right and cleaner Apalachicola data on left.

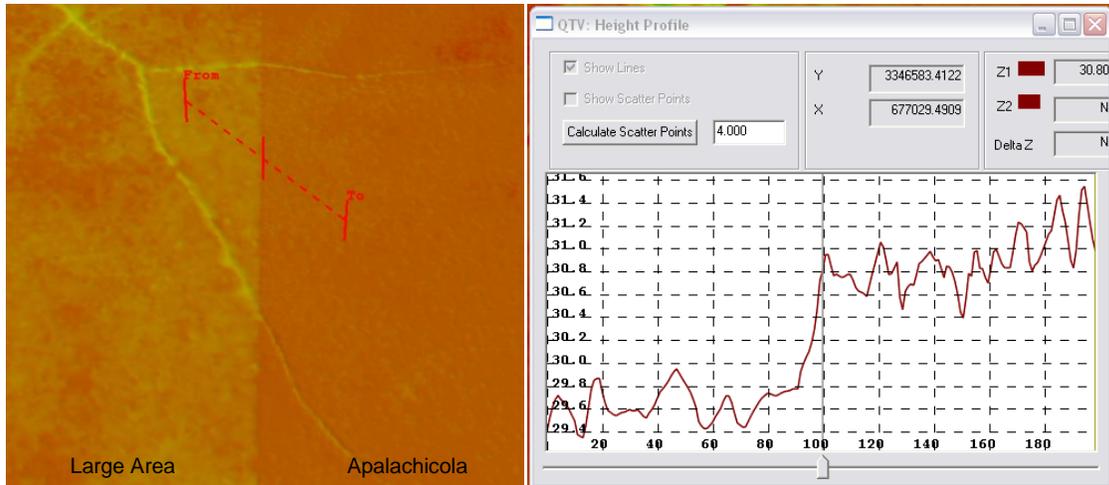
Figure 53 – Tiles 55802 and 55803. Left image is ground surface model with visible edge between Large Area LiDAR data and Apalachicola LiDAR data. Cross-section on right shows that this is approximately a 1 foot difference.

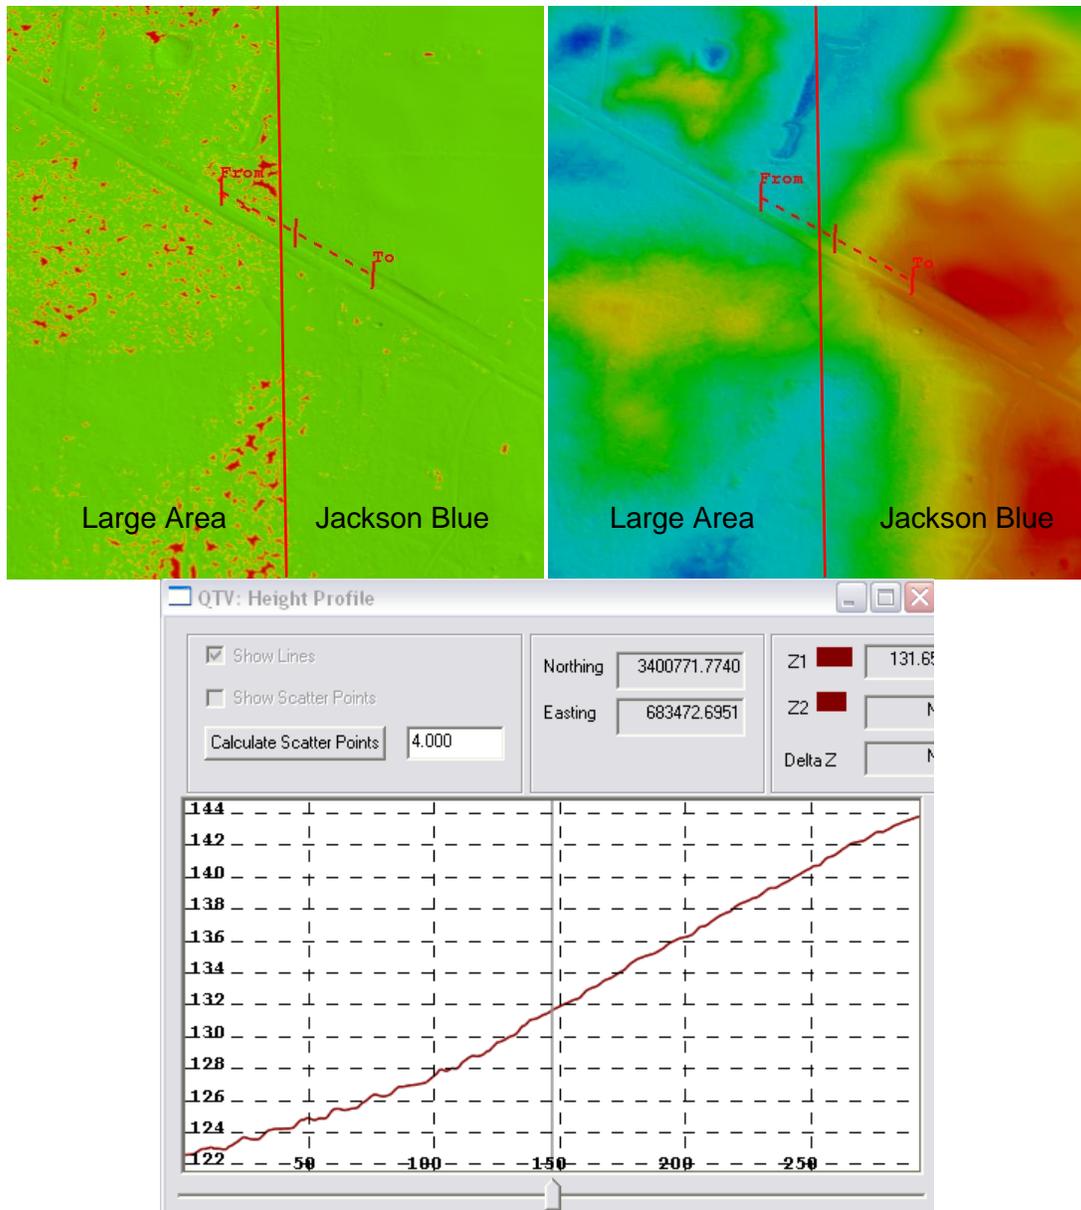
Figure 54 – Tiles 36907 and 36908. Top left is density image, right is ground surface model. The edge of each dataset is visible in both images although the cross-section does not show a difference in elevation.
