LiDAR QA/QC

- Quantitative and Qualitative Assessment Report -
Northwest Florida Water Management District
Sanborn Add-on;
Washington, Jackson and Calhoun Counties
September 2, 2008

Dewberry

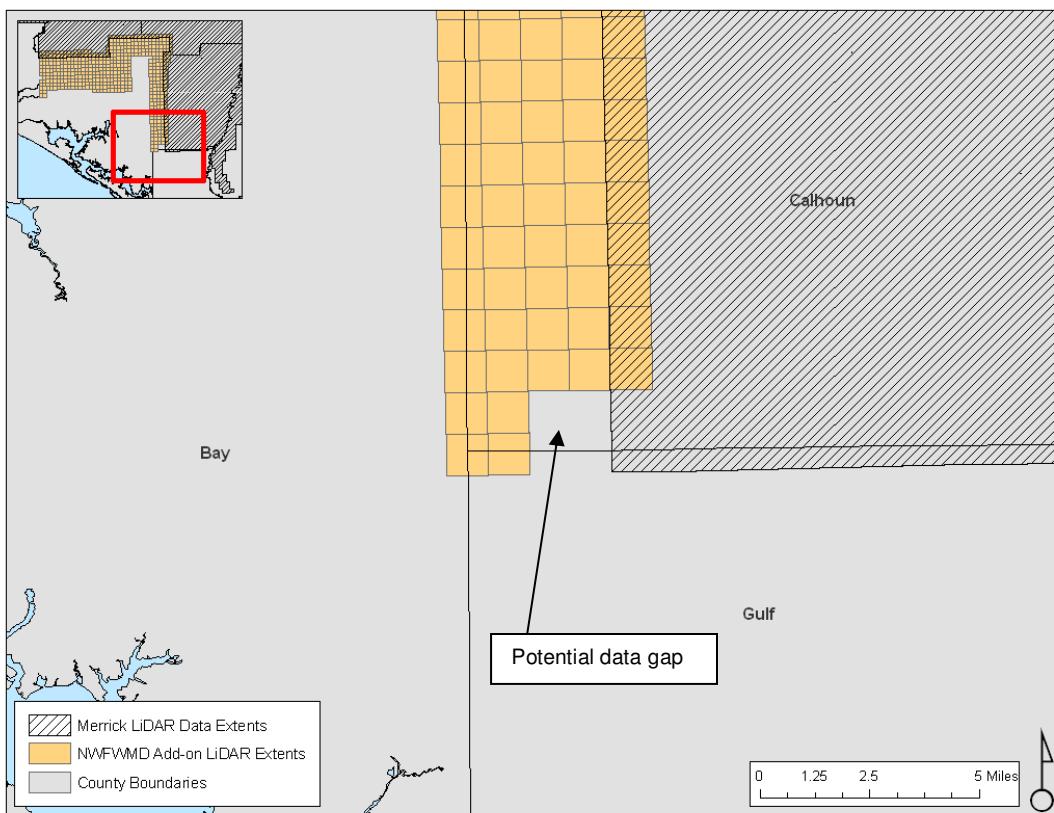
It should also be mentioned that there was a small area in southwest Calhoun County where a few tiles of data are missing. It is unsure whether these tiles should have been flown by Sanborn or Merrick. The missing area is shown in the image below (see Figure 4).

Figure 4 - This image shows a data gap where no LiDAR tiles were delivered by Sanborn or Merrick.

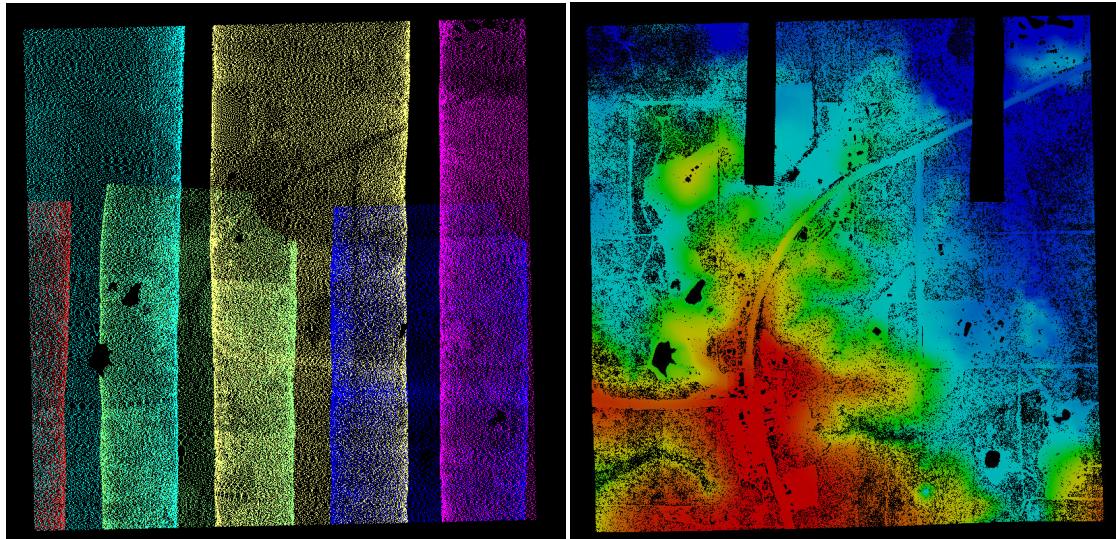
One issue that was found in the tiles located along the northern and eastern edge of the dataset was areas of missing or incomplete scanlines. Figure 9 displays this phenomenon. The image on the left is a LiDAR tile classified by flightline. It is easy to see where the scans begin and end. The image on the right is the same LiDAR tile classified by elevation. This issue is commonly seen in LiDAR tiles along the edge of a dataset and is only problematic when there is no adjacent LiDAR data that overlaps these tiles. For this project, the Merrick LiDAR data covers this area along the outer edge eliminating the missing data problem. The extent of this overlap can be seen in Figure 15. Although we have identified this issue as a missing scan line, we do not have the contractual boundaries to definitively define if it is in or outside the boundary. However this tile is full covered by LiDAR with the Merrick data.

Figure 9 - Tile 15555750. Image on left is LiDAR points classified by flightline. Image on right is LiDAR points classified by elevation.

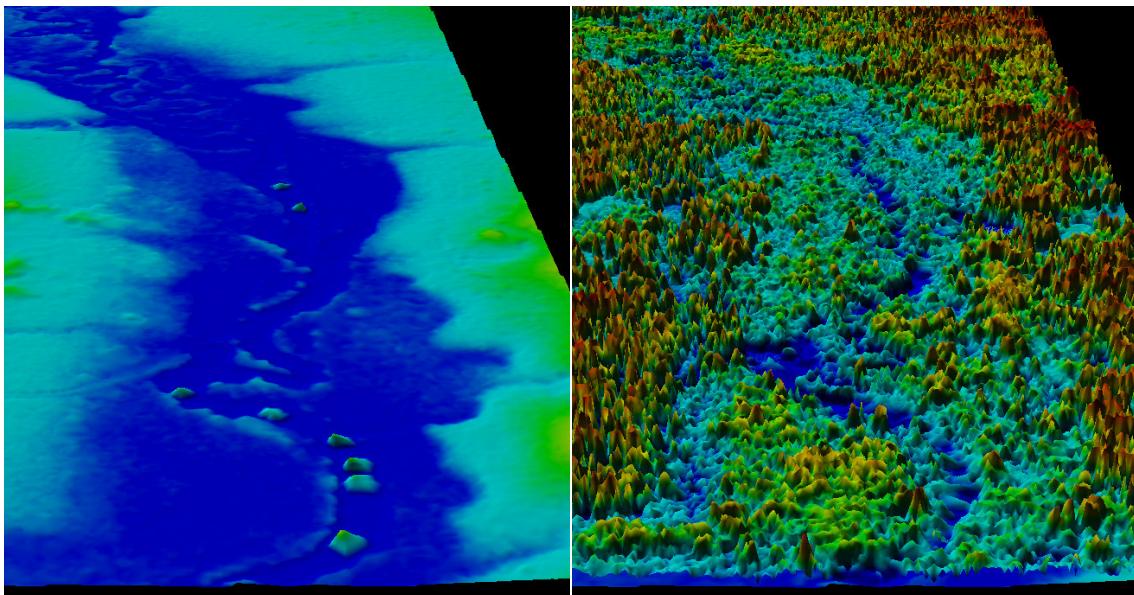
There were a few instances where the vegetation removal process was not completely successful resulting in artifacts. This is not a significant issue as it was not found to be widespread throughout the dataset and are within desirable limits. The artifacts were mostly found in areas of dense vegetation along a river bed where classification can become difficult. Figure 10 and Figure 11 display examples of the types of artifacts found in the data.

Figure 10 – Tile 15305150. Left image is ground model showing several artifacts left in after vegetation classification. Right image is full point cloud model of same area showing how dense the vegetation is in this area.

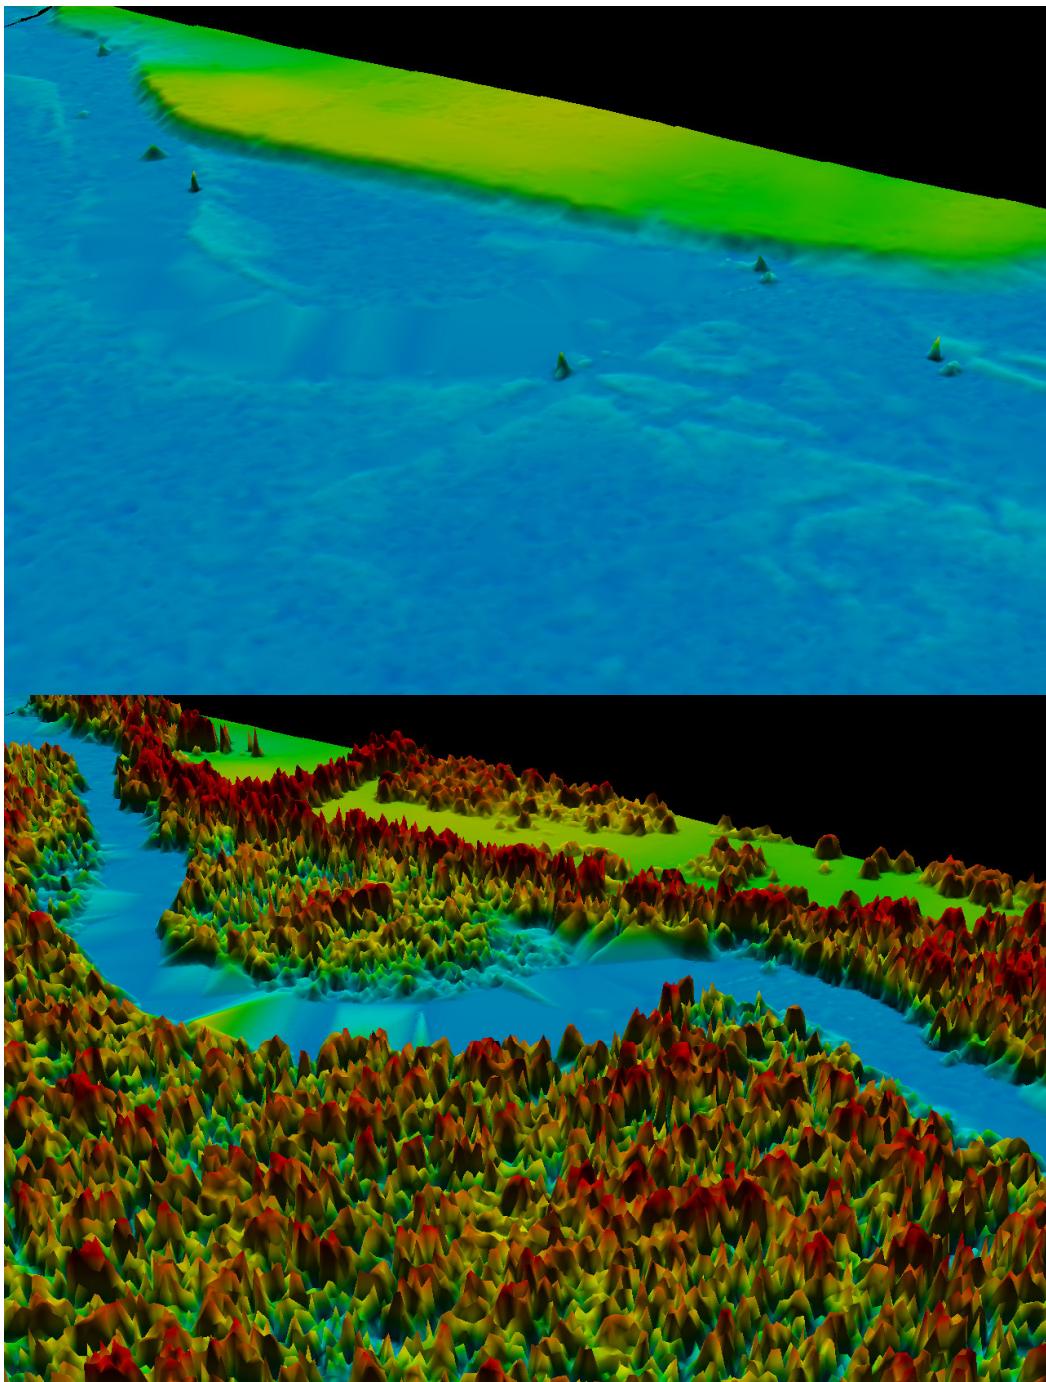
Figure 11 – Tile 15305600. Top image is ground model showing several artifacts. Bottom image is full point cloud model showing vegetation.

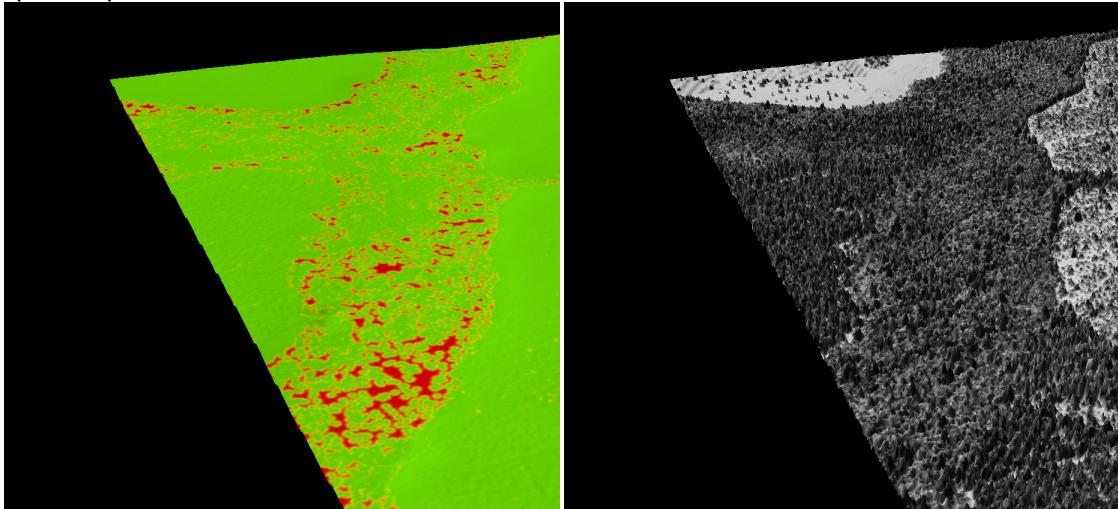
Several patches of sparse data were also found where the LiDAR did not get to the ground. This penetration problem was more pronounced in the southern section of the dataset in western Calhoun County which, as seen in Figure 14, which is characterized by dense vegetation. Figure 12 and Figure 13 display a couple examples of this. Due to the vegetation characteristics and the inability of no other technology achieving the same

accuracy as LiDAR in dense vegetation, the data is acceptable as no large significant gaps are present.

Figure 12 – Tile 17055400. Left is a density ground image where red indicates missing data. Right is full point cloud intensity image showing the vegetated area where the LiDAR pulse could not penetrate completely.

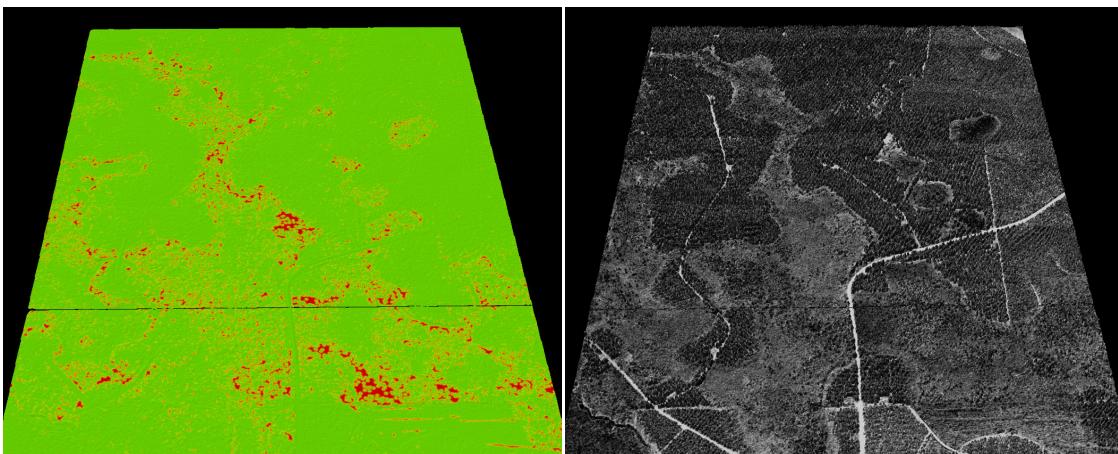
Figure 13 – Tile 16954850. Additional example of area of poor penetration.

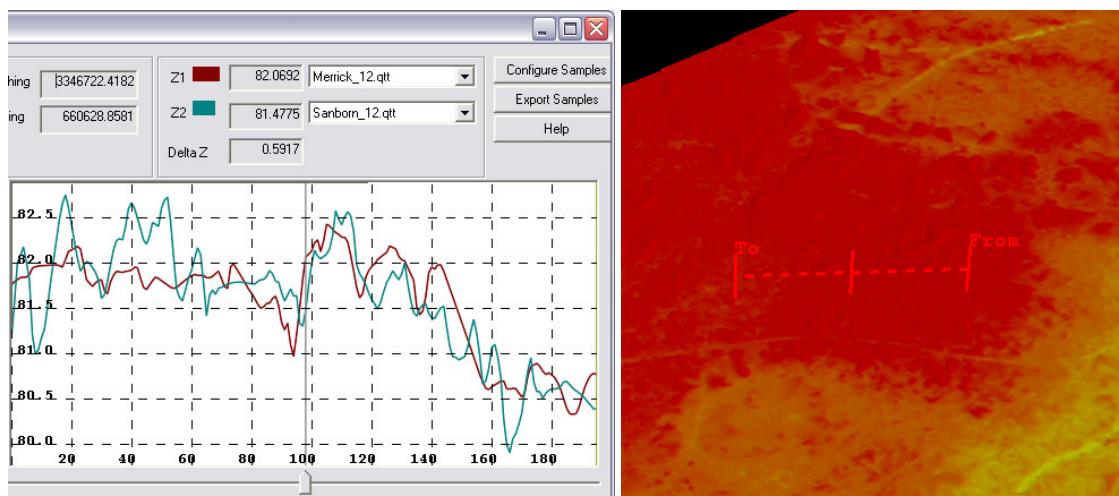
In order to analyze how well the datasets fit to each other, a number of cross sections were drawn in areas of various types of terrain. Dewberry found that for the most part the datasets were within 0.5 feet of each other however there were a few areas where there was almost one foot difference. These areas were located in the southern part of the dataset in western Calhoun County where there is much more vegetation and LiDAR pulses in both datasets had some difficulty in reaching the ground. Figure 16 displays a cross section where the two datasets fit together very well and Figure 17 displays a cross section where the datasets are not as close.

Figure 17 - Tile 17054500. Left is cross section showing a larger difference between the datasets. This cross section was taken from the southern section of the project area characterized by dense vegetation.

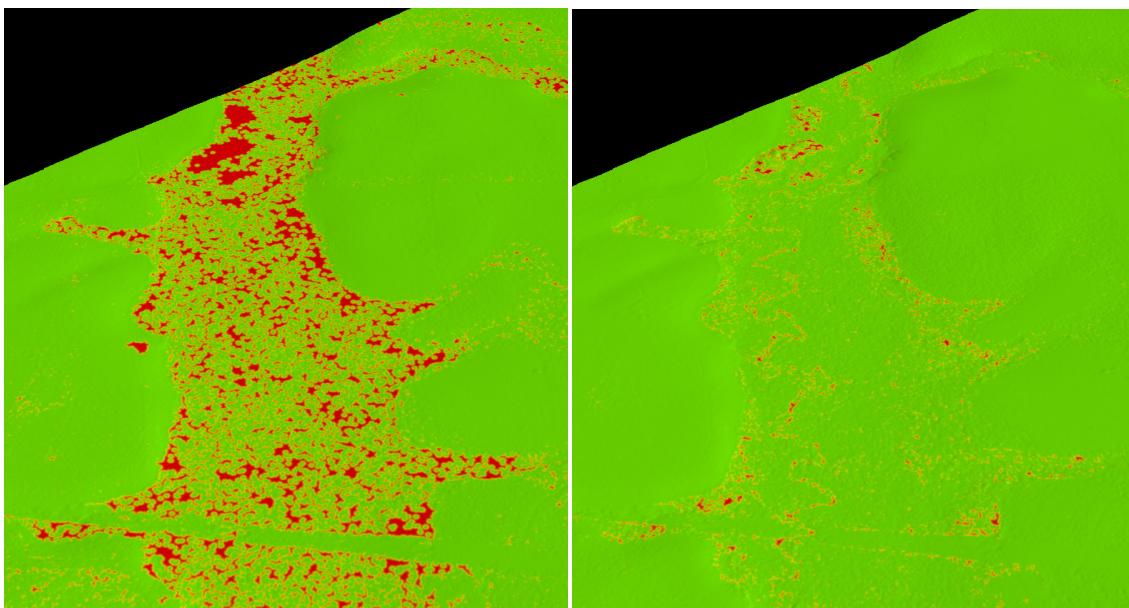
Figure 19 - Tile 17055250. Left is ground density image of the Merrick LiDAR data showing poor penetration along a stream. Right is Sanborn ground density image of same area showing excellent LiDAR coverage for this type of difficult terrain.
