# Data Post-Processing Report

2020 Lidar and Derivative Products for Cherokee, Chester,  
Fairfield, Lancaster, and Union Counties

*Data Processing Report for 2020 Lidar: Flood Map Modernization  
Initiative Contract*

**South Carolina Floodplain Mitigation Program**  
South Carolina Department of Natural Resources

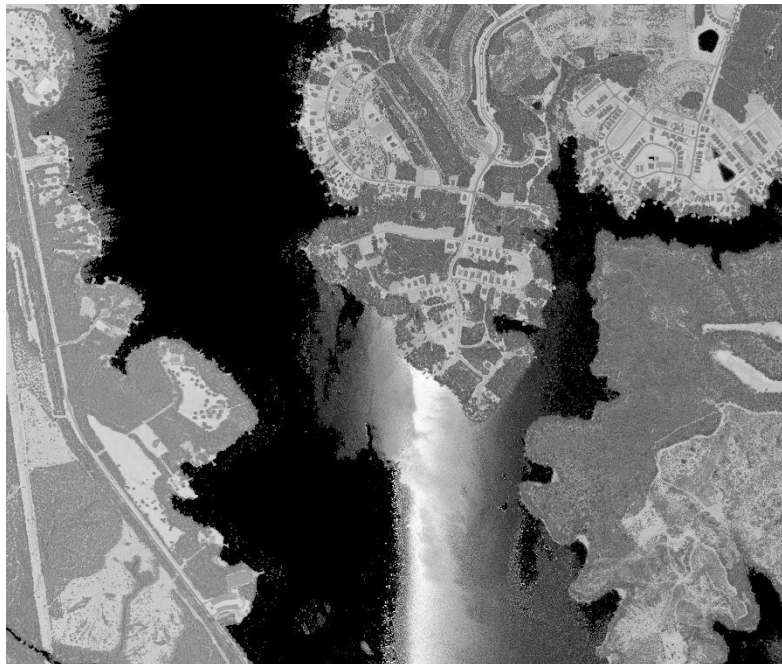
**Figure 6. Intensity example showing high reflectance values over water**

Every attempt was made to achieve homogeneity across the project area in image appearance. There will, however, be some variance in the appearance, especially over water bodies and other features where the reflected signal was either absorbed or reflected to a degree greater than normal. Figure 6 illustrates an area where the bright reflectance off the river surface gives intensity values outside of what is expected, affecting an otherwise homogenous scene.

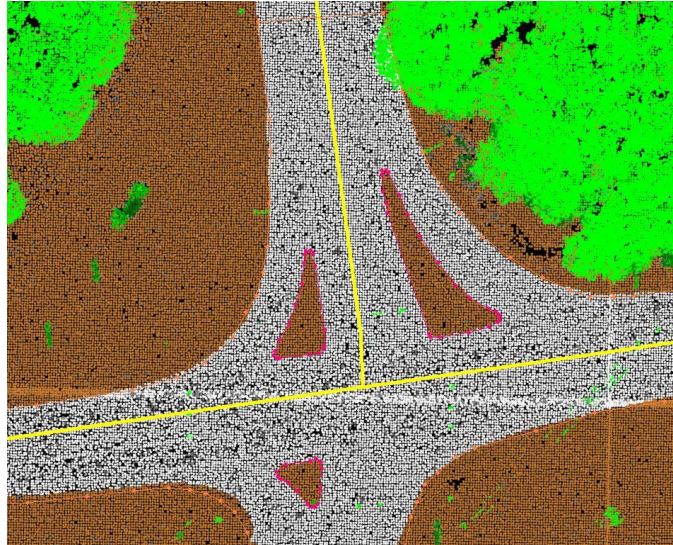
**Figure 12. Completed classifications with road islands retained in Class 2 Ground and road surfaces in Class 13**

ESP classified the road points in the lidar by using a comprehensive collection process for mapping road edges, bridge decks, and road islands. Using the collected lidar data as well as ancillary reference files such as the latest-available orthophotos, technicians collected road edge polygons delineating the edge of pavement. The process utilized the planimetric tool within ESP's proprietary software. This allowed the technician to edit polygons and lines while mapping if need be and close the polygon correctly upon completion of the drawing. The technician was able to view the lidar, orthophoto, and other ancillary GIS data simultaneously. A transparency slider bar allowed the technician to adjust how visible the Lidar was through the other layers. Figures 10 through 12 depict the steps of the process used.

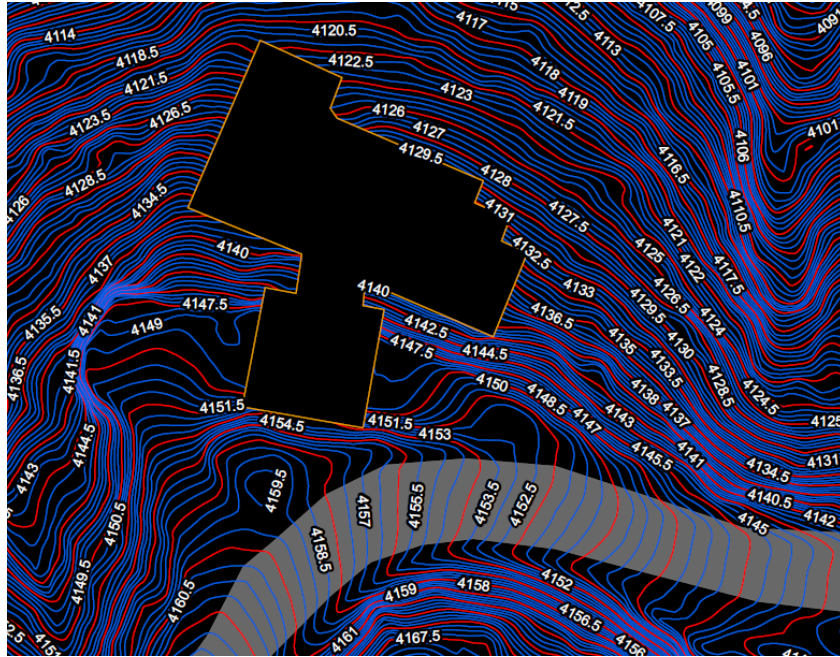
Figure 14. Example of 0.5 contours generated from lidar

Classified ground points from the lidar files were converted to an even, 5ft grid (such as a 5ft grid). This helped to remove the jagged contours common to lidar-derived contour data and smooth the lines. The grid was then used to generate a surface that supported the generations of the contours. No new breaklines will be created or used for the process, however the approved hydro-flattening layers were used for closed water bodies and rivers to help enforce the contours.

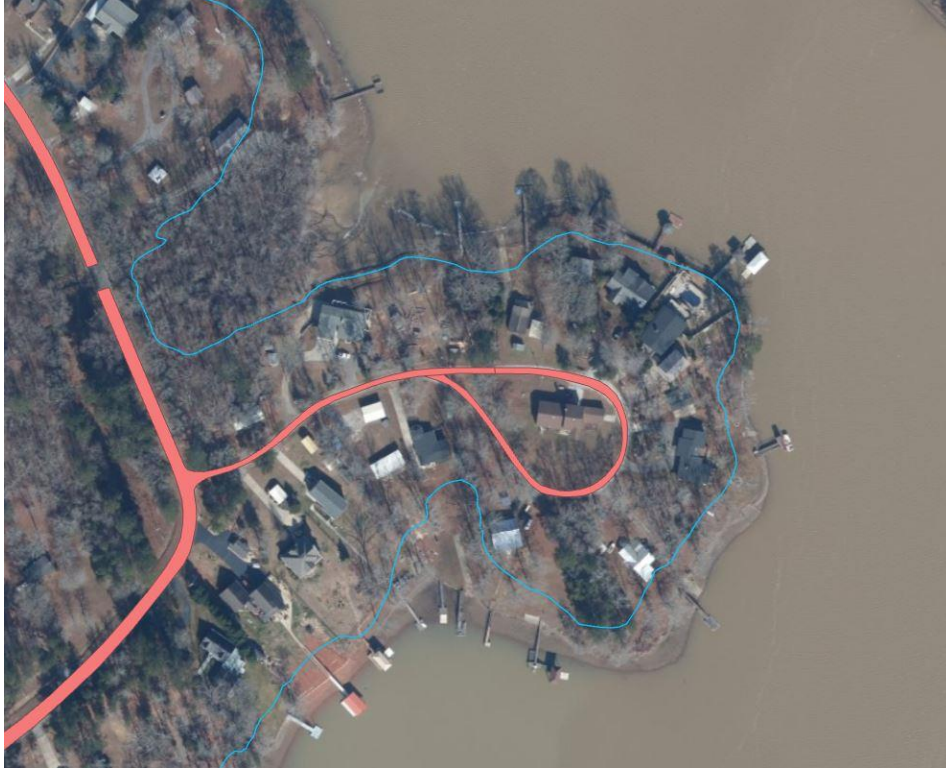
**Figure 15: Flooding in the lake resulted in the hydro breakline being inset significantly along the shoreline**

During the data collection flight the energy utility released water upstream. This was not known as a potential event during the flight nor during planning for this project. During post-processing and client QA/QC it was noted that a significant temporal difference existed between the legacy lidar data for the area and the data collected for this project. The differences in the hydro boundary lines between the new and legacy datasets are illustrated in Figures 14 - 16.

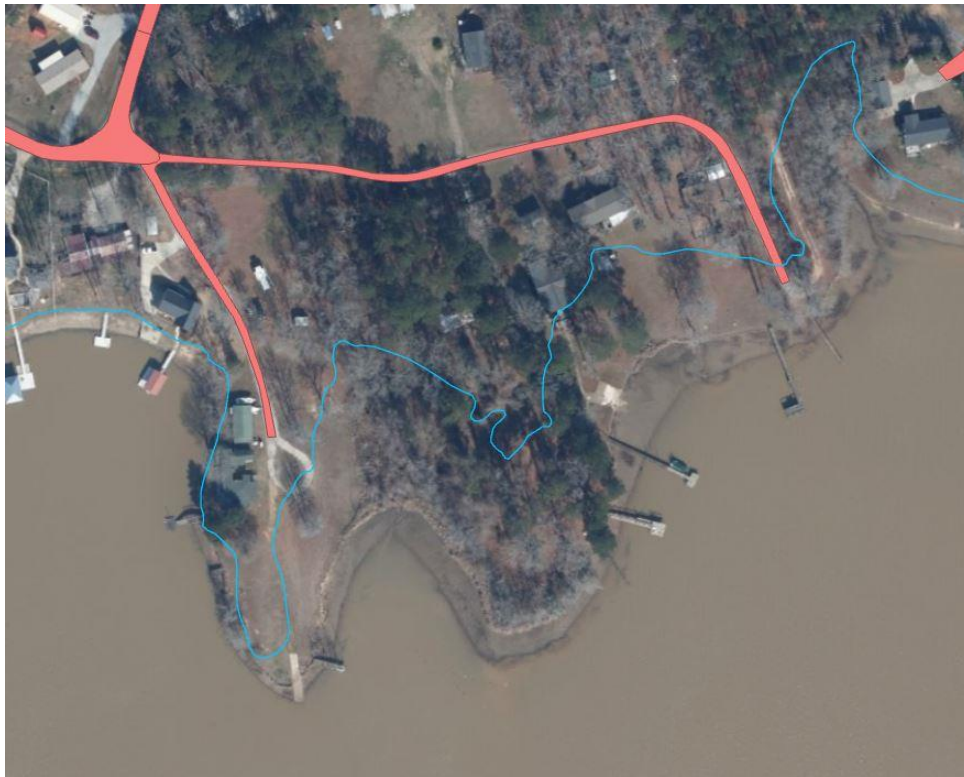
**Figure 16: Blue line is hydro breakline from current dataset**

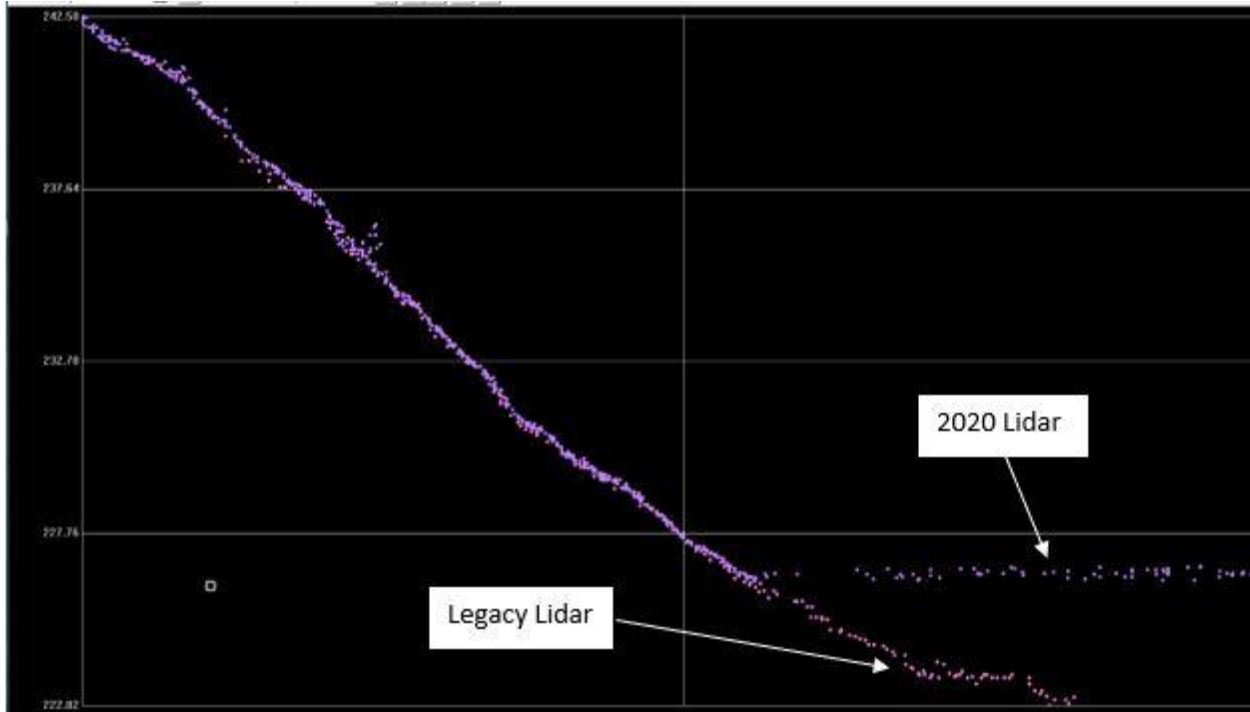
**Figure 17: Profile of legacy and new lidar showing the temporal difference**
