LiDAR Quality Assurance (QA) Report
California LiDAR and Imagery QA
NOAA Coastal Services Center
NOAA Contract: EA133C-11-CQ-0007
March 20, 2012

Submitted to:
NOAA Coastal Services Center

**Dewberry**

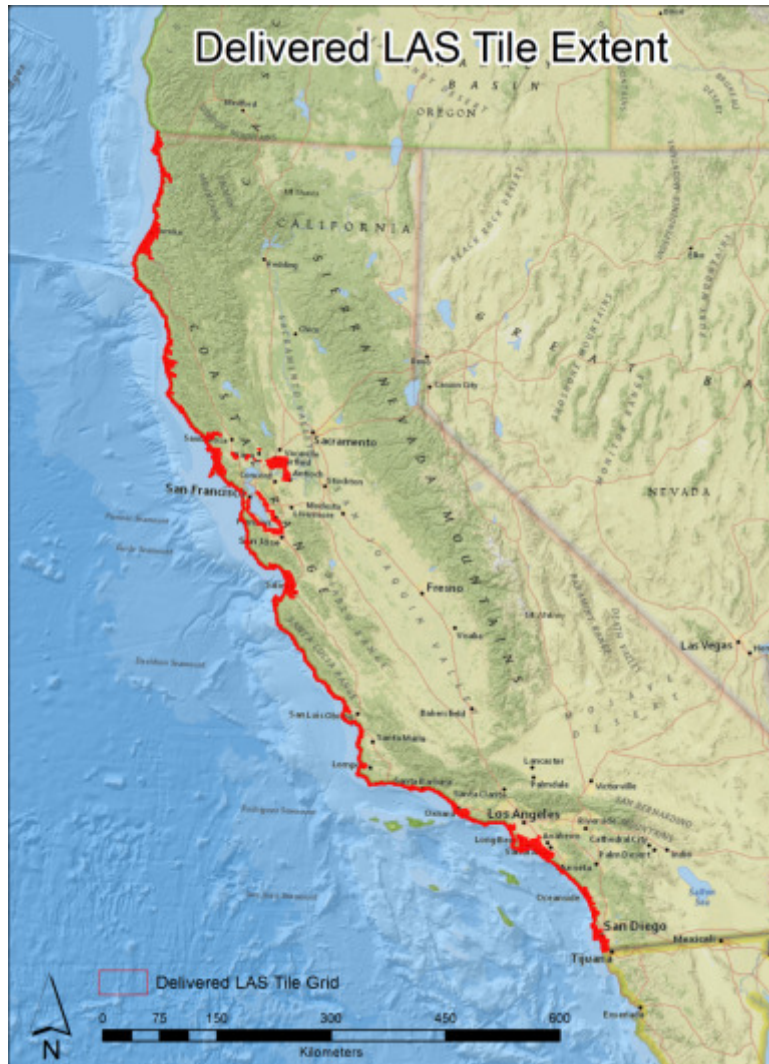
Figure 1 - Location of LAS tiles for Project Area.

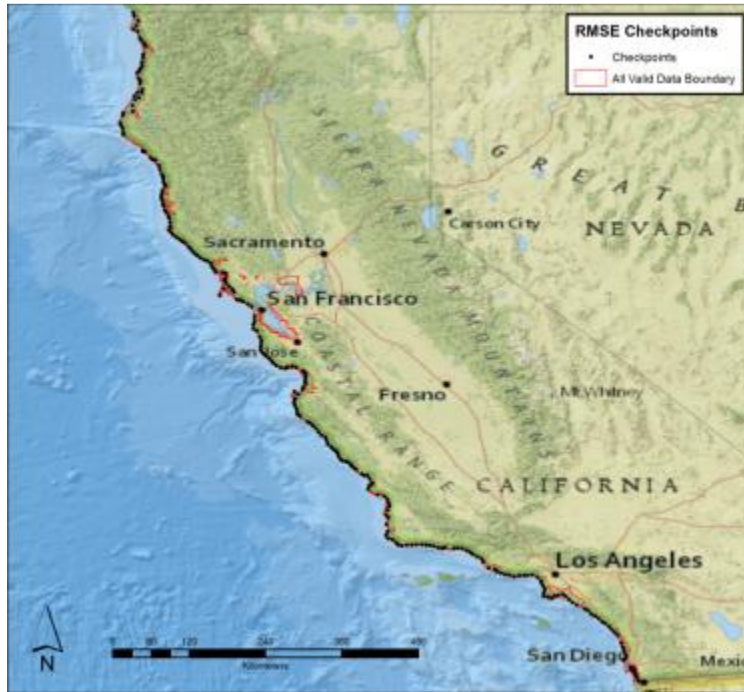
Vertical Accuracy Checkpoints

Figure 2 - Survey Checkpoint map.

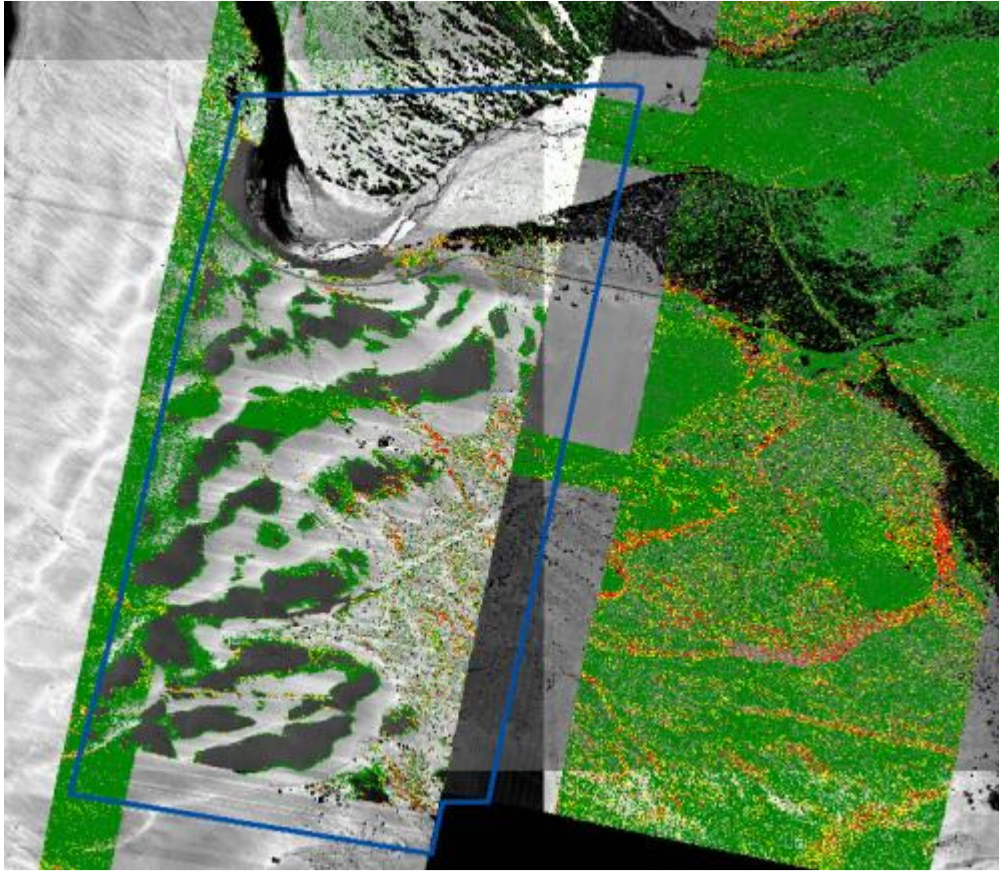
Dewberry created the DeltaZ orthos using only ground points in order to examine the relative fit of overlapping flight lines. Some yellow and red pixels are expected due to terrain change greater than 9 cm that occurs in the same 1 meter pixel, such as on embankments, berms, and cliffs. In large areas of high relief, significant portions of the flight line may appear red or yellow. For California Area 2, several such areas were detected. These areas were examined further to determine if changes in terrain or actual flight line offsets were causing the coloration. In addition, flight line ridges exceeding project specifications of 9.80 cm vertical accuracy were identified and marked during the visual LiDAR QA process. It was also discovered that some areas of flight line offsets were due to temporal changes between flights rather than line calibration issues. Dewberry found seven areas of flight line offsets which exceed project specifications. Please see the LiDAR Qualitative review section of this report for more information of flight line offsets and ridges.

Figure 3 - The amount and placement of red and yellow pixels in the delta z ortho image above indicates the possibility of flight line offsets. Further analysis showed that two flight line ridges exist within the area outlined in blue. The remaining red areas are a product of the terrain, not an offset.

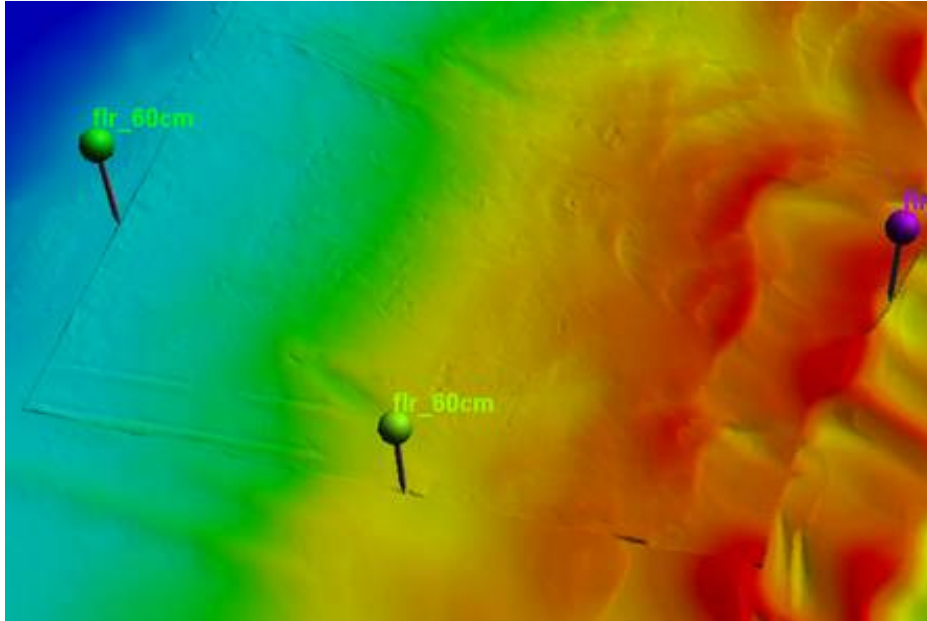
Flight line ridges occur when one flight line is vertically offset from an adjoining flight line. In one instance, flight line ridges found during the review were caused by temporal changes between flight times. Actual changes in ground conditions caused sporadic ridges of up to 2 or more meters in the ground models of some tiles. This occurred in along sandy beaches or riverbeds which are subject to frequent temporal changes. It was recommended that in those cases, the most recent depiction of the ground be used, which may necessitate the use of points previously classified as overlap.

Figure 9 – Tile c7155_38820, first delivery. Ground elevation model. Changes in ground conditions between have created the unnaturally raised portion of ground seen above. Three ridges measure approximately 60 cm each.

LiDAR by nature can only depict the ground surface at the time of collection. This means there is no easy fix for areas where cohesive data does not exist. Dewberry's original recommendation to the data provider was to correct large flight line ridges by using only points from the most recent flight line present in the area. For the second delivery LiDAR, the majority of flight line ridges were corrected or minimized in this way, however in some cases temporal flight line ridges that are over project specifications remain. Often the data provider was able to correct the ridge originally identified, however the correction created a second ridge nearby.

The temporal flight line ridges in the dataset cannot be fully eliminated because each flight line does not fully cover the area on its own. Because of this, Dewberry does not feel that further corrections from the LiDAR provider would be appreciably beneficial. The figures below show several examples of the flight line ridges and their corrections. Figure 9 shows a ridge that was identified in the original delivery. The GDB accompanying this report contains a shapefile identifying flight line ridges detected in the first delivery and is attributed with comments from the data provider indicating whether issues existed in correcting the ridge. Additionally, Dewberry has included 6 new temporal flight line ridge calls which resulted from correcting the original ridges. These calls are added as a reference for the user.

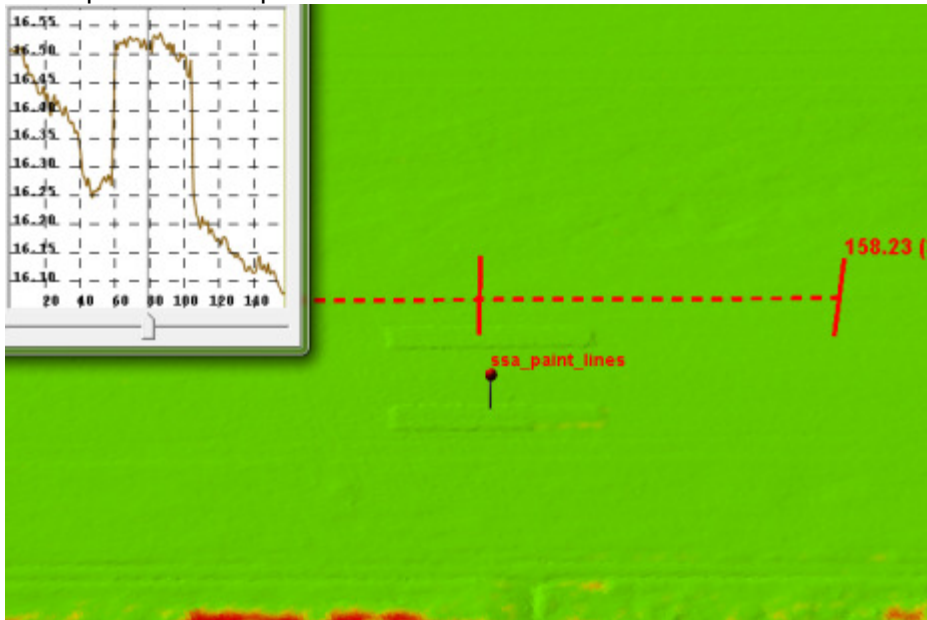
During the review Dewberry identified a few areas where reflective paint from an airport runway caused a sensory anomaly leading to an inaccurate portrayal of the ground model. These points should be moved from ground (class 2) to unclassified (class 1). These areas were corrected by FEDI in the subsequent deliveries of the dataset. An example is shown below and a GDB that contains the location of the edit calls accompanies this report.

Figure 10 - Tile 3960_46245, first delivery. Ground density model. The image shows a large spike in elevation over the surface of the painted runway.

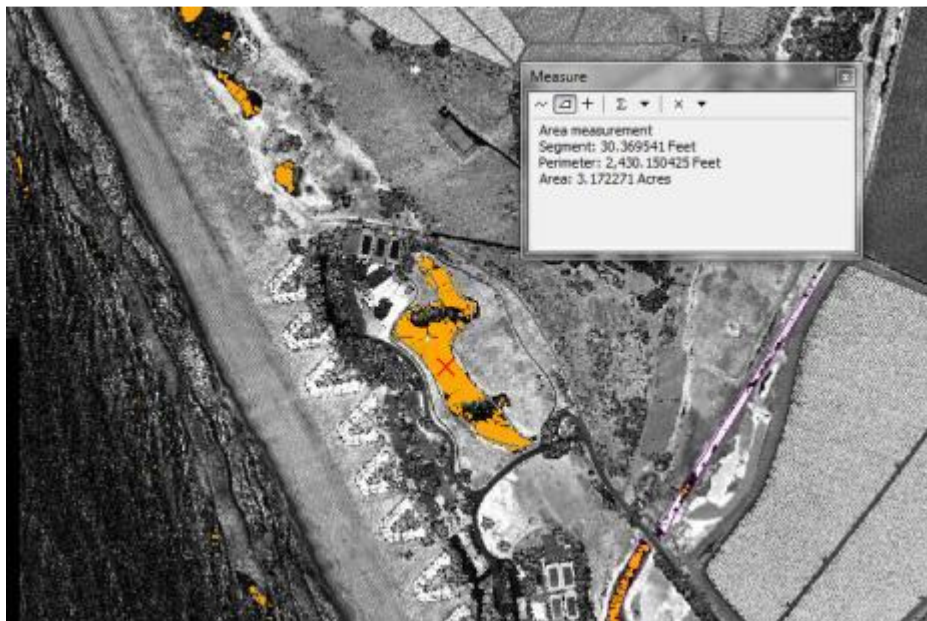
Issues were found where breaklines were not collected for pond and island features that meet collection criteria. All missing features identified by Dewberry have been captured by FEDI. Examples are shown below and all edit calls are provided in the GDB that accompanies this report.

Figure 13 - Tiles C64045_40815 and C6045_40800. Full point cloud shows a water body larger than 2 acres that has not been captured

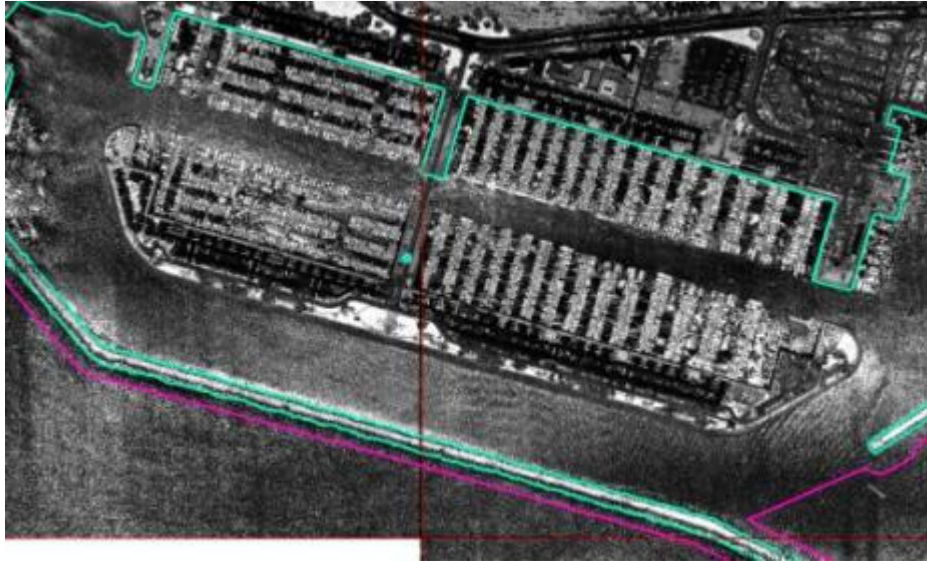
Figure 14 - Tile C4350_37020. Full point cloud intensity shows an “island” in the tidal water. This feature should be collected in the breaklines.

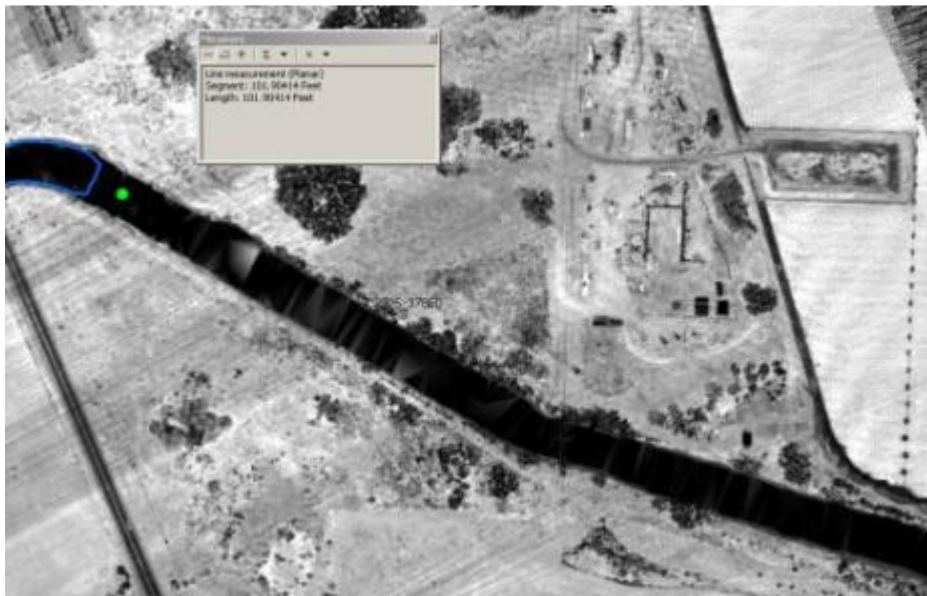
Edit calls were placed for incomplete collection of breaklines when the current breaklines did not fully capture the entire water feature. Incomplete collection of breaklines is called when more than a slight or small adjustment to horizontal placement of the breaklines is necessary. Dewberry believes that FEDI has extended all necessary breaklines.

Figure 15 - Tile C2925_37860. River here is just at 100 ft wide and should be extended as necessary.

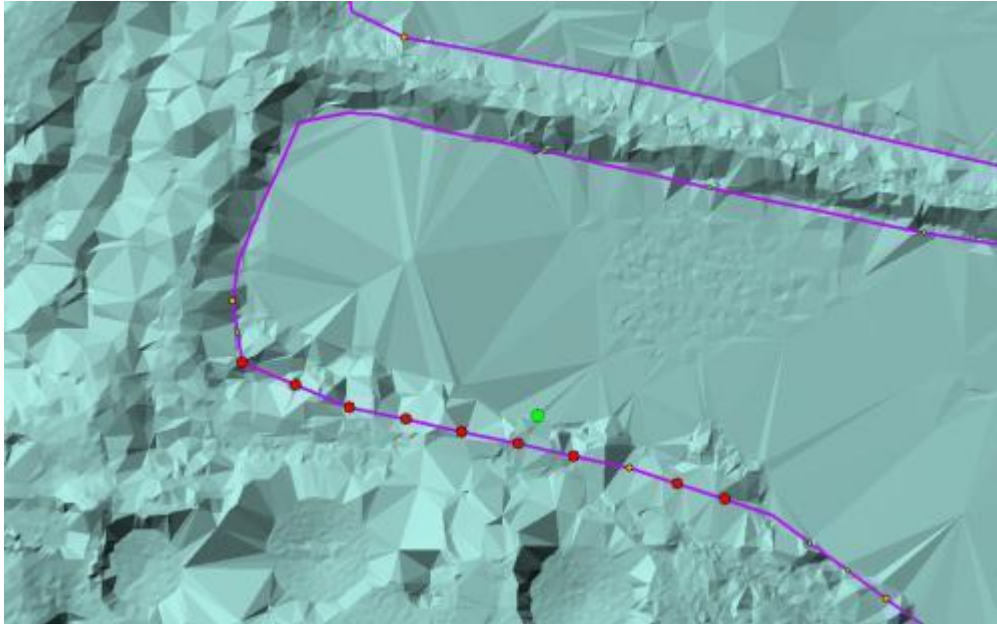
In the review Dewberry identified vertices in seventy-five (75) breakline features that dig into the terrain surface. These vertices have a direct impact on the DEM. Figure 17 show several vertices in the pond bank digging by up to 2.6 meters, shown in red. Upon review of full point cloud intensity image and ortho image, it was determined that there is some degree of tree overhang in this area but not to the degree shown here. Dewberry confirms that FEDI has adjusted the all the breaklines so that they no longer dig into the surrounding terrain.

Figure 17 - Tile C4620_36765. Pond, in purple, shown overlaid first with a GeoTerrain built from ground points in the LAS.

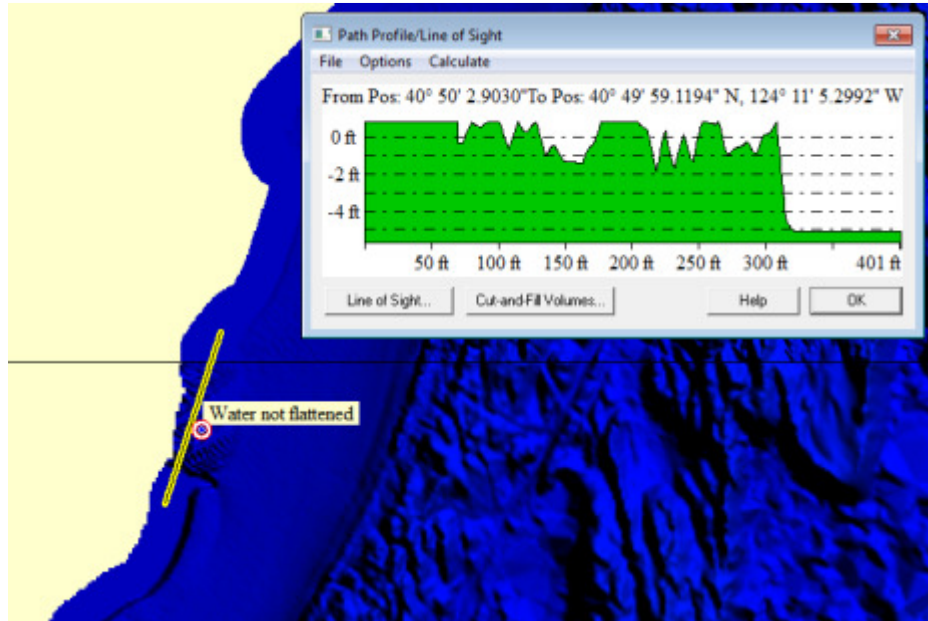
Water artifacts occur when the surrounding water in the breakline is at a constant elevation except for an unnatural spike. All of these instances were removed from the DEMs by FEDI in subsequent deliveries.

Figure 19 - DEM tile C3990_45180. The image above shows that the water was not flattened in this area.
