LiDAR Quality Assurance (QA) Report  
Coastal New York LiDAR  
NOAA Coastal Services Center  
NOAA Contract: EA133C-11-CQ-0007  
October 4, 2012

<b><u>Contract:</u></b> Coastal New York LiDAR	<b><u>Production Contractor:</u></b> Photo Science, Inc.	<b><u>Date Prepared:</u></b> 10/4/2012	<b><u>Delivery #:</u></b> Area 2, Delivery 2	<b><u>Dewberry Recommendation:</u></b> Accept all Data for Priority Area 2 (Long Island)
<b><u>Data History:</u></b> □ Area 2, Delivery 2

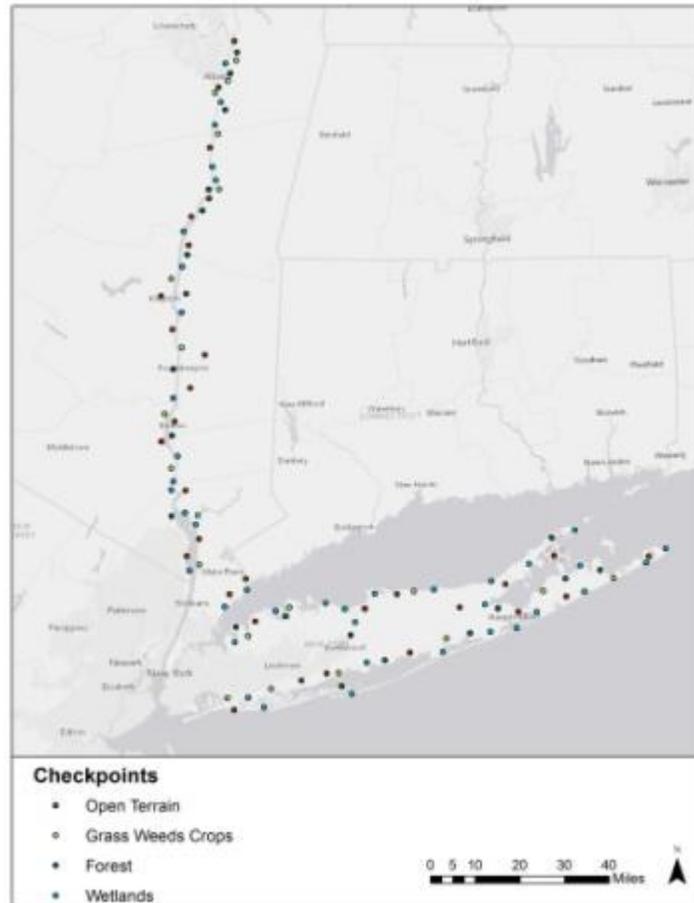
Figure 2 - Checkpoints distribution for the Coastal NY project area.

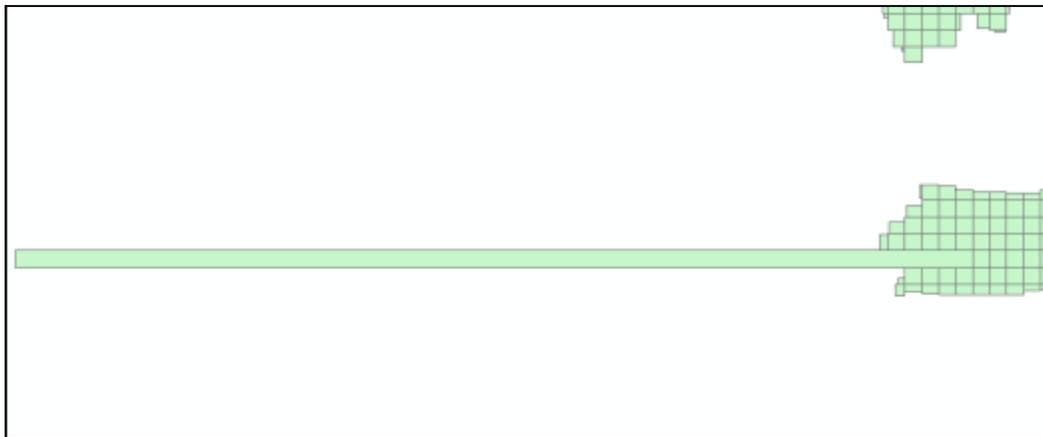
The header for tile 18TXK105955 originally contained an incorrect value for in the X Min field. The header for this tile has been reprocessed and is now correct.

Figure 3 - A feature class of the LAS files' extent created from the header information. Tile 18TXK105955 from the first delivery does not have the correct extent.

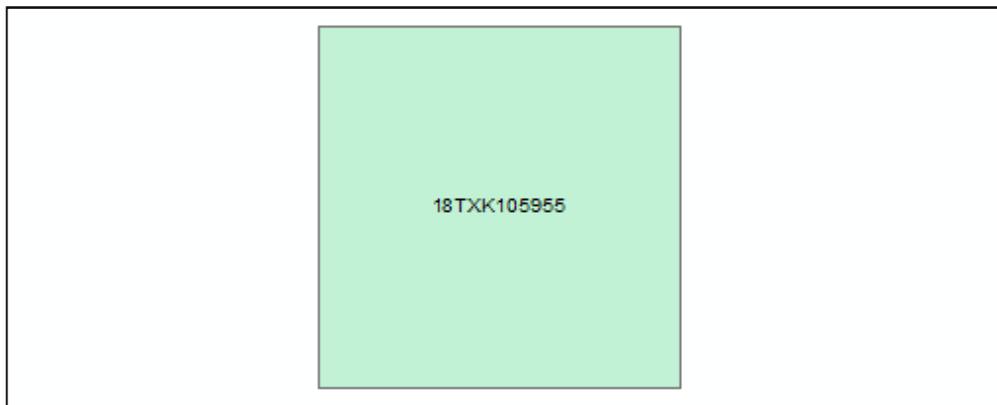
Figure 4 - A feature class of the LAS files' extent created from the header information. The extent of tile 18TXK105955 has been corrected in the second delivery.

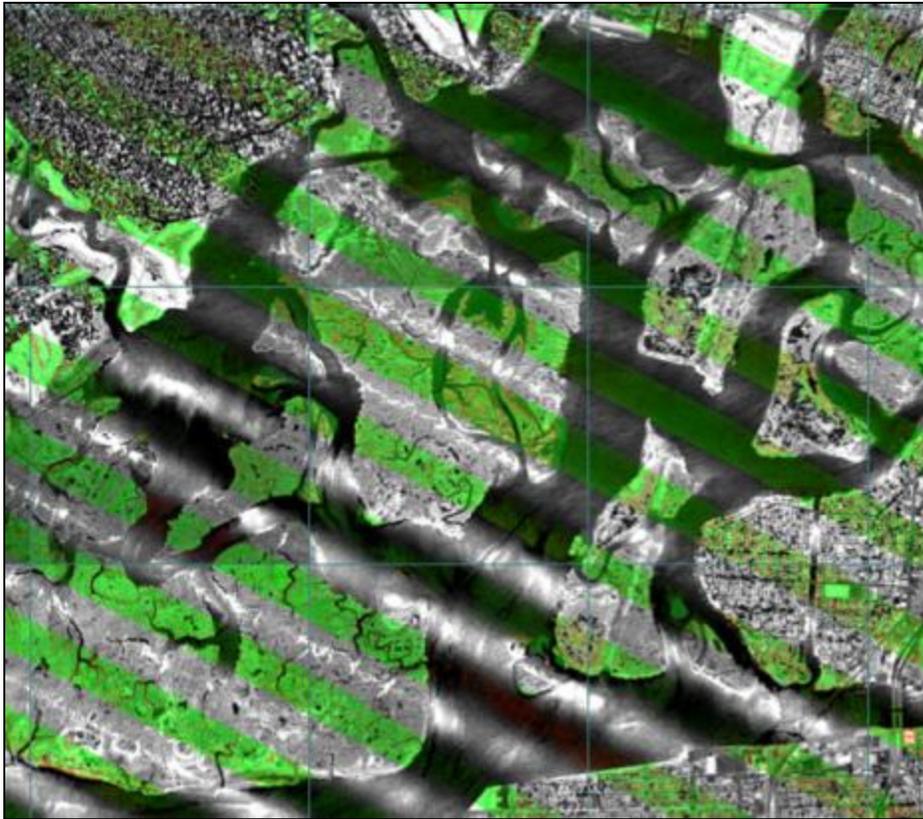
Dewberry created the DeltaZ orthos from the ground points so that we could examine the relative fit of overlapping flight lines. Some yellow and red pixels are expected due to terrain change greater than 10 cm that occurs in the same 1 meter pixel, such as on embankments, berms, and cliffs. Areas of flat, open terrain or bare earth, however, should not show large elevation discrepancies between adjacent flight lines. As the image below illustrates, all adjoining flight lines for Priority Area 2 matched within specifications.

*Figure 5 - DeltaZ Orthos for Priority Area 2 show adjoining flight lines match very well.*

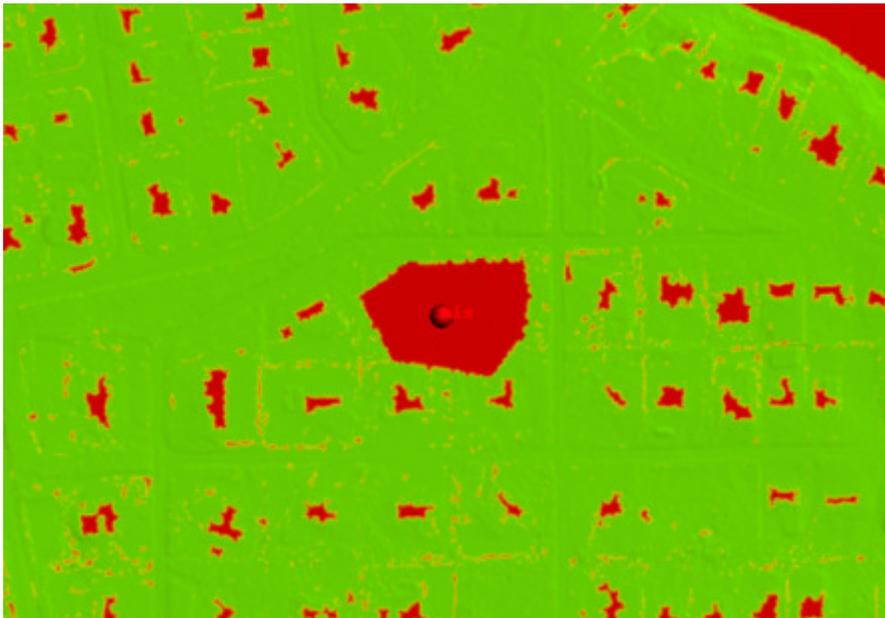
*Figure 6 - Tile 18TYL050240 from the first delivery. Ground density model shows a residential area where ground points that have been removed from the ground model are colored red. Buildings and hydrographic features are expected to appear red, but large red sections on flat ground identify areas of possible misclassification.*

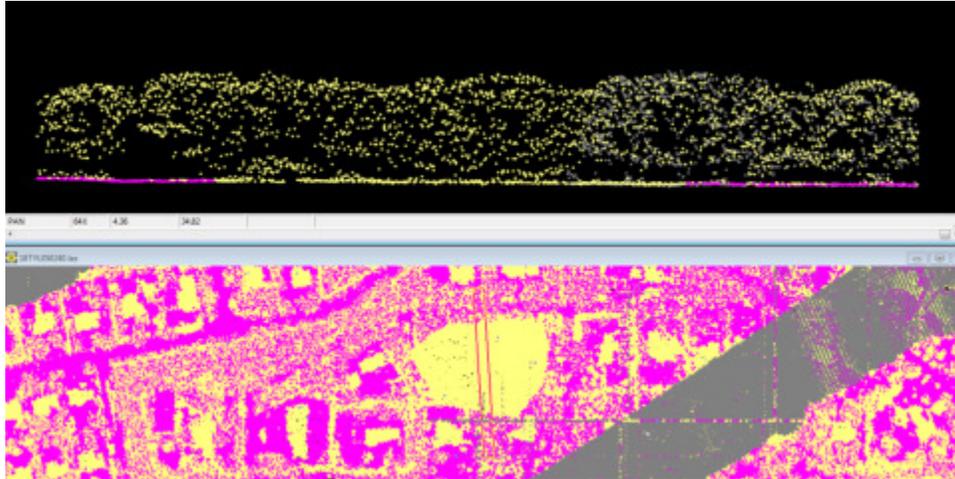
Figure 7 - Tile 18TYL050240 from the first delivery. Profile view of LAS cloud colored by classification is shown on top while LAS colored by classification is shown on bottom. This image shows that there are legitimate class 1 (yellow) points that could be reclassified to class 2 (purple), in order to improve the definition of the bare-earth surface.

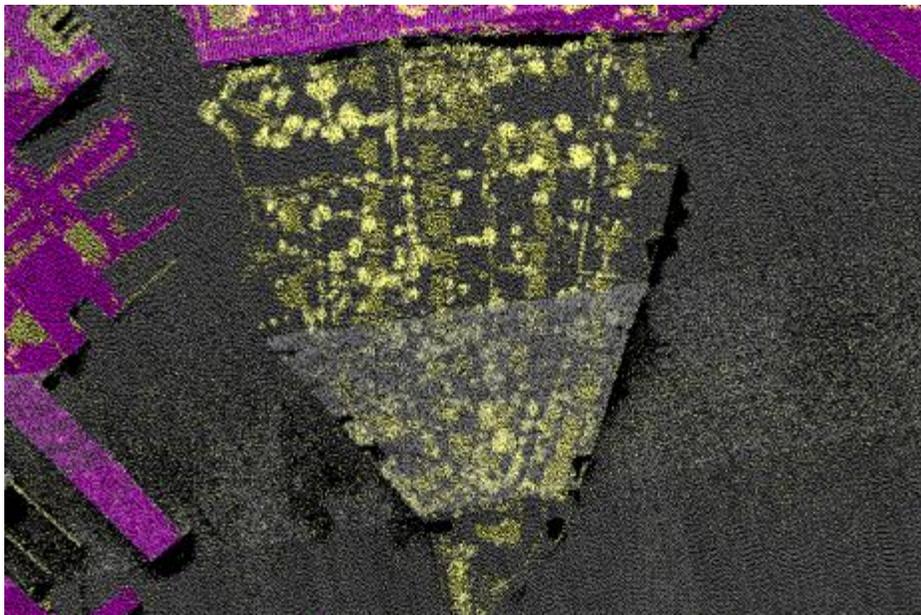
Delivery 1 contained 9 instances of misclassification where islands were incorrectly classified as water. These islands were removed from the breaklines but were not classified to ground. In order to preserve the accuracy of the ground model, these land masses needed to be changed from class 14 to class 2 (ground). All 9 instances of this type of misclassification have been corrected in the second delivery. An example of this type of misclassification, along with the correction, is shown below.

Figure 10 - Tile 18TXL480075 from the first delivery. LAS point cloud colored by classification. The island feature can be identified as incorrectly classified as tidal water (gray) and should be reclassified as ground (purple).

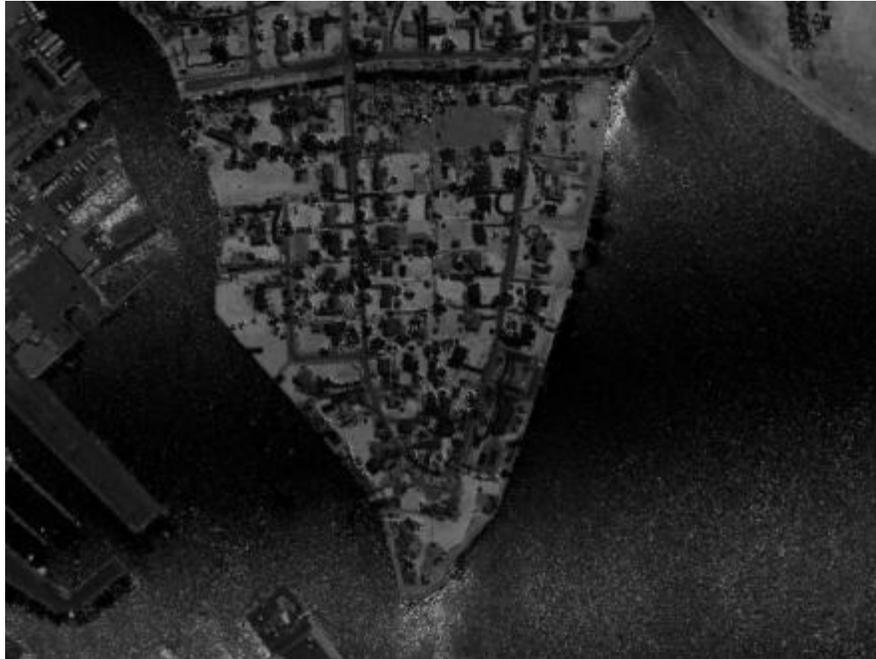
Figure 11 - Tile 18TXL480075. Intensity model showing land where it does not appear in the ground model.

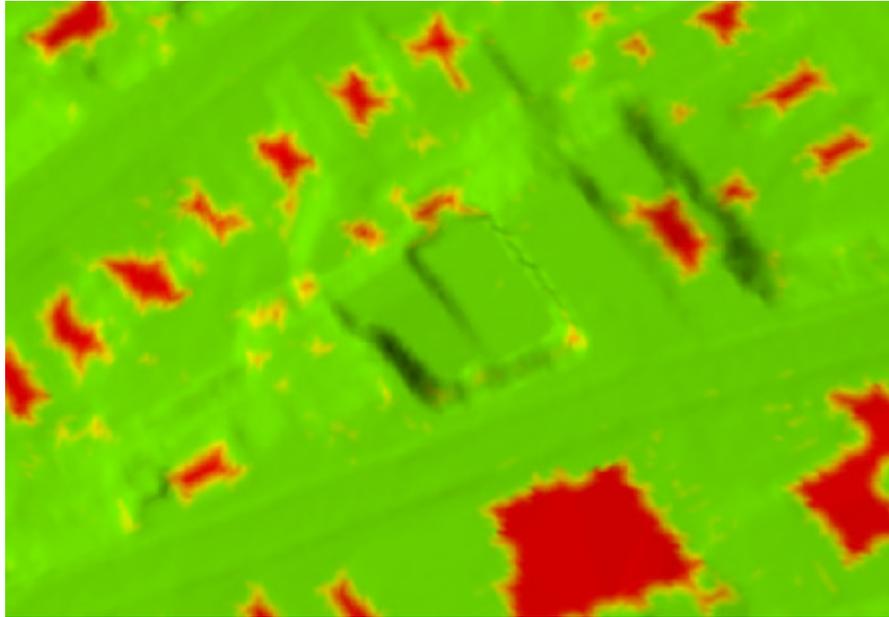
Figure 13 - Tile 18TXL105195 from the first delivery. Ground density model showing a structure that was left in the ground.

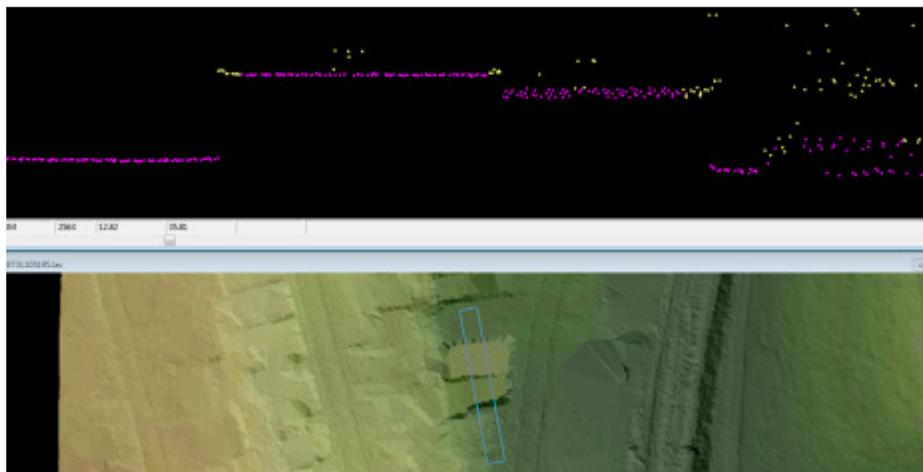
Figure 14 - Tile 18TXL105195 from the first delivery. Profile view of the LAS cloud colored by classification is shown on top while bare-earth TIN colored by elevation is shown on bottom. The structure can be seen next to the hillside and should be reclassified to unclassified (class 1).

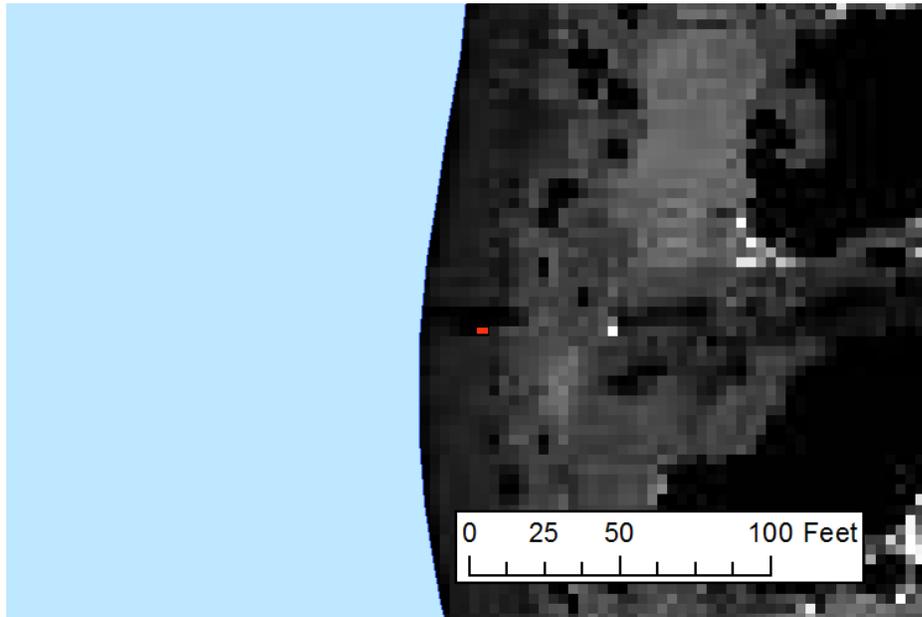
One (1) issue was previously identified for a small stream breakline that did not collect any legitimate water or meet any topological requirements. This breakline was removed from the dataset. An example of the issue, along with the correction, is shown below.

Figure 17- Tile 18TXL045165 from the first delivery. Full point cloud intensity image overlaid with a stream breakline (red) 1 meter in length. This feature should be removed from the breaklines.

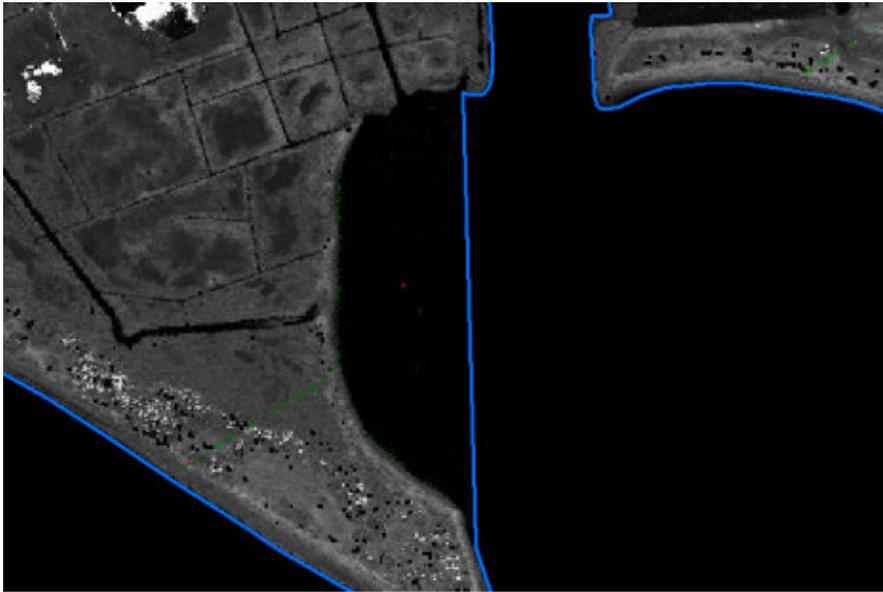
During the review of the first delivery, three (3) areas were identified where the current hydrographic breaklines did not capture all of the water in the immediate area. In the second delivery, these breaklines were either extended to fully capture the hydrographic feature or addressed with comments reflecting that extending the current breakline would only capture “wet” ground and not actual water. Two (2) issues occurred in the first delivery where breaklines captured ground within the breakline extent. These breaklines were adjusted in the second delivery to contain only water. Examples of edit calls, along with corrections, are shown below.

Figure 19 - Tiles 18TXL780105 and 18TXL780120 from the first delivery. Coastal water breakline (blue) is overlaid on the full point cloud intensity imagery. The breakline should be adjusted to capture all of the water in the area.

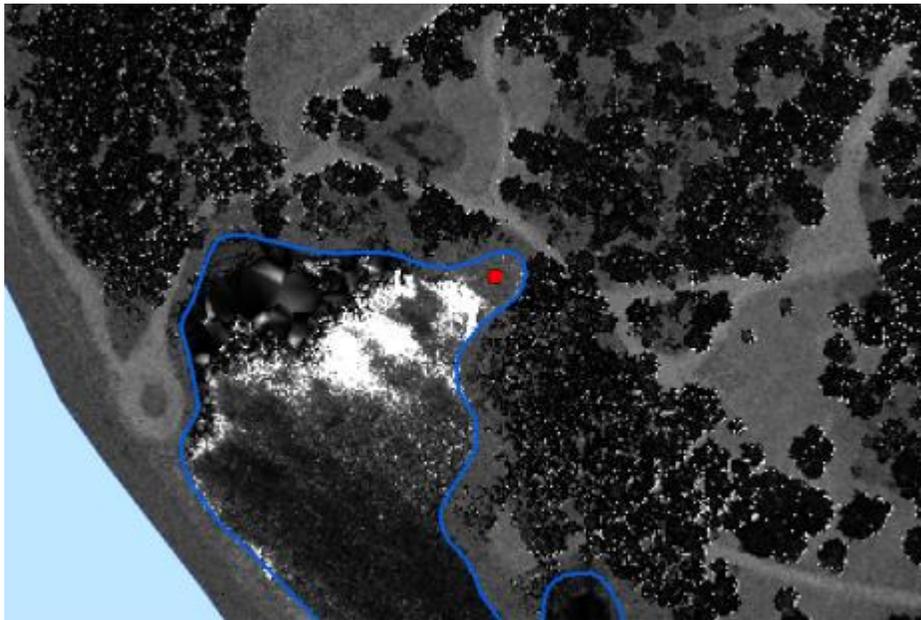
Figure 21 - Tiles 18TYL395525 from the first delivery. Pond breakline (blue) is overlaid on the full point cloud intensity imagery. The pond breakline should be adjusted to better represent the land/water interface and to exclude ground from the breakline capture.

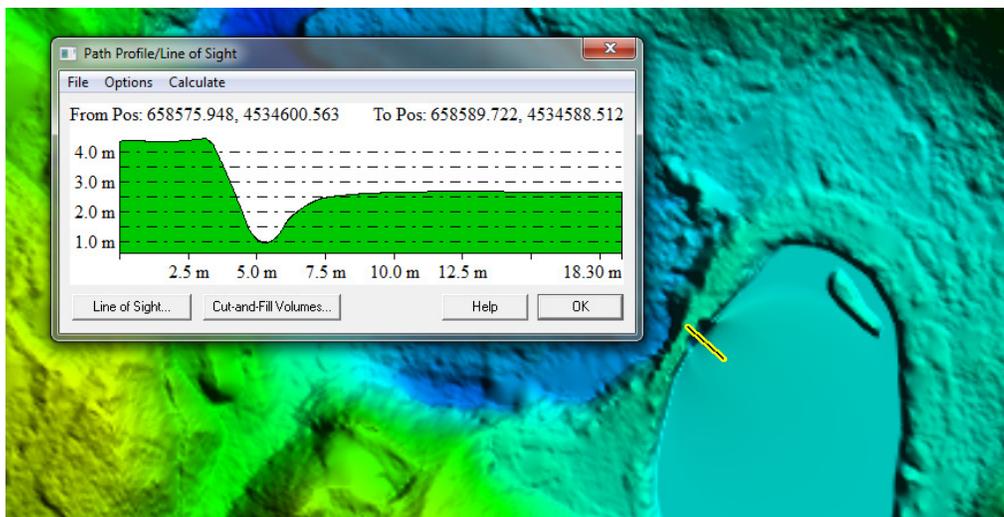
Figure 24 – DEM tile 18TXL570330 from the first delivery. The image above shows the DEM is affected by a topological error (vertices at 0 m elevation) in the ponds and lakes breaklines. This tile should be reprocessed with corrected z-values.
