Project report
TO0008 Rhode Island
8/31/2007

Submitted to:
Roald Haested inc.
Prepared by:

**Dewberry**
Fairfax, VA

EXECUTIVE SUMMARY

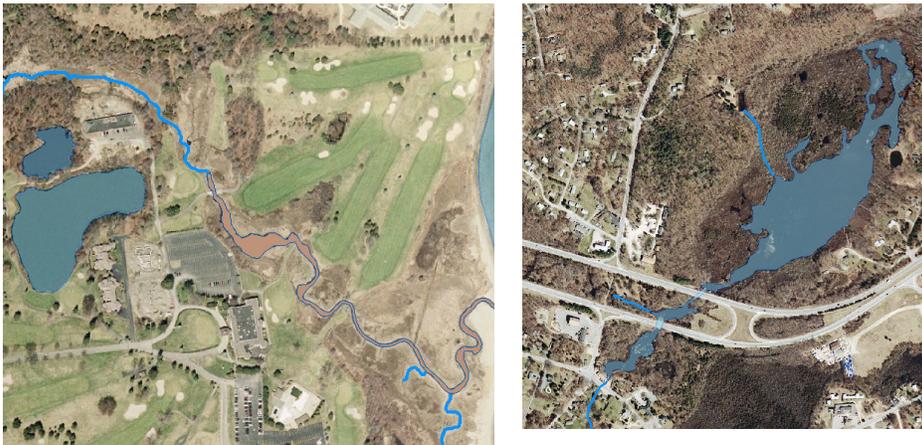
Figure 14 – Breaklines as colored polygons and polylines over the orthophoto

Supplemental 2D breaklines were acquired by Dewberry over this entire mapping area using existing 2004 orthophotos from the Rhode Island Department of Transportation (RIGIS03/04 Ortho). Only hydrographic features needed to support the terrain model for hydrology have been considered. Table 3 lists the items available in the two delivered shapefiles and Figure 14 gives an illustration.

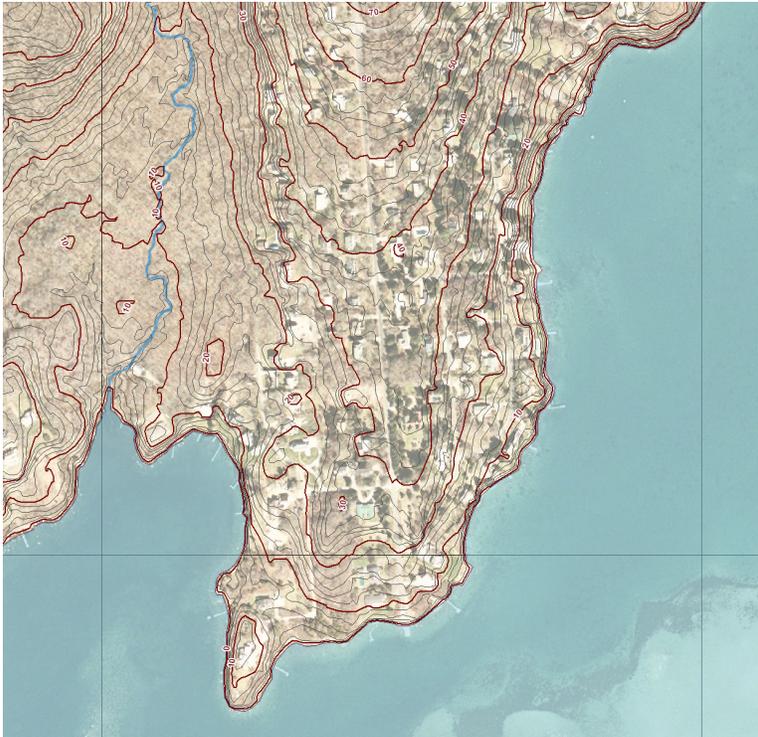
Figure 16 – Example of the generated contours with breaklines over orthophoto

The result of this process can be seen in Figure 16.
