LiDAR Quality Assurance (QA) Report
Eastern Shore Virginia (ESVA) LiDAR Project
USGS
November 16, 2011

Submitted to:
USGS

Contract:
G10PC00013

Task Order:
G10PD01537

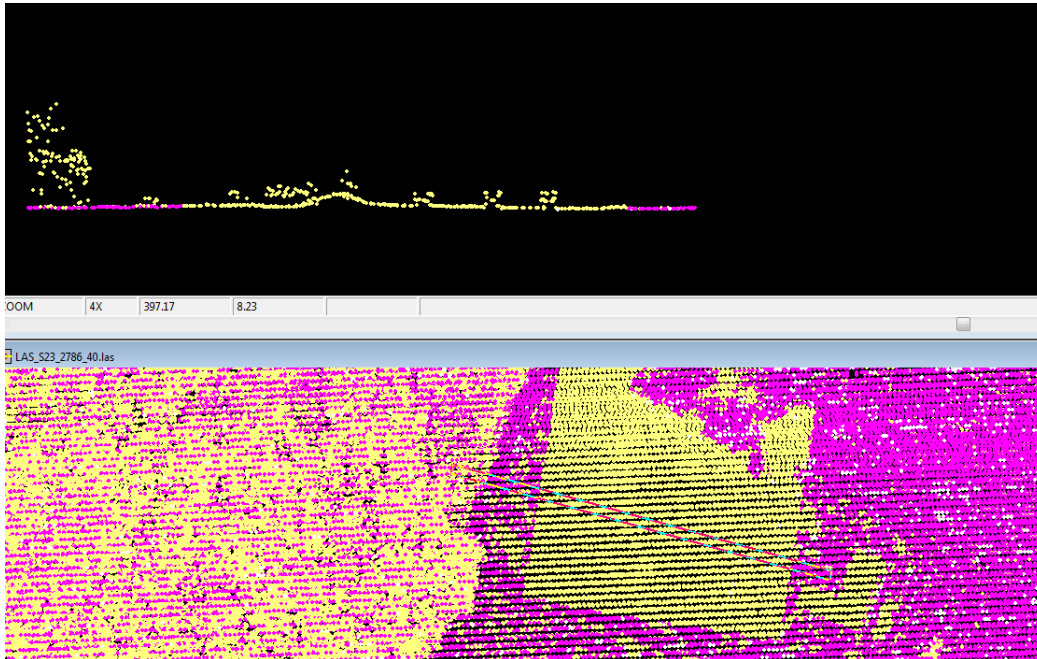
Figure 9-Tile LAS_S23_2786_40, Delivery 1. Profile view of points displayed by classification, showing points that were classified as unclassified (class 1, yellow) should have been classified as Bare Earth (class 2, Pink).

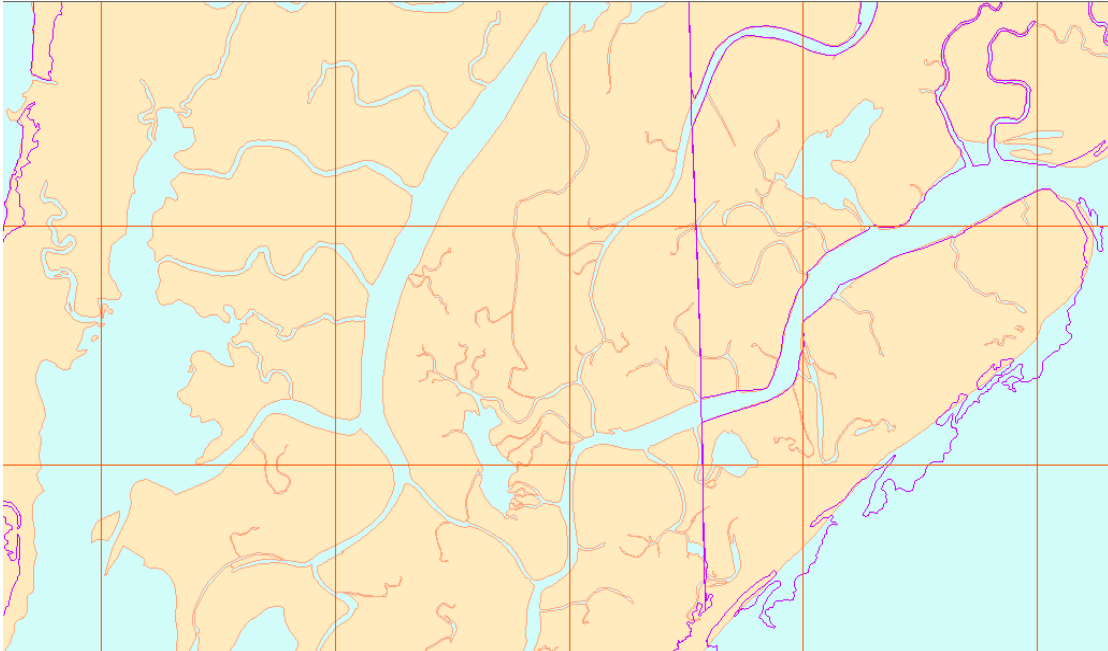
The entire coastline of this project area, which consisted of Accomack and Northhampton Counties, is tidally influenced. Differing tide levels can cause elevation changes within one flight line and can cause substantial elevation changes between flight lines. There are many low-lying islands off the coast of Accomack and Northhampton Counties. Many of these islands are only exposed at low tide. This caused some discontinuity in the data from one flight line to the next when an island is exposed in one flight line but inundated in the neighboring flight line.

This resulted in tidal breaklines that show abrupt changes between land and water interfaces. These breaklines often do not appear natural. However, this phenomenon is related to tidal fluctuations as Sanborn was not required to collect data at low tide.

Figure 13, all deliveries-Tidal breaklines are shown in purple, overlaid on the vcr_land_area" shapefile that identifies the extent of land that is used as a boundary for the USGS ESVA project. As the screenshot shows, tidal breaklines run through the middle of islands and appear unnatural.

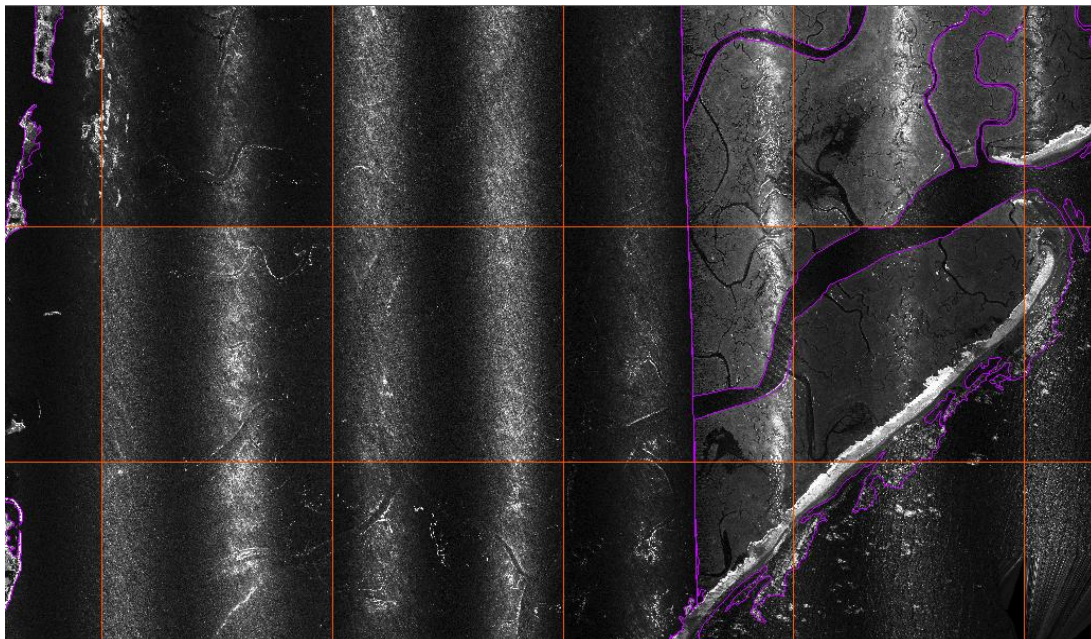
Figure 14, all deliveries-Tidal breaklines are shown in purple overlaid on intensity imagery. As the screenshot shows, the tidal breaklines follow the land water interface as seen in the intensity imagery.

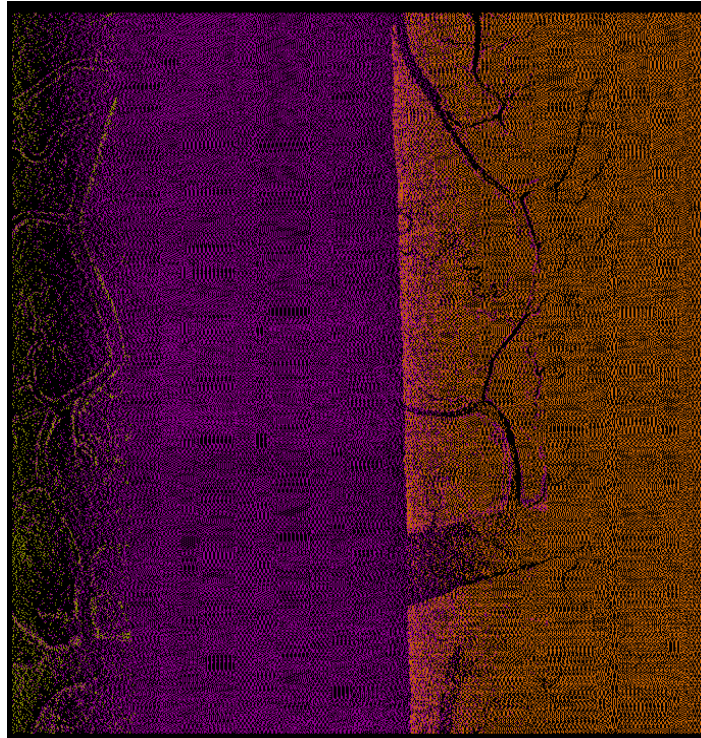
Figure 15, all deliveries-Tile LAS_S23_2559_20. Point cloud displayed by flight line source id. Flight line edges correspond to the land water interface seen in the intensity imagery and reflected in the breakline collection.

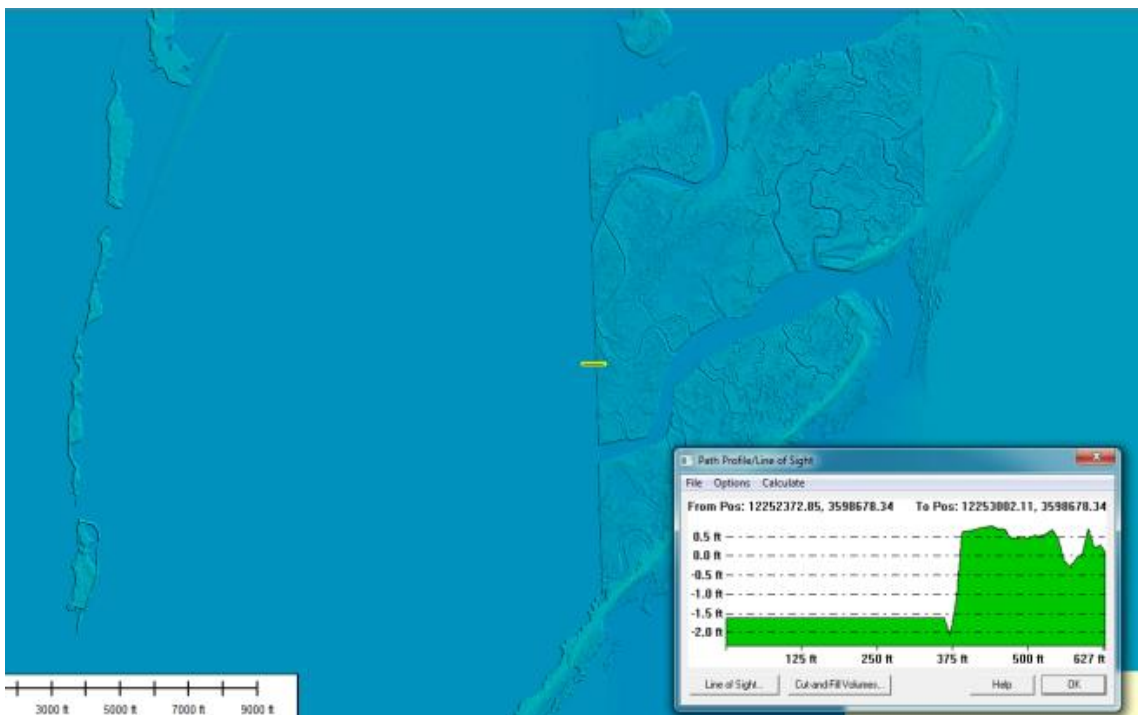
Figure 16, all deliveries-DEMs of the same area shown in the screenshots above. DEMs also seem to show an “unnatural” break between land and water interfaces due to large tidal variations between flight lines. While the water on the left side of this image is actually higher than the exposed island on the right side of this image, the water must be flattened and given a lower elevation. Otherwise, the water will appear as floating above surrounding land.

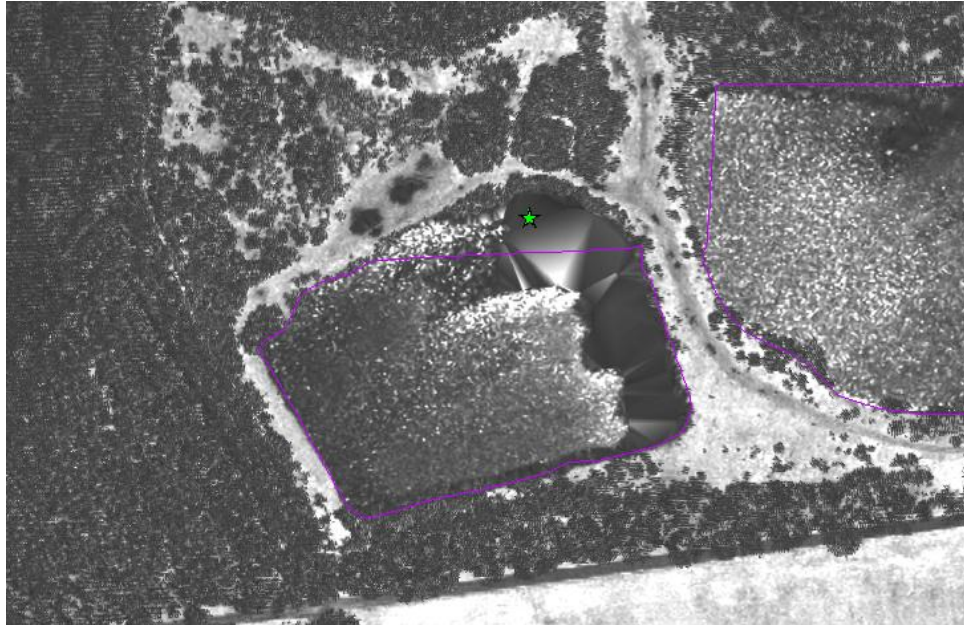
The delineation of features (104) in some areas was identified in the first delivery as not correctly following the shoreline. These features were updated in subsequent deliveries to better reflect the land/water interface at the time of LiDAR collection. An example is shown below.

Figure 21-Tile S23_3930_10, Delivery 1. Delineation of water body did not correctly follow shoreline, leaving a large area of the feature missing.

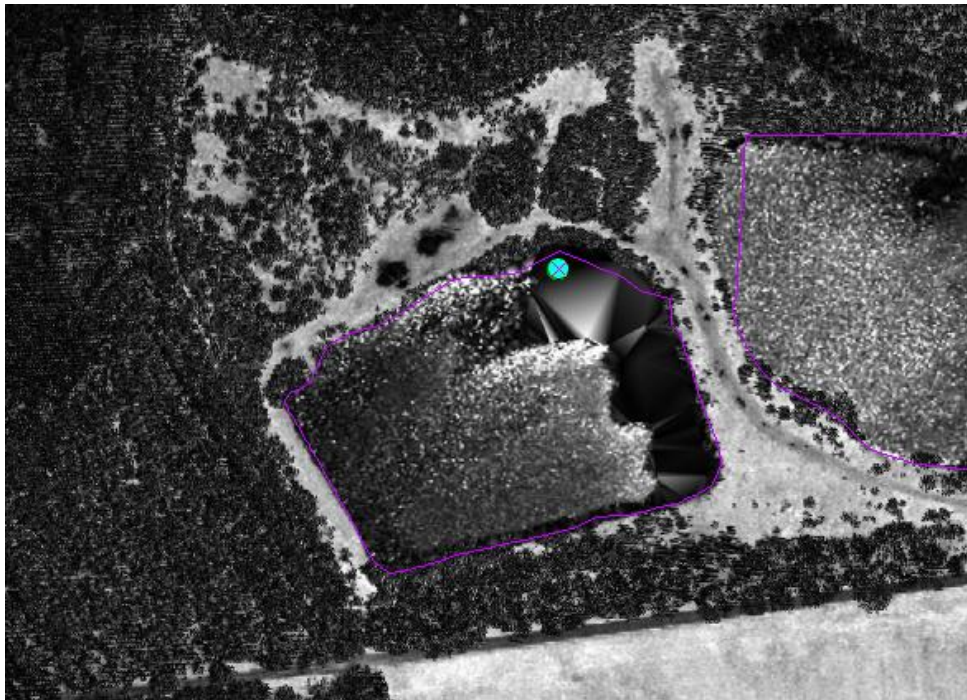
Figure 22-Tile S23_3930_10, Delivery 4. Delineation of water body has been corrected to fully capture feature.

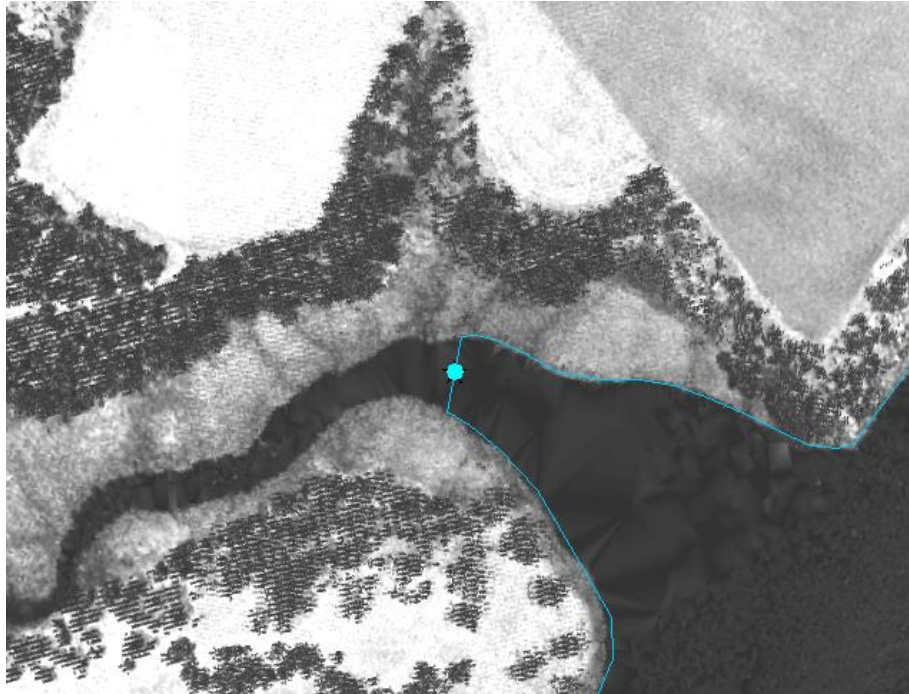
During the first review it was noted that when some features became too small to meet minimum collection requirements, the breaklines (7) were abruptly stopped or appeared “cut off” as if a man-made structure was at that location. These breaklines were corrected to appear more natural and not mistaken for man-made features, such as dams. An example is shown below.

Figure 23-Tile S23_3858_10, Delivery 1. Unnatural appearance of Inland Stream, shown with blue line. Feature should have been rounded off where it becomes too narrow to meet specifications, so as not to appear to be “cut-off”, or stopped by a man-made structure.

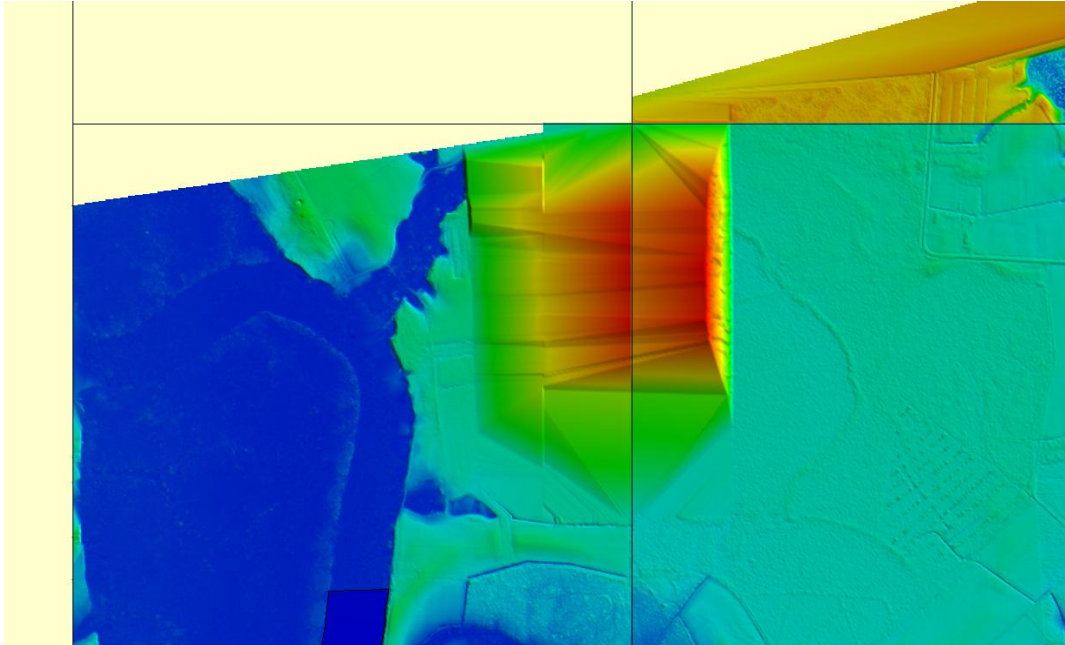
The DEMs have coverage to the full extent of the project boundary. Data was not clipped to this boundary, but extends well beyond the boundary. Data extending beyond the boundary may not always have full coverage and DEMs may not be flattened in these areas outside of the boundary. Some of this data outside of the boundary may have coverage gaps and be unusable. Sanborn is not required to clip the data. EROS has elected to receive all data and to perform the final clipping so that they control the final clipping boundary and selection of data that will ultimately be used in the NED program. An example of unusable data located outside of the project boundary is shown below.

Figure 27-DEM_S23_3910_10, all deliveries. Some areas outside of the project boundary may be unusable. The identified area is a coverage gap well outside of the required project boundary, with an anomalous high ridge along the eastern side of the gap. This particular area is unusable even though it was delivered with the final DEMs. EROS will perform the final clipping of the data.

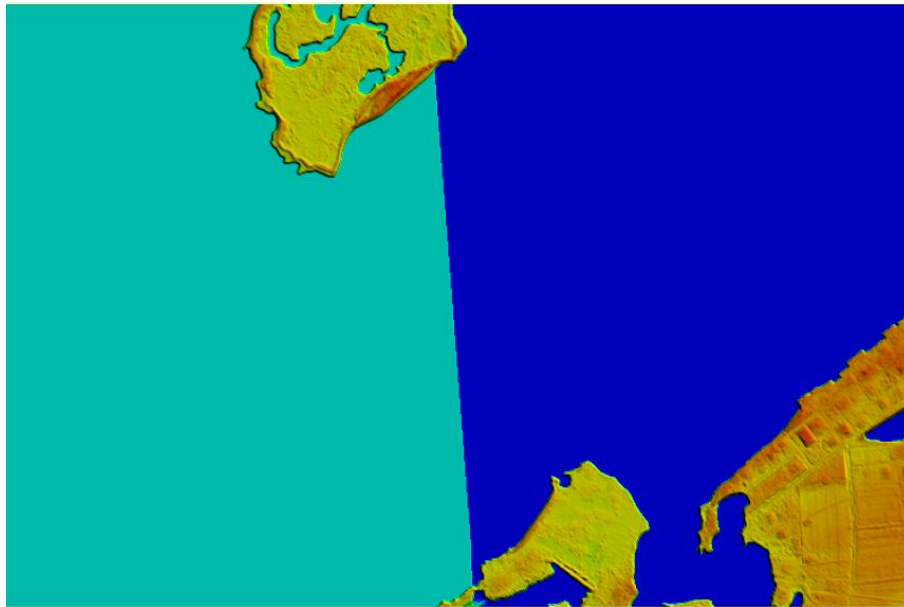
Figure 31-DEM_S23_2759_20 and DEM_S23_2759_30, Delivery 4. Now, the only elevation change in the water of these tiles occur along the flight line from tidal variations. This step is an acceptable way to show elevation change in water. The water is flat from bank to bank.

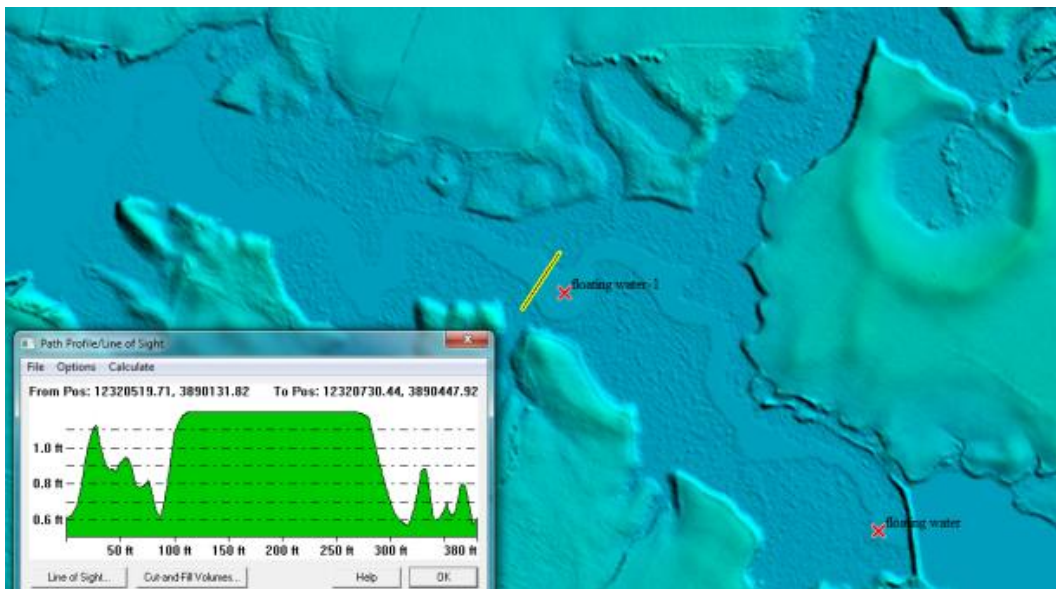
A few features (9) were identified in the first delivery as floating in the DEMs. These features were adjusted to be at or below the surrounding terrain. An example of the corrections is shown below.

Figure 32-DEM_S23_3829_10, delivery 1. Tidal waters were floating above the surrounding terrain.
