Howard and Anne Arundel County
LIDAR Review – 2004

Prepared by:
Dewberry & Davis LLC for Spatial Systems Associates

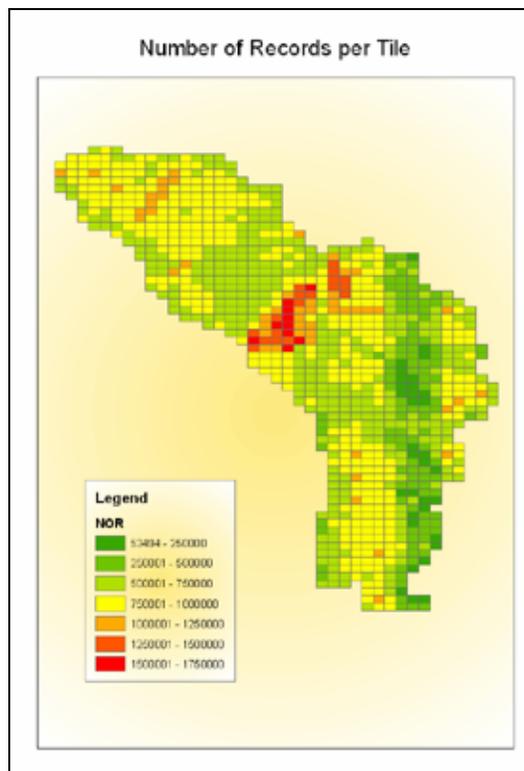
Figure 2 - Color coded map illustrating the Number of records for each tile in Howard and Anne Arundel Counties.

During the analysis process, the data is reviewed in its most basic form as text files. The review involves looking at the size of the file, the number of records (NOR) each file contains, and the minimum and maximum values within each file. The average NOR for the deliverable is computed and then compared to each file to see any large discrepancies. If a tile has a significantly lower number of points this does not necessarily conclude there is an error as the dataset may be over a large water body. However if a large number of tiles have low values, then action is warranted to investigate. For this project area no anomalies with the number of points was detected. Figure 2 illustrates the number of records (number of LIDAR points) for each tile. Additionally, the minimum and maximum values were reviewed and know anomalies were found.

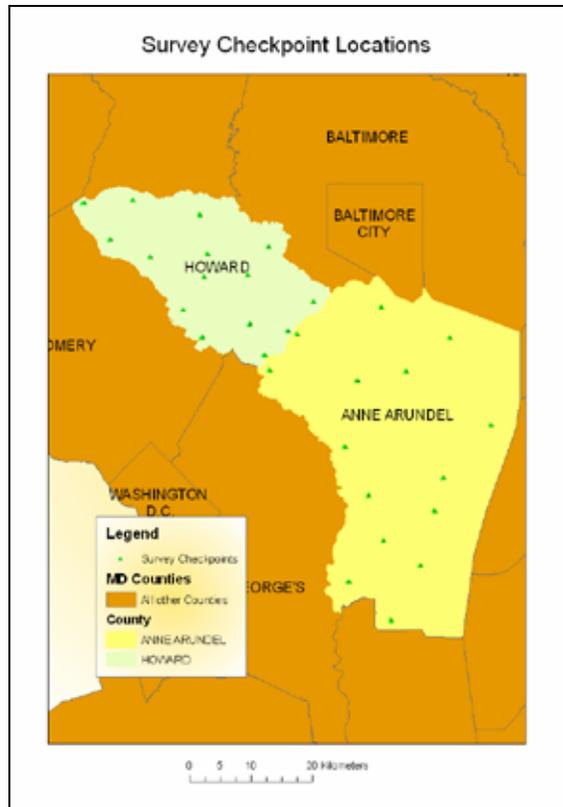
Figure 3 -Location of Survey Checkpoints. Due to the scale of the map, all points are not visible due to the clustering of points.

Figure 3 illustrates the geographic location of the checkpoints relative to the project area. It should be noted that the checkpoints encompass a large area and are in strategic geographic locations spread out to verify as much of the data as possible. Since the flight lines consisted of smaller flight line blocks of the project area, the location of the checkpoints help verify the data from different flights.

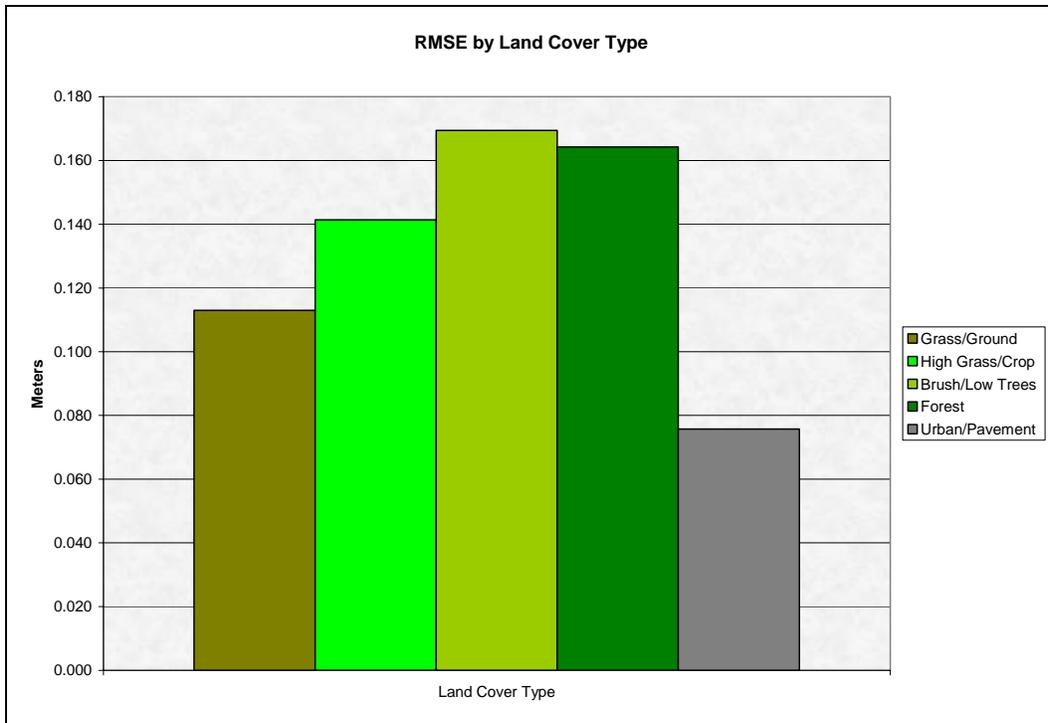
Figure 4 – RMSE by specific land cover types.

Figure 4 and Figure 5 graphically illustrate the RMSE by land cover category and the delta difference between the LIDAR compared to that of the survey QA/QC checkpoints.

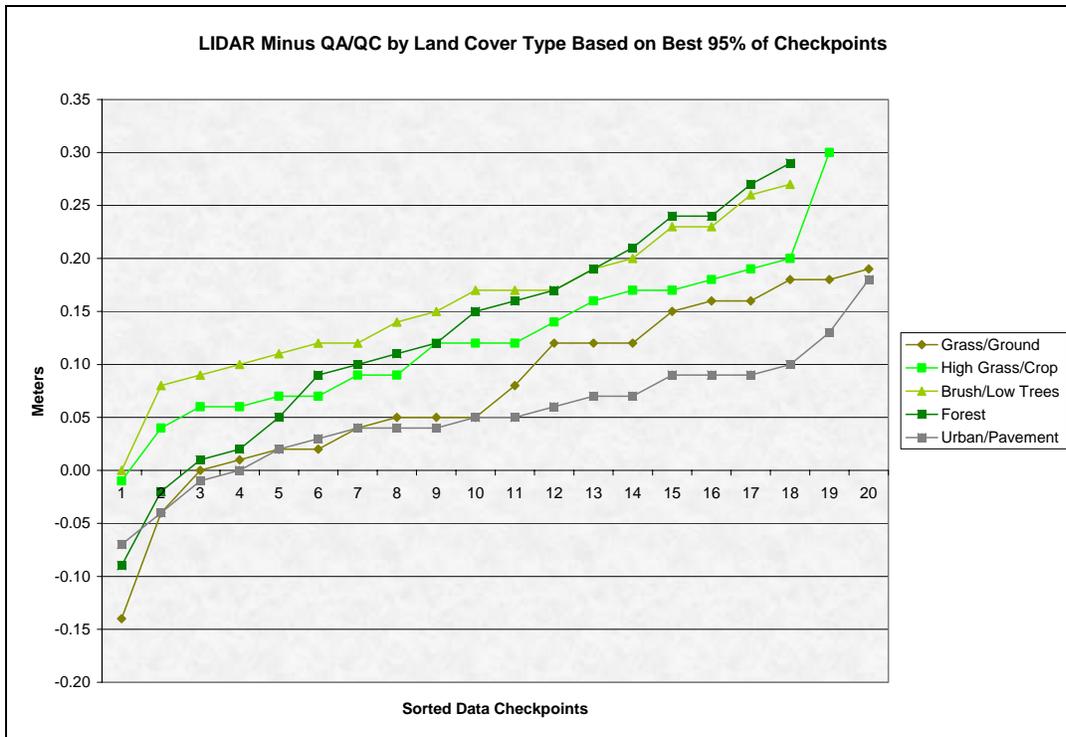
Figure 5 – Illustrates the magnitude of differences between the checkpoints and LIDAR data by specific land cover type and sorted from lowest to highest.

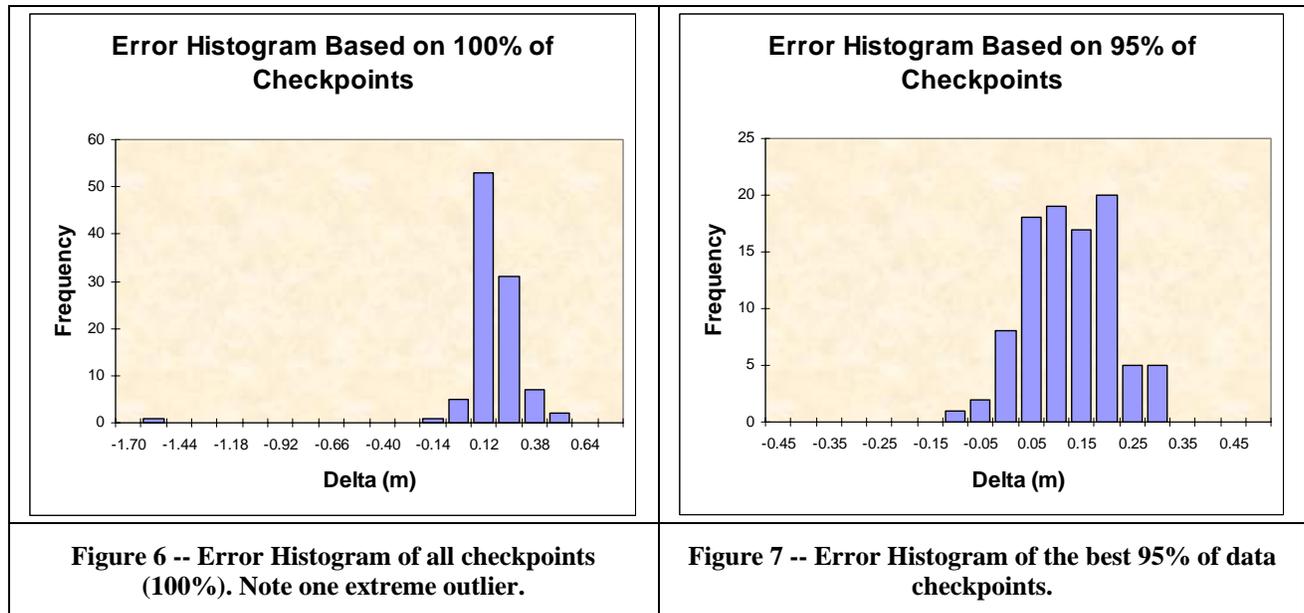
Figure 6 and Figure 7 illustrate that the errors do not follow a normal distribution even when the top 5% of outliers are removed. It also illustrates that the LIDAR data compared to survey checkpoints tends to have a slight shift, which could be in the range of 10cm. This shift could be systematic or it could be purely random since the data does not follow a normal distribution.

Figure 6 and Figure 7 illustrates the histogram of the associated delta errors between the interpolated LIDAR TIN and the survey checkpoint. It is interesting to note that the errors do not follow a normal distribution. Even when the 5% largest errors are removed, the errors still do not follow a normal distribution. With this scenario where some errors do not follow a normal distribution, invalidates the RMSE methodology, the NDEP recommends that alternative criteria be used to determine the Fundamental Vertical Accuracy (mandatory) and Supplemental and Consolidated Vertical Accuracies (optional).

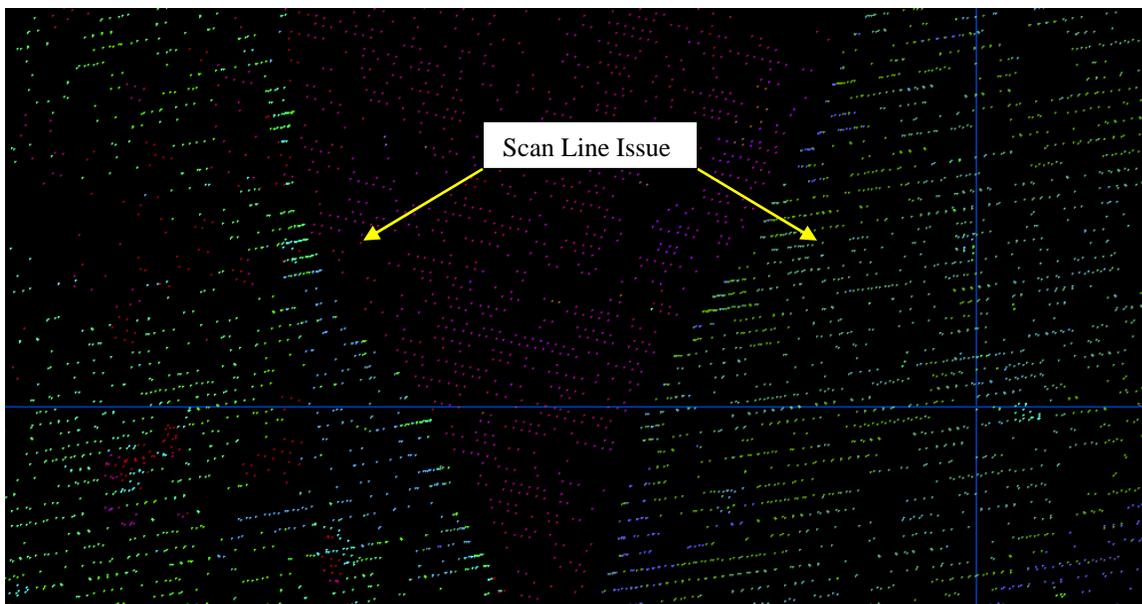
When a flight line is flown, the next one generally is flown parallel to it in the opposite direction with a defined percentage of overlap. This ensures that all areas are covered by the LIDAR scan especially since it is difficult to fly the aircraft in a perfectly straight line. The overlapping portion of the flight lines also allows the surface being measured to have the LIDAR light scan from a slightly different angle which can translate to better coverage in dense vegetation. The apparent issue within these two counties is that the adjacent flight line is either higher or lower (depending how you look at it) by as much as 98 centimeters. Figure 8 illustrates a LIDAR subset color coded by elevation of three scan lines. Interestingly the LIDAR vendor flew this mission with a sidelap of 50% which allows the data to have 100% duplicate coverage. This exceeds the norm of collecting overlap data but is extremely beneficial for data redundancy especially since it does not allow for areas of no data known as “data holidays”. In the following figure there are three flight lines, the edges of the left scan and right scan can be seen as marked (“Scan Line Issue”). In this area the sidelap deviates slightly from 50% (very bottom of image) to a lower number. This in itself is not an issue at all except that it clearly shows elevation change between the scan lines. By reviewing the color changes in elevation, two slight gaps exist where there are no points. This is partly attributed to the vegetation removal process which removes adjacent points that appear to be artifacts because of the elevation change. In this case, the difference between the two flight lines is over 50 cm as can be seen by the profile in Figure 9.

Figure 8 – AJ123B51: Data consists of three merged scan lines. Elevations are color coded and clearly identify the change in elevation between each line.

These height differences can happen for a multitude of reasons but the most common one is an error in the aircraft positioning. If the values are relatively small, at the one sigma level, the vegetation removal process can remove most of the error. However when they are large, then the data must be reprocessed.

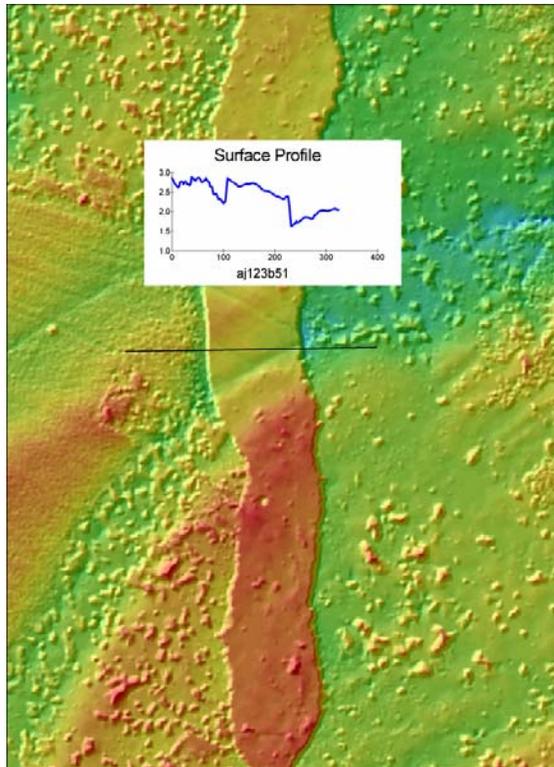
Figure 9 – Scan Line issue and potential artifacts. A surface profile of the black line across the area in question, illustrates the change in elevation of the three scans.

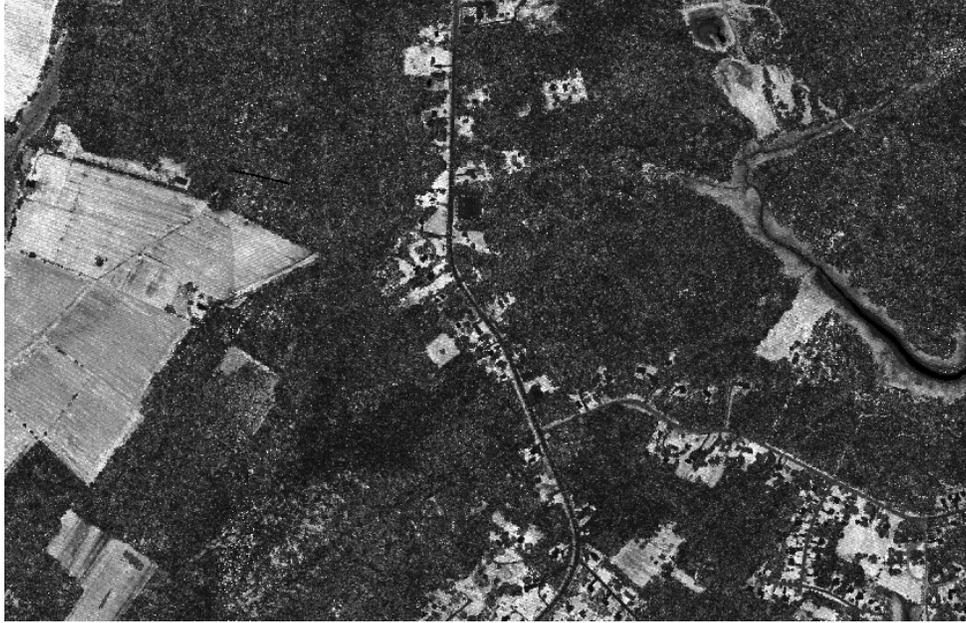
Additionally, this data may have potential artifacts as this is not typical of other tiles with heavy vegetation. It can be noted that the data with duplicate point coverage, (left and right sides of image) has a higher degree of artifacts than that of single coverage (middle). However judgment is reserved until ground verification is performed if necessary. Figure 10 illustrates the intensity image of the same area. It can be seen that the overlap issue is apparent on the left side of the image (right side of open field). Intensity images record the amount of light returning to the sensor and can be affected by multiple factors such as type of material and height of the aircraft. Figure 11 illustrates a 3D view with a vertical exaggeration of three times with a TIN overlaid to show the height differences.

Figure 10 – AJ123B51: Intensity image. Note slightly different intensity values on the left side of image illustrating the change in elevation.

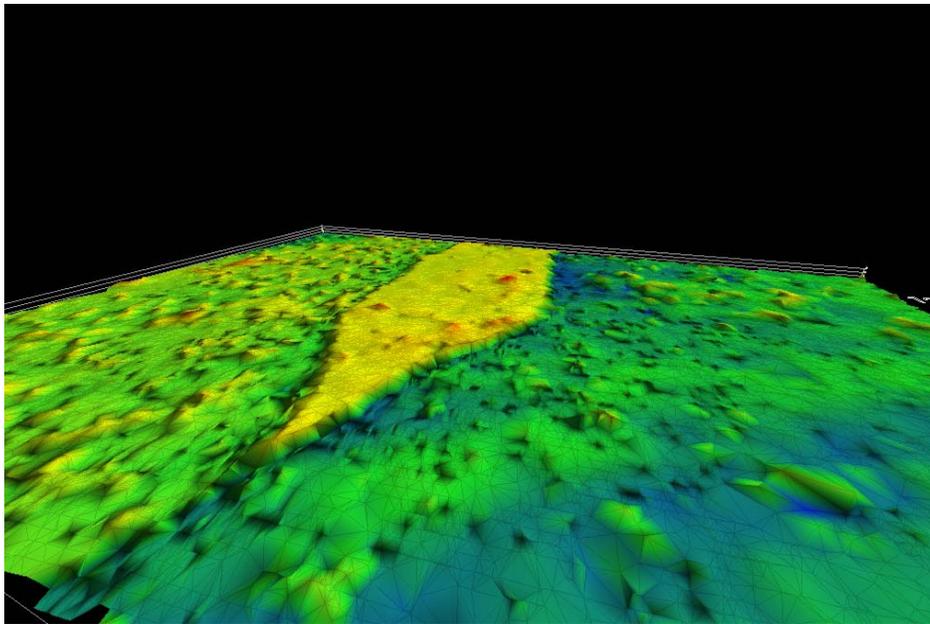
Figure 11 – AJ123B51: 3D view with TIN overlaid.

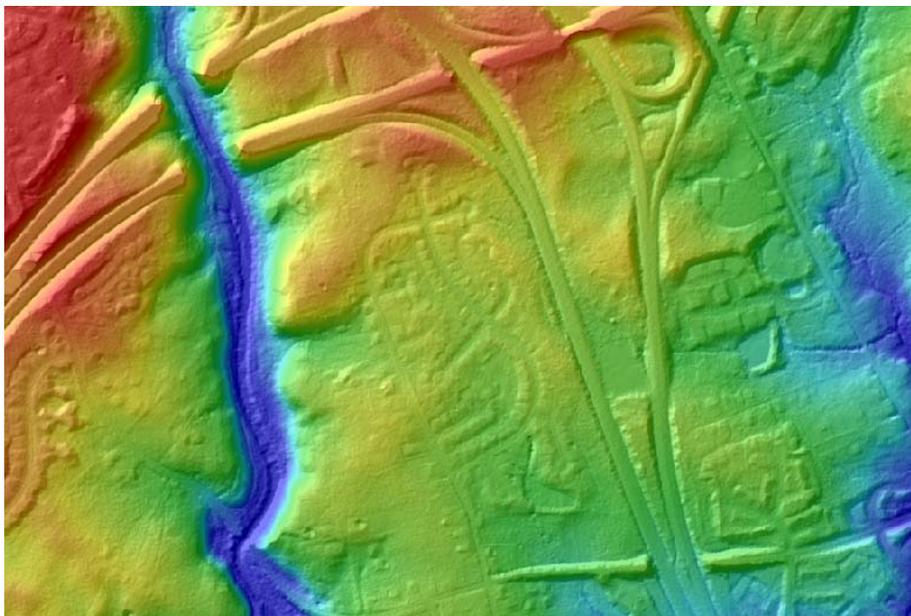
Figure 12 illustrates inconsistent bridge removal. From a hydrological point of view, removing the bridge structure over the stream is the correct process however the bridge structure on the upper right of the figure will force the flow of water in the adjacent direction of its true flow direction on a minor scale.

Figure 12 – AT116B61: Inconsistent bridge removal

During the process of vegetation removal, artifacts consisting of both man-made and non man-made features are removed to represent a bare-earth model. With bridges, this becomes extremely difficult as parts of the structures themselves are legitimate topographic features. For example, the bridge abutments usually have earth surrounding it. This affects the flow of water and therefore elevations are required around it. As previously noted different applications may or may not require the bridge deck elevations. For this dataset, bridges can be completely removed, completely existing, or partially removed. Our preference would be to have them consistent throughout the dataset, either all in or all out. When bridge deck elevations are removed, they still exist within the vegetation file which consists of all points not representing the bare-earth terrain. By having the data consistent, no questions are directed to the integrity of the data removal in other areas such as the removal of buildings. We do not believe this constitutes reprocessing of the data.

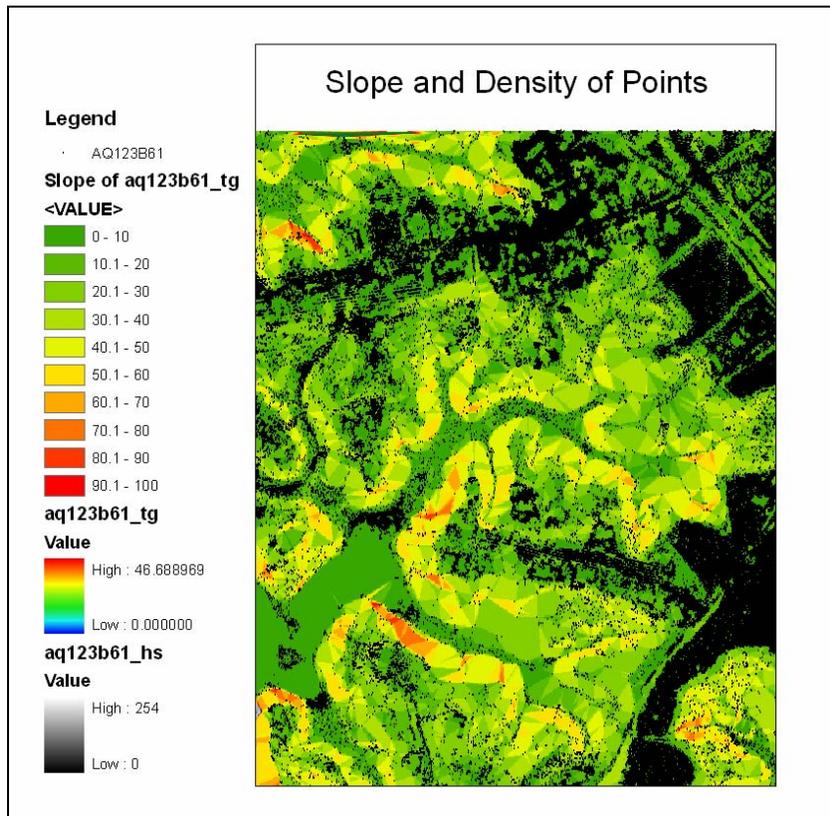
overlaid onto this layer. Figure 13 illustrates the correlation between high degrees of slope and the lack of LIDAR points. We understand the difficulties of establishing the balance of removing vegetation and that of topographic features especially since the vegetation removal process utilizes slope as part of its criteria whether or not to remove points. To compound the difficulty, vegetation is typically found on these slopes particularly around streams. What must be noted here is that although many points were removed, there is sufficient point density to support a two foot contour map. It should also be noted that any other technology including photogrammetry would not yield as many points and, in most cases, LIDAR is superior for topographic mapping.

Figure 13 – AQ123B61: LIDAR points overlaid on slope map. High degrees of slope yield less data.

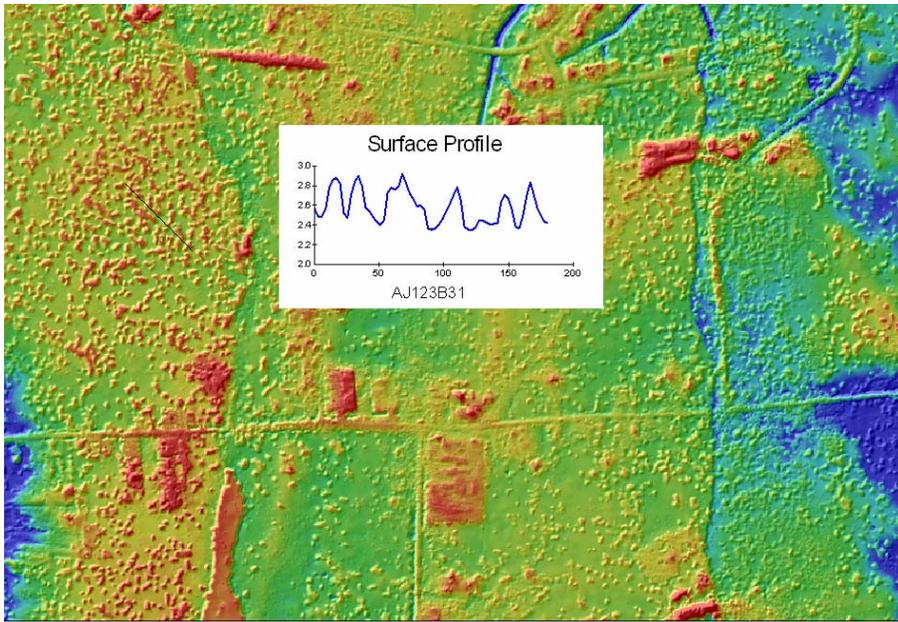
Without ground truthing on some tiles, it is difficult to definitively identify artifacts. However looking at the ubiquitous dataset, certain patterns of terrain emerge dictating what appears to be the norm. Both Figure 9 and Figure 14 are contrary to what is typically in the surrounding data.

Figure 14 – AJ123B31: Potential artifacts with surface profile (cross section). Cross section location is represented by the black line to the left of the graph. Although these appear to be artifacts, undulations of between 2.4 and 2.9 meters may accurately represent terrain conditions. However there appears to be a correlation of excessive artifacts when a scan line issue exists.

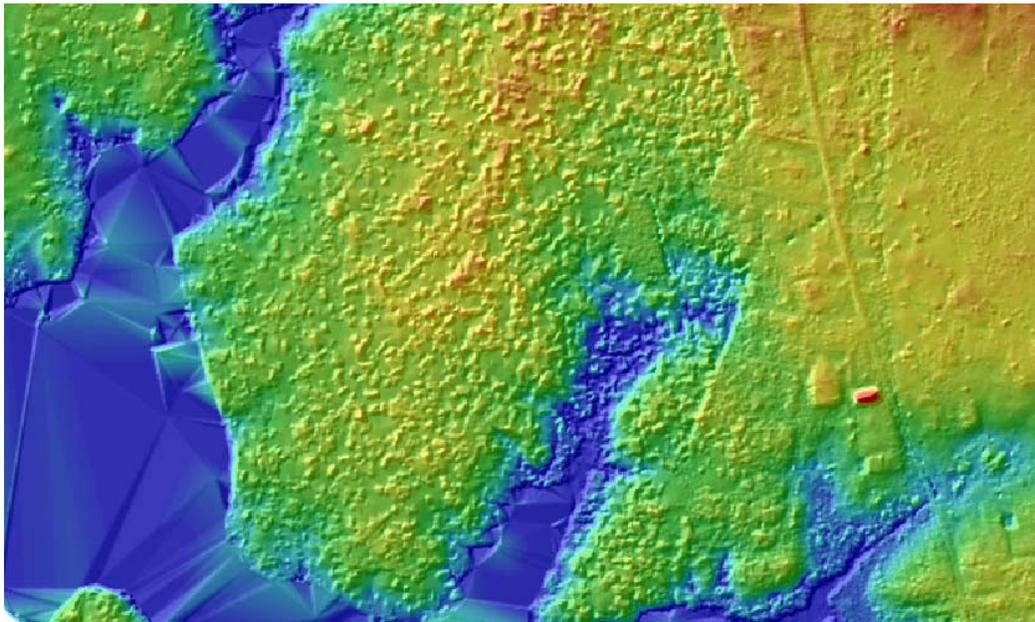
Figure 15 illustrate potential artifacts and a scan line issue. The area of higher artifacts corresponds to the urban area as can be seen in Figure 16. One would expect the higher noise level to be greater in the forest located on the right side of the image.

Figure 15 – AK123B61: Potential artifacts and scan line issue.

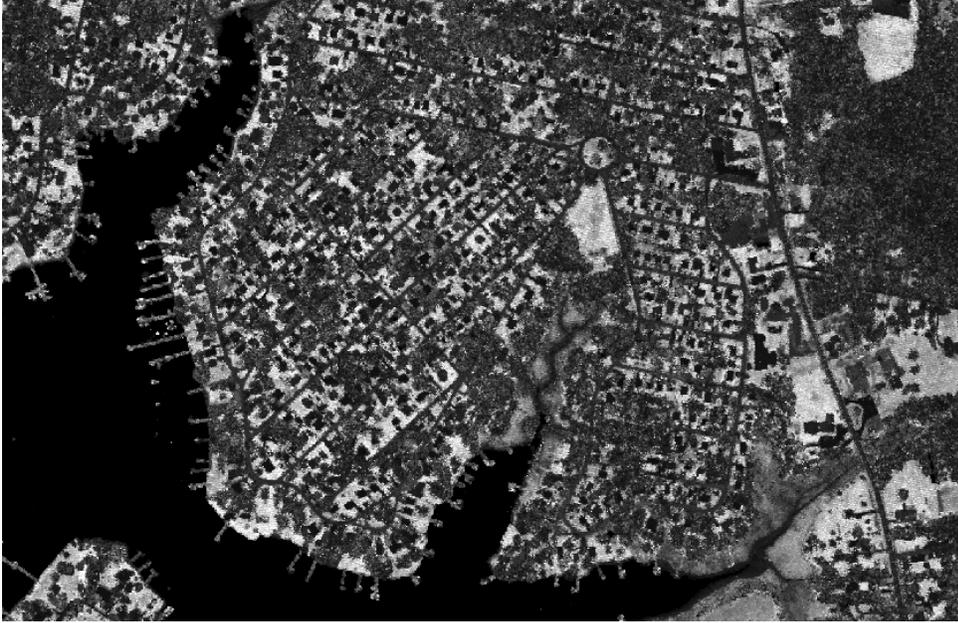
Figure 16 – AK123B61: Intensity image of urban area with forested area on right side.
