Cecil County, MD
LIDAR Review – 2005

Prepared by:
Dewberry & Davis LLC for Spatial Systems Associates
9/28/2005

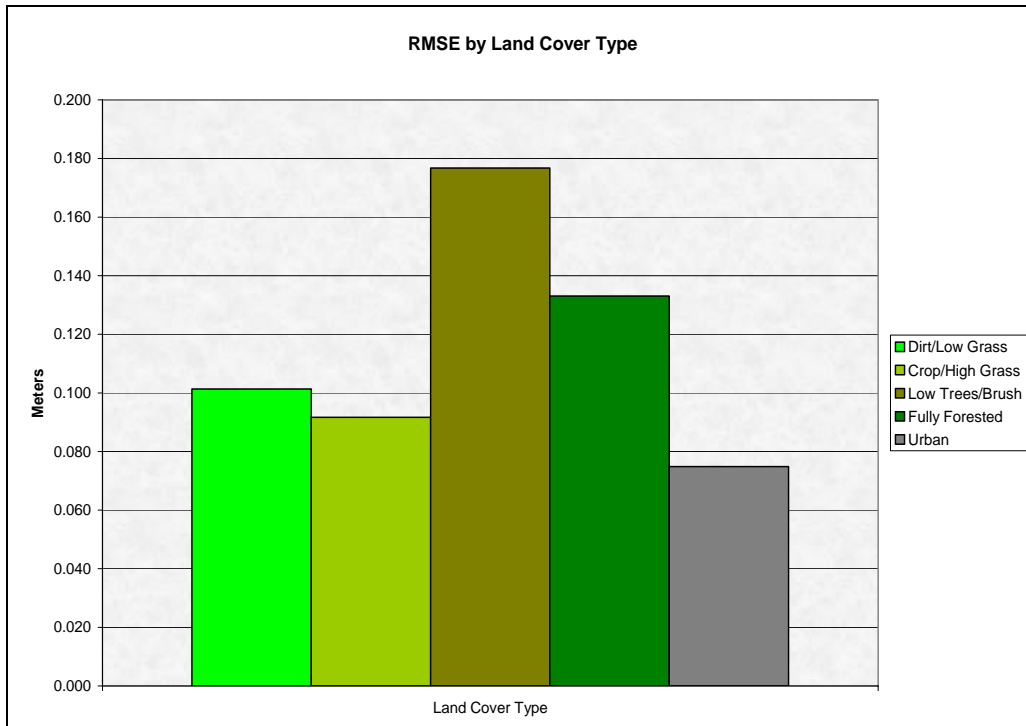
Figure 5 – RMSE by specific land cover type.

Figure 5 & Figure 6 graphically illustrate the RMSE by land cover category and the elevation differences (delta) between the LIDAR compared to that of the survey QA/QC checkpoints.

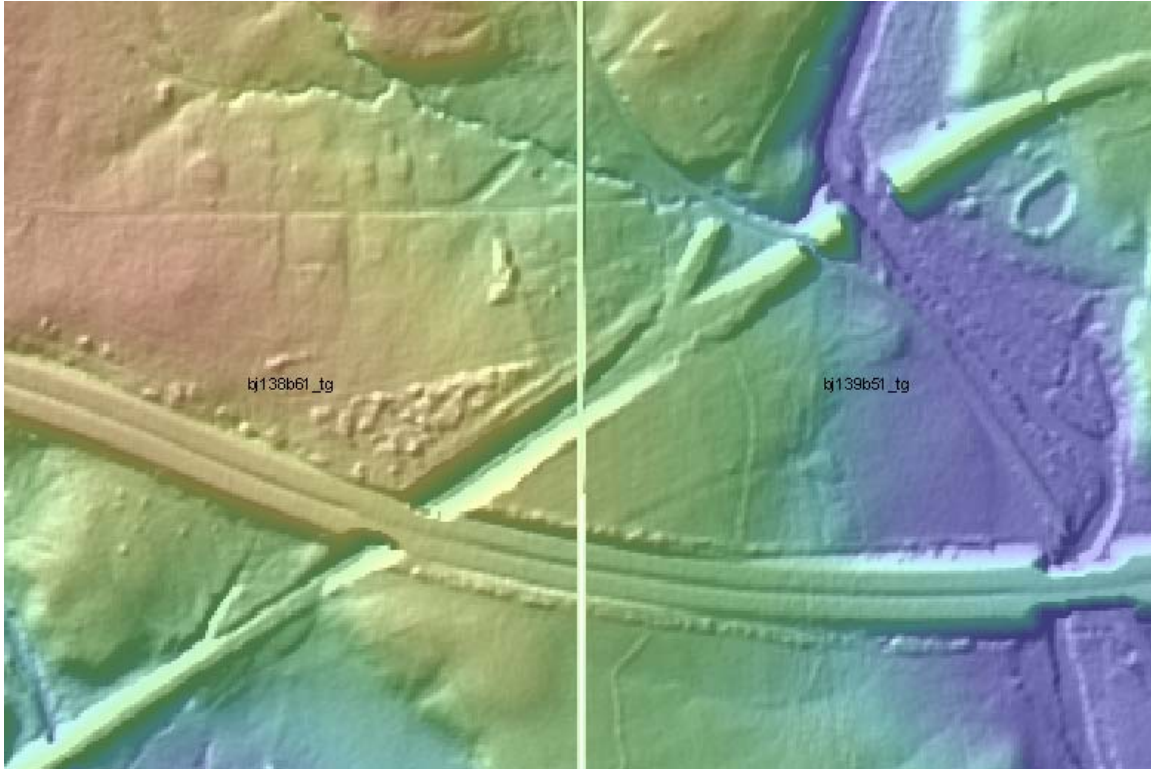
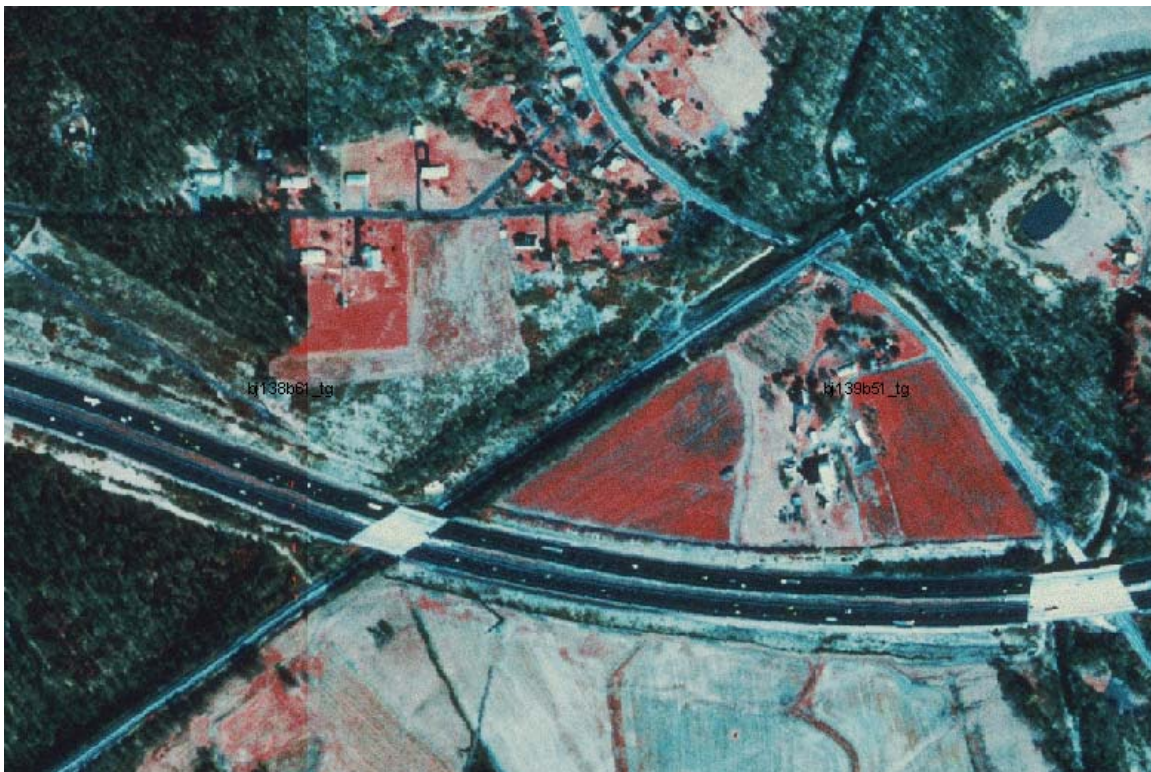
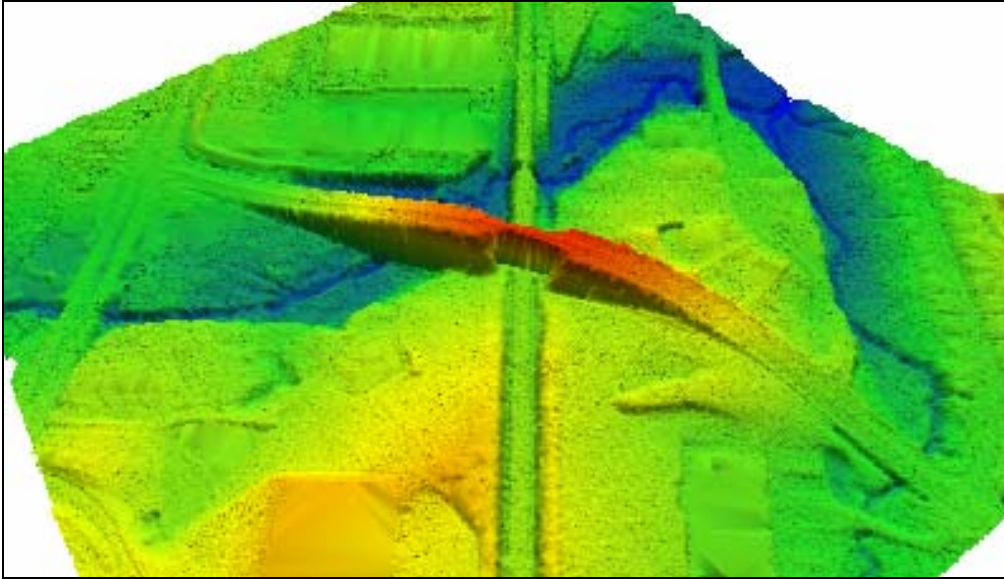
As mentioned previously, the need for having bridges maintained or removed from the data is based on the need and application of the data. Hydrologists may want them removed, transportation engineers may want them to stay and hydraulic engineers may want the bridge abutments to stay, but the deck removed. However this data has bridges that are in, or out, or have portions of the bridge deck removed. Figure 8 and Figure 9 illustrate this issue. In the northeast quadrant two bridges have been removed. However bridges in the southwest and southeast only partially are removed. Figure 10 illustrates a 3-D view of a bridge with the same issue. There are many examples of inconsistent bridge editing throughout this project.

Figure 8 - TIN Grid and Hillshade illustrating inconsistent bridge editing (BJ138b61).

Figure 9 - Aerial color-infrared photograph of area illustrating bridge locations (BJ138b61).

Figure 10 - 3-D view of bridge editing issue.

The data for this county exhibits excellent characteristics for cleanliness for a bare-earth terrain product. The issues outlined above tend to be very minor and do not hamper the general use of this product. Our recommendation is only directed towards the bridge editing and the elevations set to a zero value.

From a qualitative perspective, the data are clean without being too clean (over-smoothed), with only a few manmade structures that were not removed during the bare-earth processing. Bridge editing for hydro-enforcement should be performed in a consistent manner. Furthermore Dewberry recommends that the zero elevations be reviewed to determine elevations that should be legitimately below zero relative to NAVD88 vertical datum.

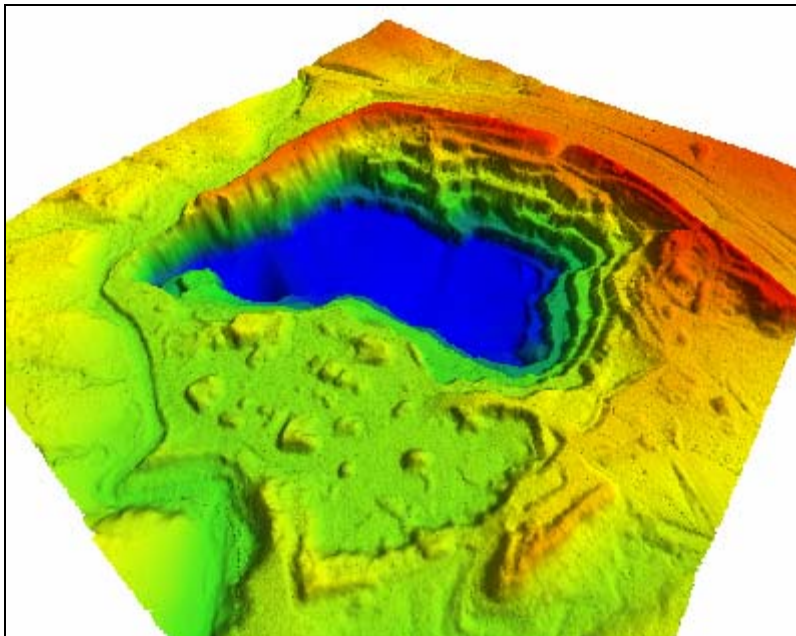
Figure 11 - Quarry with a minimum elevation of 0.00 meters.

As mentioned in the verification process, many tiles have a minimum elevation of zero meters. Since this is a coastal community, it is conceivable that some elevations can be less than the zero meters in NAVD88. Figure 11 illustrates a quarry where the floor elevation is exactly zero meters. We believe that this quarry, as well as other areas, could be less than zero.

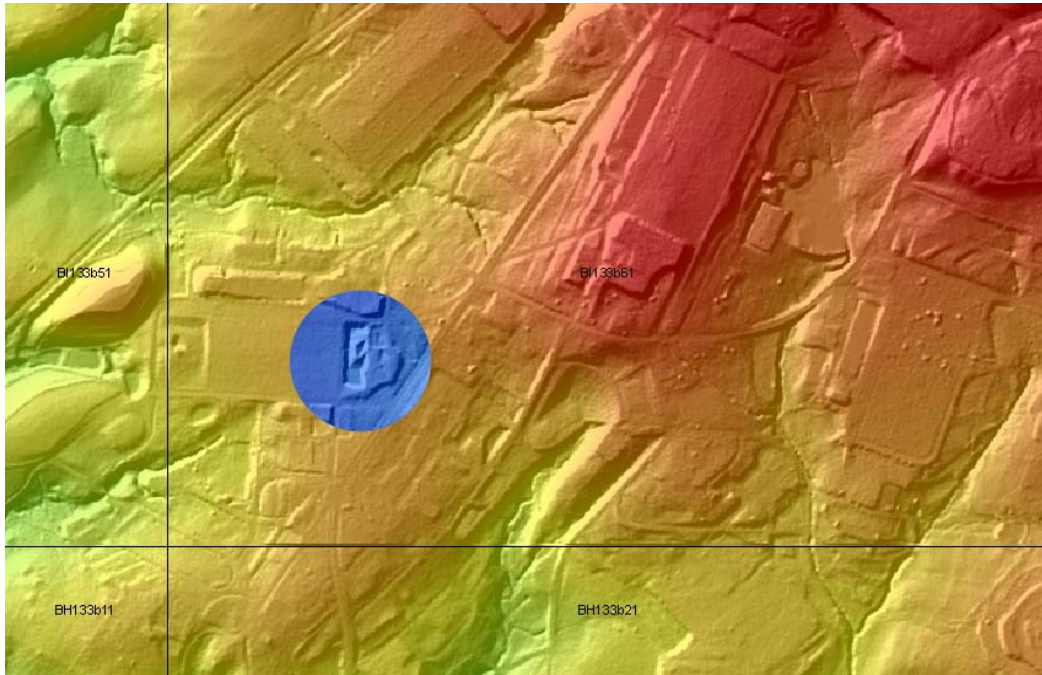
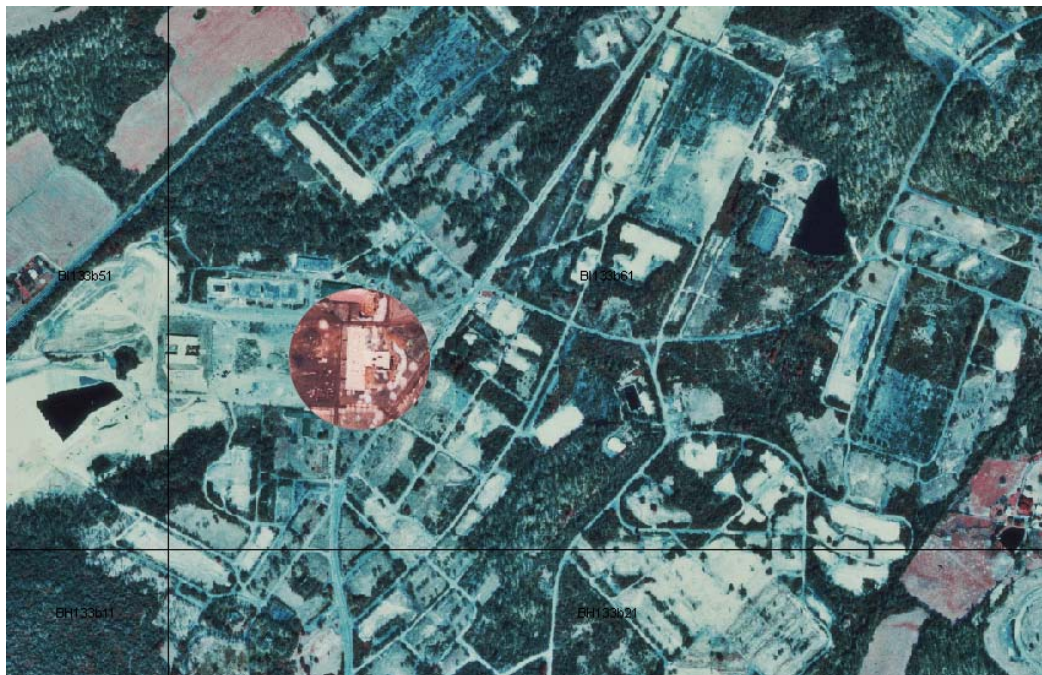
Figure 12 and Figure 13 illustrates show one of several buildings that remain after the post processing to remove building and vegetation.

Figure 12 - Potential artifact highlighted within the circle.

Figure 13 - Potential artifact highlighted within the circle

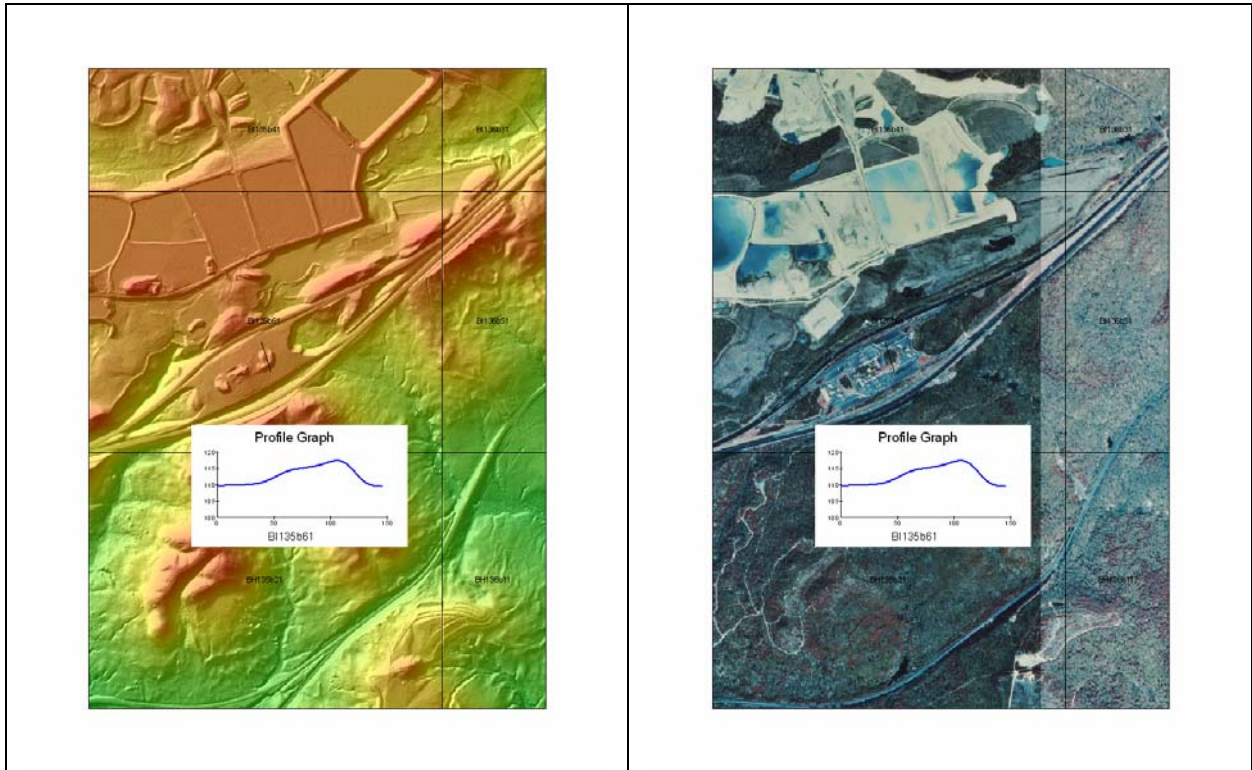
Figure 14 - Potential artifact with associated profile for both the Tin GRID/Hillshade and a CIR photograph.

Figure 14 illustrates a rest stop along the highway that may have a large artifact consisting of vegetation beside the structure. The profile illustrates a change in elevation of over 4 meters.

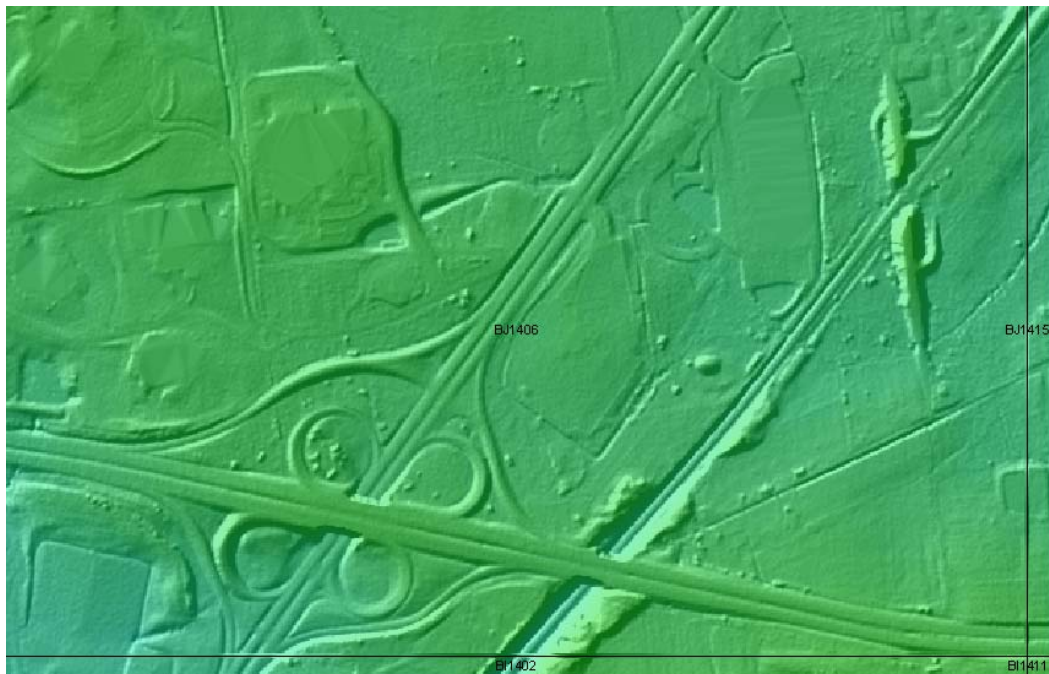
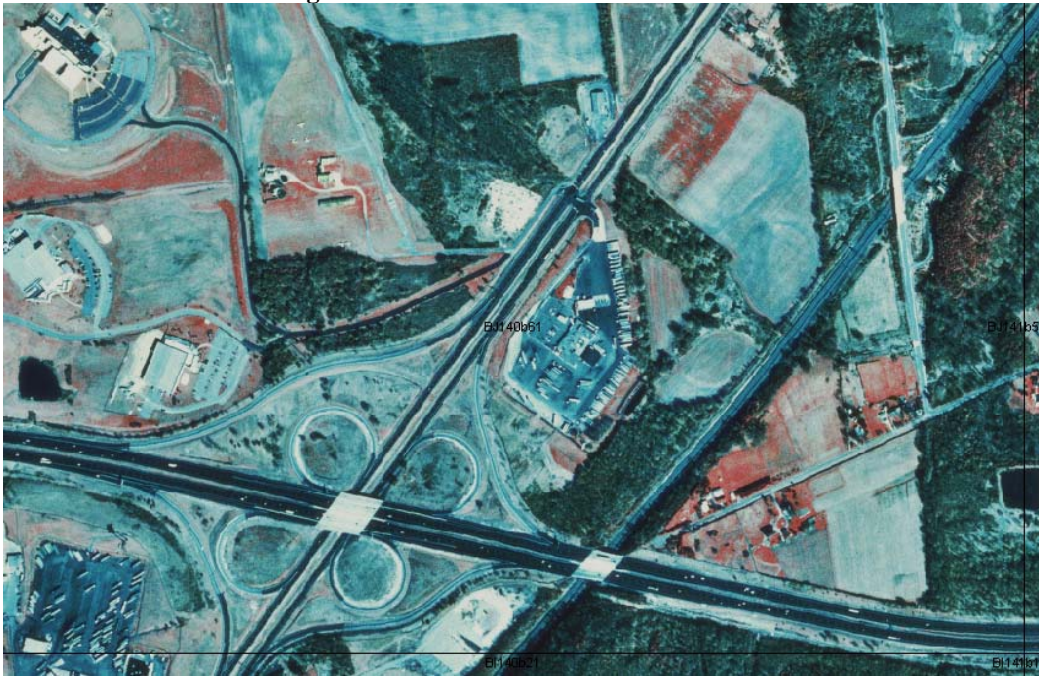
Figure 15 and Figure 16 illustrate potential artifacts within the clover leaf circles.

Figure 15 - Potential artifact in clover leaf.

Figure 16 - Potential artifact in clover leaf.

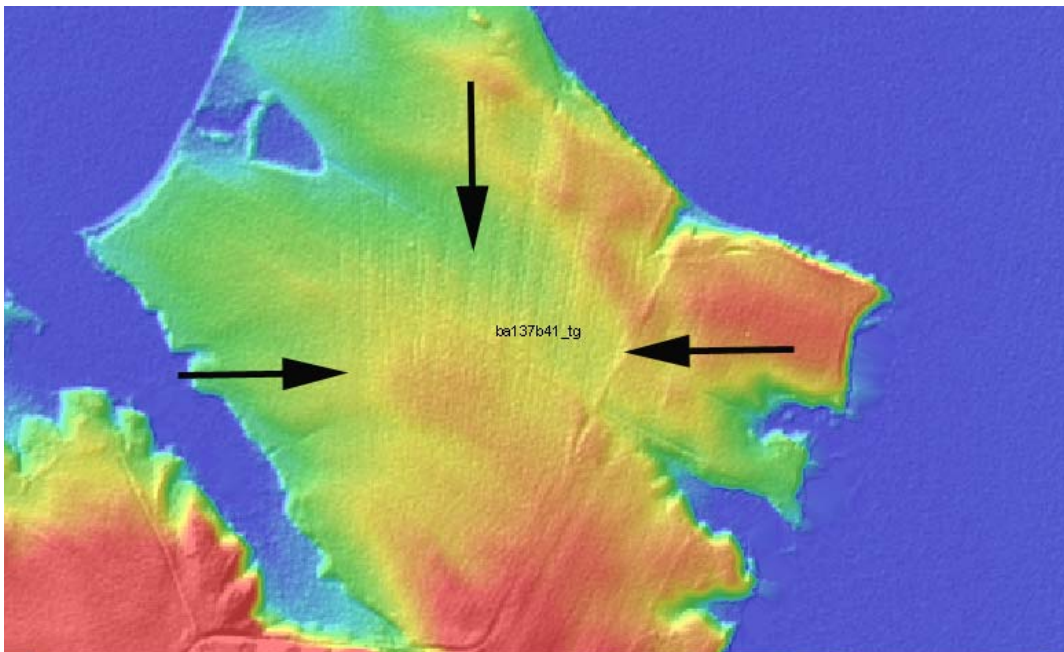
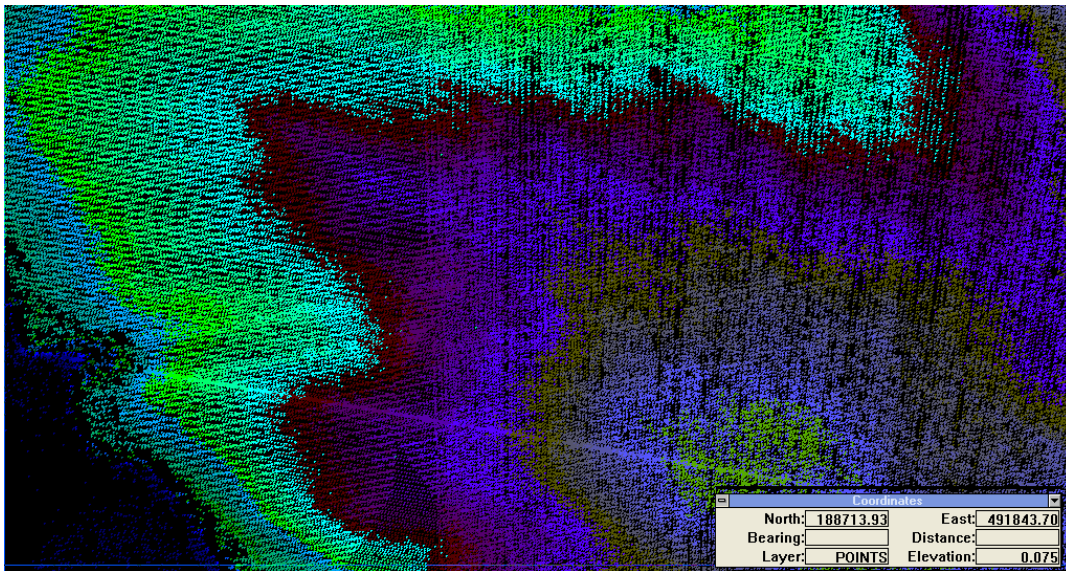
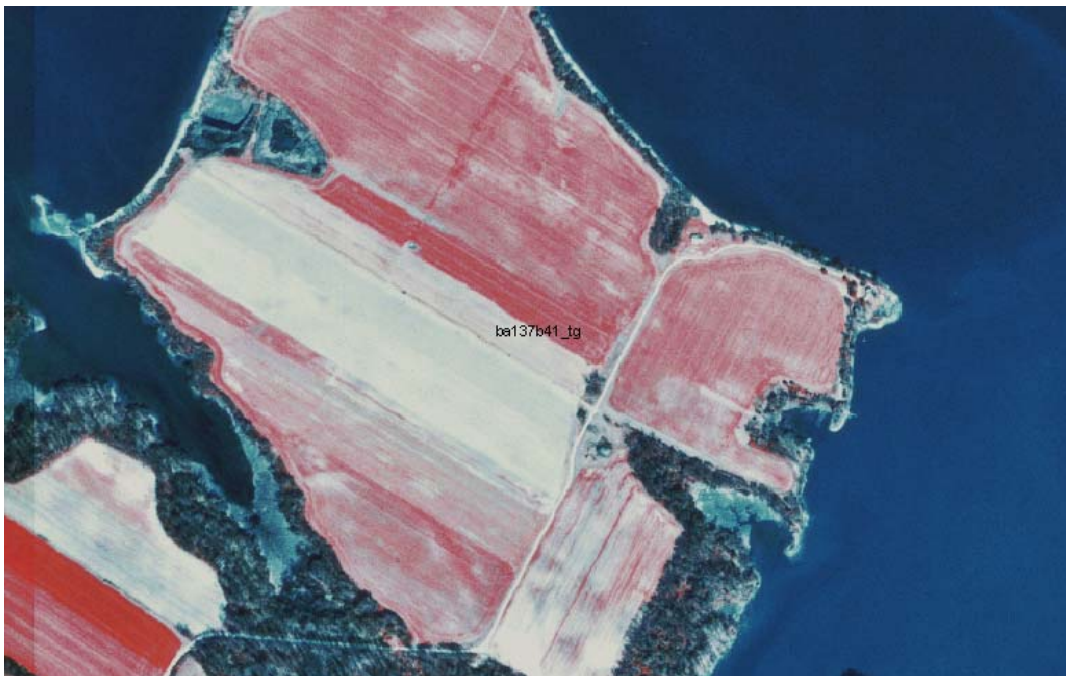
Figure 17 to Figure 19 illustrate “noisy data.” Noisy data is data within specification but showing a high variance in the elevations relative to each other. This particular area consists of flight lines that are flown perpendicular to each other. On the left side of Figure 18, the flight line was flown north-south whereas the right side of the image has lines north-south and east-west. The difference between these two datasets are approximately 0.15 meters.

Figure 17 – Tin Grid/Hillshade with “noise” within the arrow area.

Figure 18 – Scan lines, note the right side of the image has flight lines that are flown perpendicular to each other.

Figure 19 – CIR photo of area with noisy data.

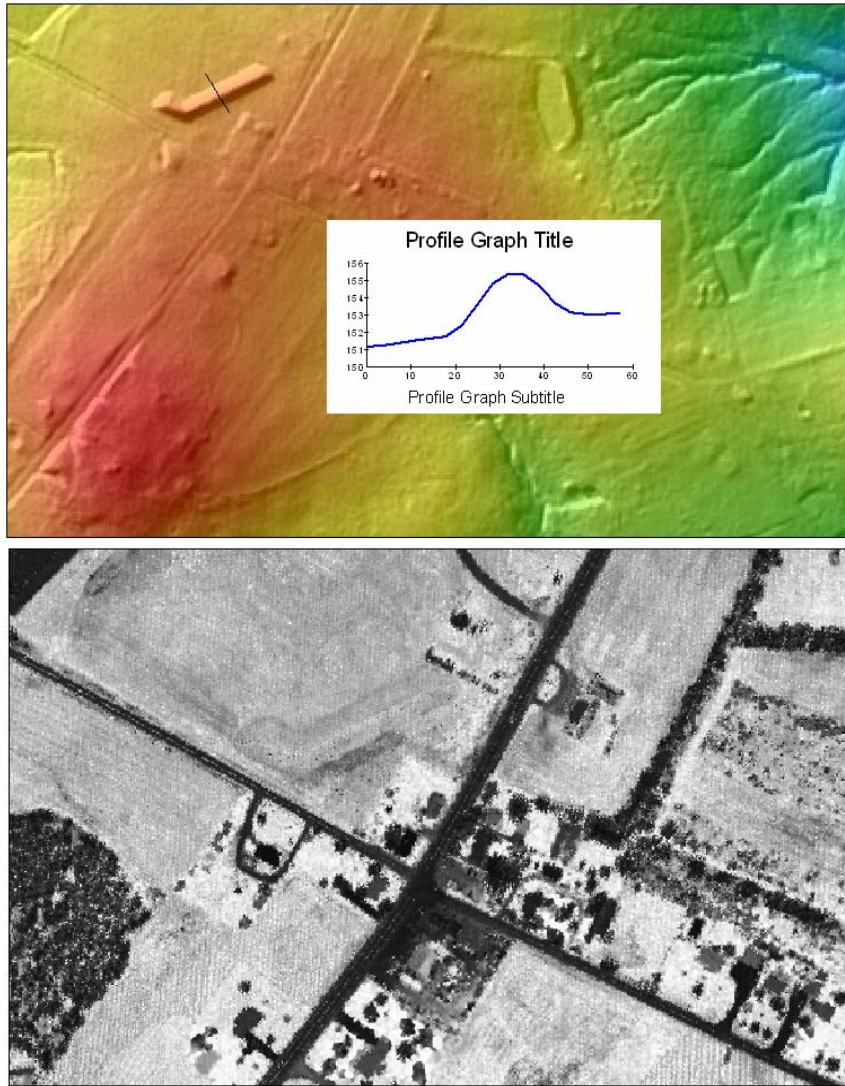
Figure 20 - Legitimate feature illustrated by Tin Grid/Hillshade and intensity image.

Figure 20 illustrates what appears to be an artifact nearly five meters tall based on the shape and elevation. However by using the intensity imagery, the feature in question is clearly identifiable and its texture is similar to the surrounding area.

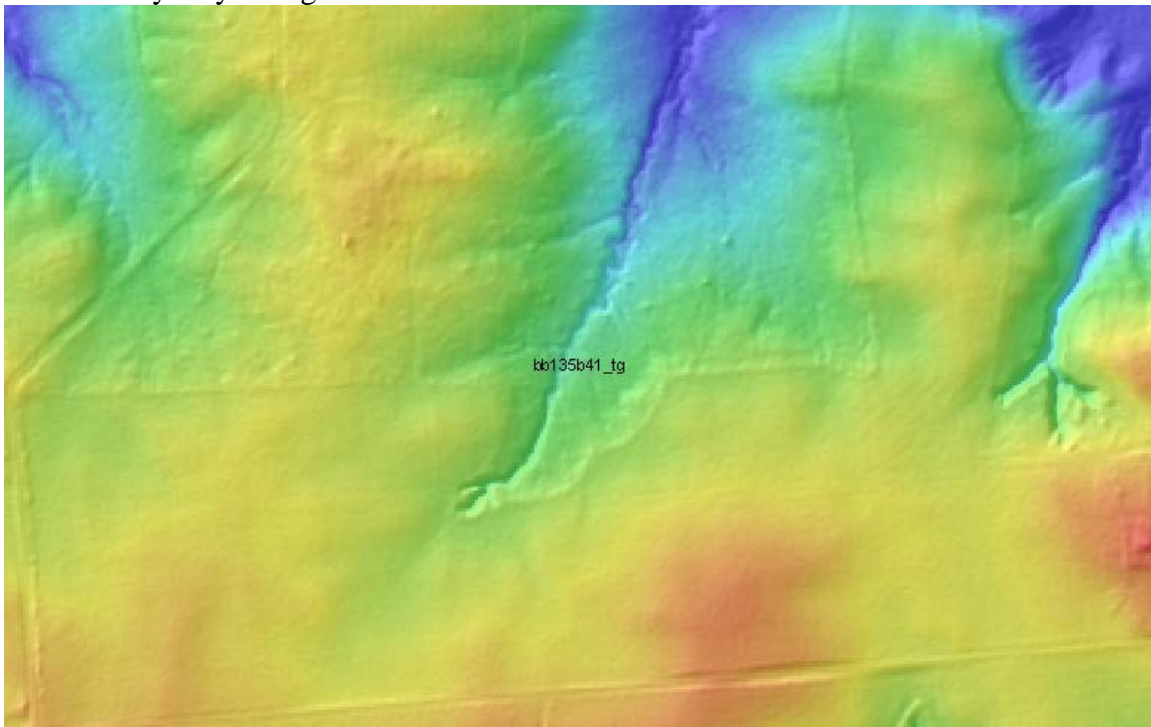
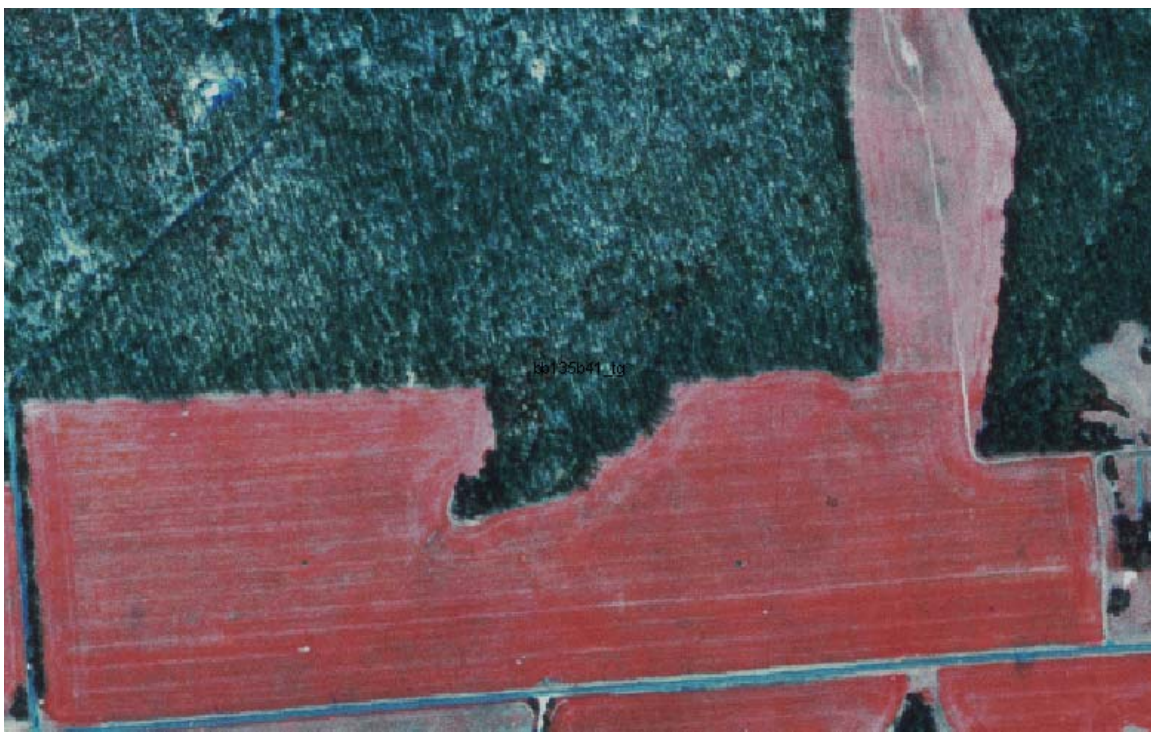
Figure 21 and Figure 22 illustrate what appears to be noisy data; however the photo shows the smoothness is from a plowed field and the roughness is an area within a forest. These are shown as to not misconstrue noisier terrain values with errors in the LIDAR because they may be legitimate features.

Figure 21 – Plowed Field and forest floor from LIDAR

Figure 22 – Plowed field and forest from CIR imagery.
