**MINIMUM TECHNICAL STANDARDS, VOL. 2
FINAL REPORT OF LIDAR MAPPING**

LEE COUNTY BUY-UP AREA

**STATE OF FLORIDA
DIVISION OF EMERGENCY MANAGEMENT**

**PURCHASE ORDER 3961
CONTRACT NO. 07-HS-34-14-00-22-469**

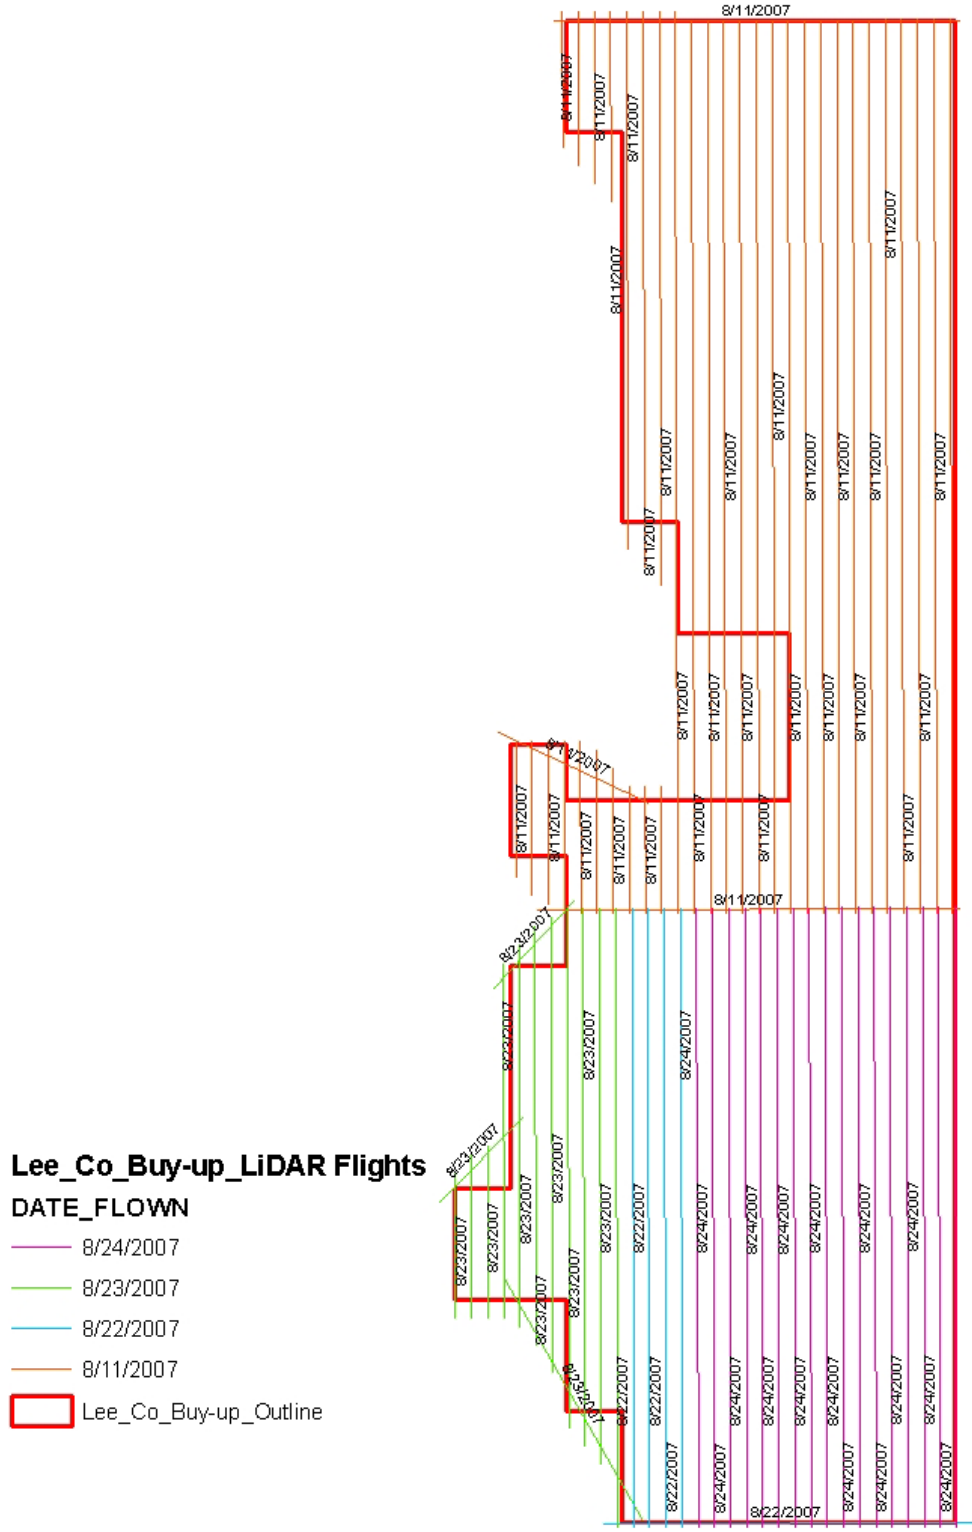
APPENDIX E: LIDAR FLIGHT DATES

The LiDAR data was acquired August 11-24, 2007. A map of the LiDAR flight lines and the dates of those flights may be found in Appendix E. The GPS ground control and QA/QC
