FINAL REPORT OF SPECIFIC PURPOSE LIDAR SURVEY

LiDAR, Breaklines and Contours for Levy County, Florida

State of Florida
Division of Emergency Management
Contract 07-HS-34-14-00-22-469
Task Order 20070525-492718a
PDS Task Order B

October 30, 2009

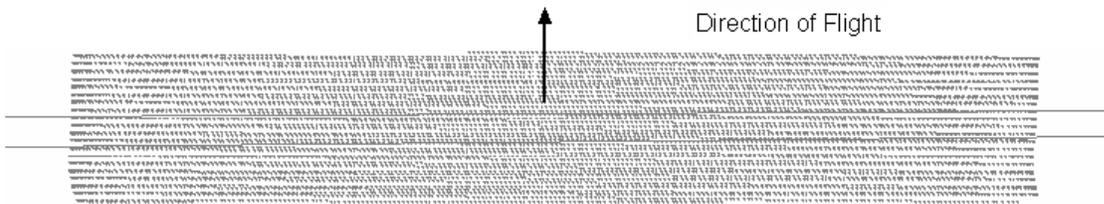
Figure 4: Runway Calibration

Approximately 25,000 LiDAR points are observed with each pass. A Triangulated Irregular Network (TIN) surface is created from these passes. The ground control x,y,z points are then compared with the z of the LiDAR surface to compute vertical residuals of the LiDAR data. After careful analysis of noise associated with non-runway returns, any system bias is documented and removed from the process.

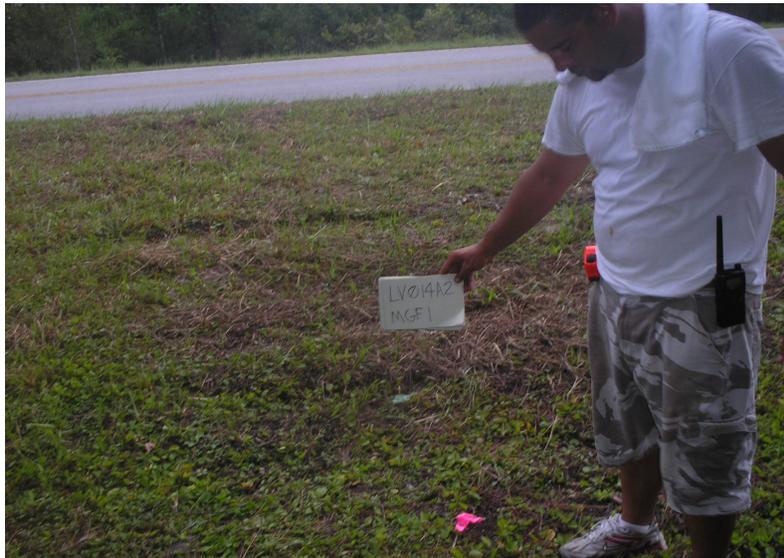
Figure 6 shows the field picture location of checkpoint LV014M2, which is at the edge of the tree line depicted in the field sketch (point is circled in red). This point was reclassified as a category 2 point, as it did not meet the selection criteria for a Category 1 checkpoint.

Figure 6 — Checkpoint LV014M2 Field Picture and Page from Field Notes

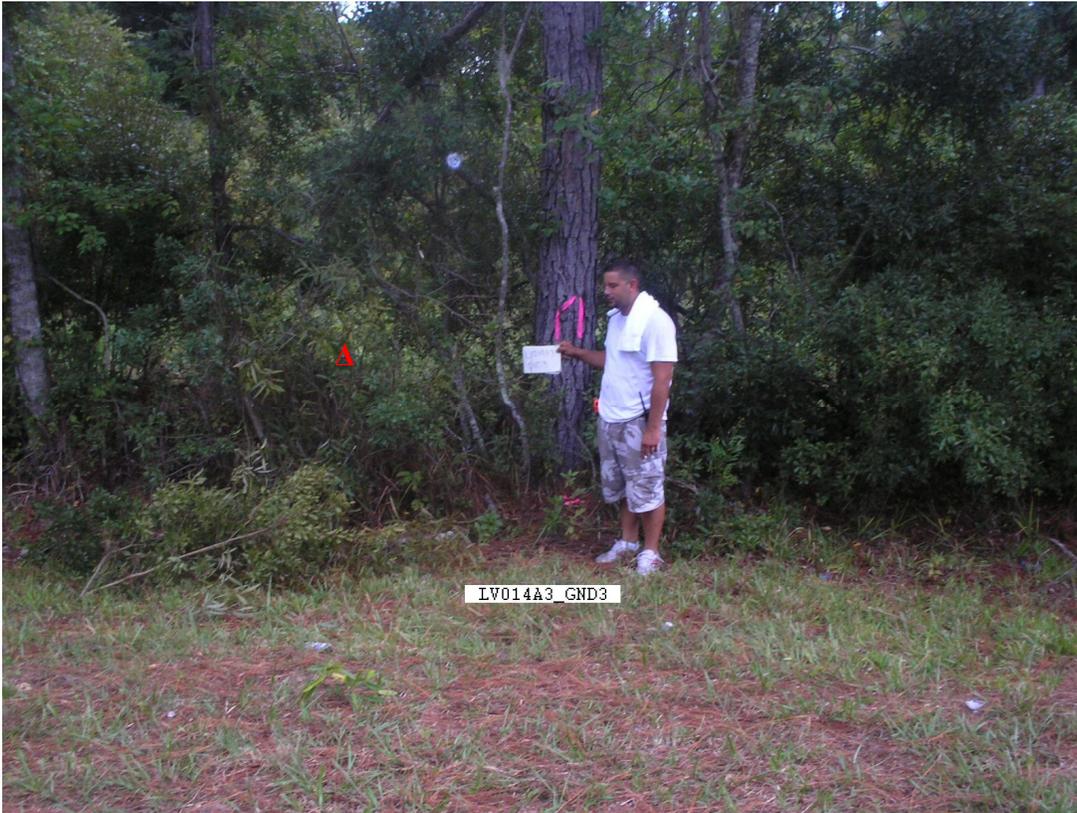
location. This point was deemed a low confidence point due to the proximity to the base of the tree and it was not used in the vertical accuracy assessment.

**Figure 8 —
Field Picture
of
Checkpoint
LV014M3**

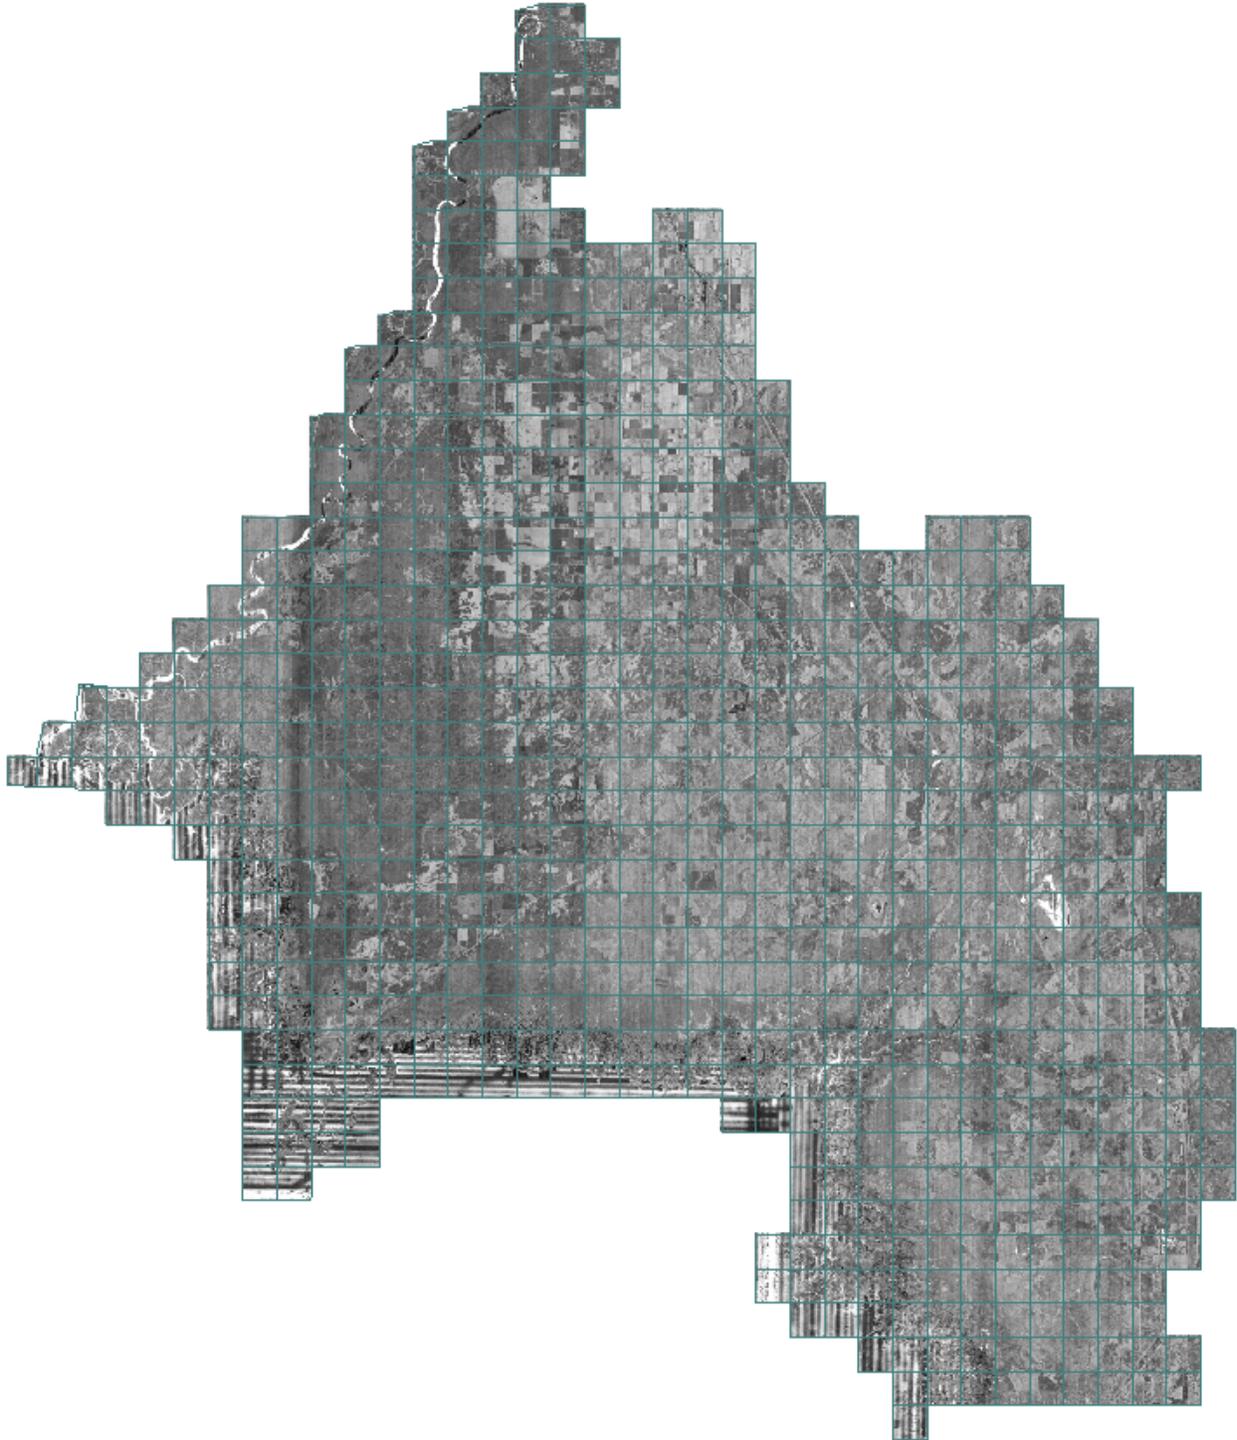
3. *Data Void/ Gap Checks*-The imported .LAS files were used to create LiDAR “orthos”. The LiDAR orthos were one of the tools used to verify data coverage and point density, to check for data voids or gaps, and to use as reference data during checks for data anomalies and artifacts. This product is not intended to be a project deliverable. The orthos were derived from the Full Point Cloud elevations and LiDAR pulse return intensity values. The intensity values were used as delivered with no normalization applied. Due to the point density of the Florida Baseline Specifications, the orthos were produced at a 1.2m pixel for the entire area of interest (see Figure 1).

Figure 9 Screenshot of Levy County LiDAR Orthos produced from Intensity Returns

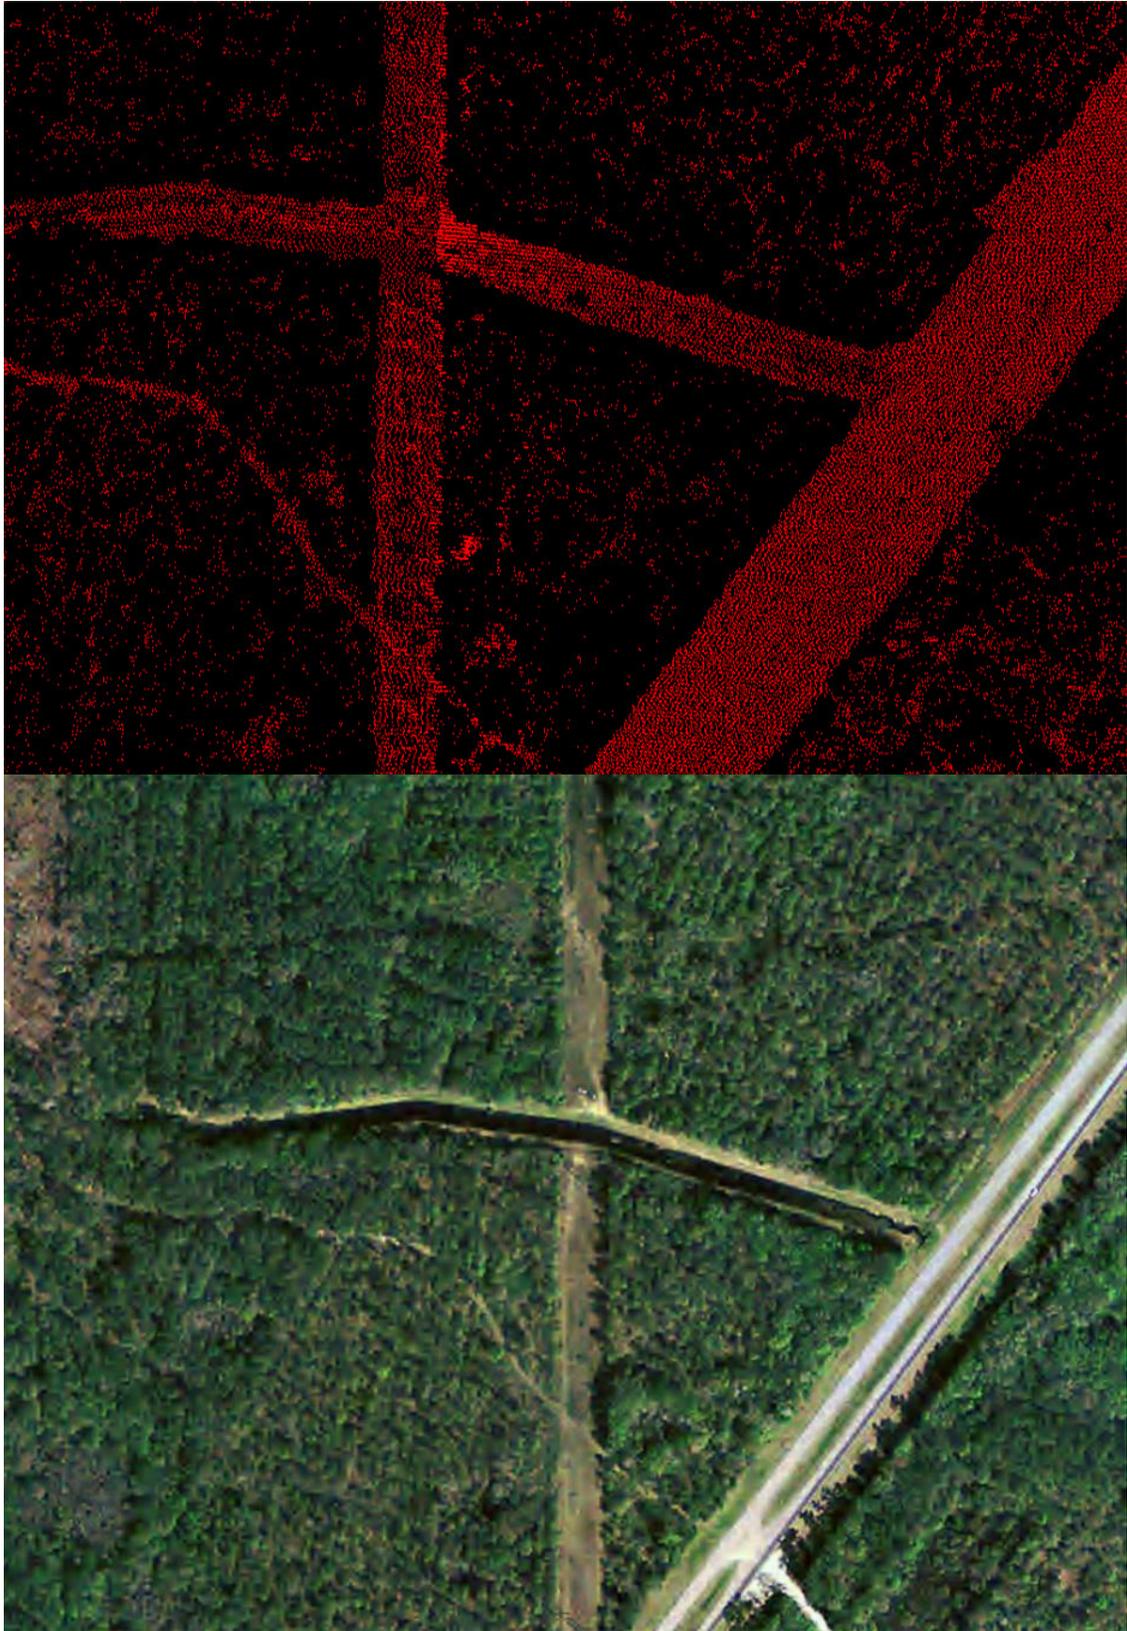
In several areas ground points were found in the .LAS files that should have been classified as water (see Figures 7 - 9). This was likely due to an automated filter confusing the points with ground points, based on elevation. In addition, two culverts were inadvertently removed from a major highway feature (see Figure 10). These tiles were rejected and subsequently corrected by The Sanborn Map Company.

Figure 9 Tile 0100842 – Canal or water-filled ditch classified as Class 2- ground points.

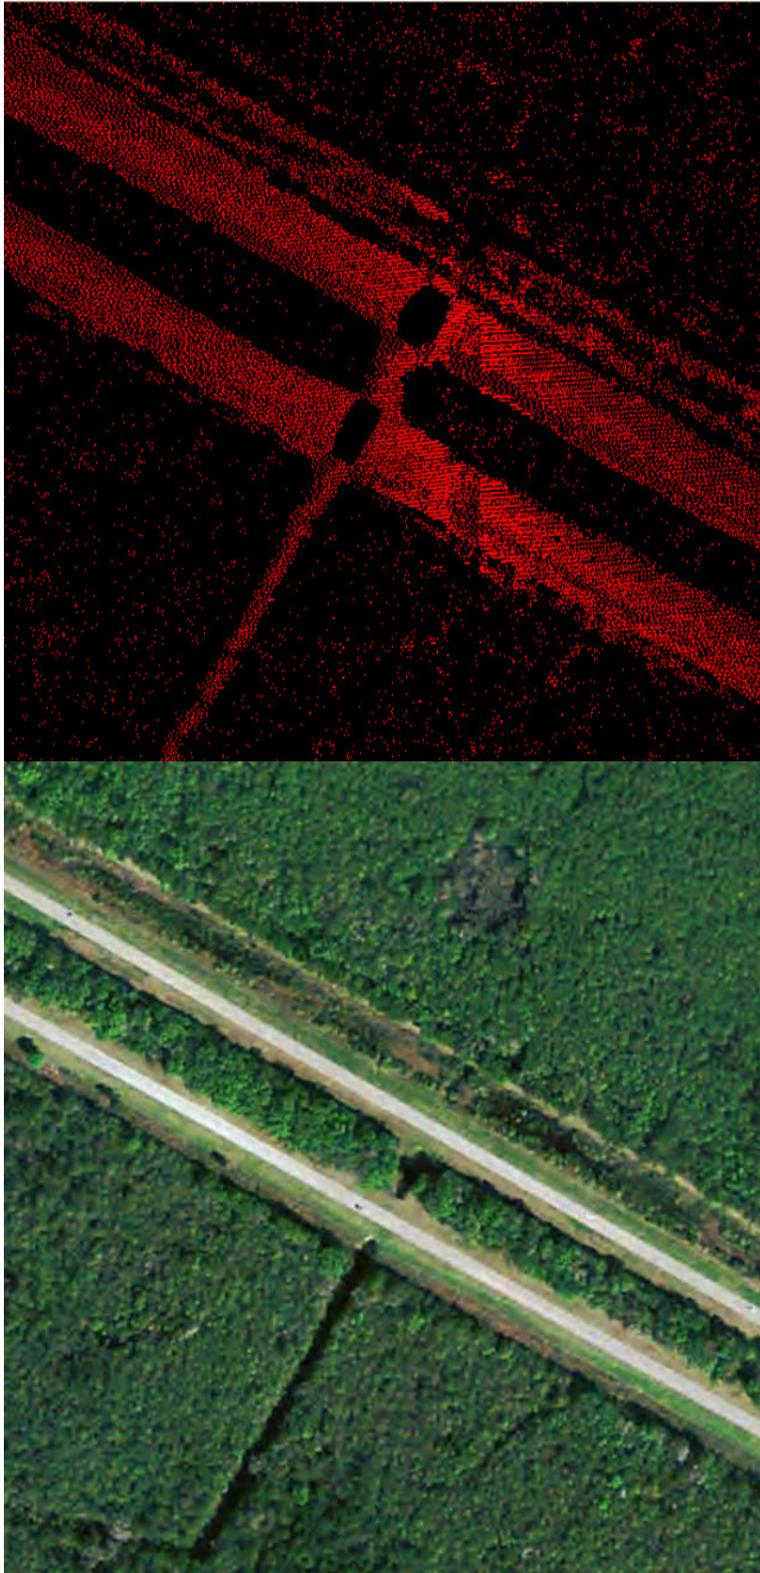
Figure 10 Tile 0100849 – Culverts removed from bare earth classification

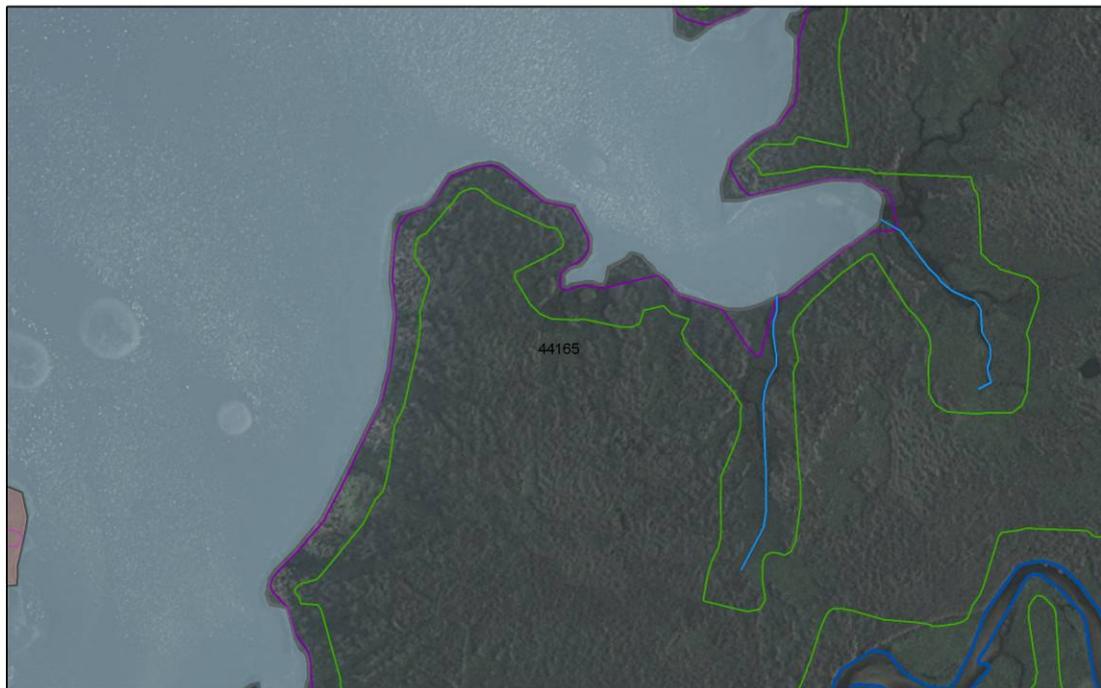
Coastal shorelines are correctly captured as two-dimensional polygon features, extracted from the LiDAR data and not from digital orthophotos, except for manmade features with varying heights such as seawalls which are captured as three-dimensional breaklines. Coastal breaklines merge seamlessly with linear hydrographic features. Shorelines continue beneath docks and piers. There is no “stair-stepping” of coastal shorelines. Figure 1 shows example coastal breaklines and contours.

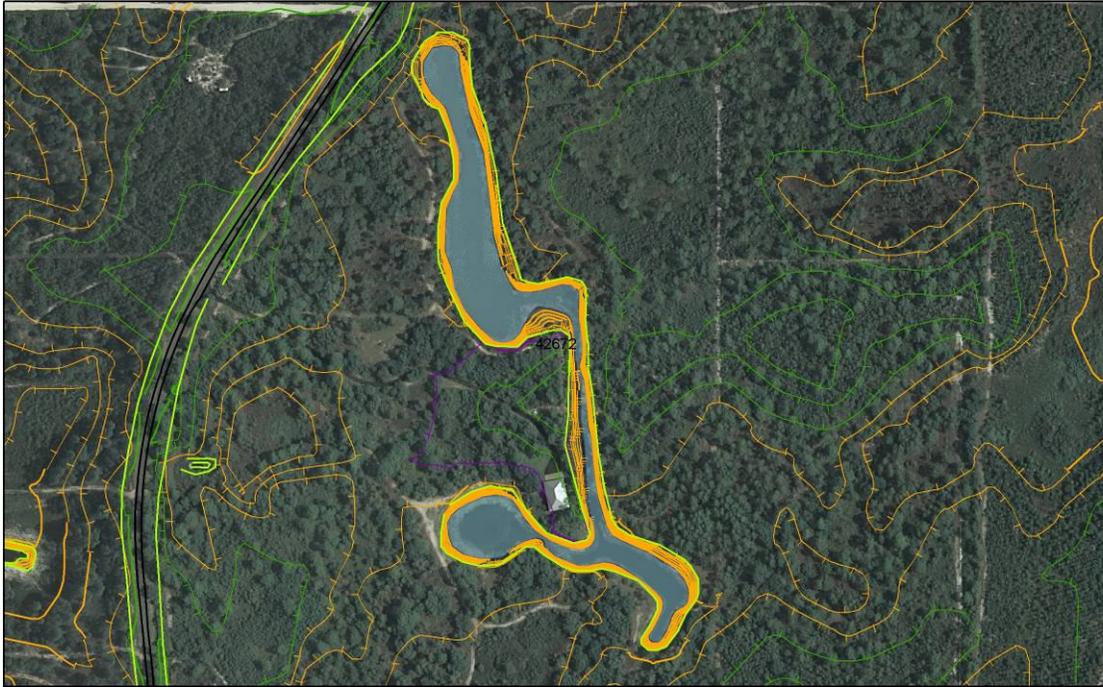
Closed water body features with an area of one-half acre or greater are correctly captured as two-dimensional closed polygons with a constant elevation that reflects the best estimate of the water elevation at the time of data capture. “Donuts” exist where there are islands within a closed water body feature. Figure 3 shows example breaklines and contours of closed water body features.

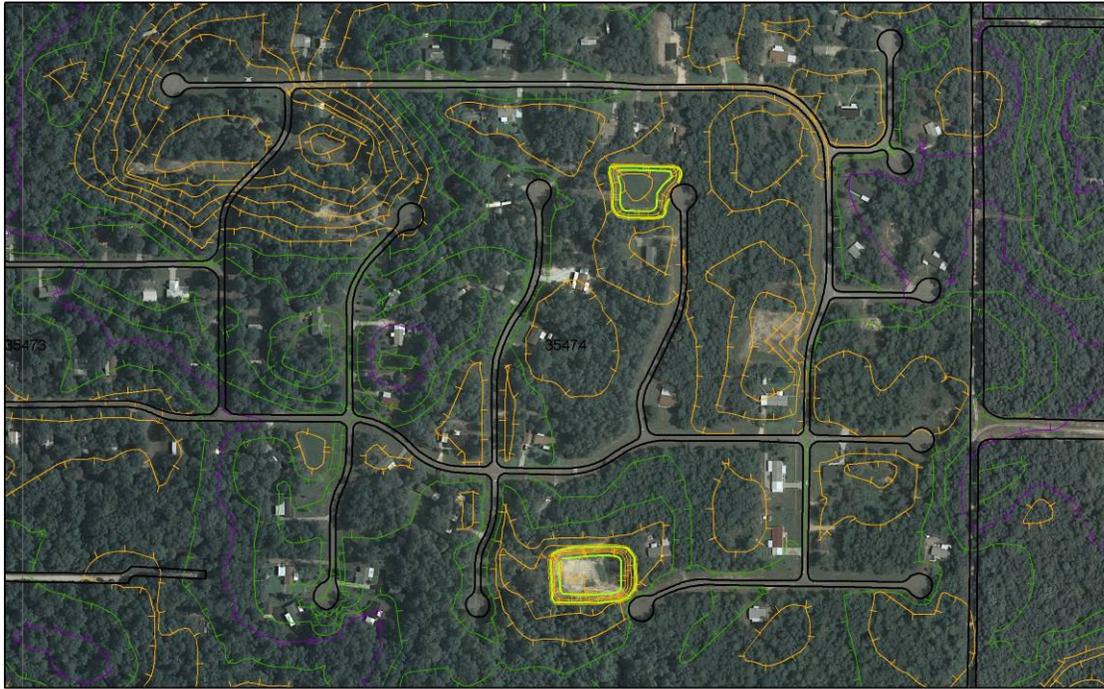
Road edge of pavement features are correctly captured as three-dimensional breaklines on both sides of paved roads. Box culverts are continued as edge of pavement unless a clear guardrail system is in place; in that case, culverts are captured as a bridge or overpass feature. Each vertex maintains vertical integrity. Figure 4 shows example breaklines and contours of road features.
