FINAL REPORT OF SPECIFIC PURPOSE LIDAR SURVEY

LiDAR, Breaklines and Contours for Franklin County, Florida

State of Florida
Division of Emergency Management
Contract 07-HS-34-14-00-22-469
Task Order 20070525-492718a
PDS Task Order B

February 12, 2009

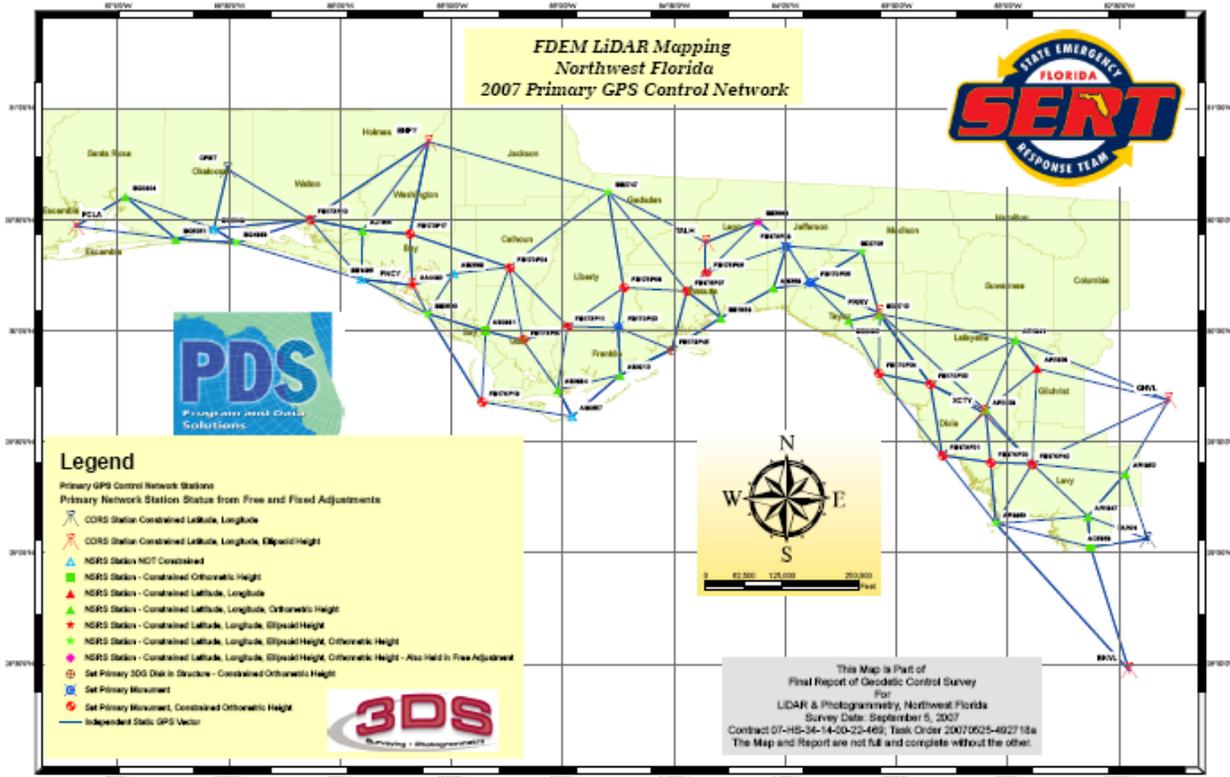
Figure 1. Primary Control Network

The Primary network stations (see Figure 1) were used as base stations supporting the airborne GPS data acquisition, and as a consistent control framework for the more densely spaced Secondary control networks, and all subsequent control surveying activity on the project. They were setup at 40 kilometer spacing per the 2 centimeter requirements for Primary Control stated in the NOS NGS-58. The Primary Control network consisted of 55 stations, including 10 Continuously Operating Reference Stations (CORS), 27 existing monuments from the National Spatial Reference System (NSRS) and 18 new monuments set so as to limit LiDAR GPS baseline lengths to 20 Km relative to GPS base stations on either side of stations spaced ≈ 40 Km apart. Third order differential leveling was used to establish elevations on 20 Primary network stations in specific areas where published vertical stations could not be occupied directly with GPS. A minimally constrained (free) Least Squares adjustment was run to verify the internal accuracy of the Primary network. After evaluating and removing any outliers, a final free adjustment was generated, consisting of 191 independent vectors. The input error estimates were scaled by a factor of 14.90 which resulted in a properly weighted adjustment with a variance factor of 1.0154, with no flagged residuals. A constrained (fixed) 3-D horizontal adjustment was run using the same input error estimates as were used in the free adjustment; the variance factor was 1.3712 and there were no flagged residuals. A constrained (fixed) 1-D vertical adjustment was run using the same input error estimates as were used in the free adjustment; Station BE3991 was fixed in latitude, longitude and orthometric height; the variance factor was 1.2866 and there were no flagged residuals.

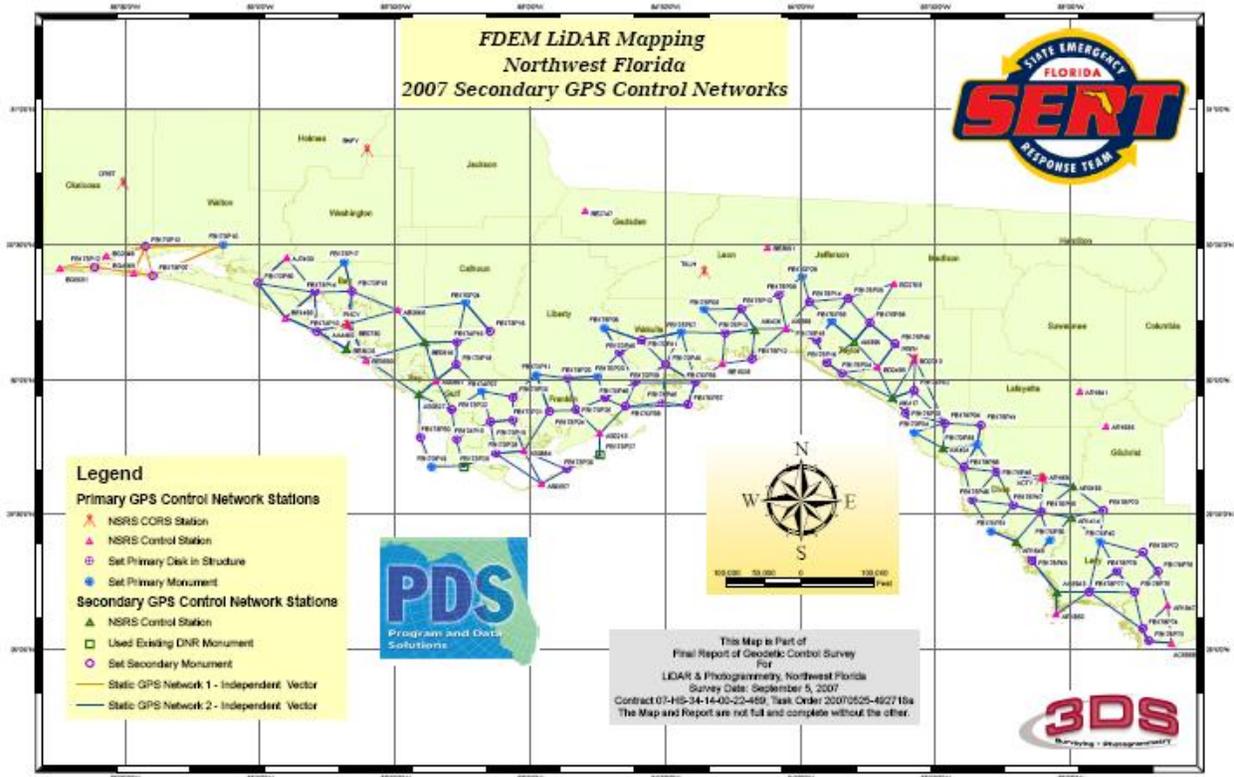
Figure 2. Secondary Control Networks

The first Secondary Control network consisted of 4 stations in the Okaloosa County area. The second Secondary Control network consisted of all remaining mapping areas in the Florida Panhandle. The Secondary Control networks included a total of 80 control points, including 16 recovered NSRS monuments, 2 recovered DNR monuments, and 62 new monuments set for this network. A minimally constrained (free) Least Squares adjustment was run to verify the internal accuracy of the Secondary networks. After evaluating and removing any outliers, a final free adjustment was generated. This final free adjustment consisted of 254 independent vectors. The input error estimates were scaled by a factor of 6.234, which resulted in a properly weighted adjustment with a variance factor of 1.000; there were no flagged residuals. A constrained (fixed) 3-D horizontal adjustment was run using the same input error estimates as were used in the free adjustment; the variance factor was 1.6339 and there were six flagged residuals. A constrained (fixed) 1-D vertical adjustment was run using the same input error estimates as were used in the free adjustment; Station BE3991 was fixed in latitude, longitude and orthometric height; the variance factor was 1.2136 and there were no flagged residuals.

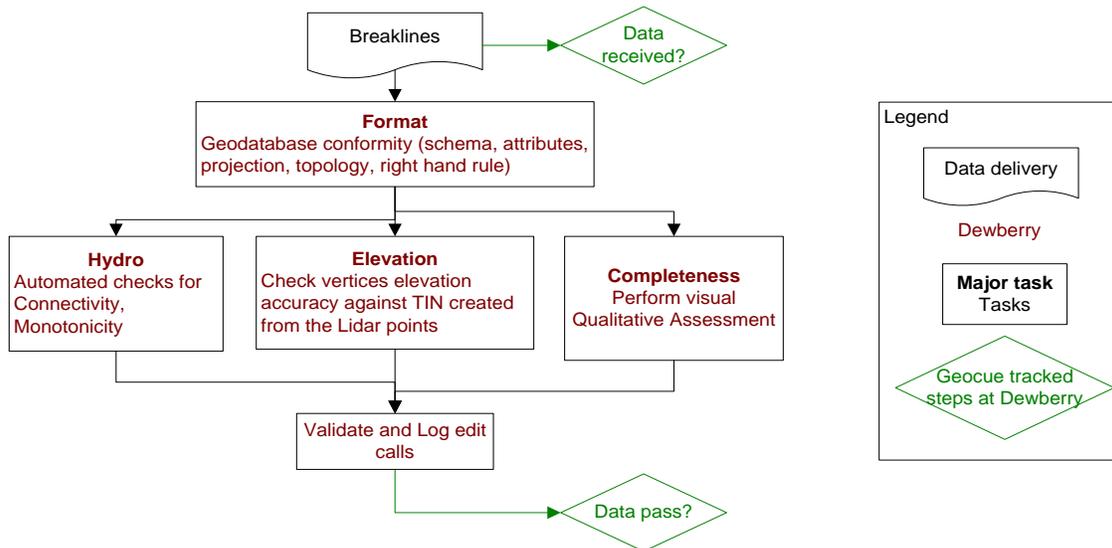
Dewberry performed the breakline qualitative assessments. The following workflow diagram represents the steps taken by Dewberry to provide a thorough qualitative assessment of the breakline data.

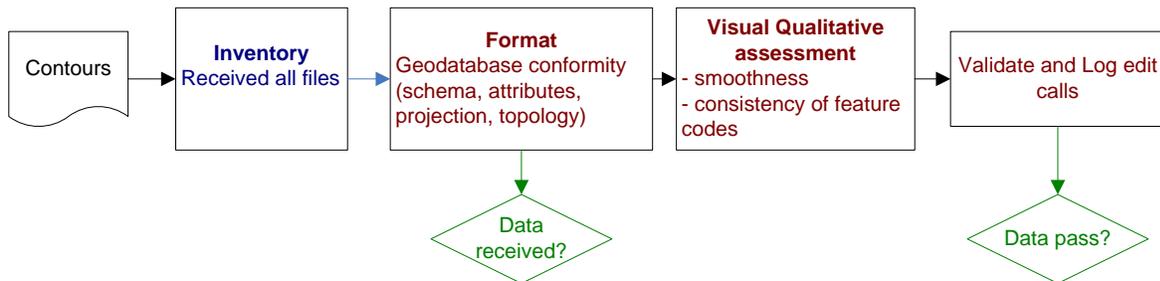
Dewberry also performed the qualitative assessments of the contours using the following workflow.

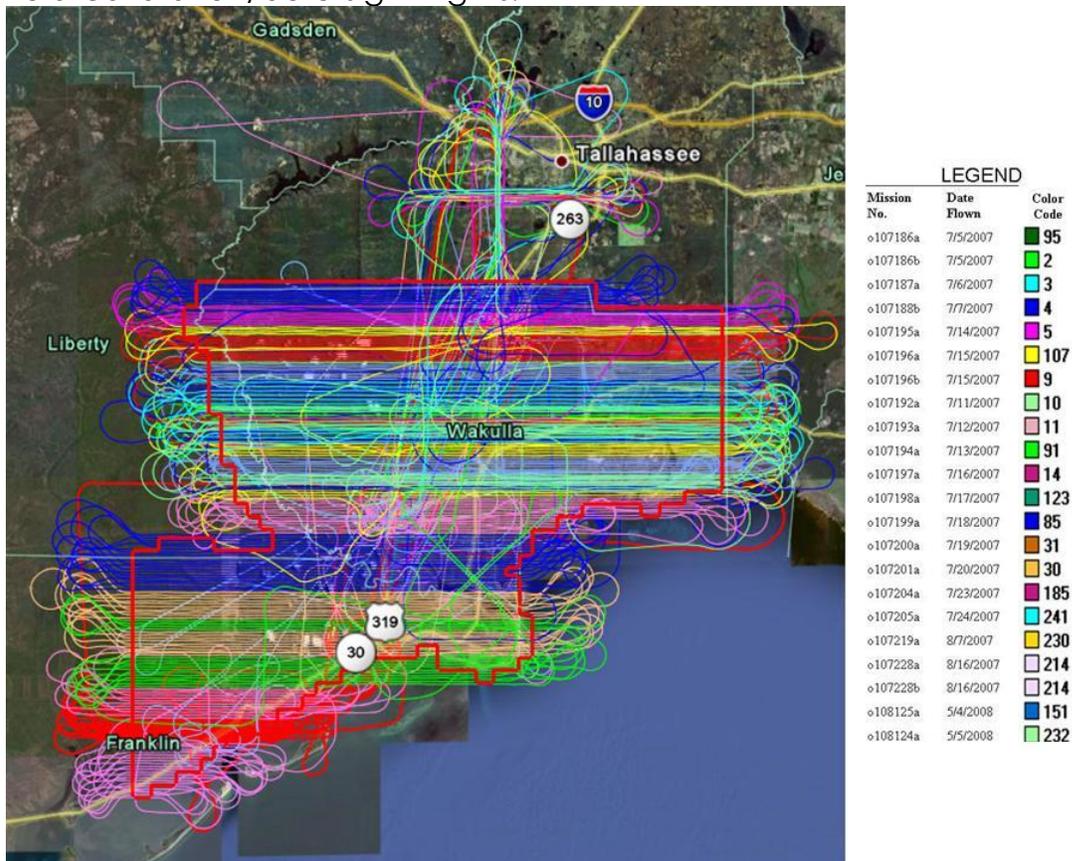
The flight lines and dates are shown in the image below, to include the field-calibration/bore-sight flights.

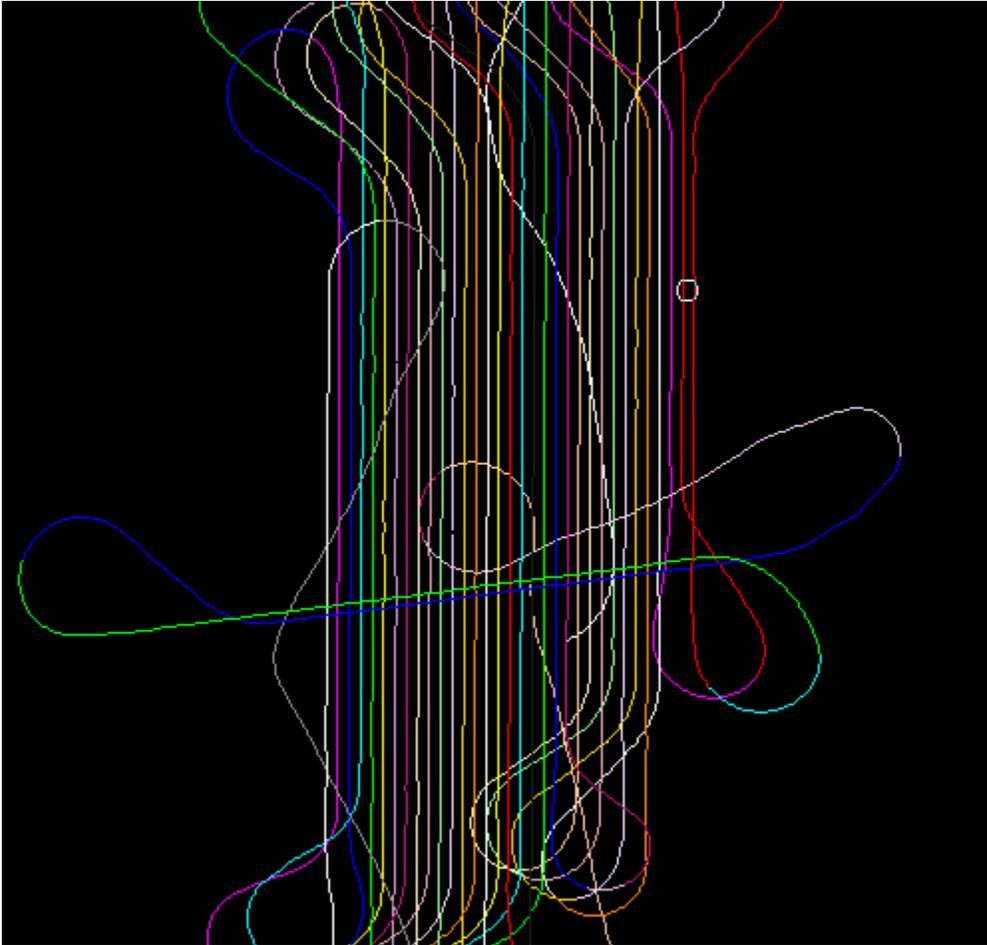
Figure 4 Example of mission trajectory showing cross lines used to determine calibration values

Field Calibration is used to determine the roll, pitch, heading and scanner scale values. This is essentially the same as bore-sighting. The roll pitch heading and scanner scale biases are determined by comparing overlapping and opposing flightlines. Each mission is flown to have two cross lines that intersect every flightline and these lines are used to determine the roll, pitch heading and scanner scale.

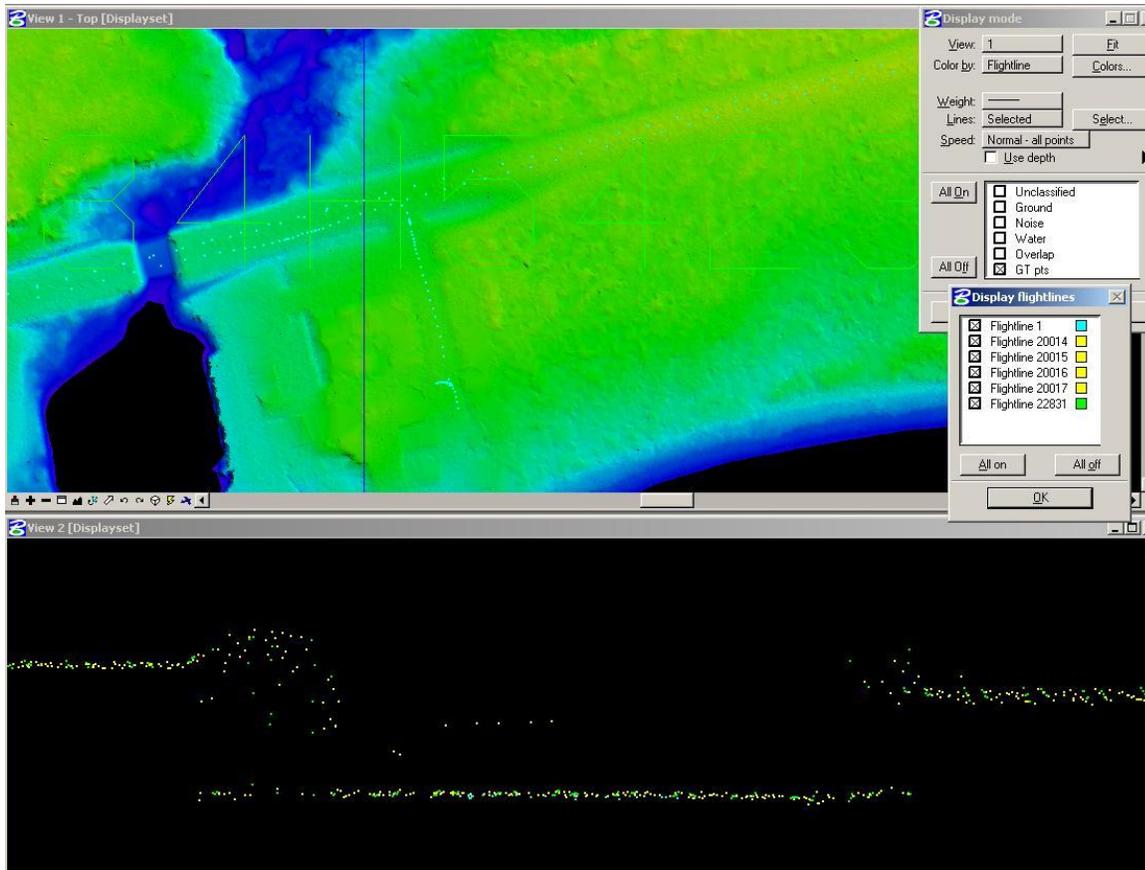
Figure 2 Example of Control pts (flightline 1) loaded with the raw data to check vertical accuracy

Instead, a point to point comparison of a recently acquired or existing high confidence ground survey point to its nearest neighbour LiDAR laser return point. This is done in the raw data set and usually with Terrascan software. The tolerance for finding a near-by LiDAR point elevation to compare to a survey point elevation is that the two points must be within a 0.5m radius of each other in open flat areas is made. If no LiDAR points can be found within in this tolerance, then alternative methodologies are used to convert the LiDAR to a TIN, though this can introduce biases and processing errors in the end products and could cause the RMSE values to be skewed and fall beyond project specifications.

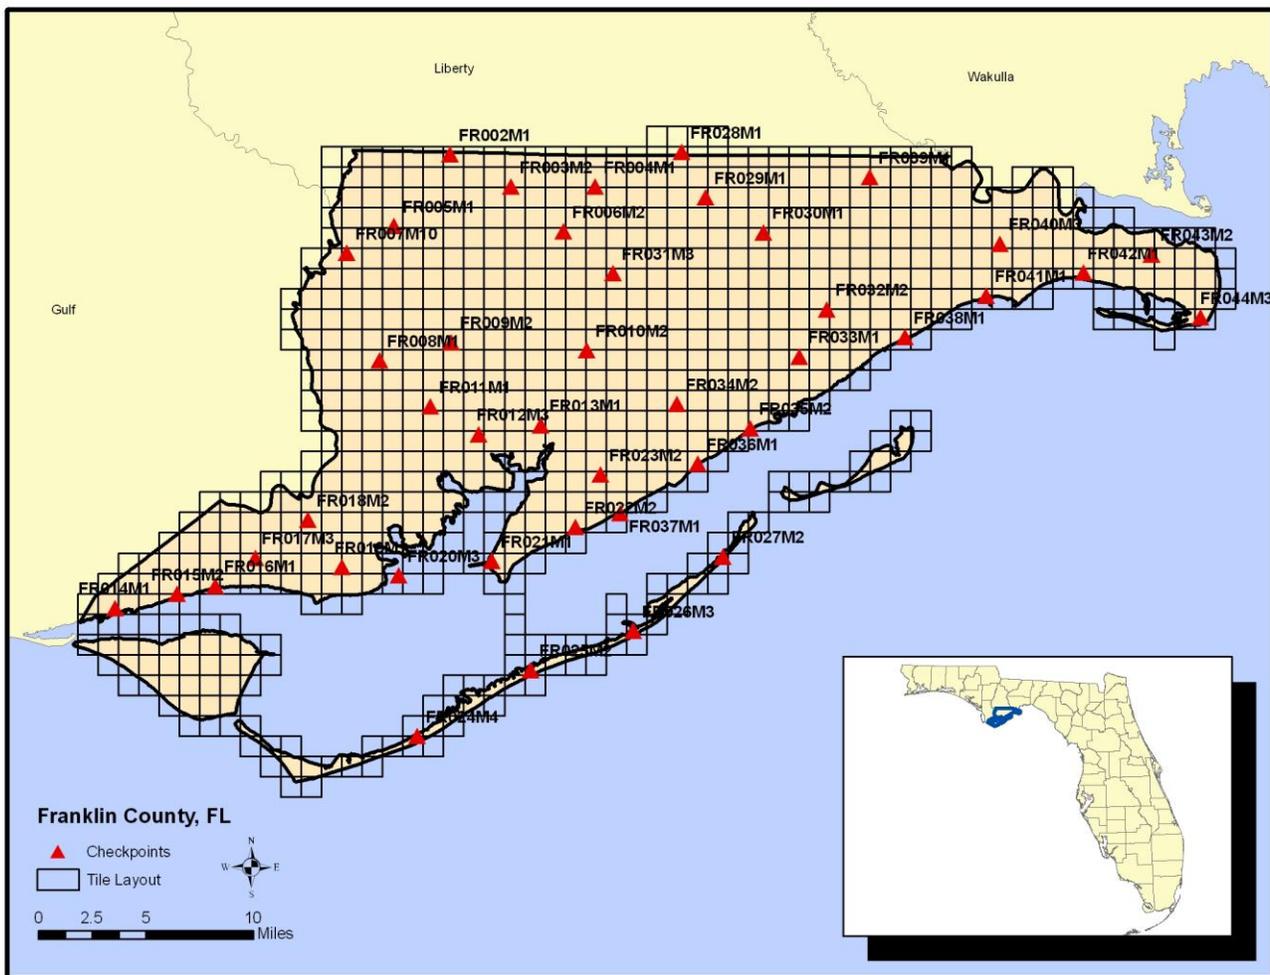
Figure 1 — Location of QA/QC Checkpoint Clusters for Franklin County

Note the initial vertical accuracy assessment of Franklin County clearly indicated a negative error bias averaging \sim .35 ft. This information was passed on to the LiDAR vendor with the recommendation that they apply a positive “z-bump” to all of the points contained in the .LAS files for this county. The z-bump was accurately applied and it is those corrected .LAS files that were used in this final vertical accuracy assessment.

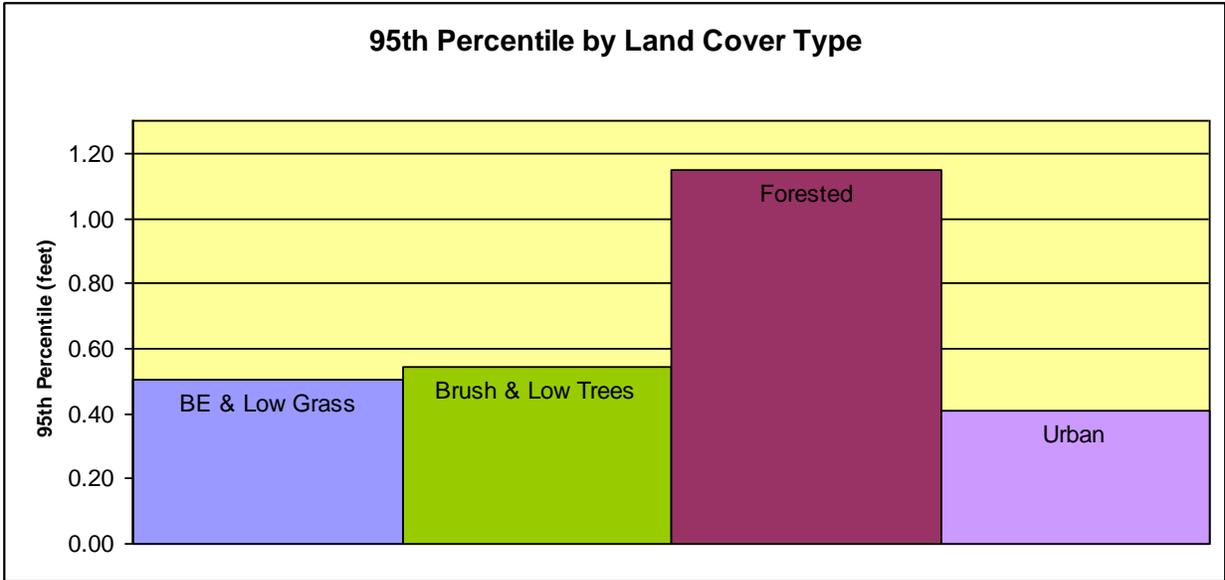
Figure 2 — Graph of SVA Values by Land Cover

Figure 2 illustrates the SVA by specific land cover category.

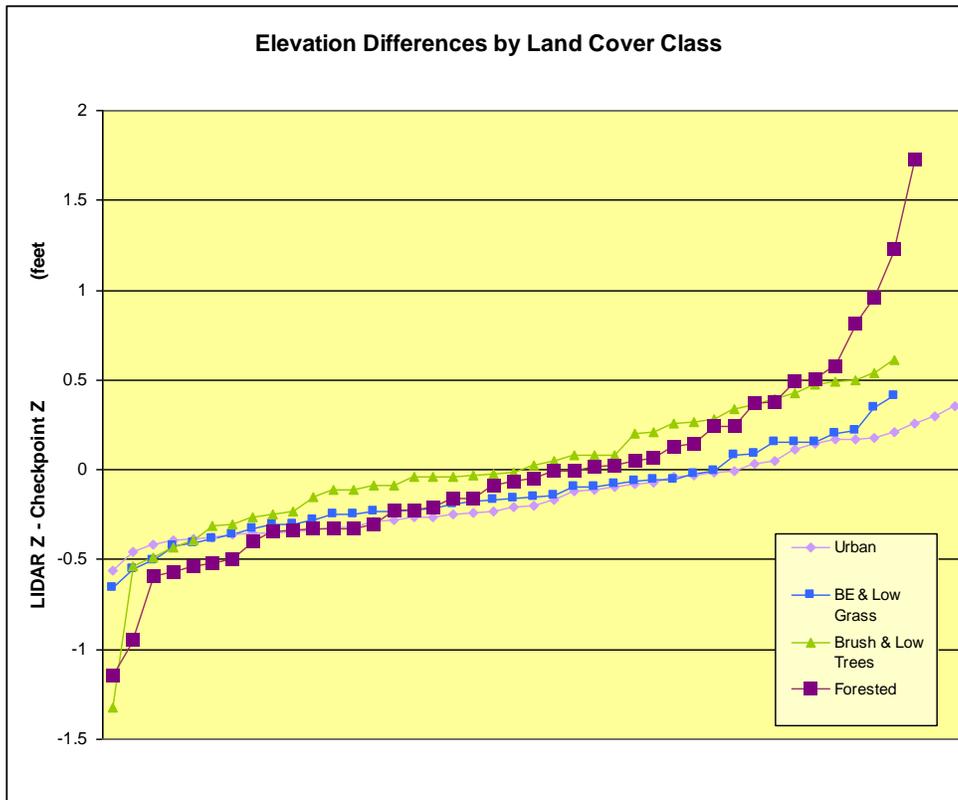
Figure 3 – Magnitude of Elevation Discrepancies, Sorted from Largest Negative to Largest Positive

Figure 3 illustrates the magnitude of the differences between the QA/QC checkpoints and LiDAR data by specific land cover category and sorted from lowest to highest. This shows a negative skew to the distribution of points in bare-earth and low grass; however, that deltas are well within specification.

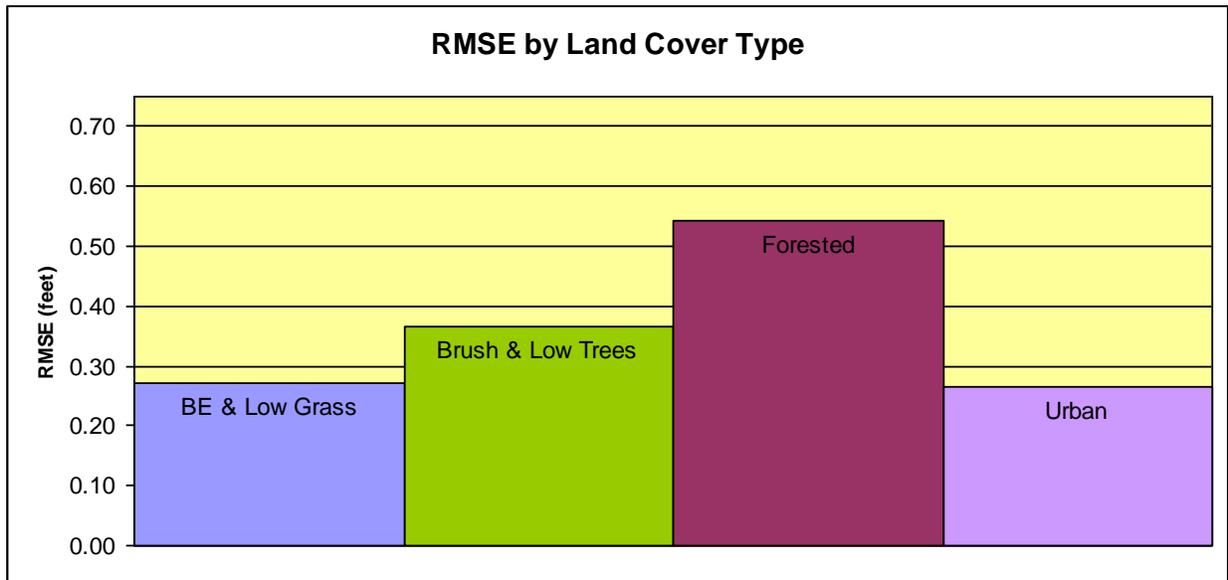
Figure 4 — $RMSE_z$ statistics by Land Cover Category

The NSSDA and FEMA guidelines were both published before it was recognized that LiDAR errors do not always follow a normal error distribution. Future changes to these FGDC and FEMA documents are expected to follow the lead of the NDEP and ASPRS. Nevertheless, to comply with FEMA’s current guidelines in Reference C, $RMSE_z$ statistics were computed in all four land cover categories, individually and combined, as well as other statistics that FEMA recommends to help identify any unusual characteristics in the LiDAR data. These statistics are summarized in Figures 4 and 5 and Table 4 below, consistent with Section A.8.6.3 of Reference C.

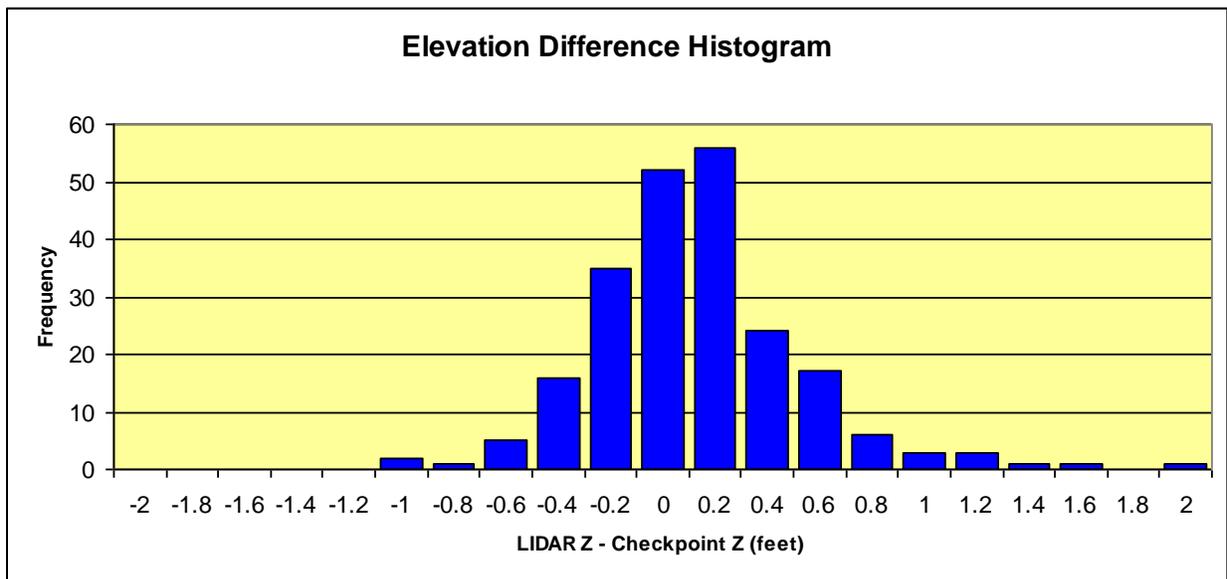
Figure 5 — Histogram of Elevation Discrepancies within 0.10 m Bands

Figure 5 illustrates a histogram of the associated elevation discrepancies between the QA/QC checkpoints and elevations interpolated from the LiDAR triangulated irregular network (TIN). The frequency shows the number of discrepancies within each band of elevation differences. Although the discrepancies vary between a low of -1.33 ft and a high of +1.73 ft, the histogram shows that the majority of the discrepancies are skewed on the positive side of what would be a “bell curve,” with mean of zero, if the data were truly normally distributed. Typically the discrepancies tend to skew a bit more to the positive side, because discrepancies in vegetation are typically positive. The vast majority of points are within +/- 0.5 ft range.

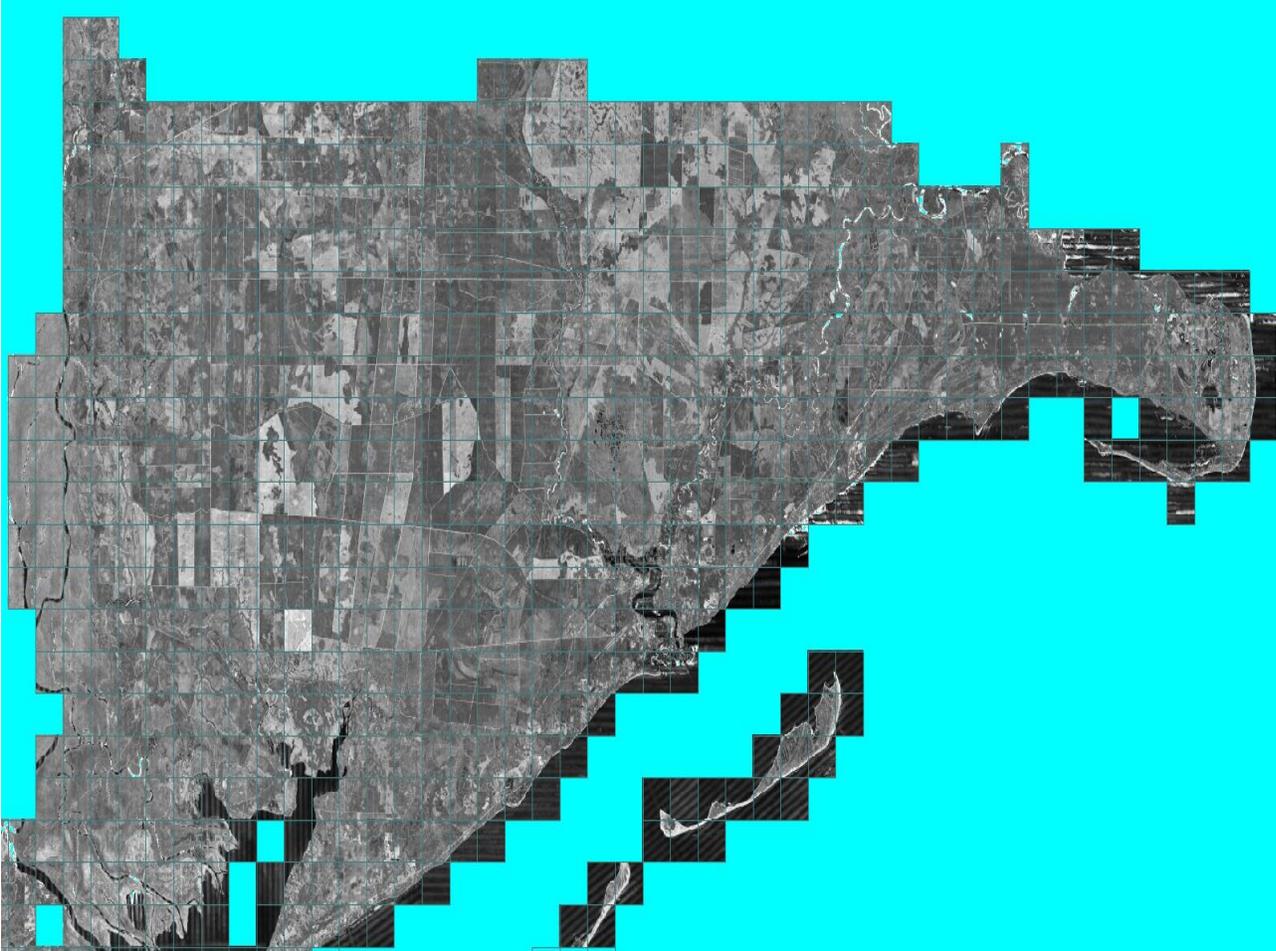
Figure 5 Lidar Ortho Sample from Franklin County. Areas in Blue are acceptable Data Voids caused by Ponds, Streams or Water Bodies.

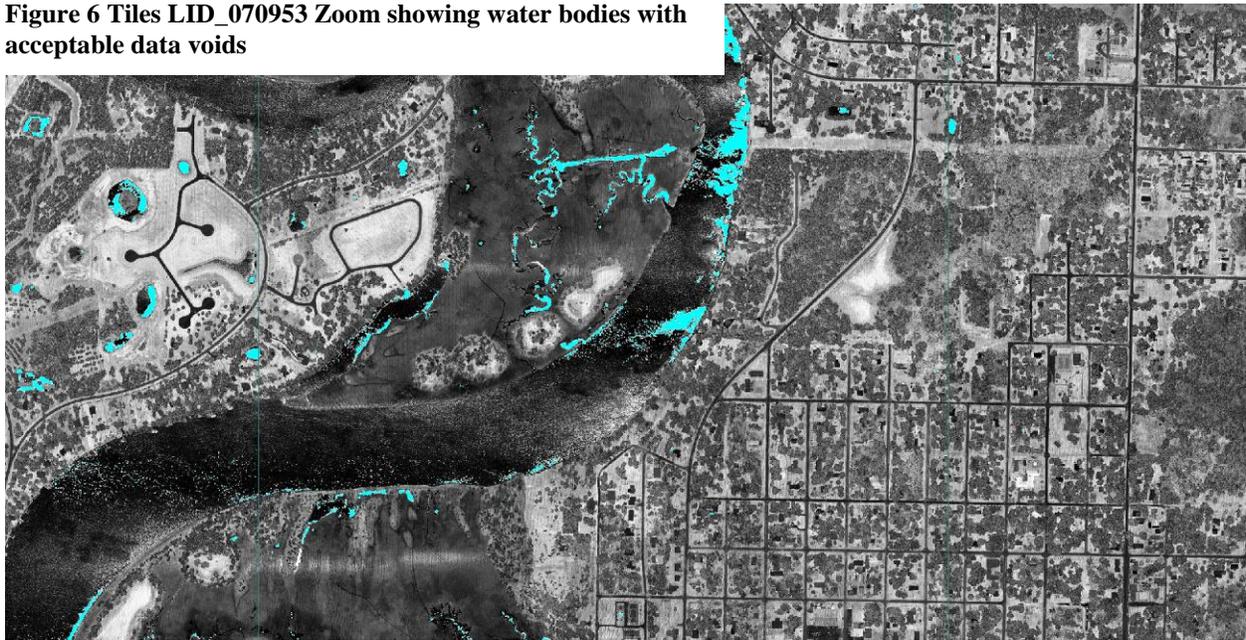
Figure 6 Tiles LID_070953 Zoom showing water bodies with acceptable data voids

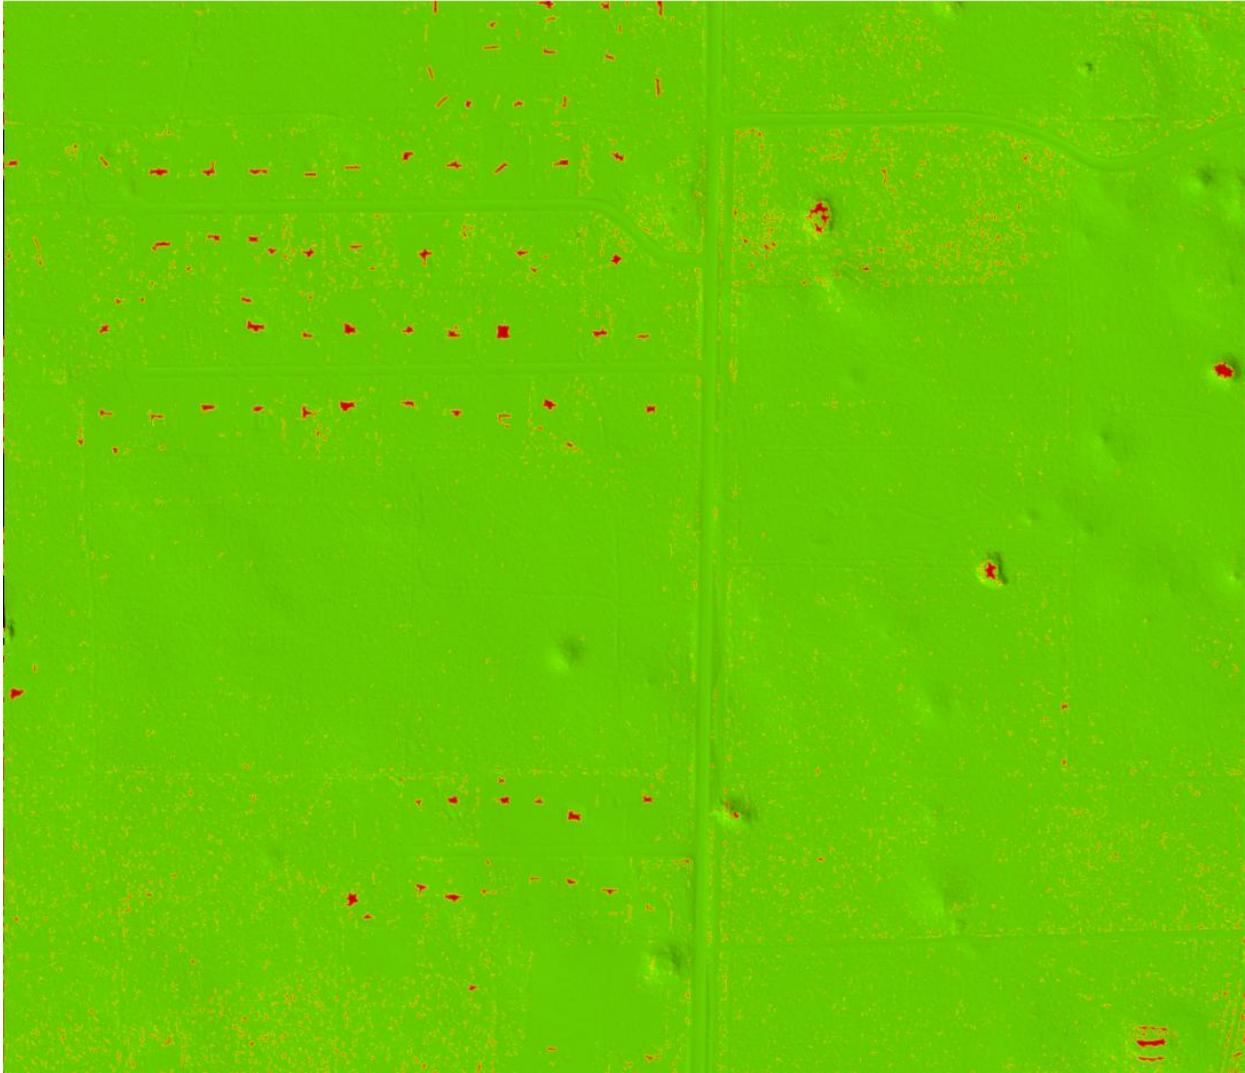
The QC for Franklin County was done at the most stringent data density requirement. For the FDEM project this requirement was that LiDAR point cloud data meet a maximum post spacing of 4 ft in un- obscured areas for random point data. Model statistics were produced and characterized by density as well as elevation. This data model was created from class 2 ground points and model statistics were characterized by density, scale, intensity as well as elevation. (Figure 2) The low confidence area polygons were referenced with the density grids to ensure that all low confidence areas are properly identified with a low confidence area polygon. Again, these products were produced for Quality Assessment purposes only.

Figure 7 Sample density grid (Tile LID053696)

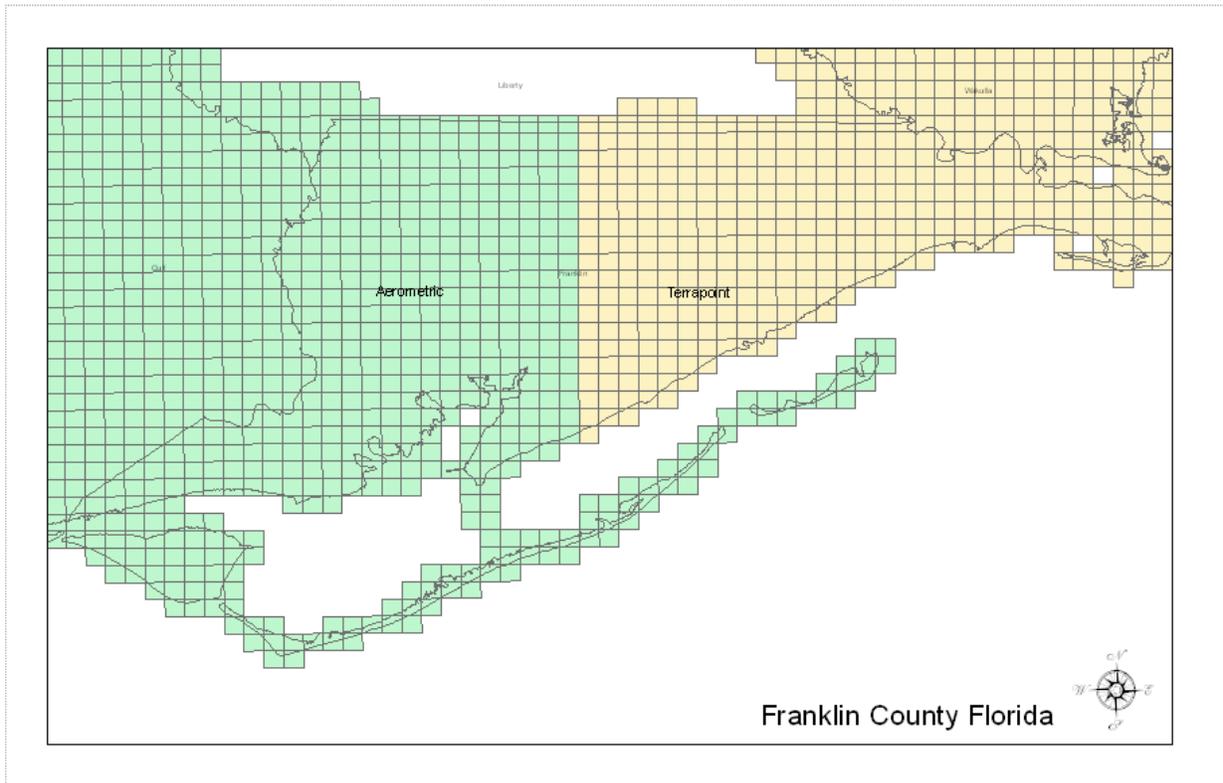
Figure 5 Tile Franklin County layout by Contractor. The County was flown by two different Contractors, the data was QC'd together.

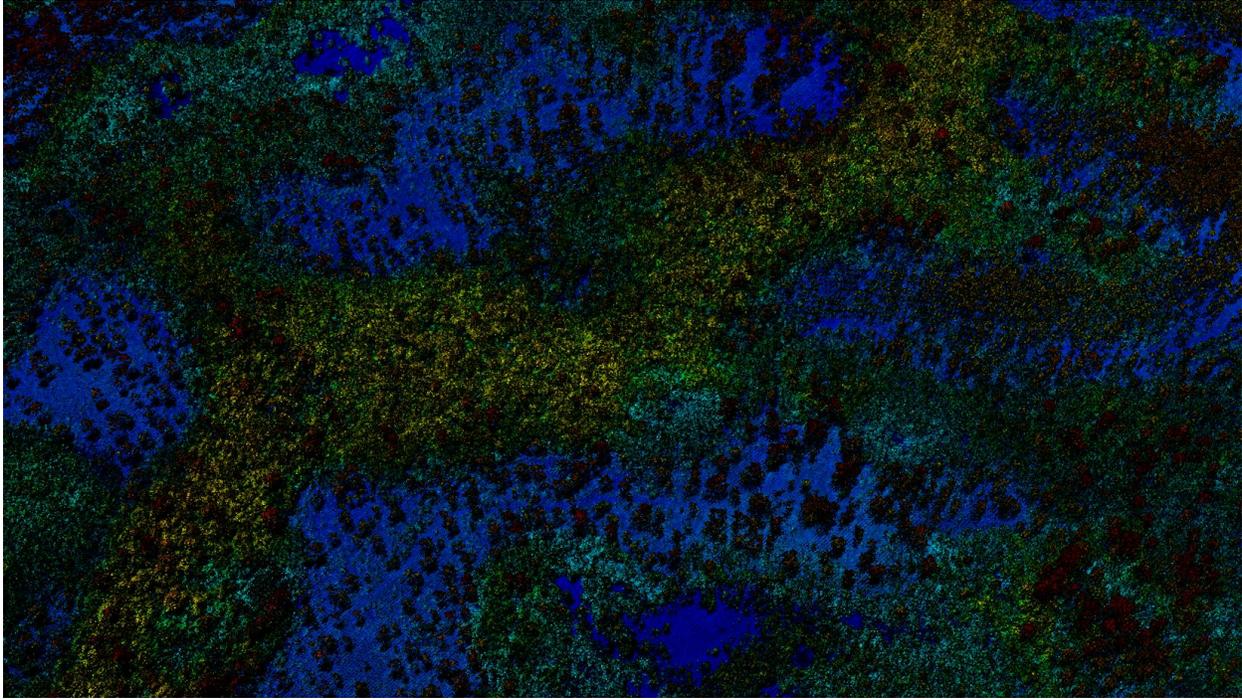
Figure 6 Tile 054216 - example of heavy vegetation in Franklin County Florida

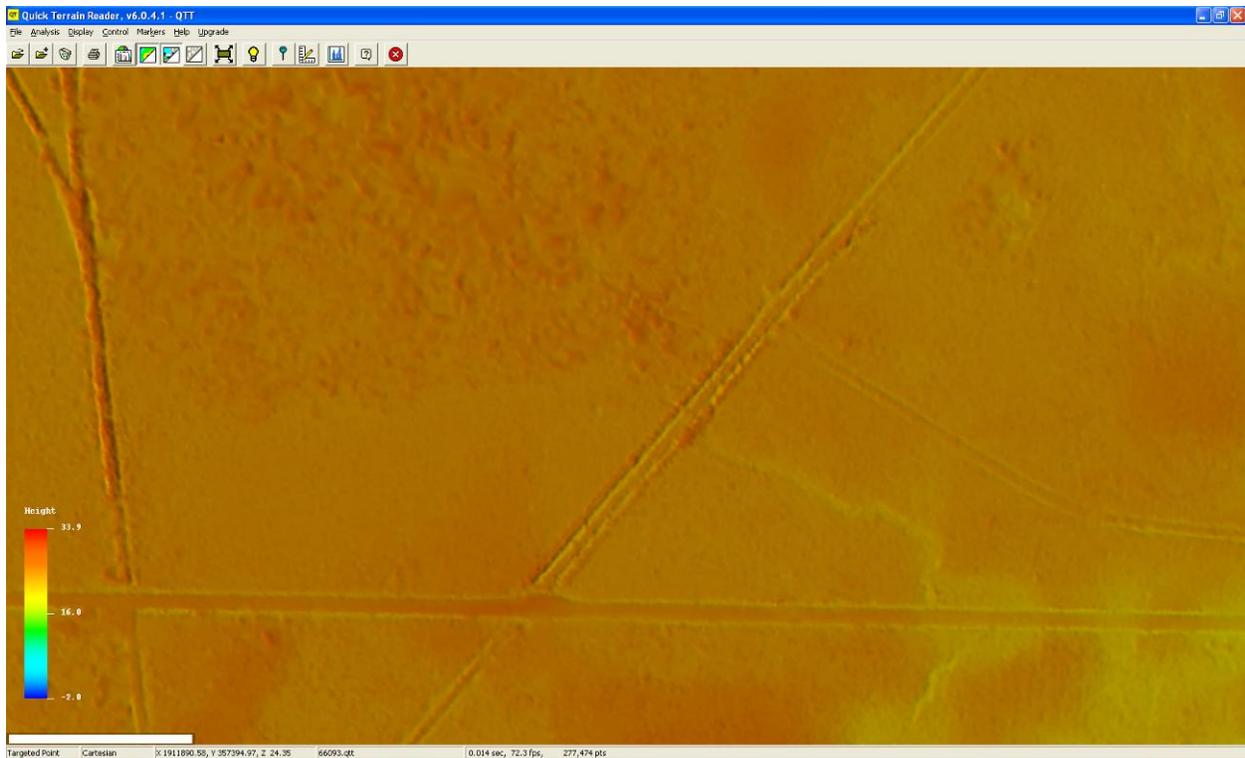
Figure 9 Tile 066093 - dense vegetation at road edge. Breaklines are necessary to define road edges for contour generation.

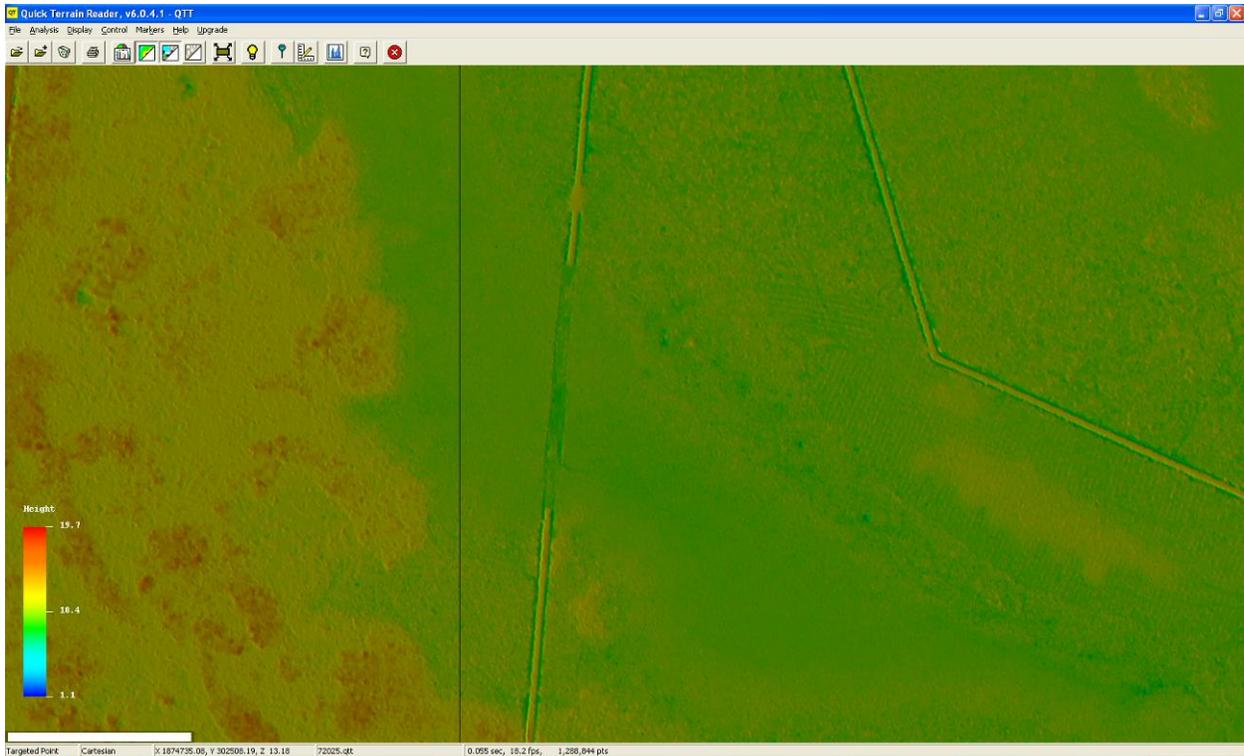
Figure 8 & 9 Tile 0072026 – There were some areas with standing water that affected some terrain features. Here is an example of water standing in the road.

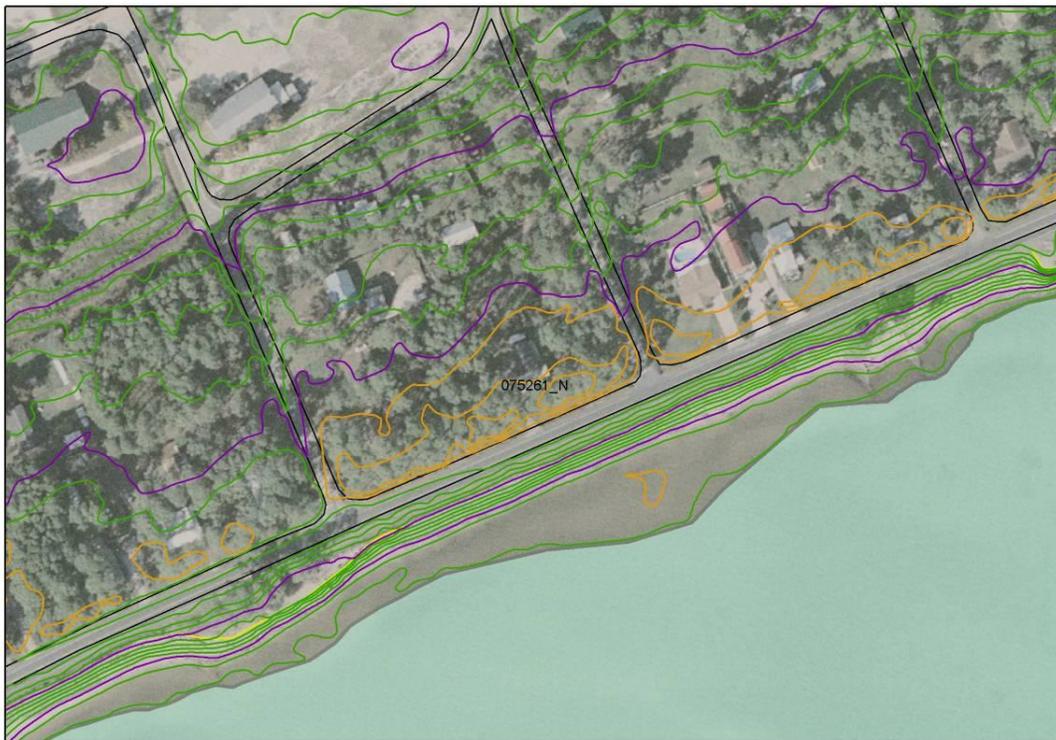
Coastal shorelines are correctly captured as two-dimensional polygon features, extracted from the LiDAR data and not from digital orthophotos, except for manmade features with varying heights such as seawalls which are captured as three-dimensional breaklines. Coastal breaklines merge seamlessly with linear hydrographic features. Shorelines continue beneath docks and piers. There is no “stair-stepping” of coastal shorelines. Figure 1 shows example coastal breaklines and contours.

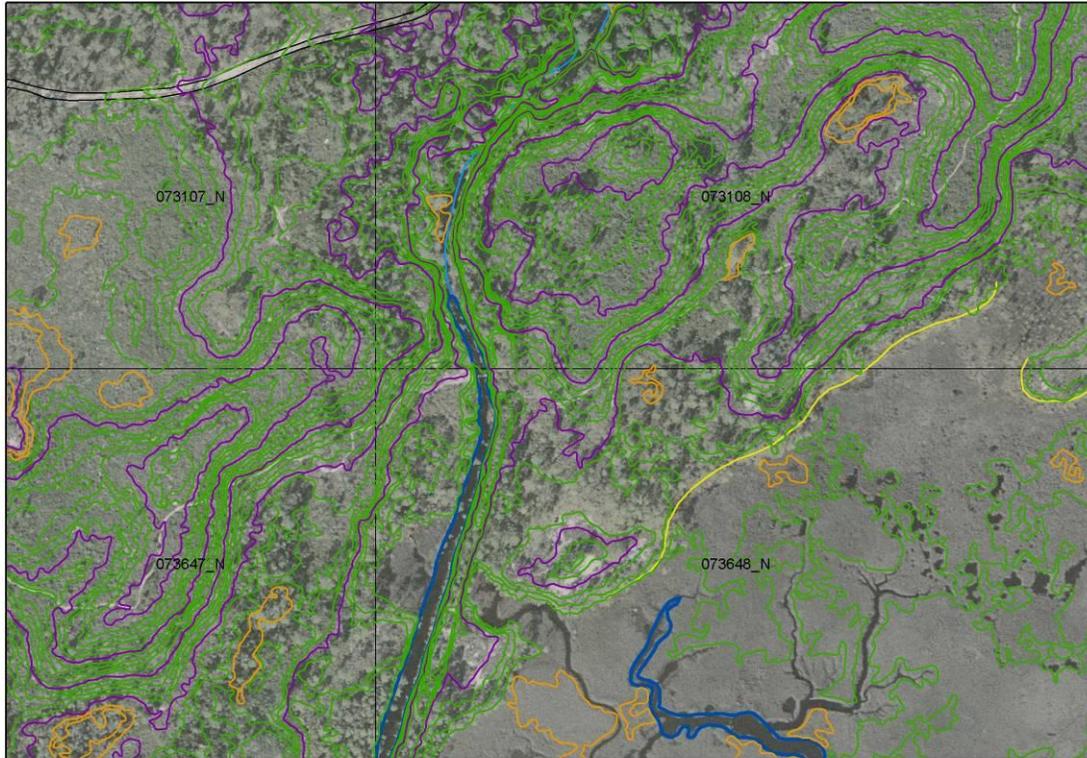
Linear hydrographic features are correctly captured as three-dimensional breaklines – single line features if the average width is 8 feet or less and dual line features if the average width is greater than 8 feet. Each vertex maintains vertical integrity. Figure 2 shows example breaklines and contours of linear hydrographic features.

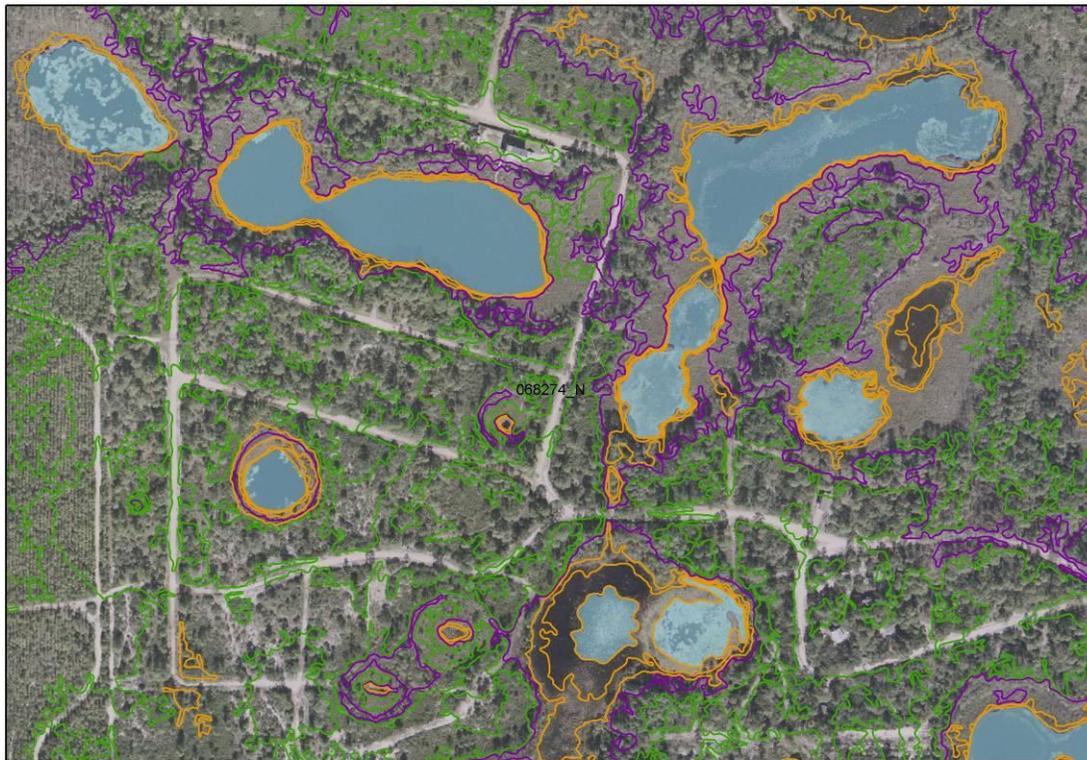
Closed water body features with an area of one-half acre or greater are correctly captured as two-dimensional closed polygons with a constant elevation that reflects the best estimate of the water elevation at the time of data capture. “Donuts” exist where there are islands within a closed water body feature. Figure 3 shows example breaklines and contours of closed water body features.
