FINAL REPORT OF SPECIFIC PURPOSE LIDAR SURVEY

LiDAR, Breaklines and Contours for Franklin County, Florida

State of Florida
Division of Emergency Management
Contract 07-HS-34-14-00-22-469
Task Order 20070525-492718a
PDS Task Order B

February 12, 2009

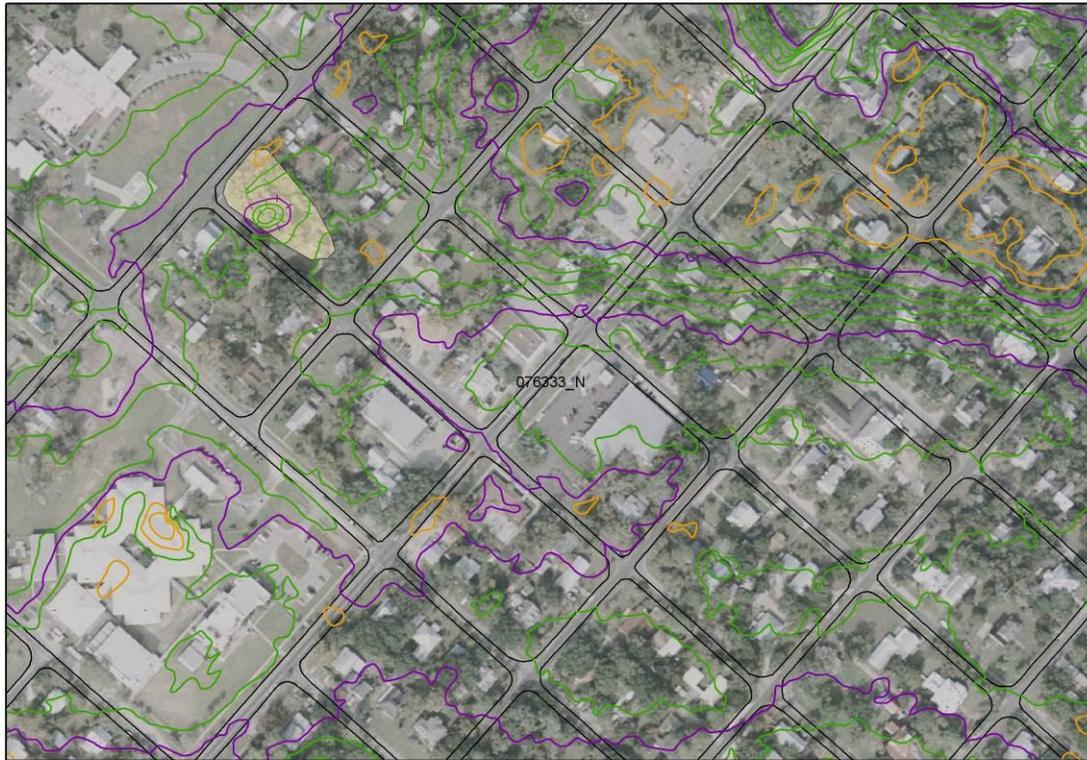
Road edge of pavement features are correctly captured as three-dimensional breaklines on both sides of paved roads. Box culverts are continued as edge of pavement unless a clear guardrail system is in place; in that case, culverts are captured as a bridge or overpass feature. Each vertex maintains vertical integrity. Figure 4 shows example breaklines and contours of road features.

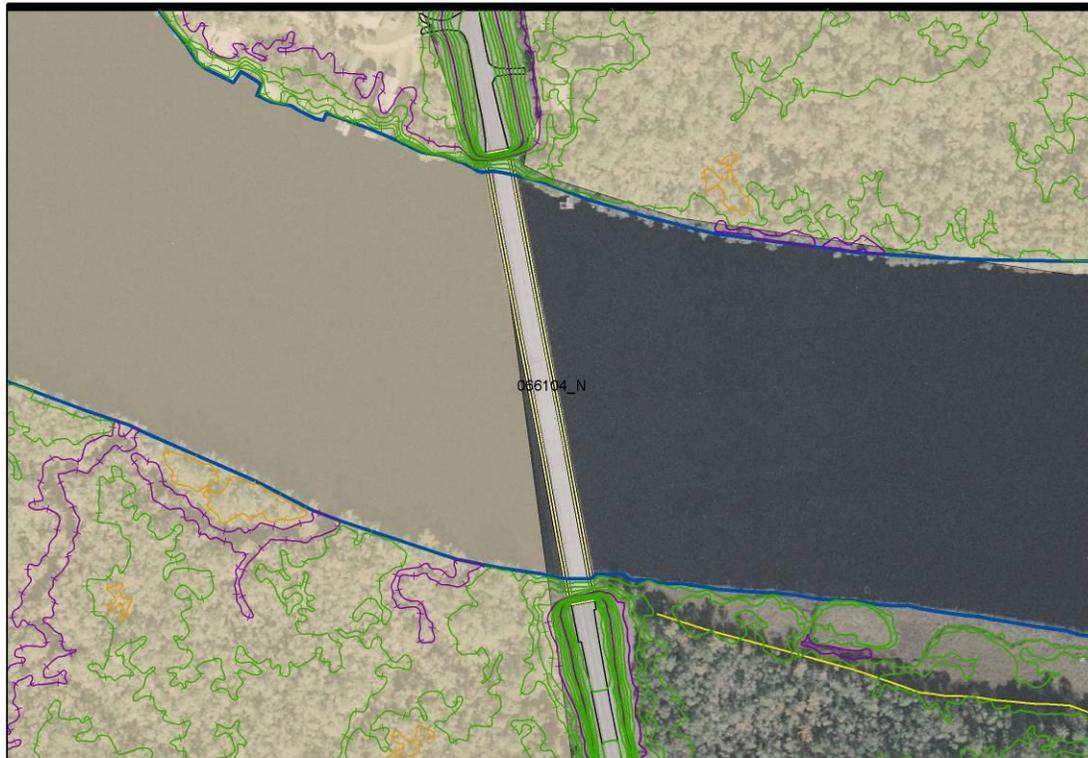
Bridges and overpasses are correctly captured as three-dimensional breaklines, capturing the edge of pavement on the bridge, rather than the elevation of guard rails or other bridge surfaces. Each vertex maintains vertical integrity. Figure 5 shows example breaklines and contours of bridge and overpass features.

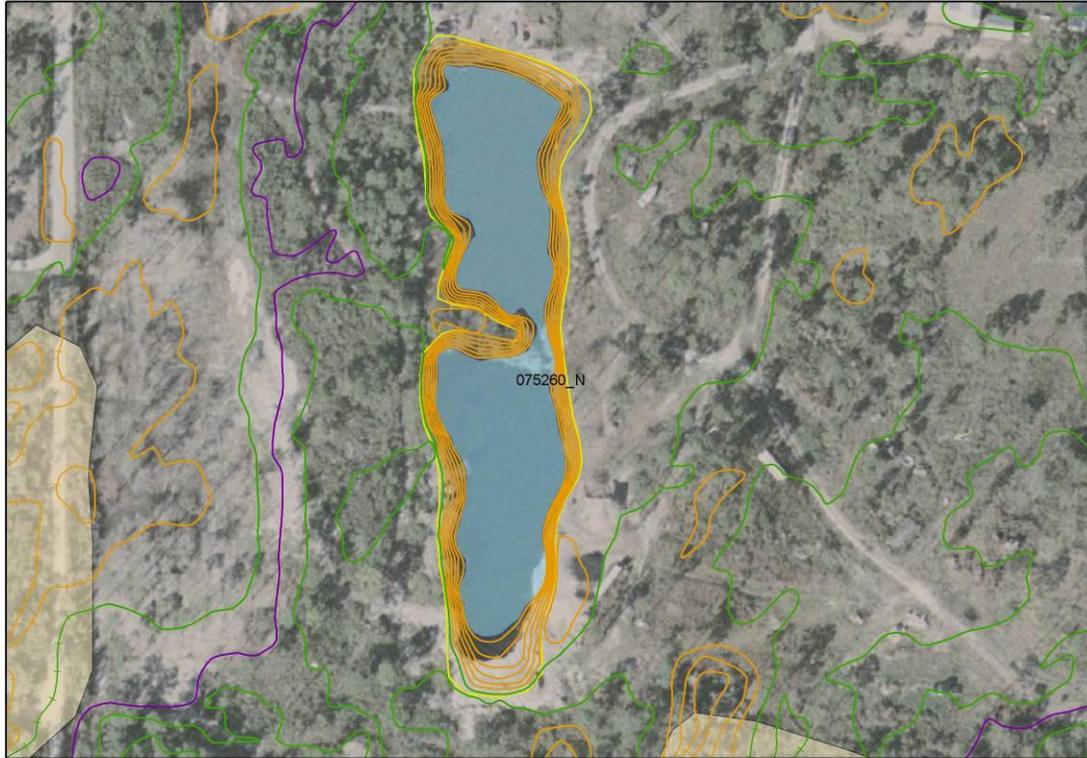
Soft features such as ridges, valleys, top of banks, etc. are correctly captured as three-dimensional breaklines so as to support better hydrological modeling of the LiDAR data and contours. Each vertex maintains vertical integrity. Figure 6 shows example breaklines and contours of soft features.

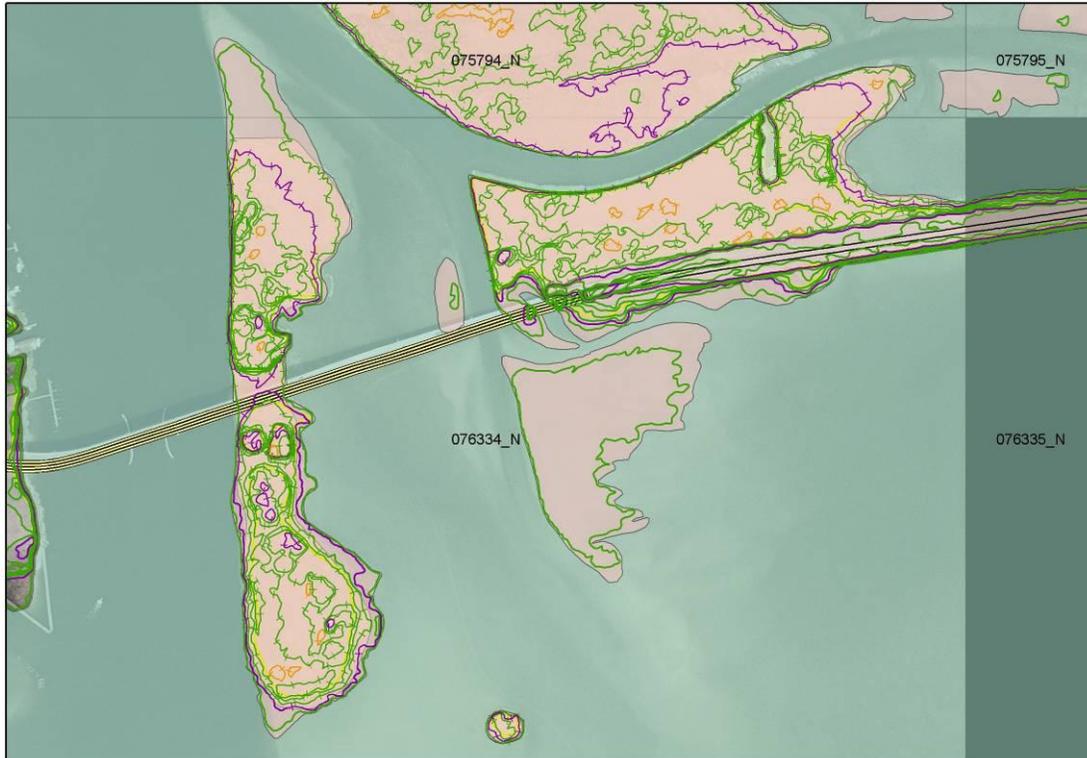
The shoreline of islands within water bodies are correctly captured as two-dimensional breaklines in coastal and/or tidally influenced areas and as three-dimensional breaklines in non-tidally influenced areas for island features one-half acre in size or greater. All natural and man-made islands are depicted as closed polygons with constant elevation. Figure 7 shows example breaklines and contours for island features.

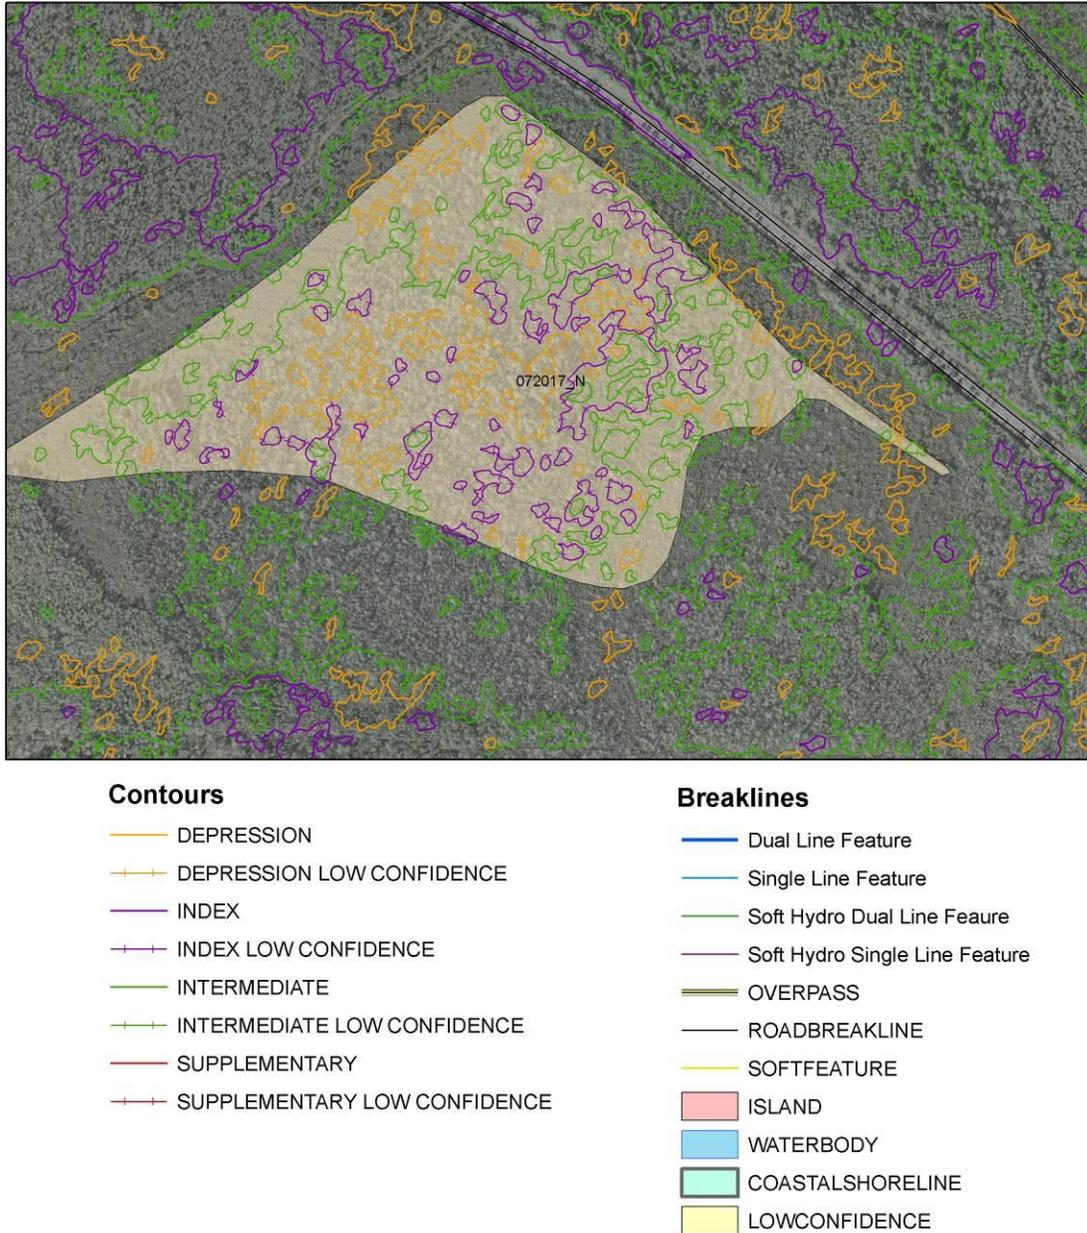
Figure 8. Example low confidence area feature breaklines and contours from tile # 72017

The apparent boundary of vegetated areas (1/2 acre or larger) that are considered obscured to the extent that adequate vertical data cannot be clearly determined to accurately define the DTM are correctly captured as two-dimensional features with no z-values. Figure 8 shows example breaklines and contours for low confidence areas.
