LiDAR QA/QC
- Quantitative and Qualitative Assessment Report -
Gloucester County
December 4, 2007

EXECUTIVE SUMMARY

This LiDAR project covered approximately 353 square miles for the entire county of Gloucester (New Jersey) in spring of 2007. The LiDAR data were acquired and processed by Terrapoint USA, as subcontractor to Leonard Jackson. The product is a mass point dataset with an average point spacing of 0.7m. The data is tiled, stored in LAS format, and LiDAR returns are classified in 4 ASPRS classes: non-ground (1), ground (2), noise (7) and water (9).

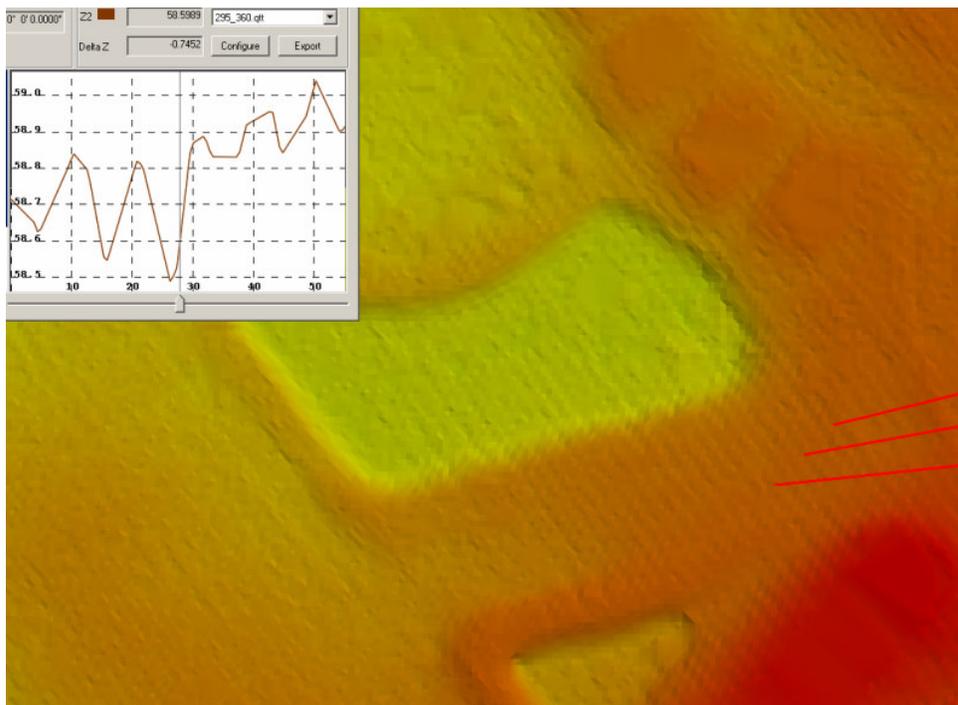
Cornrows were typically seen throughout the project. There are multiple reasons as to why this happens but the end result is that adjacent scan lines are slightly offset from each other. This will give the effect that there are alternating rows of higher and then lower elevations. Although this is common with LiDAR data, as long as the elevation differences are less than 20 cm and the occurrences are minimized, it is acceptable because it is within the noise and accuracy levels. However this also can be an indication that the sensor is mis-calibrated, or offsets exist between adjacent flight lines so each area identified is analyzed. Our review found several negligible instances of the cornrow effect however only two or three were significant (see for instance Figure 20) and the remainder of this effect was within acceptable limits.

Bare earth model colored by elevation

Figure 20 – tile 295_360. Cornrows under the acceptable limit (0.5feet)

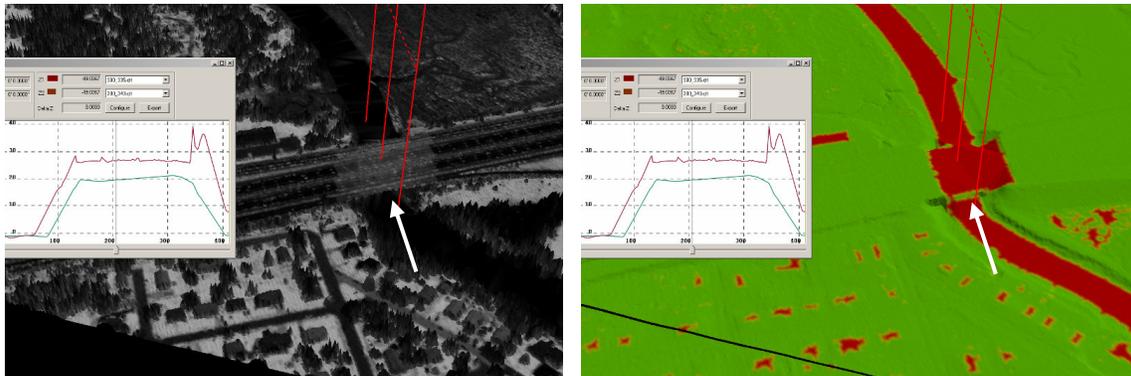
One minor issue for the bare-earth terrain is the classification of bridges.. Some users may require bridges to be removed (classified to non-ground) while others may require them classified as ground. For the user community if this is an issue this is easily remedied because it is clearly identifiable and the data can be reclassified. In this dataset, the majority of them are removed from the ground but some instances of bridges partially removed were found. *Figure 21* illustrates this case..

Full point cloud model colored by intensity

Bare earth model colored by density (red=no points)

Figure 21 – Tile 300_370: inconsistent Bridge editing. Bridges are sometimes removed, totally retained or sometimes portions of the bridge remain in the bare earth terrain.

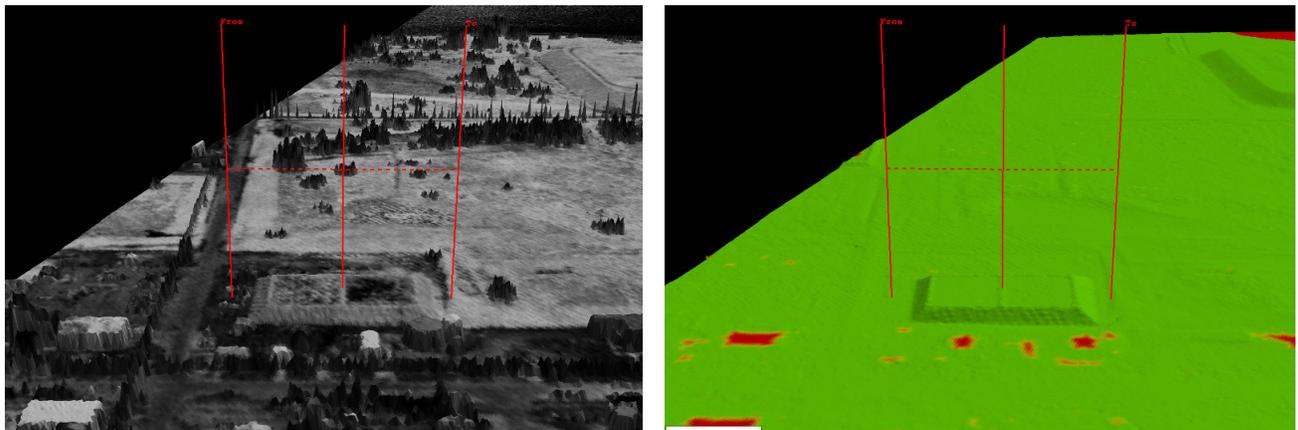
Due to the vast amounts of data and geographic phenomena, the classification algorithms can sometimes erroneously classify data. This misclassification results in artifacts which can be remnants of vegetation or manmade structures that do not represent the bare-earth terrain. *Figure 22* illustrates potential artifacts based on the visual inspections of the bare-earth terrain. None of these tiles have been ground-truthed and therefore are identified only as potential issues. Moreover, it is evident that these potential areas are relatively small and easily within the specification of being 95% cleaned of artifacts.

Surface model with intensity

Bare-earth model with density information (red = no data).

Figure 22 – Tile 240_350: possible human artifact in bare-earth model

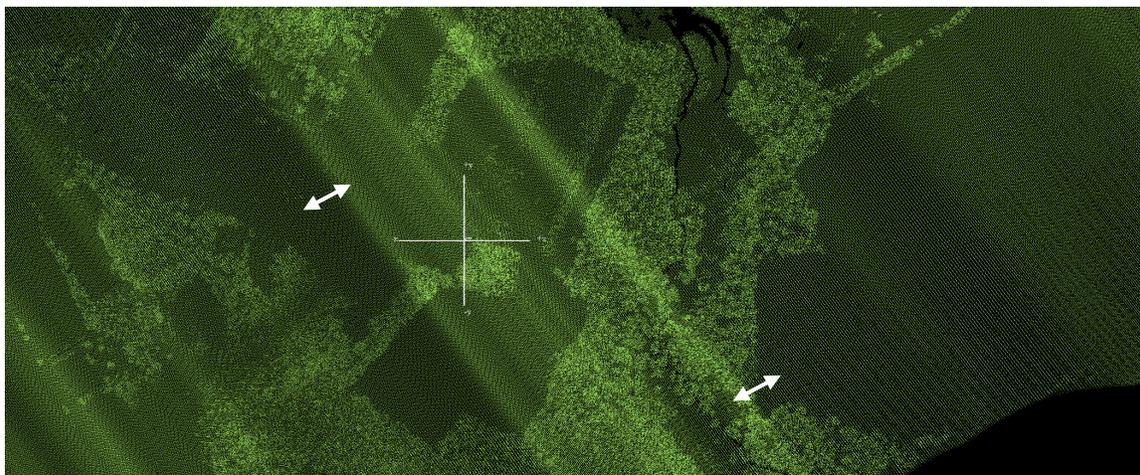
Sometimes scan pattern can vary along a flight line due to windy conditions or due to mirror acceleration. *Figure 24* shows a tile with large variations. Note however that the point spacing along the scan line conform to the requirements. This type of irregular scan is recurrent but does not compromise the integrity of this data.

Figure 24 - Tile 487500_4663500: Lidar points. Note the variation in point spacing between scans inside a same flightline.

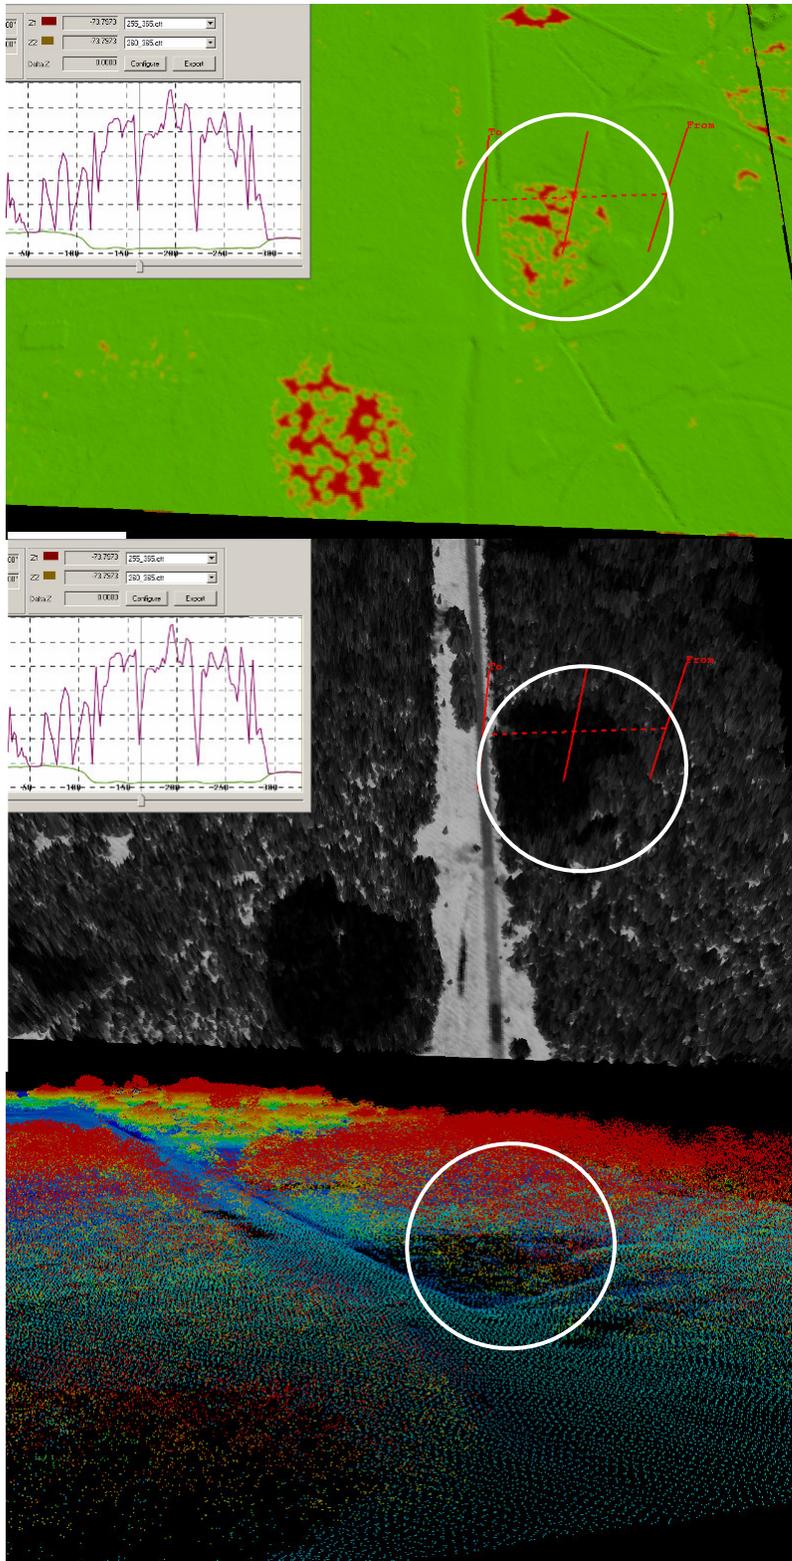
We did find some isolated spots of sparse density of points in the bare earth model with no apparent change in the vegetation density at these locations; however the intensity image is characterized by a darker tone. After carefully inspecting the full point cloud, which really shows presence of Lidar points inside the vegetation but very few at ground level and based on the dark coloration of the intensity images we assumed that these are swamp areas where the Lidar is not reflected by the wet ground surface. Indeed, except at angles close to nadir, the Near Infrared Lidar beam is usually not reflected by water.

Bare-earth (class 2) model with density information (red = no points),

Surface model with intensity (all classes

Full point cloud colored by elevation

Figure 25 – Poor LiDAR reflection in swamp area, the cross section and the full point cloud show the presence of vegetation but the Lidar do not seem to be reflected by the underlying surface.

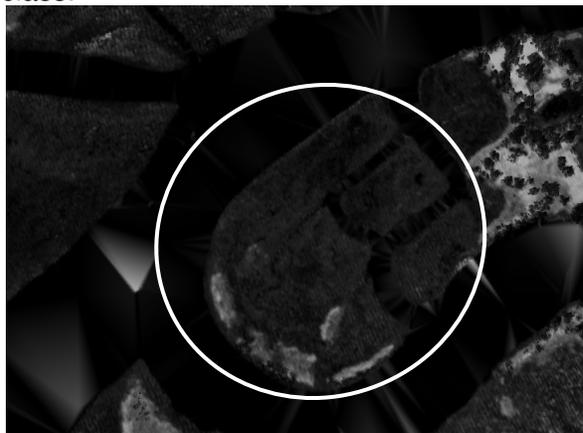
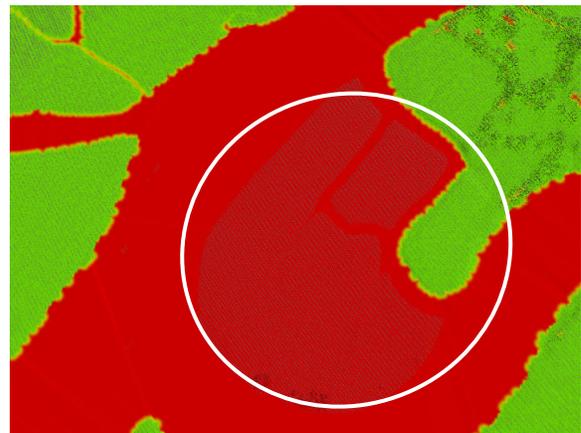
In addition, users should be aware that the contract for acquisition and processing identified only two classes: Class “1” for unclassified and Class “2” for ground. However Terrapoint did classify water points in a separate category using breaklines developed with the intensity images. Globally the classification of water was satisfactory. We found few instances of ground points wrongly classified as water, mainly islands or sand bars (see example in *Figure 26*). In addition, some sections of water bodies remained in the ground class, most of the time they were portions of rivers looking like salt and pepper noise in the intensity image as illustrated in *Figure 27*.

Surface model with intensity (all classes)

Bare-earth (class 2) model with density information (red = no points), with full point cloud as overlay

Figure 26 – Islands classified as water (tile 250_350)

Once again, as the classification of water was not required in the scope of work, this is not something we consider as an issue, the end user should just be aware that further processing may be needed to completely remove the water points from the ground class.

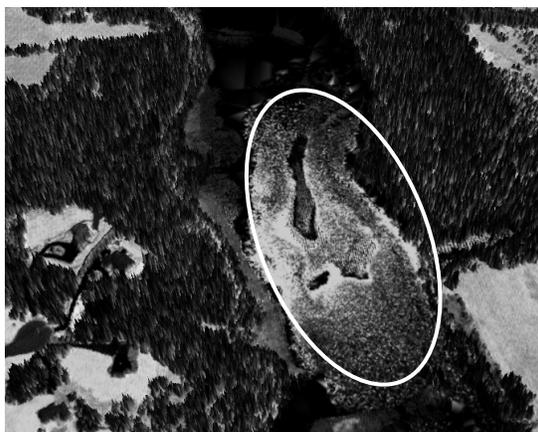
Surface model with intensity (all classes)

Bare-earth model with density information (red = no points), class 2

Figure 27 – Tile 295_350, river section with bright reflections remains in the ground class

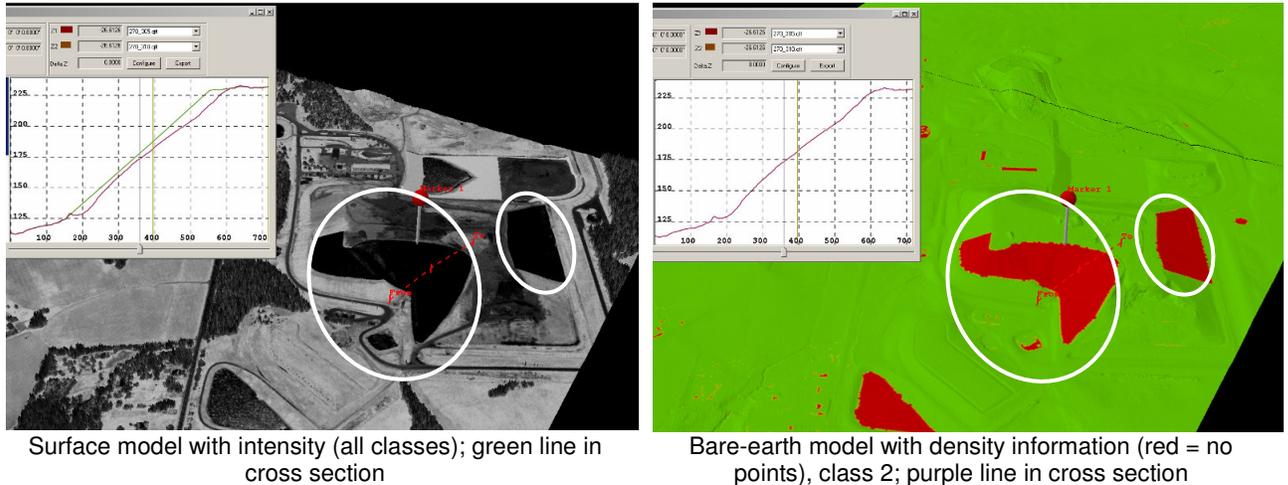
Finally, one occurrence of misclassification of ground was encountered in the data (see *Figure 28*). Two large slope sections of this mine heap are removed from the ground class leaving gaps in the bare earth surface, however the summit of the hill is still there leaving the general surface profile fairly unaffected. Therefore, we do not consider this as a critical issue but users of this data in this area may need to reclassify to suit their intended need and use.

Figure 28 – Tile 270_315 misclassification of ground
