Oregon Department of Geology & Mineral Industries  
800 NE Oregon St, Suite 965  
Portland, OR 97232

# Upper Umpqua 3DEP Lidar Project Lidar QC Report – February 15, 2017

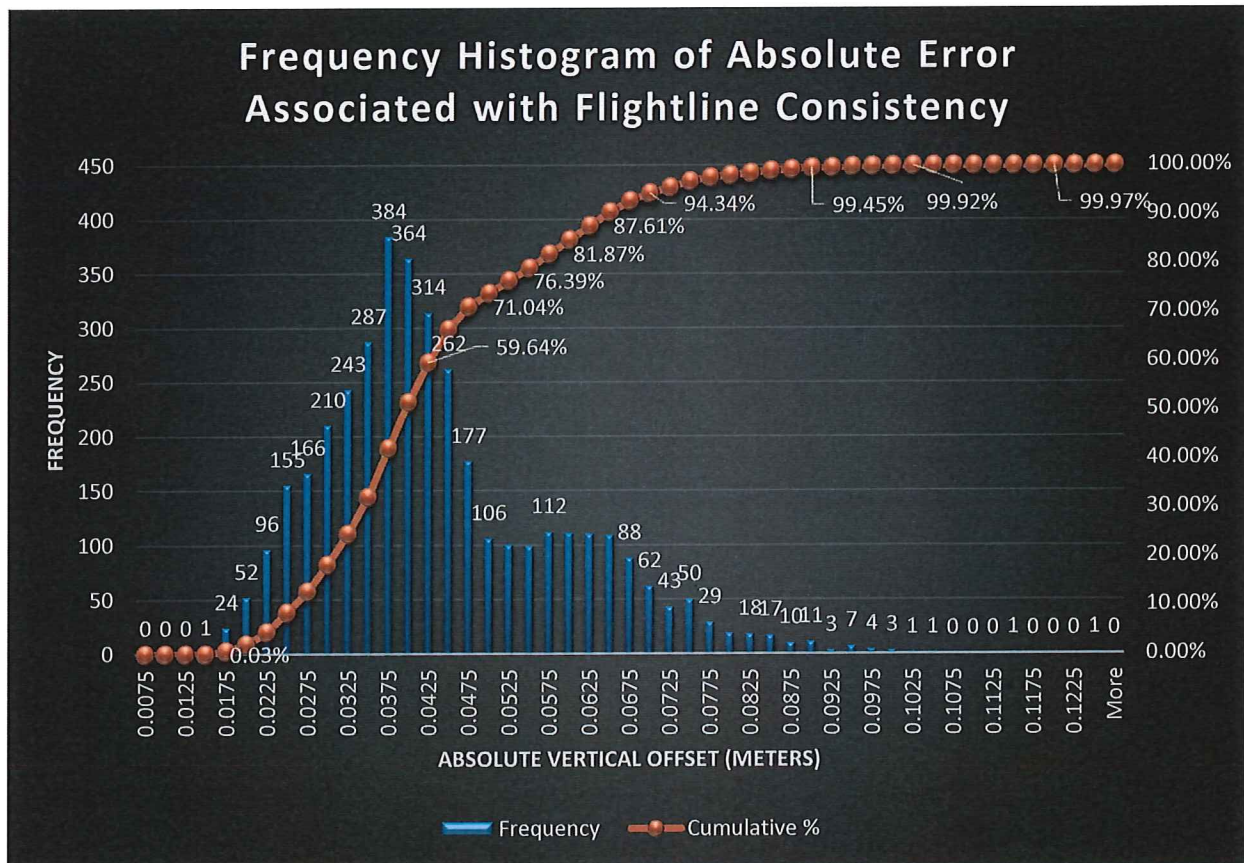
Results of the consistency analysis found the average flight line offset to be 0.04 meters (0.14 feet) with a maximum error of 0.12 meters (0.40 feet) (Table 8b). Distribution of error showed 98% of all error was less than 0.08 meters (0.26 feet) and 100% less than 0.12 meters (0.39 feet) (Figure 4 and 5). These results show that all data are within specification.

**Figure 4. Flight line Consistency Histogram in meters**

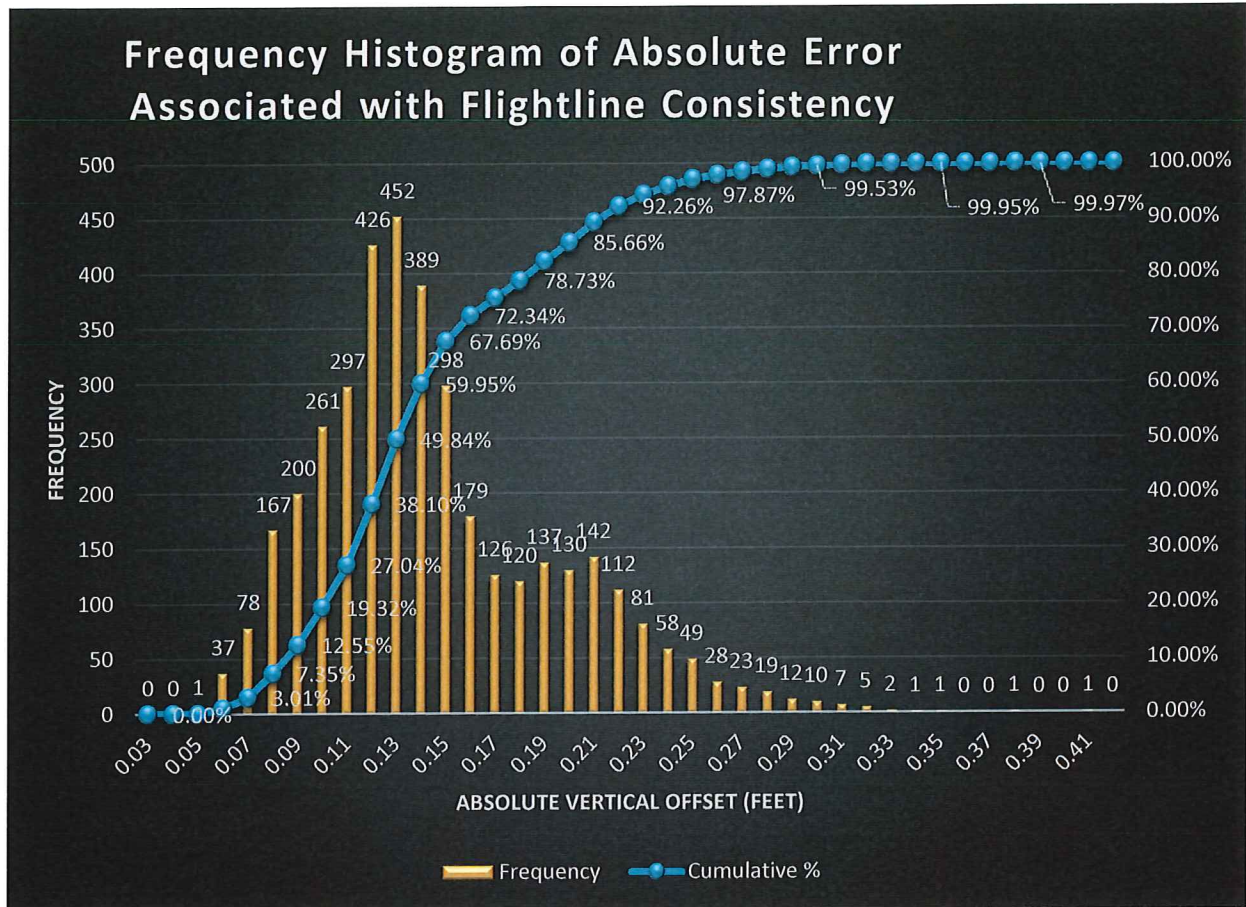
Figure 5. Flight line Consistency Histogram in feet

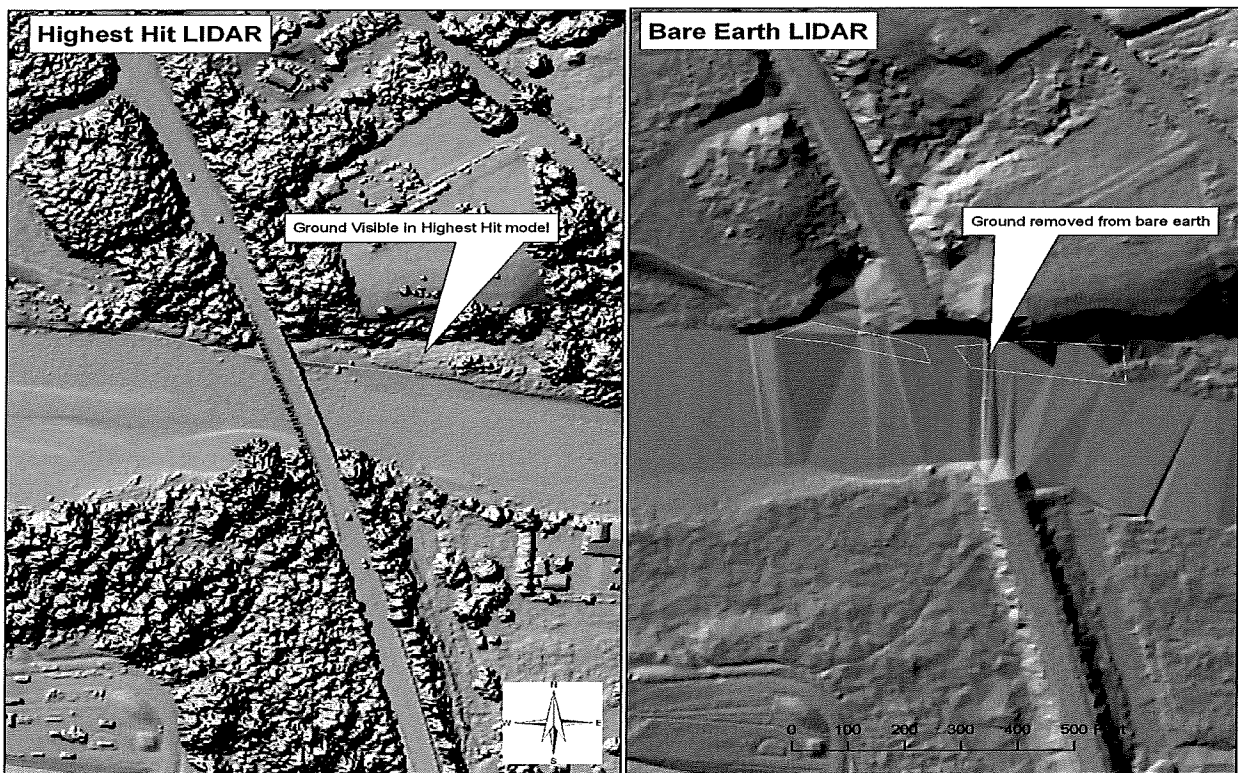
Lidar 3ft grids were loaded into ArcGIS™ software for visual analysis. Data were examined through slope and hillshade models of bare-earth returns. Hillshades of the highest hit models were used to identify areas of missing ground (Figure 6). Both bare-earth and highest hit rasters were examined for calibration offsets, tiling artifacts (Figure 7), seam line offsets, pits (Figure 8), and birds.

**Figure 6. Example of missing ground in lidar bare earth data. Ground is clearly visible in highest hit model, but has been removed from the bare earth model. This type of classification error is common near water body features**

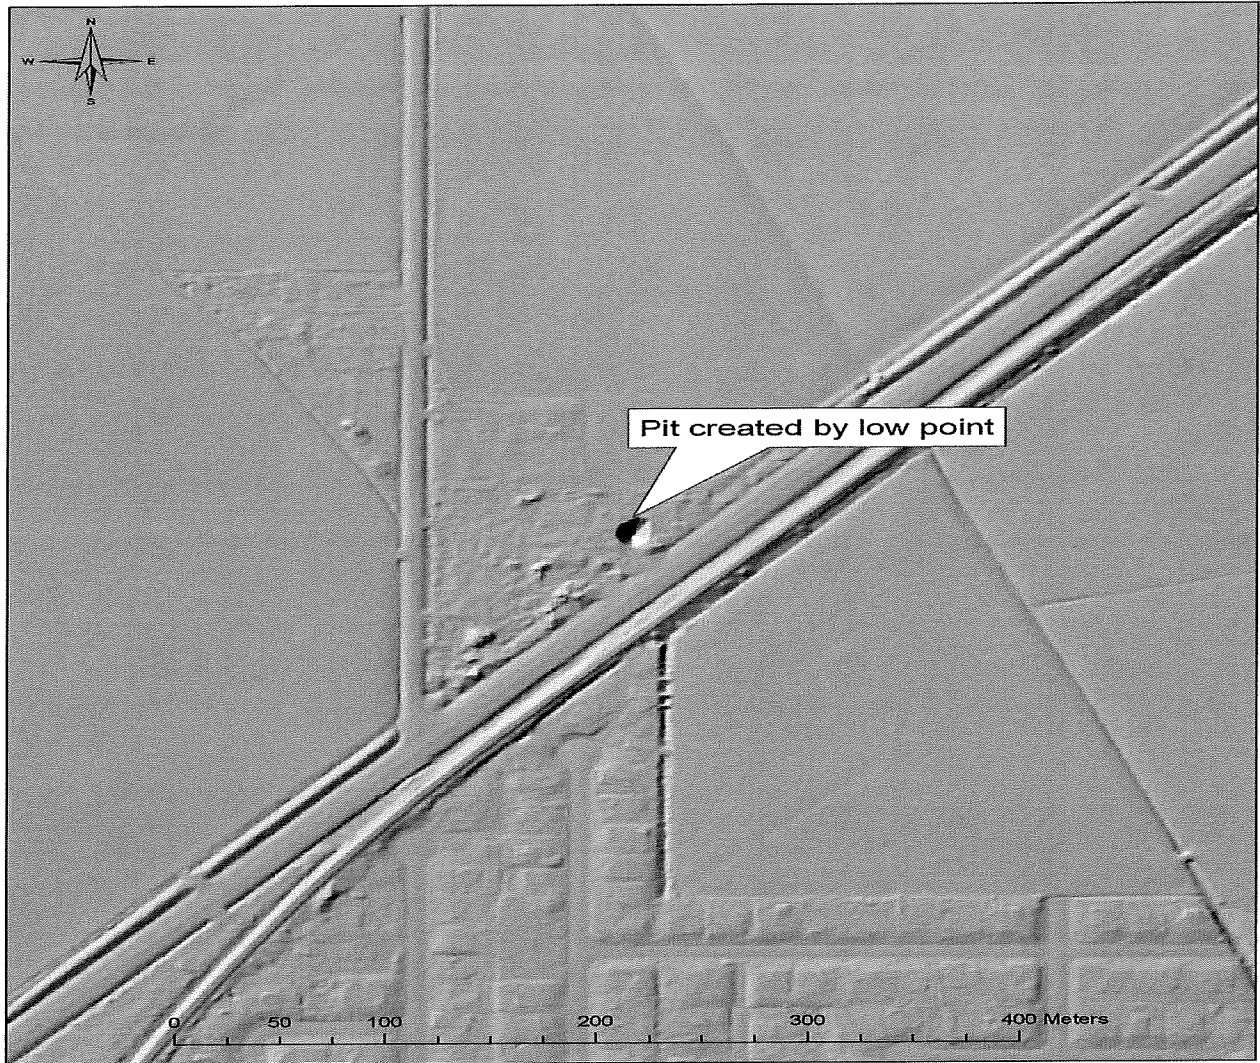
the laser comes in contact with water on the ground (Figure 8). Birds (high points) typically occur where the laser comes into contact with atmospheric<sup>1</sup>.

**Figure 8. Example of “Pit” caused by low point in ground model. Pits are caused when standing water absorbs the lidar pulse. Pits are evident in ground model as the lowest point elevation is assigned to the grid cell value. Inversely the pit is not observable in the highest hit model as the highest point elevation is assigned to the grid value.**

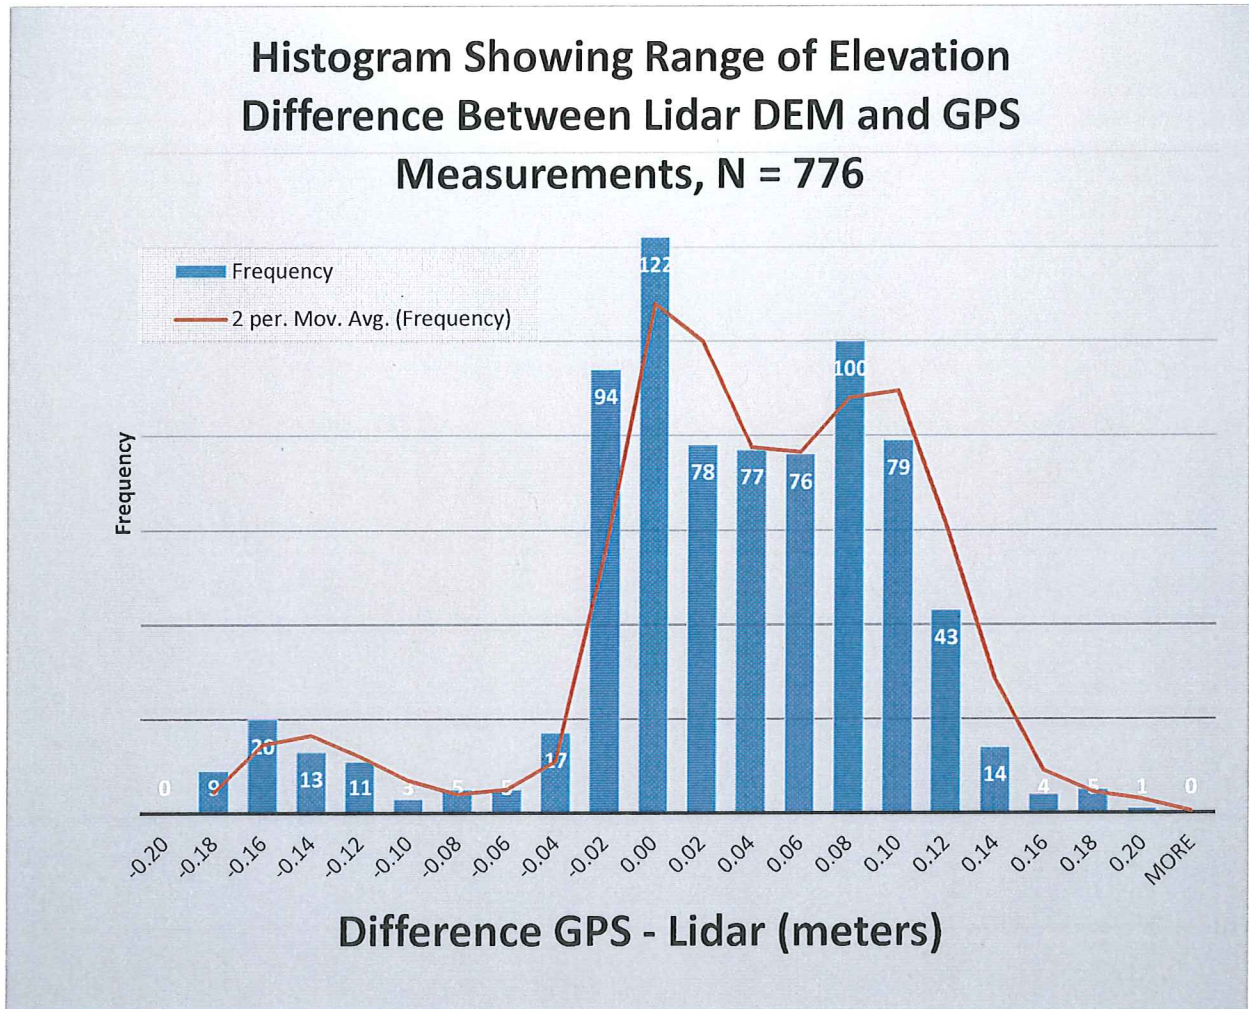
A total of 776 measured NVA check points were obtained in the Upper Umpqua 3DEP project area and were compared with the lidar elevation grids (Figure 12). The data delivered to DOGAMI was found to have a mean vertical offset of 0.02 meters (0.06 feet) and an RMSE value of 0.07 meters (0.23 feet). Offset values ranged from -0.18 meters (-0.62 feet) to 0.18 meters (0.59 feet) (Table 10 and Figure 13 and 14).

**Figure 12. Histogram of absolute vertical accuracy in meters.**

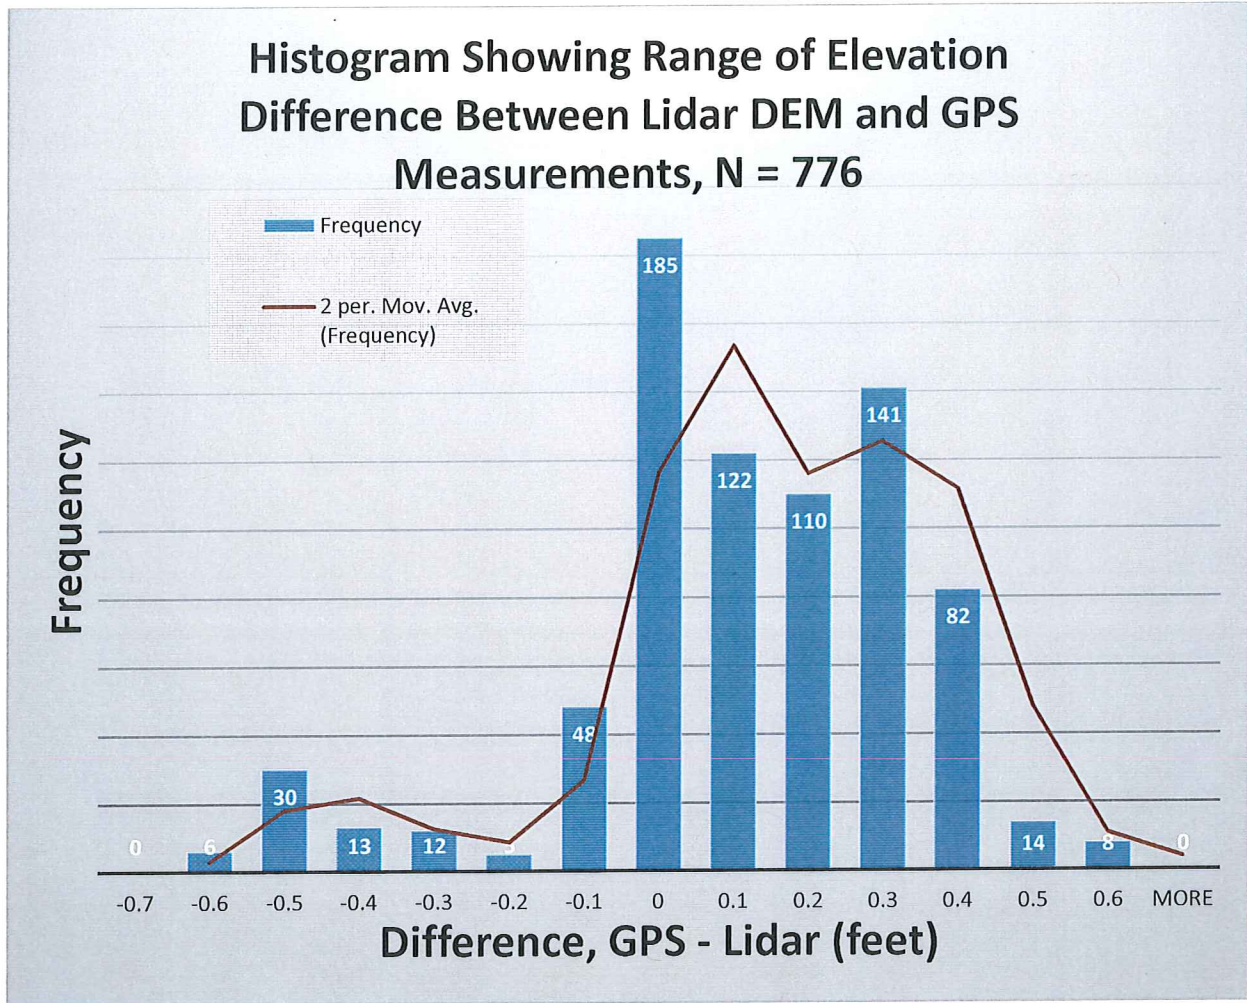
Figure 13. Histogram of absolute vertical accuracy in feet.

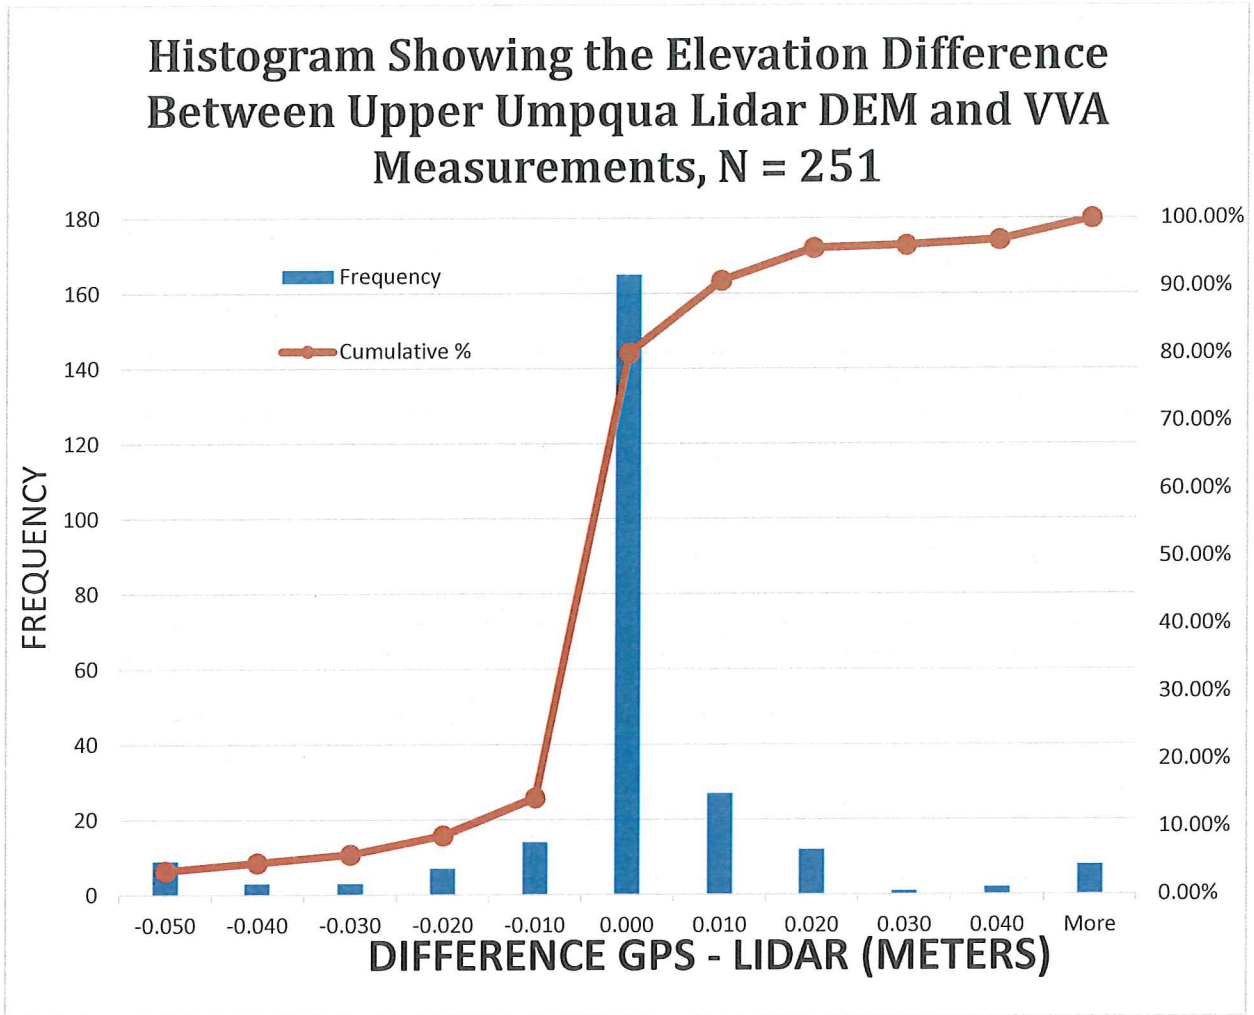
A total of 251 VVA check points were obtained in the Upper Umpqua 3DEP project area and were compared with the lidar elevation grids. The data delivered to DOGAMI was found to have a mean vertical offset of 0.003 meters (0.009 feet) and an RMSE value of 0.008 meters (0.029 feet). Offset values ranged from -0.05 meters (-0.16 feet) to 0.03 meters (0.10 feet) (Table 11 and Figure 16 and 17). VVA is evaluated at the 95<sup>th</sup> percentile.

Figure 15. Histogram of VVA in meters.

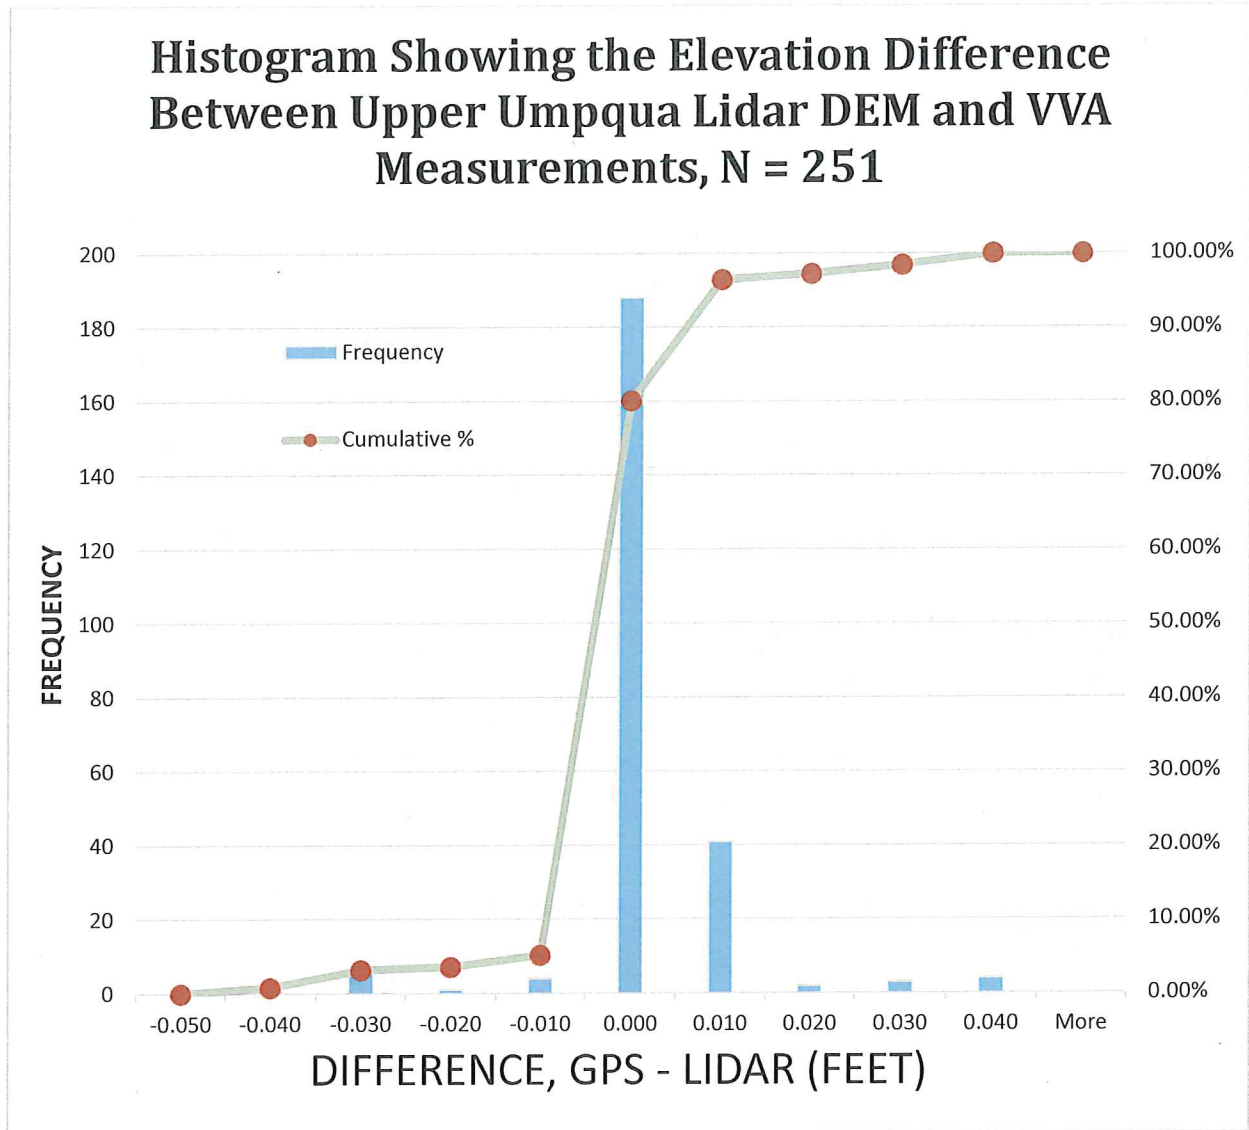
Figure 16. Histogram of VVA in feet.

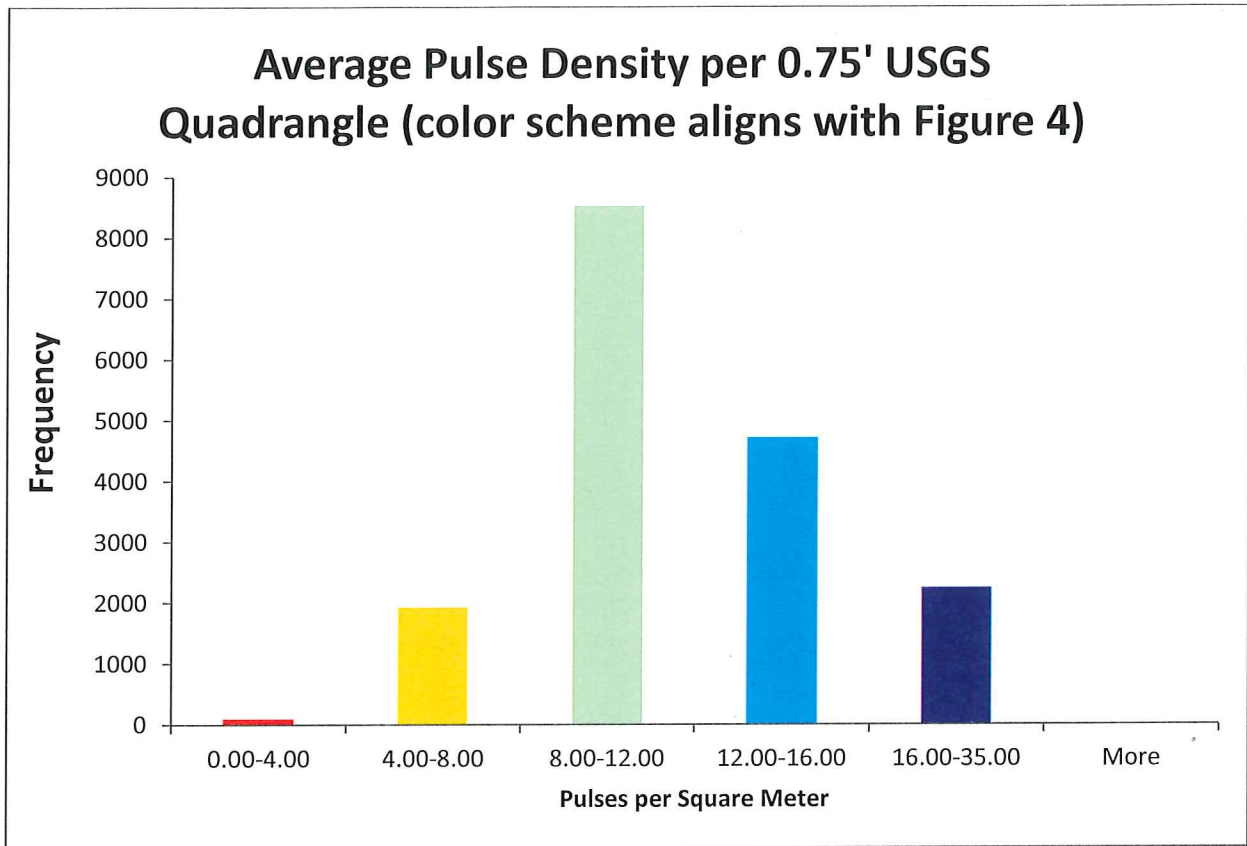
To quantify pulse density of Upper Umpqua 3DEP, 17,511 all-return LAS files (100%) were parsed into first-return point files and compared to their data extents. Results of the pulse density analysis found the average pulse density to be 11.88 pulses per m<sup>2</sup> (Table 12). Certain types of surfaces (dense vegetation, water) may return fewer pulses than the laser originally emitted; therefore density values can vary according to terrain and land cover. Pulse densities for Upper Umpqua 3DEP LAS tiles ranged from 1.35 pulses per m<sup>2</sup> to 34.82 pulses per m<sup>2</sup>(Figure 17). 15,487 LAS tiles out of 17,511 (88%) have a pulse density of  $\geq 8.00$  pulses per m<sup>2</sup> (Figure 18). These results show that all data are within tolerances of pulse density according to the contract agreement.

Figure 18. Histogram of Average Pulse Densities for Upper Umpqua 3DEP.
