# LIDAR QUALITY ASSURANCE AND QUALITY CONTROL REPORT FOR INLAND OKALOOSA COUNTY, FLORIDA

NATIONAL OCEANIC AND ATMOSPHERIC ADMINISTRATION (NOAA)  
COASTAL SERVICES CENTER

September 2008

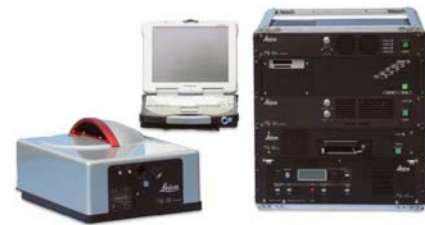
For this project, Fugro EarthData used the **Leica ALS50-II MPiA** (Multiple Pulse in the Air) laser scanning measurement system. The ALS50-II MPiA System is capable of recording three range points, and three intensity values for each emitted laser pulse. The ALS50-II MPiA is a state-of-the-art LIDAR sensor with the following operational specifications:

- ✈ Variable field of view from 10° to 75° (Field of view and altitude combination allow variable swath widths)
- ✈ Up-to 150 kHz laser pulse rate
- ✈ Altitude capability of 200 metres to 6000 metres AGL (above ground level)

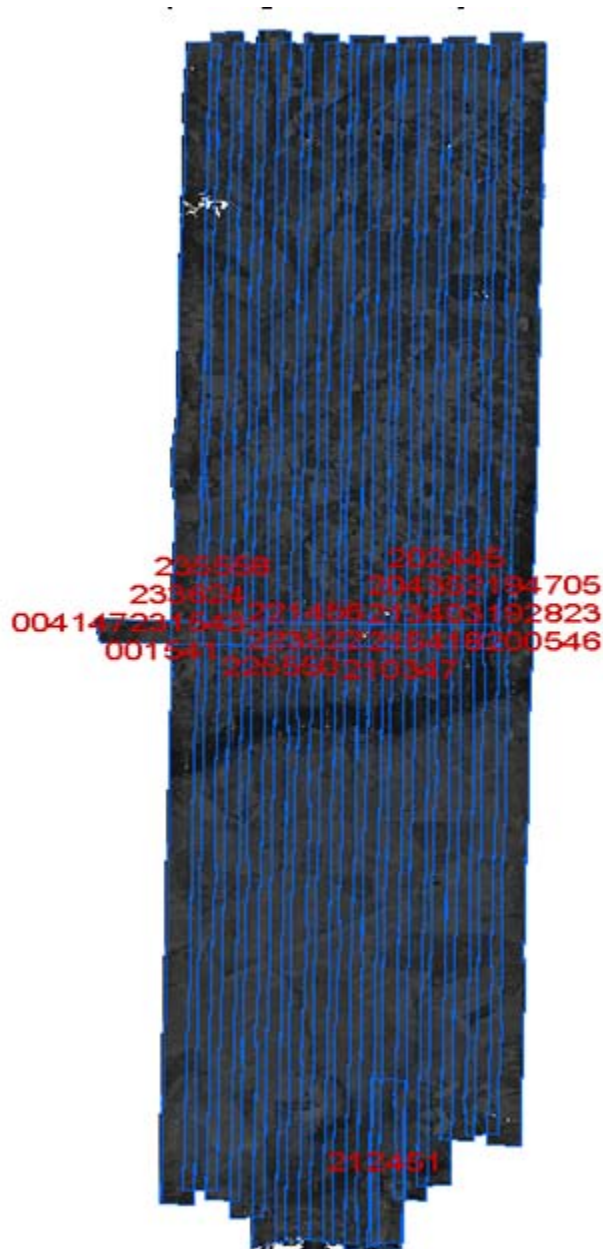
## Lift 2

Lift 2 was collected on Feb. 10, 2008. The LIDAR data was reviewed by Fugro EarthData for coverage and gross anomalies.
