New York State Airborne LIDAR

Final Review Report

Southwest 17 - Spring Quality Level 2 LIDAR Project

3DEP Project G17AC00096

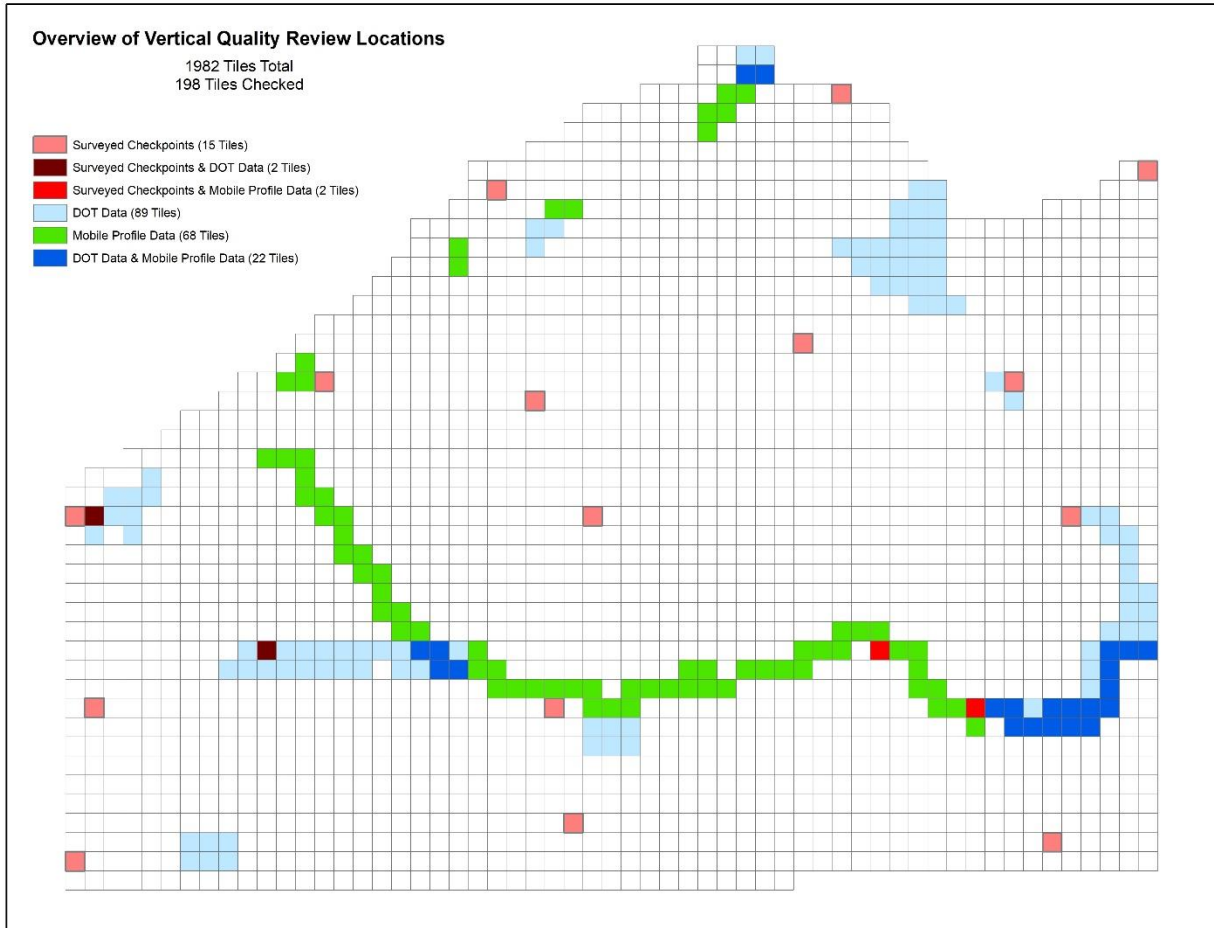
This project succeeded in producing high quality LIDAR point cloud data and bare earth DEMs. Final products were judged to meet 3DEP specifications. As stated earlier in this report, many of the review steps included all tiles. Given the specific locations of the check data for quantitative vertical review, the following graphic provides an overview showing good distribution of these checks.
