TX1803-TB-C, Hurricane Harvey Post Storm Topography/Bathymetry Project Final Report of Survey

Produced for the National Oceanic and Atmospheric Administration, National Geodetic Survey

Task Order: TX1803-TB-C, Hurricane Harvey Post Storm Topography/Bathymetry Lidar Project

December 31, 2019

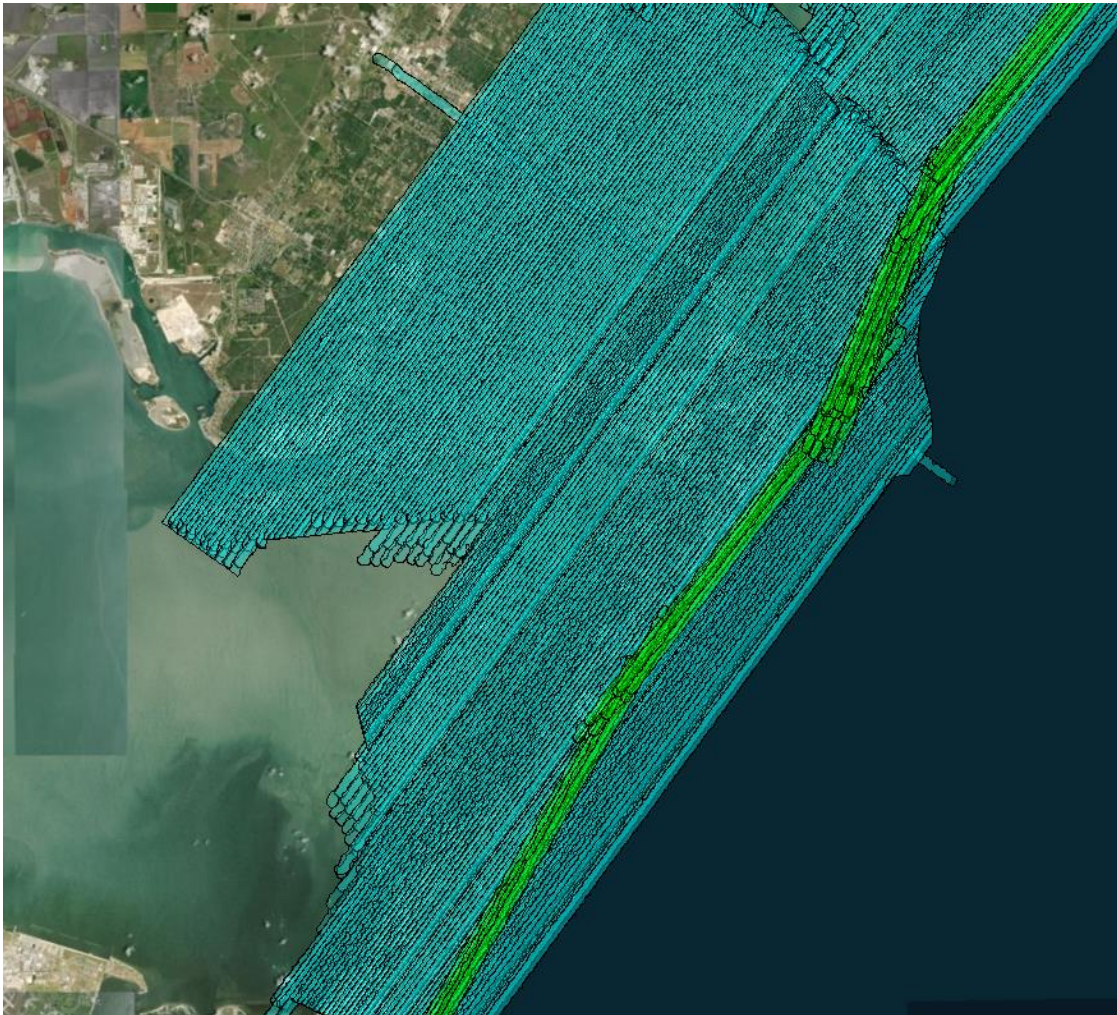
Figure 3 – Sample lidar swath output showing complete coverage of selected area.

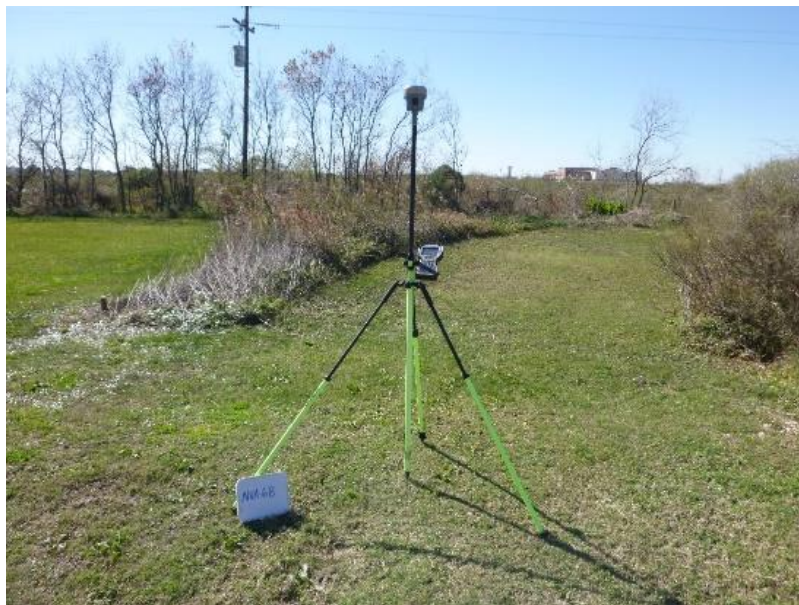
Figure 21 – NVA-68 is located under a vehicle. This checkpoint was removed from all vertical accuracy calculations.

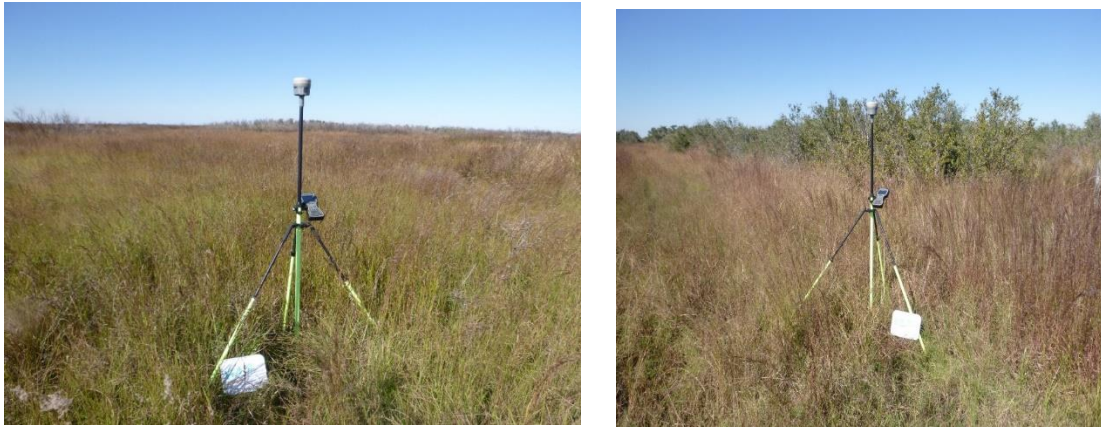
Figure 22 – VVA-9 (left) and VVA-10 (right). These checkpoints were outside of the lidar swath coverage for the AOI. Accuracy could not be assessed. These checkpoints were removed from all vertical accuracy calculations.

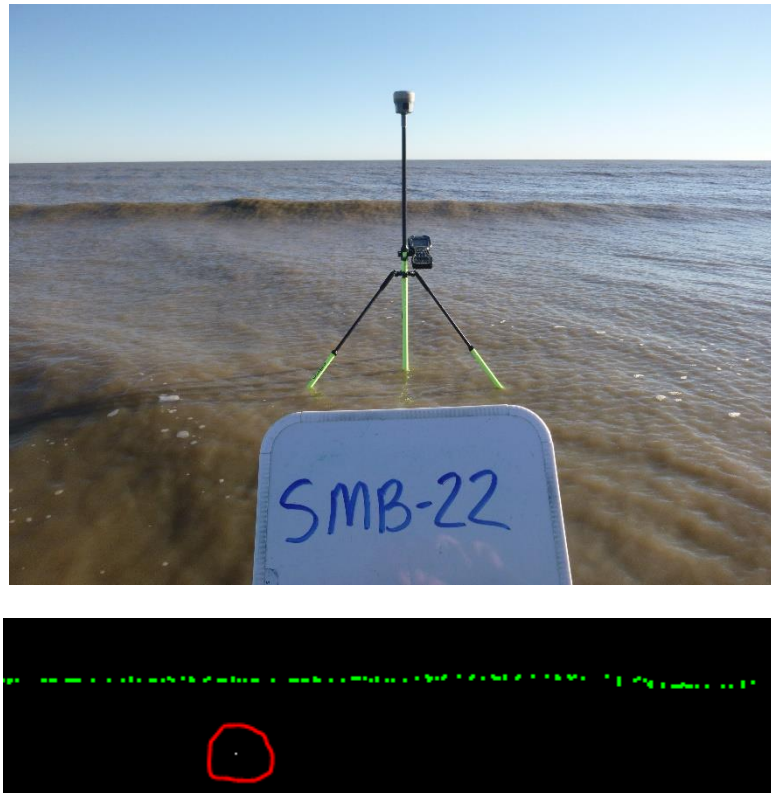
Figure 25 – SMB- 22 circled in red. This checkpoint was affected by temporal between the date of survey and data acquisition. Accuracy could not be assessed. This checkpoint was removed from all vertical accuracy calculations.
