**Acquisition of Underwater LiDAR Data Sample**

**RH20-018**

### **Great Lakes Observing System**

**Surveys Completed: 16-18 November 2020**

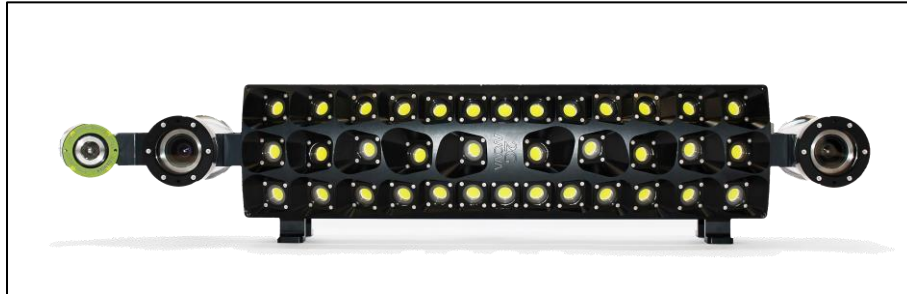
2G Robotics made a version of their ULS-500 available for this project (Figure 1). The unit is a large assembly consisting of a blue laser line projector and a receiving Dalsa HD ethernet camera angled to track the line. In addition, the model provided had a second camera and a LED lighting array for bottom imagery.

Figure 1: ULS-500 Micro Laser Scanner from 2G

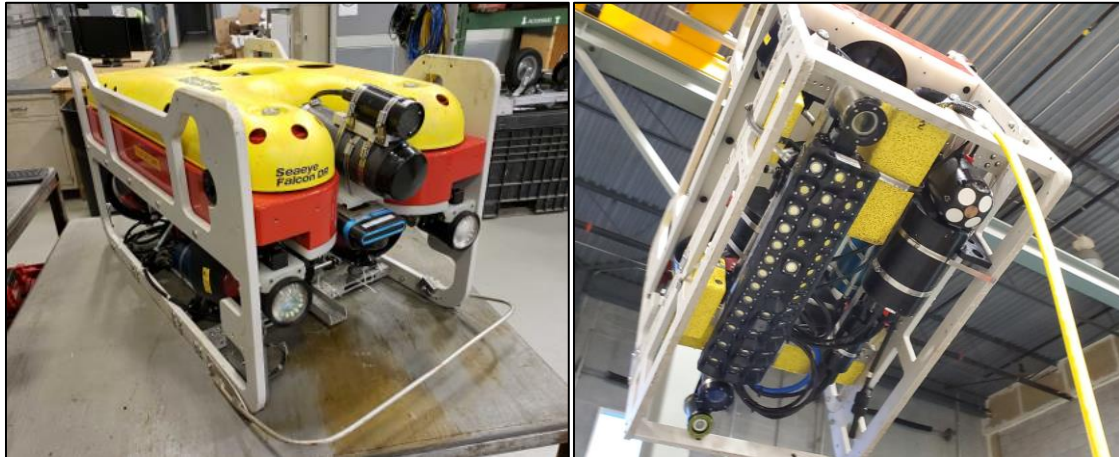
ASI chose the Seaeye Falcon DR ROV to conduct this inspection based on its capabilities and size. The ROV uses five electric thrusters to propel itself through the water; four horizontal vectored thrusters for forward, reverse, and lateral travel, with one vertical thruster to move the ROV vertically through the water column. The vehicle was equipped with two variable intensity 2520 lumen LED lights to illuminate the area of inspection for the high-resolution colour video camera.

Figure 4: Seaeye Falcon DR ROV (left) and underside equipped with ULS-500 and INS (right)

The system utilized a neutrally buoyant, highly visible umbilical 300 m (990 ft) in length. The umbilical housed both signal and power conductors (fiber optic and copper respectively), along with a Kevlar strength member in a protective jacket. The umbilical was neutrally buoyant in fresh water to reduce the drag and allow for enhanced vehicle handling. The ROV pilot controlled the vehicle's movement, lighting, camera position and tooling from the surface by the use of a hand-held control console.

After integrating the laser unit and INS, the vehicle was ballasted to be neutrally buoyant in fresh water.

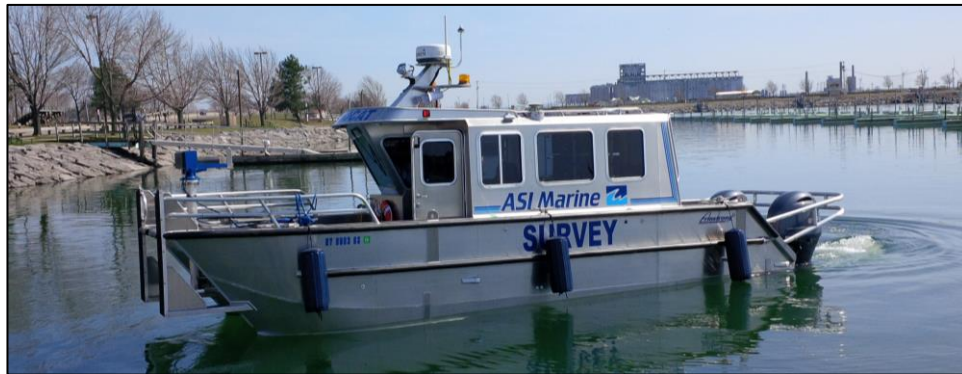
ASI used its dedicated survey vessel, the ASI Echocat, to complete all the survey field work (Figure 6). The Echocat is a custom-built Armstrong Marine aluminum catamaran survey vessel. The vessel is 7.9 m long, powered with twin Yamaha 150HP outboard engines, and equipped with a fully enclosed, climate-controlled cabin.

Figure 6: ASI Echocat survey vessel

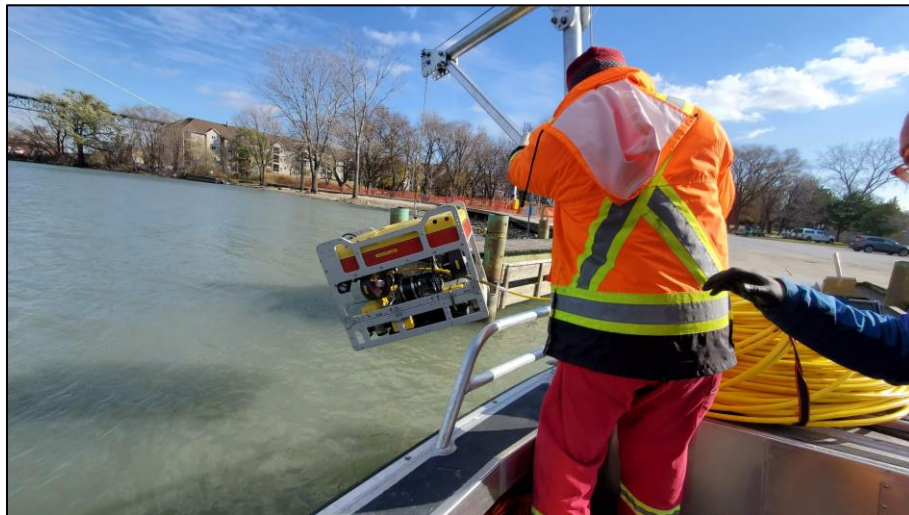
Figure 8: Launching the Falcon ROV with the ULS off the side of the vessel.
