Puerto Rico and US Virgin Islands Topobathy Final Report of Survey

Produced for National Oceanic and Atmospheric
Administration, Office for Coastal Management

Task Order: Topographic/Bathymetric Data Acquisition on Puerto Rico and the US Virgin
Islands

February 24, 2020

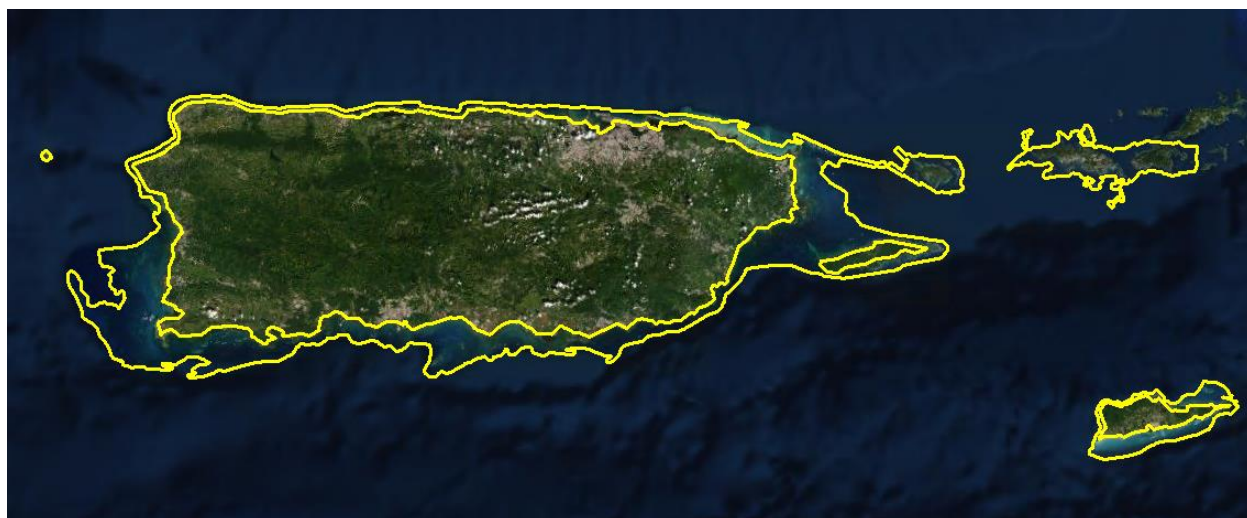
Figure 1 – The Puerto Rico and US Virgin Islands Topobathy collection area outlined in yellow.

The project area addressed by this report covers the coastlines of the commonwealth of Puerto Rico and the US Virgin Islands (figure 1). The total size of the project is approximately 1400 square miles.

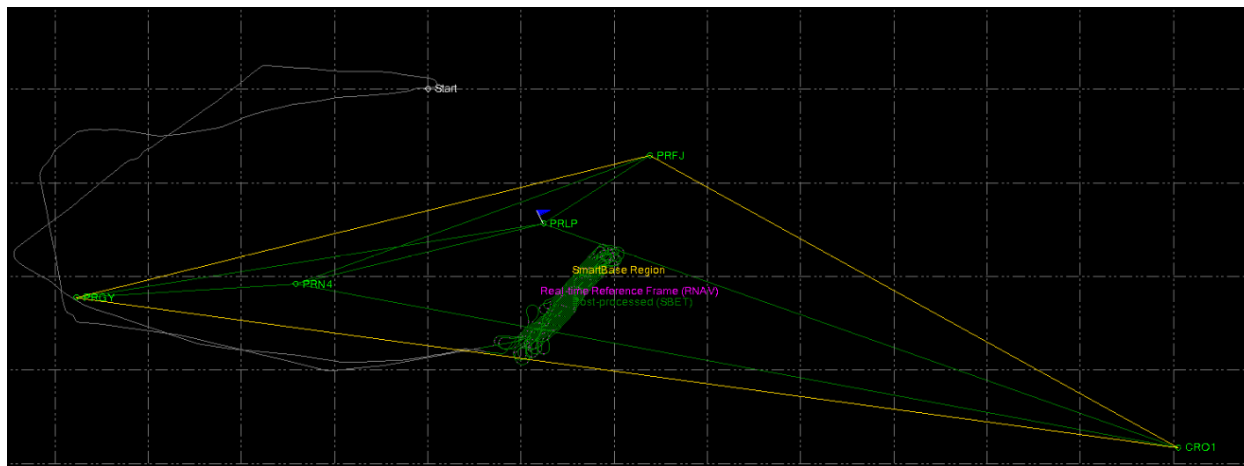
Figure 2 – 037A trajectory as flown by Leading Edge Geomatics

Figure 2 shows an example of a trajectory from mission 037A flown on February 6th, 2019 with the VQ880-GII using a SmartBase network in Applanix PosPAC.

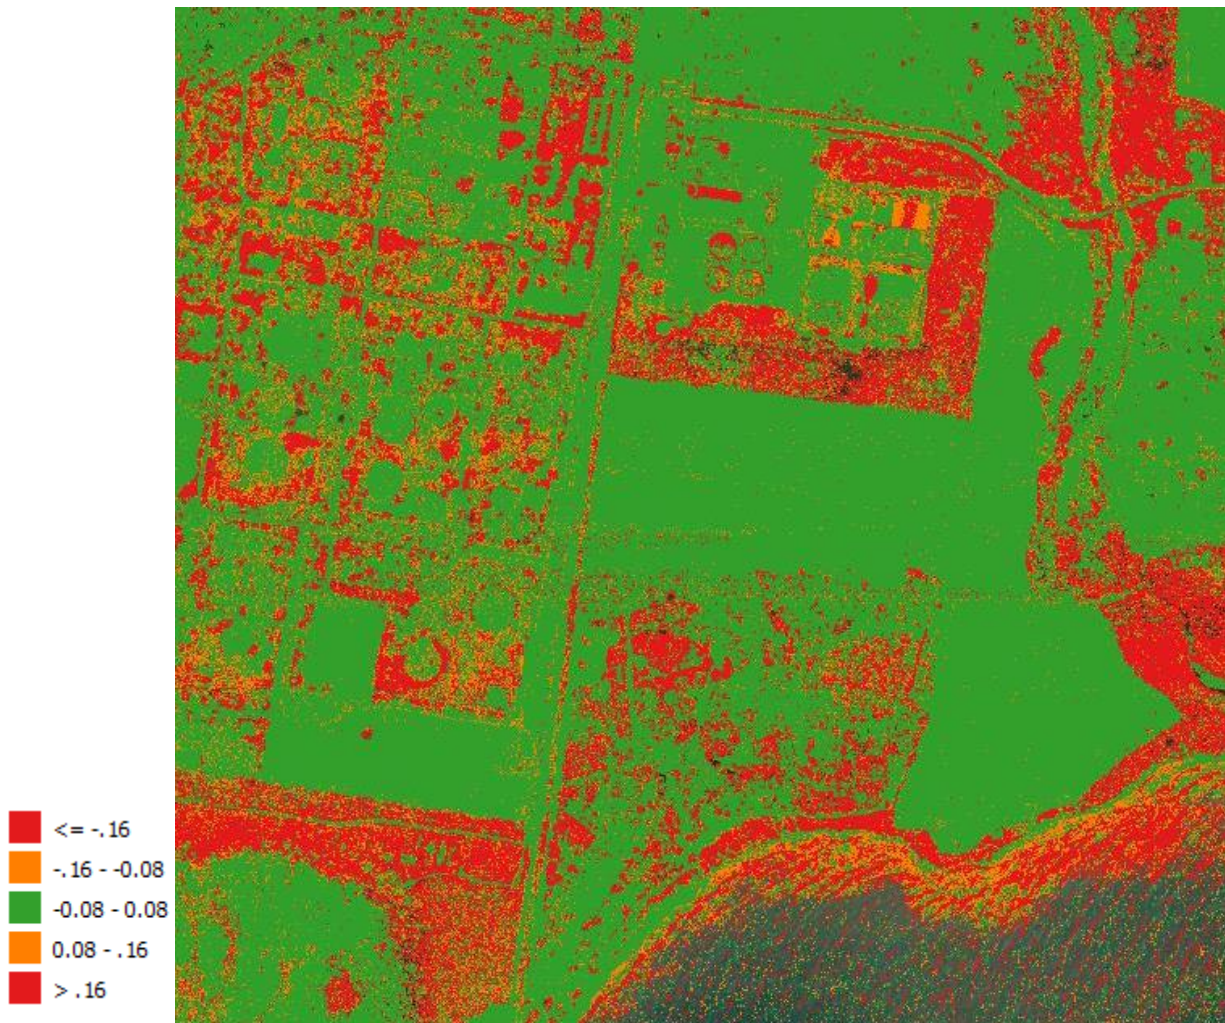
Figure 5 – QC block colored by vertical difference to ensure accuracy at swath edges and throughout.

Relative accuracy and internal quality are checked using between swaths. Vertical differences between ground surfaces of each line are displayed. Color scale is adjusted so that errors greater than the specifications are flagged. Cross sections are visually inspected across each block to validate point to point, flight line to flight line and mission to mission agreement.

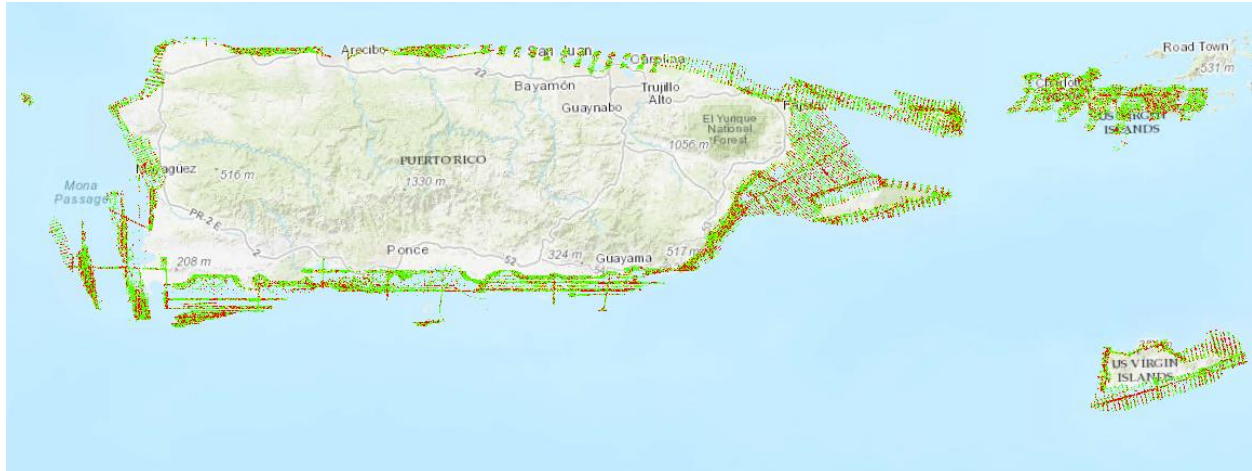
Flat, open areas are expected to be green in the DZ orthos. Bathymetric areas may be yellow or red due to varying elevations of returns within the water column. Large or continuous sections of yellow or red pixels following flight line patterns and not the terrain, vegetation, or bathymetric areas can indicate the data was not calibrated correctly or that there were issues during acquisition that could affect the usability of the data. The DZ orthos for Puerto Rico and US Virgin Islands Topobathymetric Lidar Project are shown in the figure below; this project meets inter-swath relative accuracy specifications.

Figure 6 – DZ orthoimages. Offsets between flight lines of 0-8 cm are green, 8-16 cm are yellow, and above 16 cm are red. Larger offsets in vegetated and bathymetric areas are expected as different returns from water column and vegetation can occur between different flight lines. Inter-swath relative accuracy passes specifications.

Dewberry verifies inter-swath or between swath relative accuracy of the dataset by creating Delta-Z (DZ) orthos. According to the SOW and ASPRS Positional Accuracy Standards for Digital Geospatial Data, 10 cm Vertical Accuracy Class or QL2 data must meet inter-swath relative accuracy of 8 cm RMSDz or less with maximum differences less than 16 cm. These measurements are to be taken in non-vegetated and flat open terrain using single or only returns from all classes. Measurements are calculated in the DZ orthos on 1-meter pixels or cell sizes. Areas in the dataset where overlapping flight lines are within 8 cm of each other within each pixel are colored green, areas in the dataset where overlapping flight lines have elevation differences in each pixel between 8 cm to 16 cm are colored yellow, and areas in the dataset where overlapping flight lines have elevation differences in each pixel greater than 16 cm are colored red. Pixels that do not contain points from overlapping flight lines are colored according to their intensity values. Areas of vegetation and steep slopes (slopes with 16 cm or more of valid elevation change across 1 linear meter) are expected to appear yellow or red in the DZ orthos. If the project area is heavily vegetated, Dewberry may also create DZ Orthos from the initial ground classification only, while keeping all other parameters consistent. This allows Dewberry to review the ground classification relative accuracy beneath vegetation and to ensure flight line ridges or other issues do not exist in the final classified data.

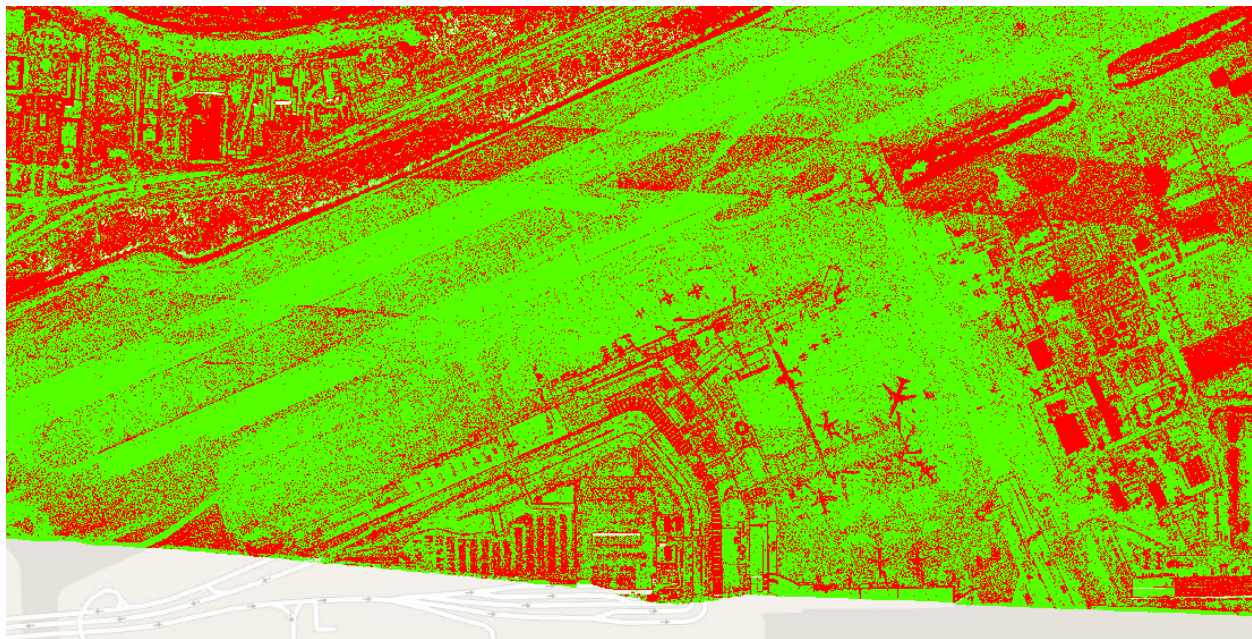
Dewberry verifies the intra-swath (within swath) relative accuracy by using Esri and GeoCue software to generate Z-range rasters that colorize the precision of the laser point density within each swath. Visual inspections are performed using these z-range rasters. Areas that are not aligned with project specifications are flagged and investigated. According to the SOW and ASPRS Positional Accuracy Standards for Digital Geospatial Data, 10 cm Vertical Accuracy Class or QL2 data must meet intra-swath relative accuracy of 6 cm maximum difference or less.

Figure 7 – Intra-swath relative accuracy. Areas where the maximum difference is ≤ 6 cm per pixel within each swath are colored green and areas exceeding 6 cm are colored red. Flat, open areas like this runway are the most reliable metric of intra-swath relative accuracy. Intra-swath relative accuracy passes specifications for this project.

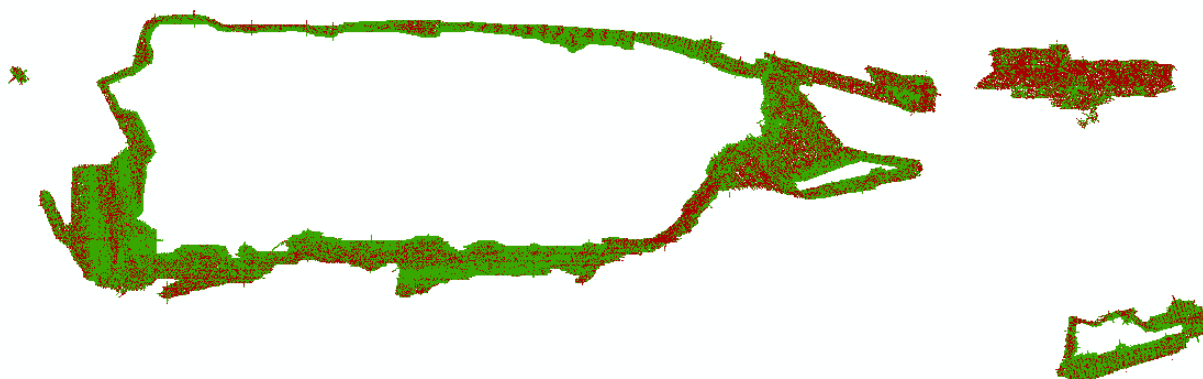
Density calculations were performed using first return data only located in the geometrically usable center portion (typically ~90%) of each swath. The project area was determined to have a combined NPS of 0.48 meters or an NPD of 4.28 ppsm which satisfies the project requirements. A visual review of a 1-square meter density grid (figure 9) shows that there are some 1-meter cells that do not contain 2 ppsm (red areas) due to the irregular spacing of lidar point cloud data and the inclusion of bathymetric areas in the 2 ppsm count (bathymetric areas are considered passing if they have 0.5 ppsm). Most cells contain at least 2 ppsm (green areas) and when density is viewed/analyzed by representative 1-square kilometer areas (to account for the irregular spacing of lidar point clouds), density passes with no issues.

Figure 9 – 1-square meter density grid. There are some 1-meter cells that do not contain 2 ppsm (red areas) due to the irregular spacing of lidar point cloud data and inclusion of bathymetric areas in this more stringent threshold. Most 1-square meter cells contain at least 2 points per square meter (green areas) showing there are no systematic density issues. When density is viewed/analyzed by representative 1-square kilometer areas, density passes with no issues.

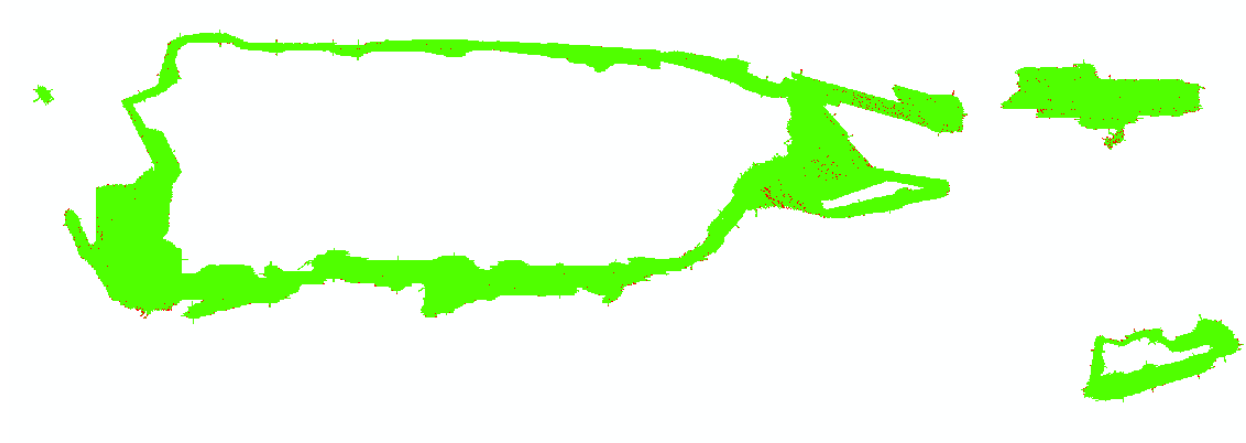
Figure 10 – All cells (2*NPS cellsize) containing at least one lidar point are colored green. Cells that do not contain a lidar point are colored red. 98.7% of cells contain at least one lidar point.

The spatial distribution of points must be uniform and free of clustering. This specification is tested by creating a grid with a cell size equal to the design NPS*2. ArcGIS tools are then used to calculate the number of first return points within each grid cell. At least 90% of the cells must contain 1 lidar point, excluding acceptable void areas such as low NIR reflectivity features, i.e. some asphalt and roof composition materials. This project passes spatial distribution requirements, as shown in the figure 10.

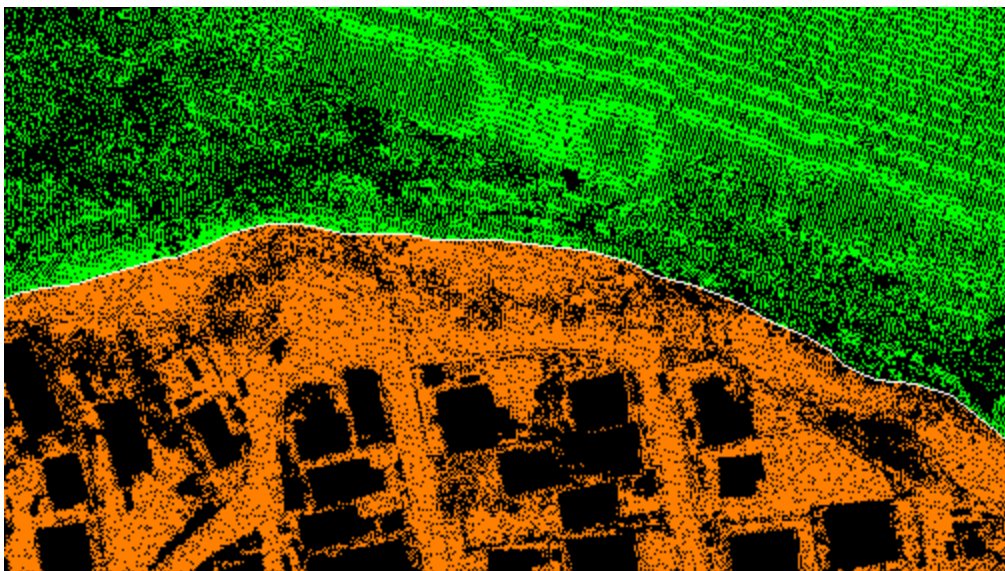
Figure 11 – Tile 2019_833300e_2041500n_las. The refraction extent is shown as a white line. The lidar point cloud shows topographic points in orange and bathymetric points in green.

The refraction extent delineation is used to finalize the lidar classification of ground and bathymetric points (figure 11).

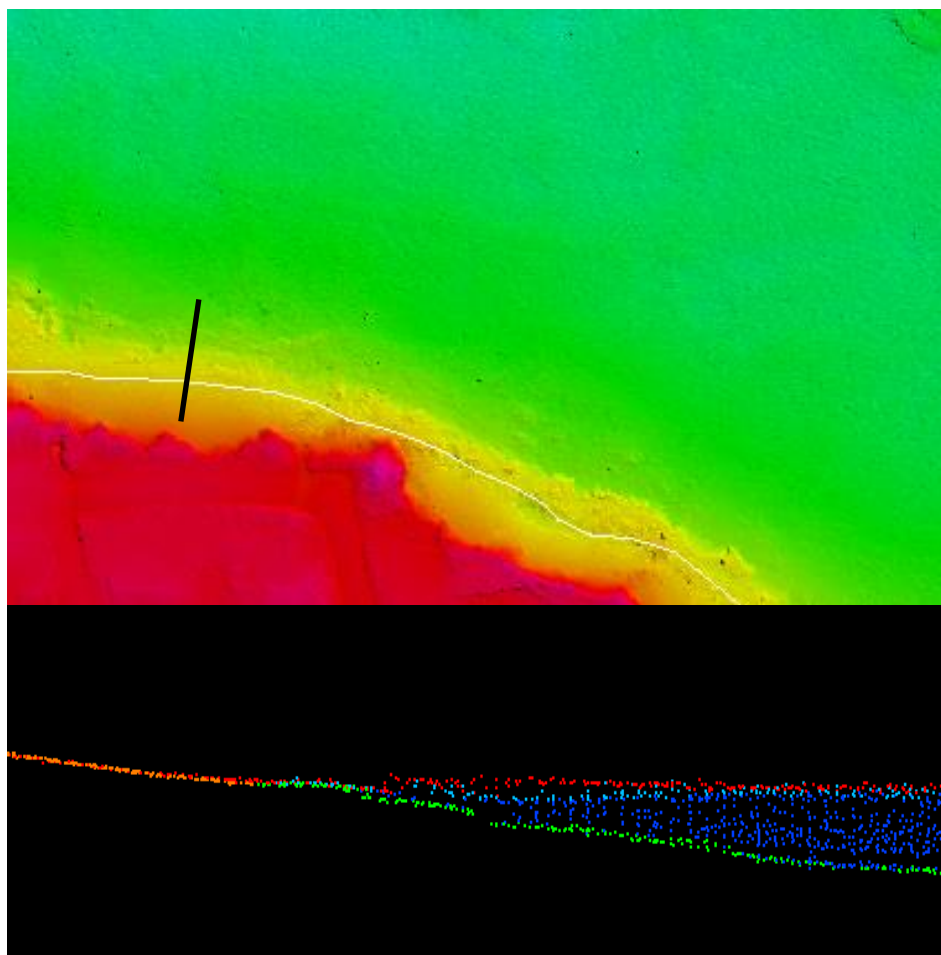
Special attention was given along shorelines or the land/water interface as no hard edges or seams should exist between ground and bathy bottom.

Figure 12 – The land water interface should be seamless with no hard edges or seamlines. The topobathy surface model is shown on the top with a profile location overlaid. The profile is shown in the image below where bathy bottom points are green, water surface points are turquoise, and water column points are blue, ground points are orange, and unclassified points are red.

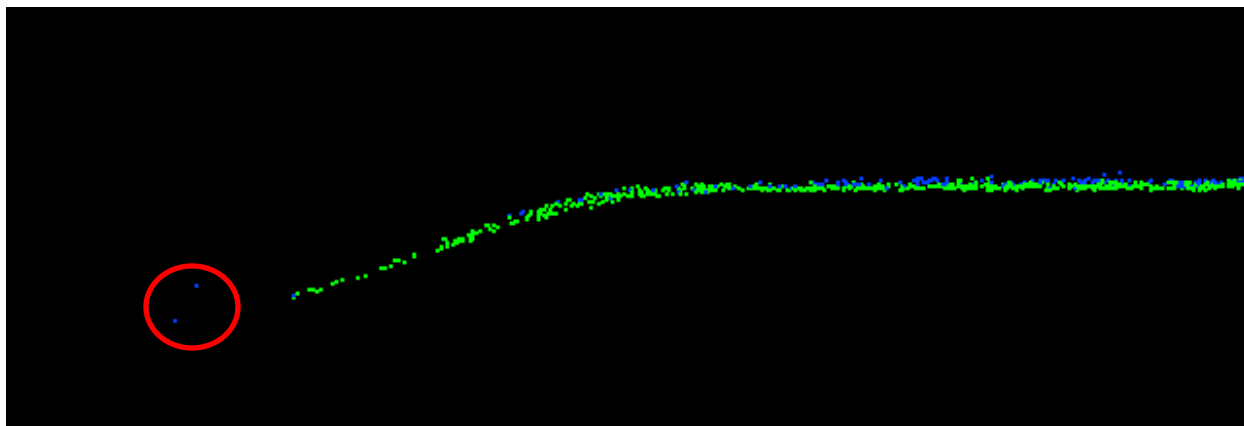
Figure 13 – Bathy bottom points (green) are shown with water column (blue) and water surface points (turquoise) in this profile. The two water column points circled in red would cause inconsistent and upward changes in the topobathy model if these points were classified to bathy bottom. These points should remain classified as water column.

1. Gradient consistency – if the points are part of consistent gradients or consistent channel geometry, they are more likely to be bathy bottom rather than low water column noise. Conversely, points that would cause abrupt changes or inconsistency in the overall gradient or channel geometry are less likely to be bathy bottom points, especially if the abrupt change would result in shallower (higher) bathy bottom points above lower bathy bottom points with a high confidence.

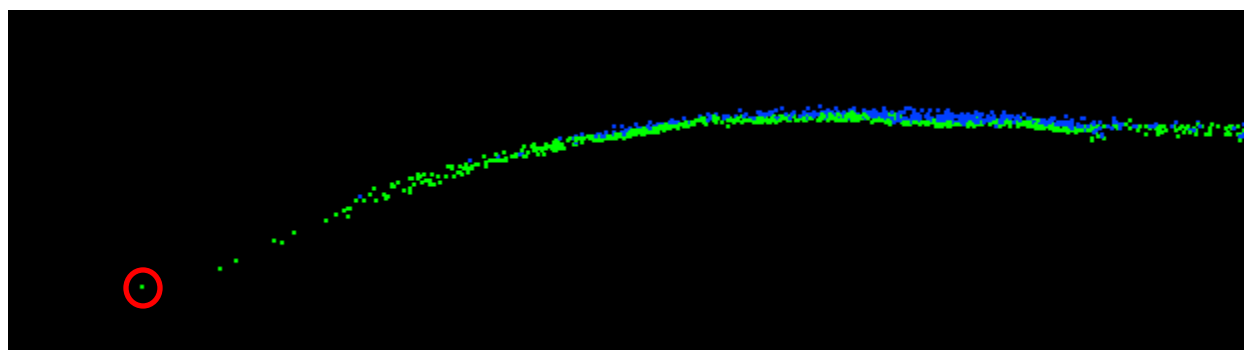
Figure 14 – Bathy bottom points (green) are shown with water column (blue) and water surface points (turquoise) in this profile. The bathy bottom point circled in red is isolated, but maintains a consistent gradient with other bathy bottom points to the east. This point should remain classified as bathy bottom.

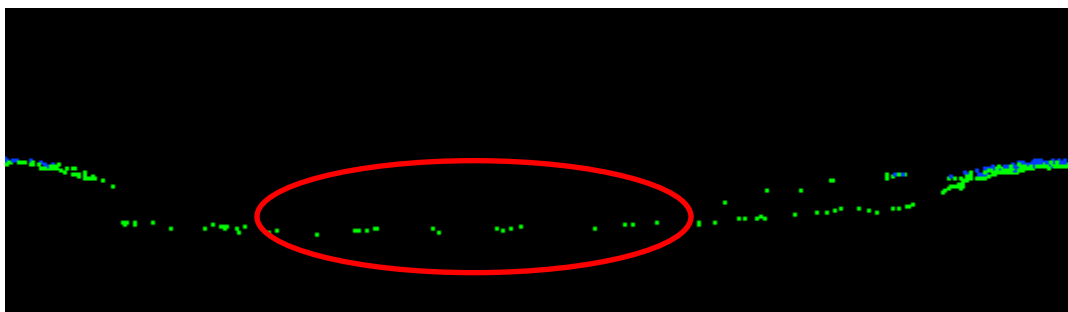
Figure 15 – Bathy bottom points (green) are shown with no bottom found (blue) and water surface points (turquoise) in this profile. The bathy bottom points circled in blue were classified as bathy noise by the initial grounding macro, resulting in a small void. These points were re-classified as bathy bottom to fill the small gap because they are at the same depth as surrounding points, maintain a consistent gradient, and are more likely to be submerged bottom rather than low water column noise.

2. Small gap verification – if bathy bottom was obtained for the vast majority of a channel, but small random gaps or voids in the bathy bottom exist after the initial grounding where it is unclear if existing points are bathy bottom or low water column, these small gaps should usually be filled by classifying the points in question to bathy bottom. It is unlikely such small portions of the channel are that much deeper where no bathy bottom was obtained when the lidar penetrated to the bathy bottom in the rest of the channel. However, if the gaps/voids are larger or consistently form over specific areas or locations, then these areas are more likely to represent deeper areas where the lidar may

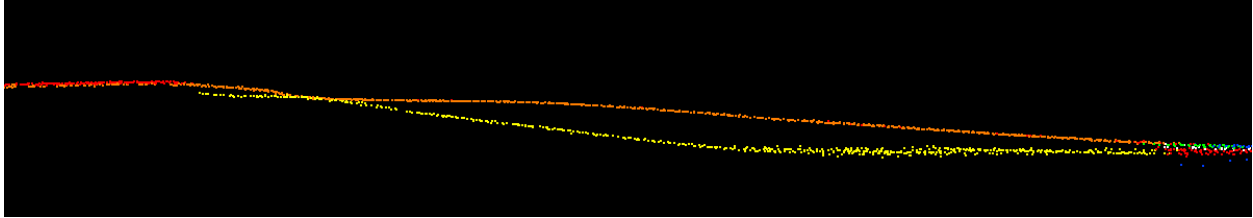
Data acquisition for the project area was collected over a wide time period (January-June 2019 2018 thru May 2019). Due to varying environmental conditions at the time of different acquisitions, there may be temporal changes within and between flightlines where missions from different acquisitions are merged together. Areas of temporal changes were identified during the manual editing and review of the lidar data. An additional classification, class 46 – temporal, was added to the final classification schema to accommodate these temporal differences within the data. Class 46 was used when data was edited to classify out the incorrect ground/bathy surface (to class 46), and classify in the correct ground/bathy surface from class 1/45 (e.g., figure 16)

Figure 16 – Points colored by class showing the elevation differences along the identified ground surface. Orange represents ground, yellow represents the temporal class (i.e. less-recent ground), green represents bathymetry, blue is no bottom found, and red is unclassified. Care was taken to use the most recent data to represent the topobathy surface. In this example, the orange line represents the most current ground while yellow represents a ground surface captured from different day's flight; the green bathymetric surface was not affected in this example.

1. Use most recent flight lines to model bathy bottom data.
2. Use older flight lines if it will provide full coverage, will prevent ridges/abrupt changes in the data, or represents better water clarity (i.e. bathy returns) than more recent data.
3. If ridge/abrupt change is unavoidable or boundaries for #1 or #2 are not definable, then use more recent data to full extent and fill in with older/earlier collect where necessary.

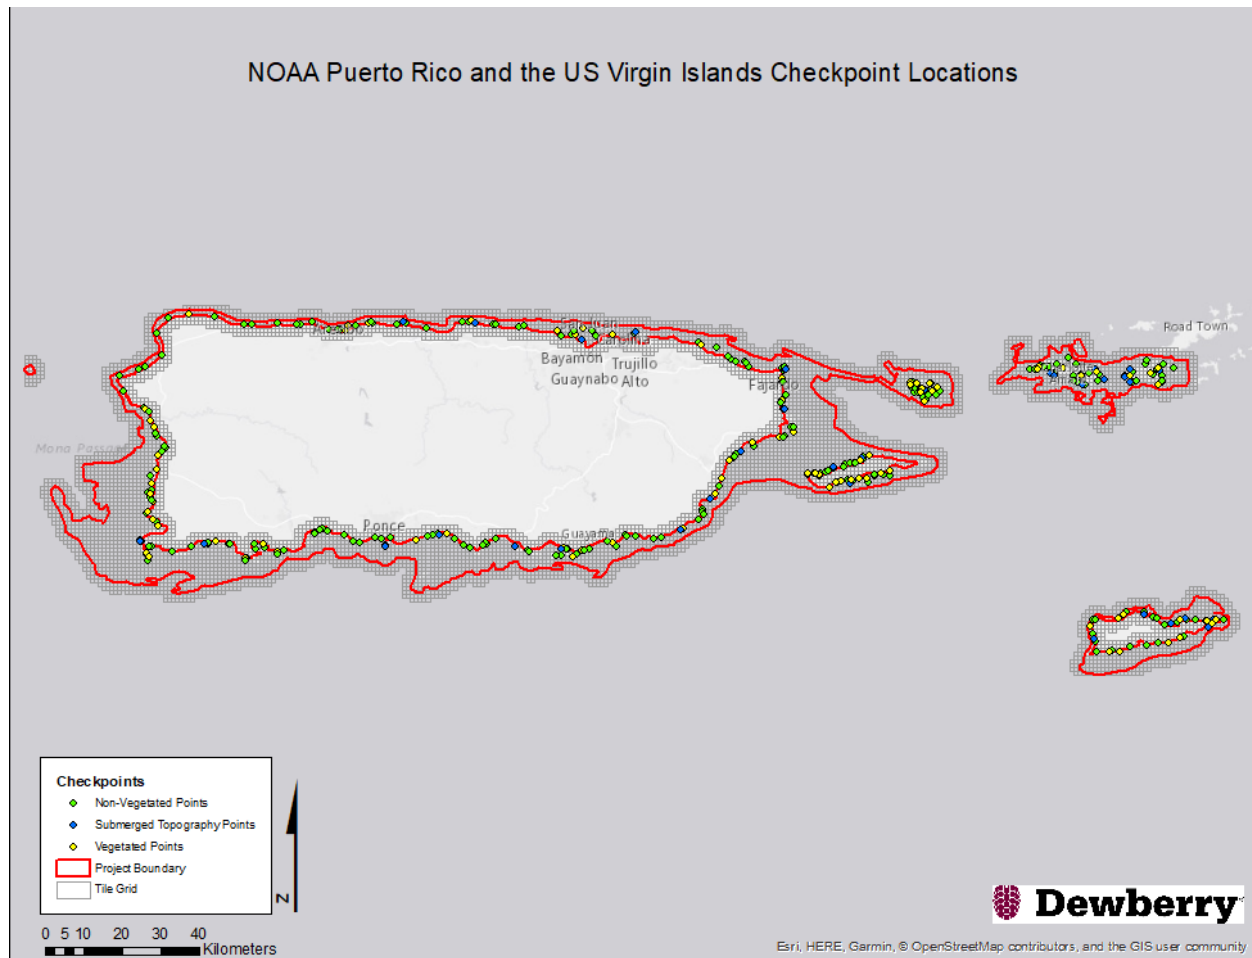
Figure 18 – Location of QA/QC checkpoints.

Checkpoints were evenly distributed throughout the project area so as to cover as many flight lines as possible using the "dispersed method" of placement. Figure 24 shows the location of the QA/QC checkpoints used to test the positional accuracy of the dataset.

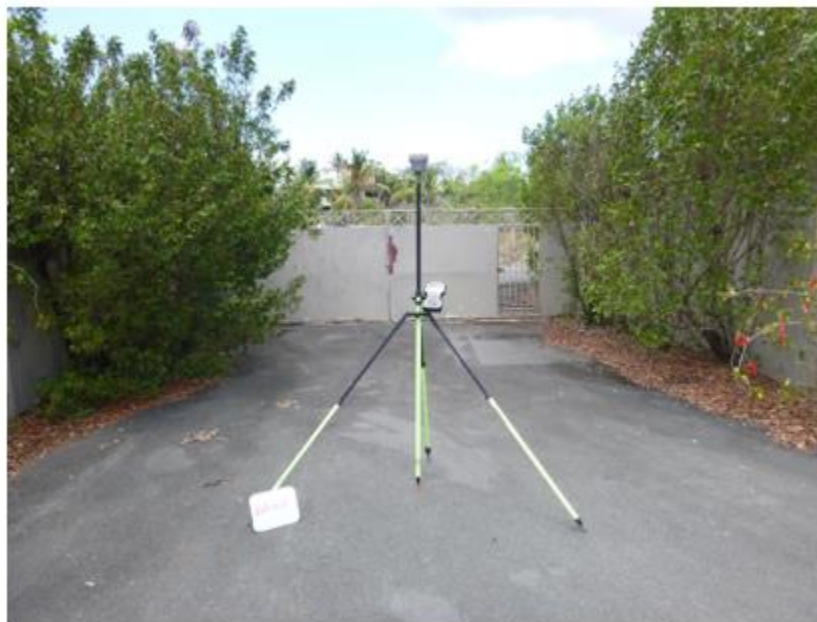
Figure 19 – Field photo for checkpoint NVA-609. Field photo shows the checkpoint should be located on a flat asphalt driveway, but final coordinates locate the checkpoint on a slope. Review by the surveyor deemed this survey checkpoint erroneous and unsuitable to use in the final vertical accuracy testing.

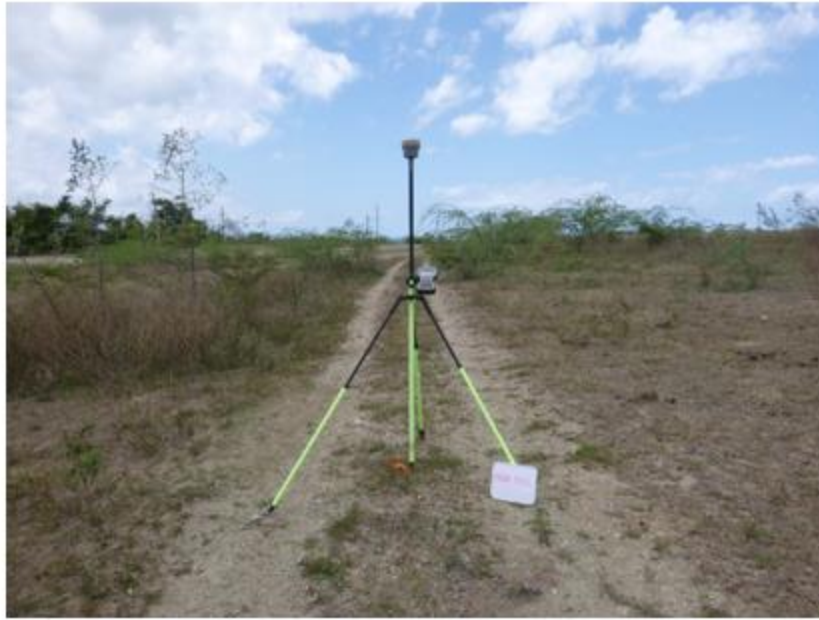
Figure 21 – Field photo for checkpoint NVA-305. Field photo shows the checkpoint should be located on a flat gravel pathway, but final coordinates place it on a slope in short grass. Review by the surveyor deemed this survey checkpoint erroneous and unsuitable to use in the final vertical accuracy testing.

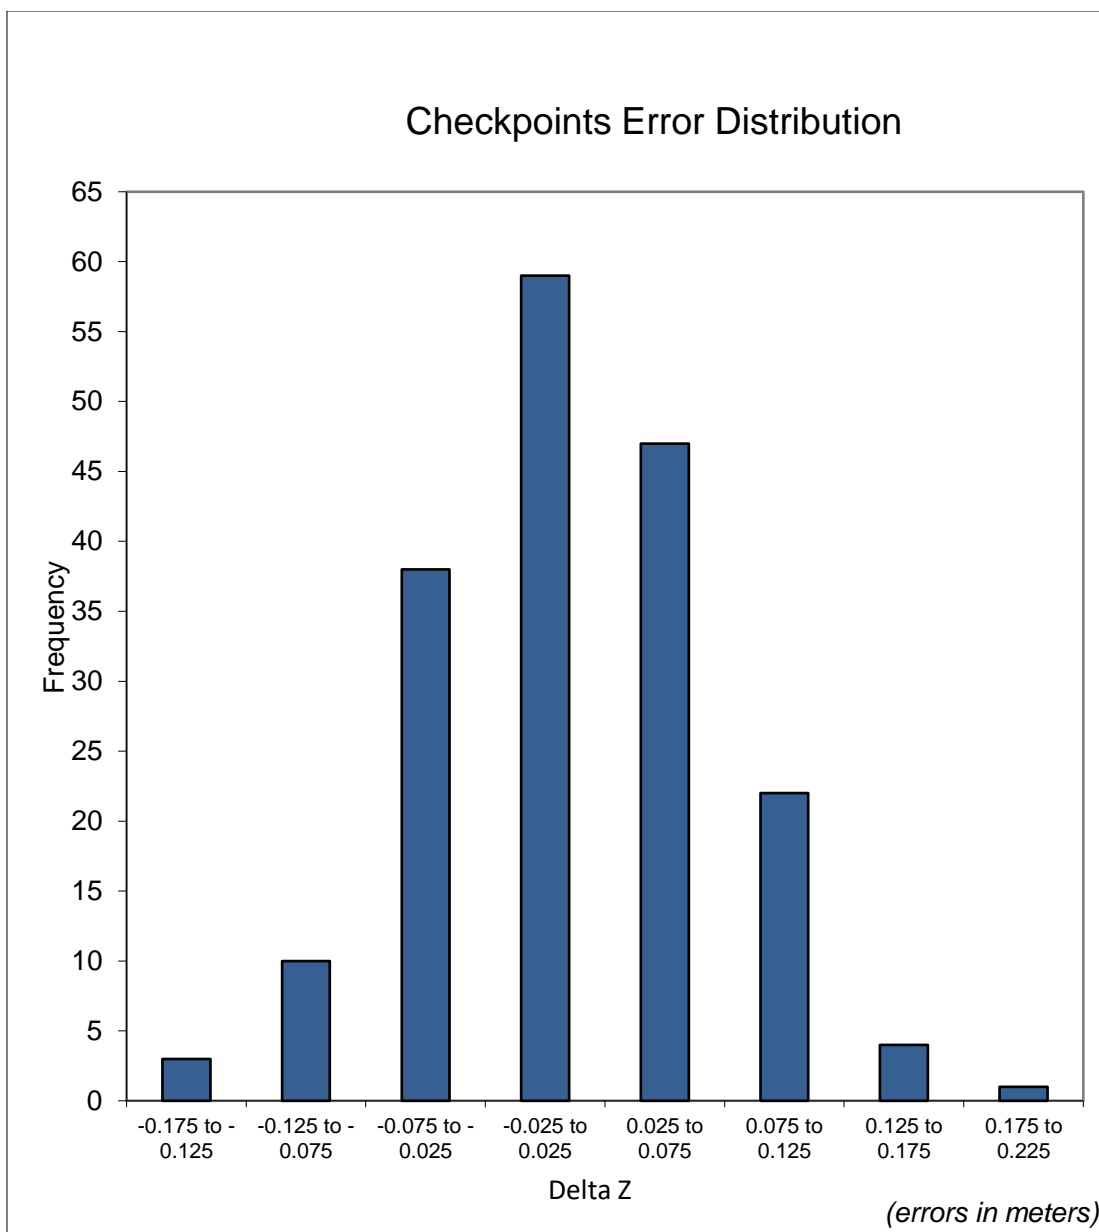
Figure 25 – Histogram of elevation discrepancies in meters.

Figure 25 illustrates a histogram of the associated elevation discrepancies between the QA/QC checkpoints and elevations interpolated from the lidar triangulated irregular network (TIN). The frequency shows the number of discrepancies within each band of elevation differences. Although the discrepancies vary between a low of -0.15 meters and a high of +0.7 meters, the histogram shows that the majority of the discrepancies are skewed on the positive side. The vast majority of points are within the ranges of -0.05 meters to +0.05 meters.

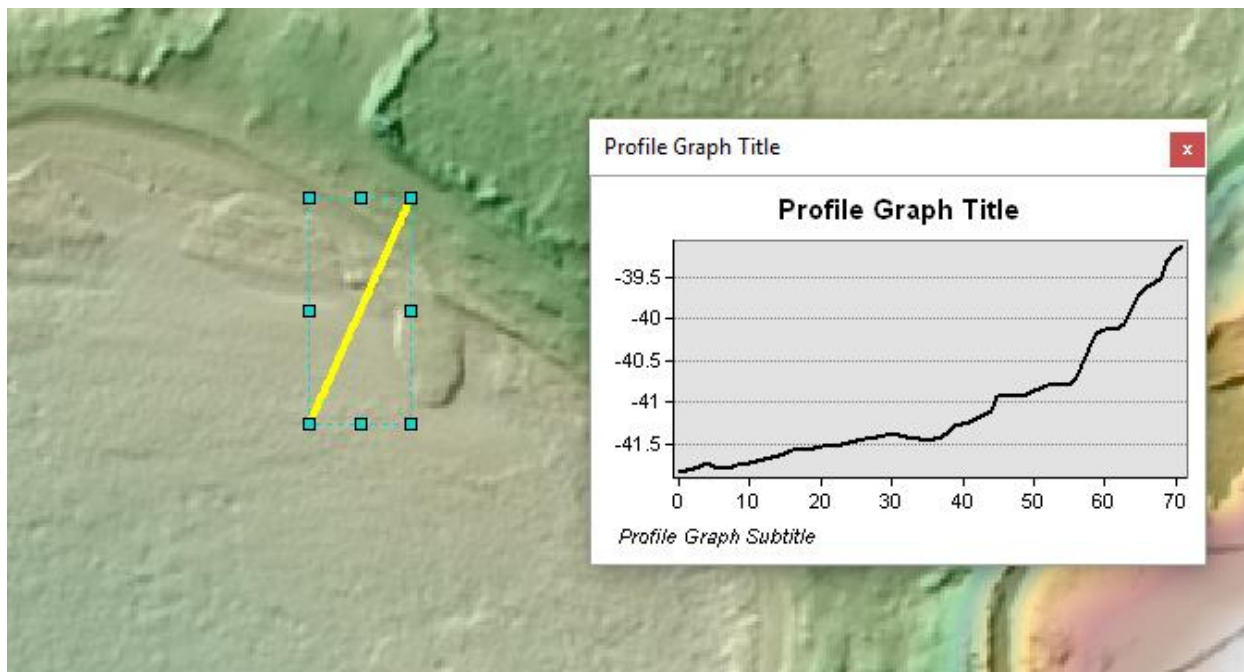
Figure 26 – DEM tile 2019_849300e_2014500n_dem. An example of the land-water interface is shown. No hard edges along the interface were identified during DEM QA/QC.

The final topobathy DEMs were then reviewed in Global Mapper at a 1:3000 scale. A review with the void polygons visible and another review without the void polygons visible was performed in order to ensure voids were enforced properly and there were no issues along the boundaries of the void layer. Special attention was given along the land/water interface to ensure there were no hard edges along the interface (figure 26). Any remaining lidar issues and DEM artifacts were flagged by the reviewer and corrected by the editing team as necessary.
