LiDAR QAQC Report
Hawaii TO12: Molokai, Maui, Lanai islands
March 2008

**Dewberry**
Fairfax, VA

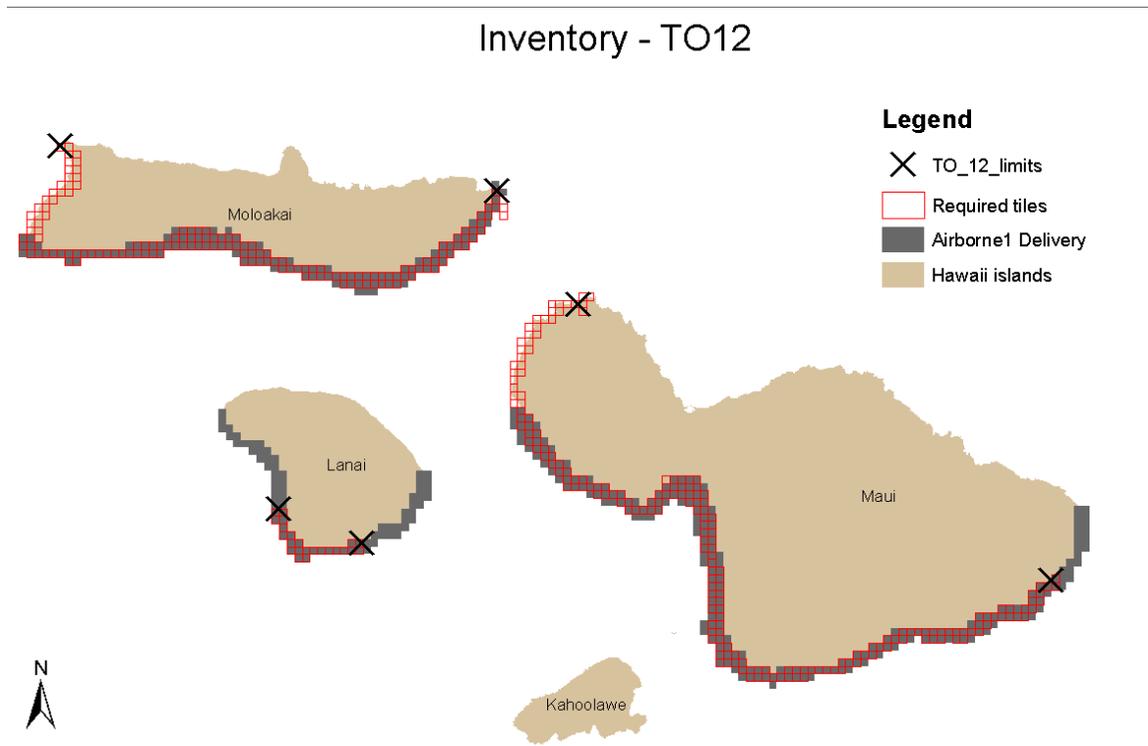
In total there were 77 LAS files for Lanai, 265 LAS files for Maui, and 175 LAS files for Molokai. There were multiple deliveries for the islands, because of missing files, missing annotation, and duplication. The result of our first inventory indicated, on the one hand, that 32 files were missing for the westerly coastlines of Molokai and the north-west coastlines of Maui. On the other hand, too many data were acquired on the south-east and south-west part of Lanai shore and on the south-east part of the Maui shore. This is illustrated on Figure 1. The criteria that Airborne1 seems to have followed is to acquire on the south oriented side of the coastlines without considering the limits points provided. The missing files for Molokai were delivered on 06/01/2007. All the required tiles were present (and more), as illustrated on Figure 2.

Figure 1 – Comparison of delivered data and required tiles (first deliveries); location of the check points

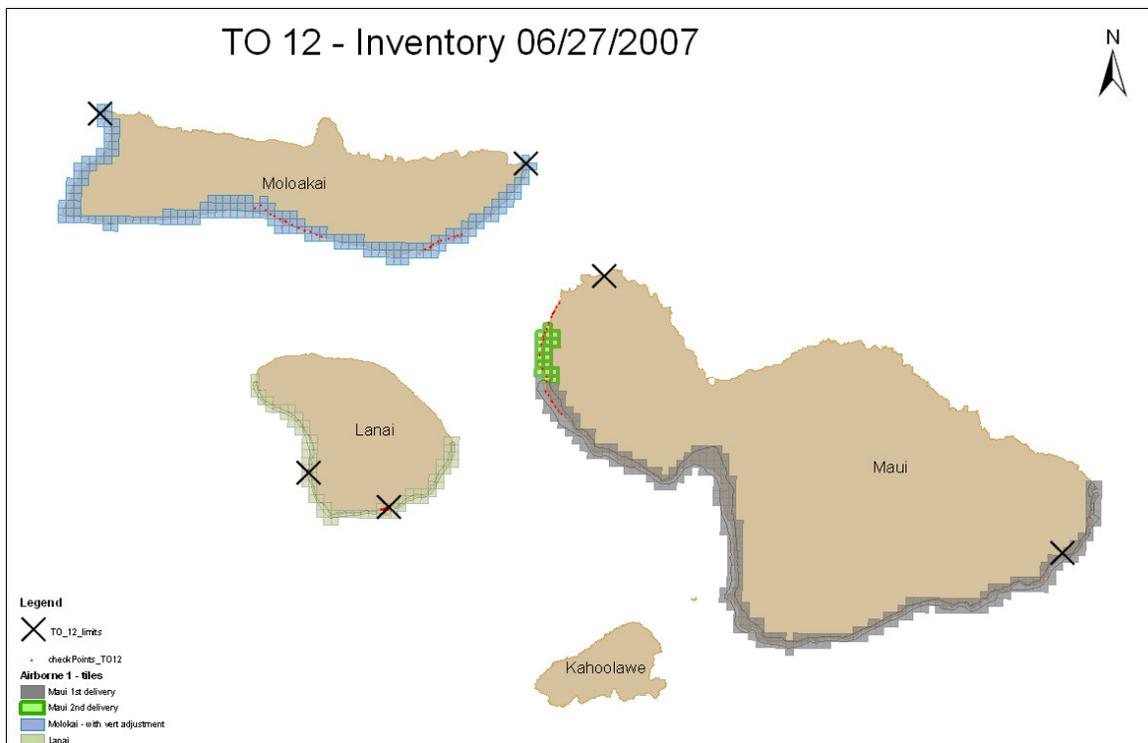
Figure 2 – Comparison of delivered data and project limits (final deliveries); location of the check points

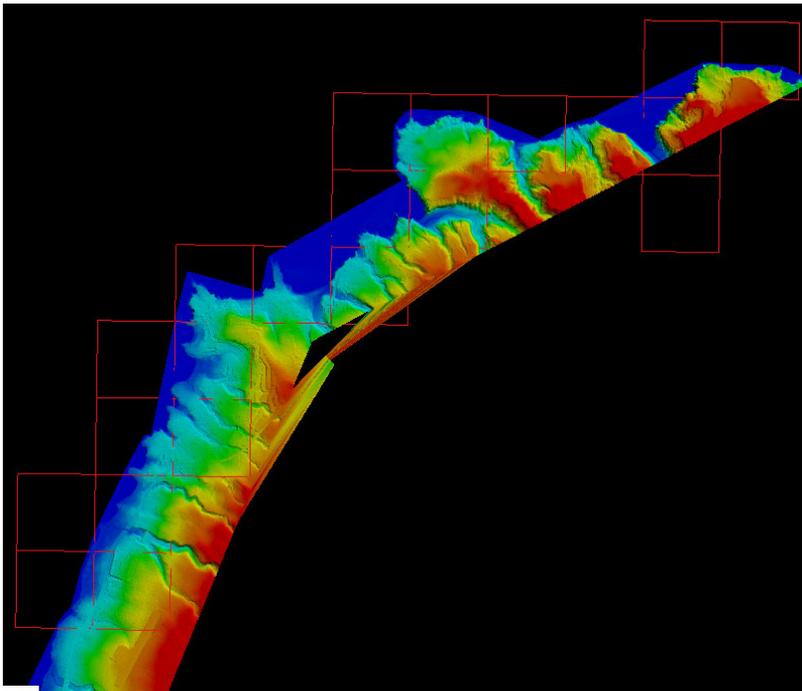
For Maui, we are still missing 21 tiles. Besides, it should be noted that 7 over of the 23 check points reside in this missing area. In order to replace these missing data we have downloaded a ground LIDAR dataset from NOAA (see Figure 3):

Figure 3 – Maui missing tiles (red outlines) and replacing dataset from NOAA, 3D model colored by elevation

- Originator: NOAA Coastal Services Center Coastal Remote Sensing Program, <http://www.csc.noaa.gov/LiDAR>
- Publication_Date: 20070710
- Title: Oahu/Maui 2005 LiDAR mapping project
- ASCII files (xyz), ground only (we also downloaded a full point cloud dataset which covers in a slightly larger area)
- State plane Hawaii Zone 2 US Feet, Z in feet

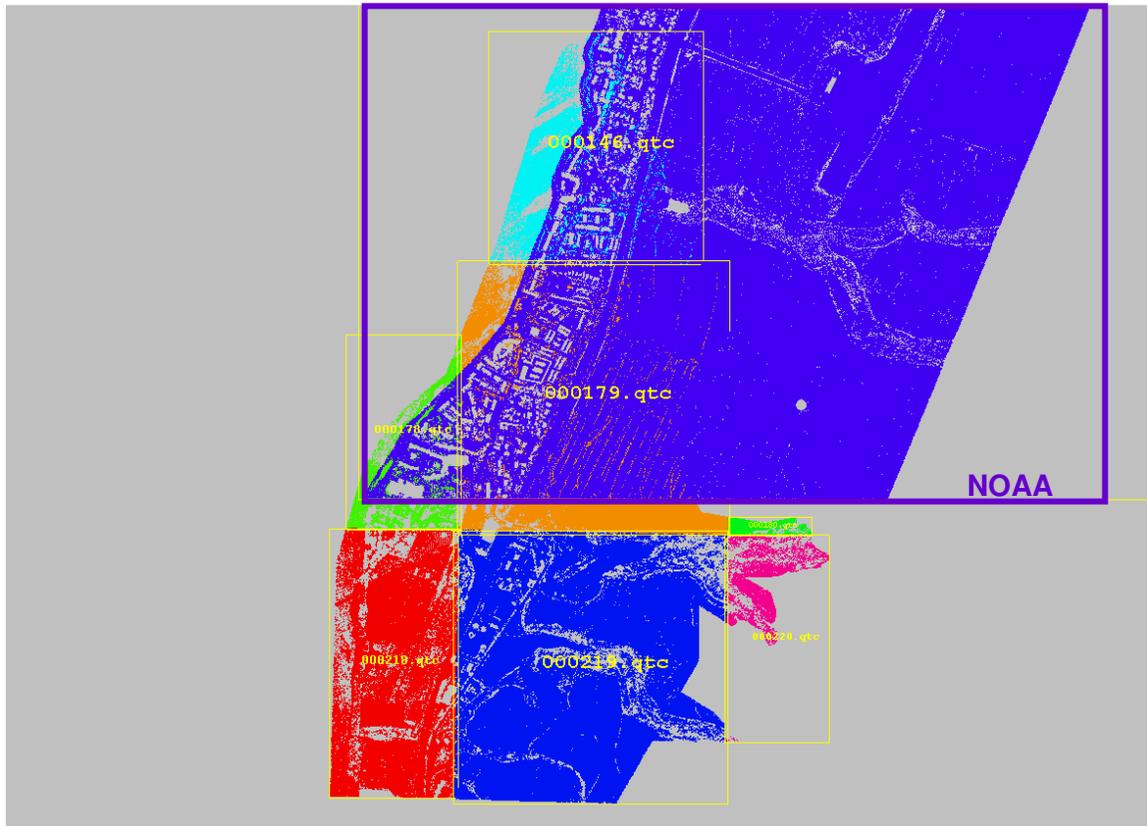
The overall quality and point spacing are comparable to the data that we already have. This dataset will completely overlap the Airborne 1 tile 000146 and partially overlap tiles no. 000178 and 000179 (Figure 4). If the data ties in adequately with the A-1 acquired data is further analyzed in this report.

Figure 4 – Overlap between NOAA dataset and tiles 000146, 000178 and 000179

For delivery purpose, the Airborne1 data was clipped to the extent of the NOAA dataset (affects tiles 178 and 179 and remove tile 146). The NOAA ground points and the remaining ground points in tiles 178 and 179 were then used to populate the missing tiles. In total 24 tiles were created (21 plus 3 replaced) shown in red in Figure 5. These tiles were also renamed with an N in front of the old tile name in order to identify them. See Appendix A for the list of tiles.

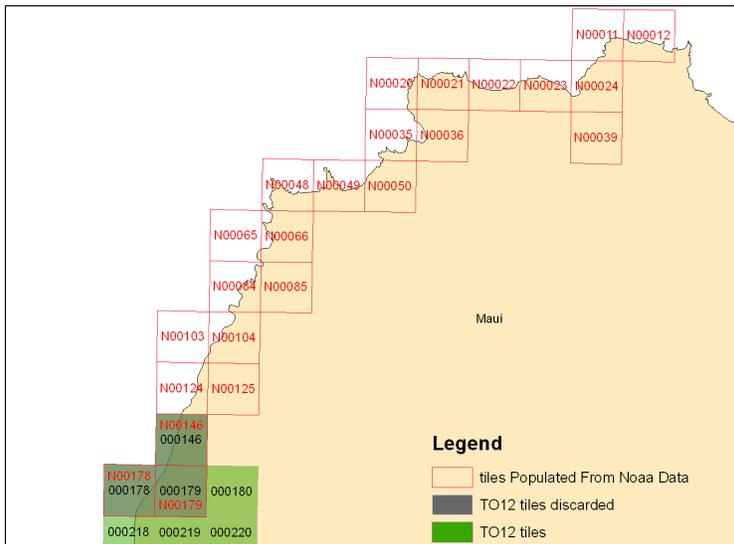
Figure 5 – Tiles populated from NOAA data

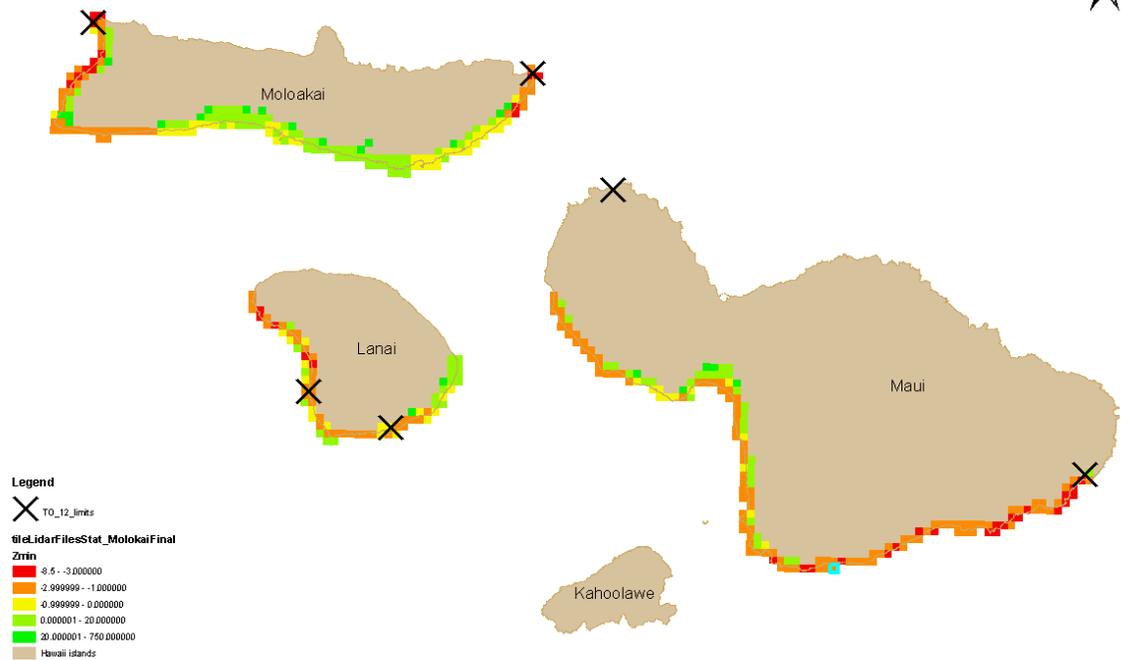
We checked the minimum and maximum elevation values in each ground classified files. Figure 7 illustrates the Zmin value for each tile; it can be noticed that a lot of the files situated on the east part of Maui have negative Zmin values, and 30 files have a Zmin value under -5ft, further investigation may be needed to explain this. Nevertheless, we can see on Figure 8 that there is no noticeable anomaly for the max value. The 3 tiles in Lanai Island that have values above 600ft are very steep cliffs right on the coast as seen in Figure 9. Consequently, all highest Zmax values are legitimate LiDAR points. We can also see that the project boundary is very close to the shoreline on this particular area.

Figure 7 – Minimum elevation in ground LAS files (in feet)

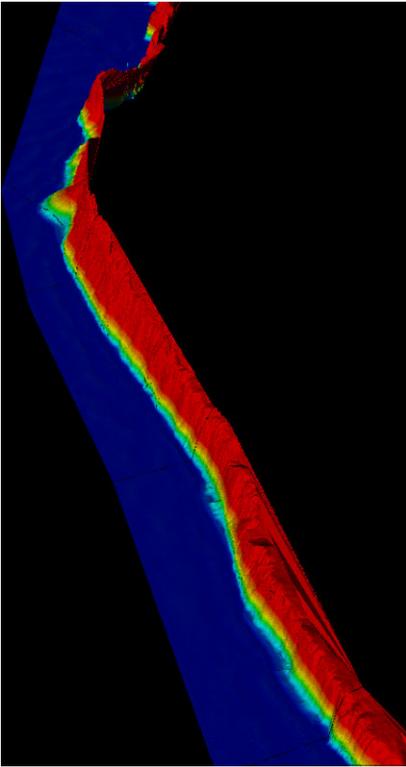
The west part of Lanai project area consist of steep bare earth cliffs, consequently, the inland extent of the data is very limited as illustrated in Figure 18. On this portion of the data, almost no problems were found except some spikes in the extracted feature product (see Figure 19) which are acceptable since they are contained in the “unclassified” class of the LAS data.

Figure 18 – Lanai coast, the area coverage is very narrow

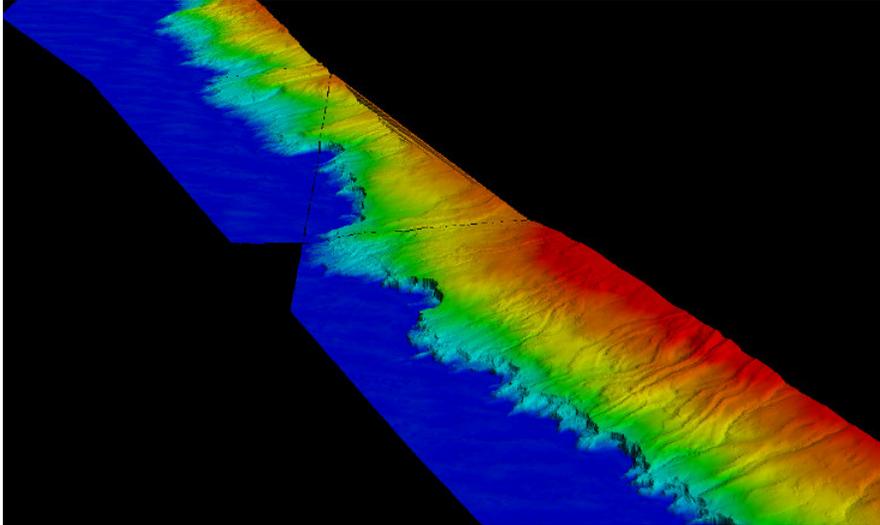
As previously stated, cliffs and naturally bare earth areas tend to exhibit fewer issues and are of better quality than other zones (see Figure 21 and Figure 22).

Figure 21 – Perspective view of a well define coast

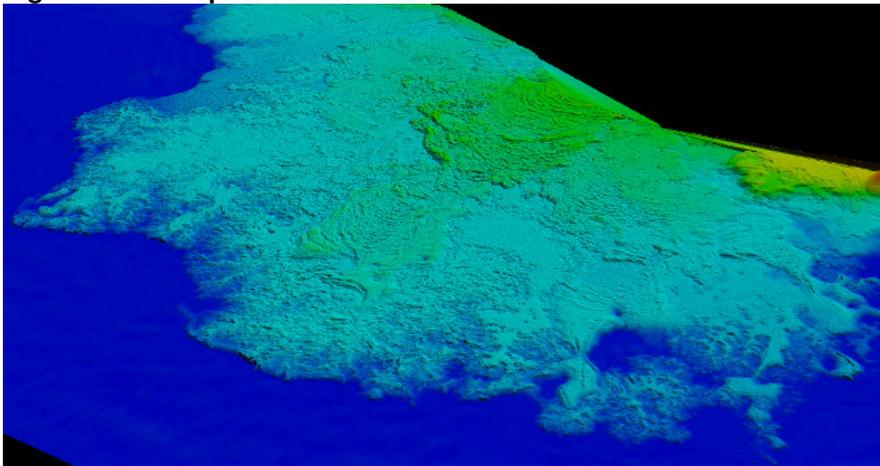
Figure 22 – Lava extrusion
