LiDAR QA/QC
- Quantitative and Qualitative Assessment Report -
Northwest Florida Water Management District
July 17, 2008

EXECUTIVE SUMMARY

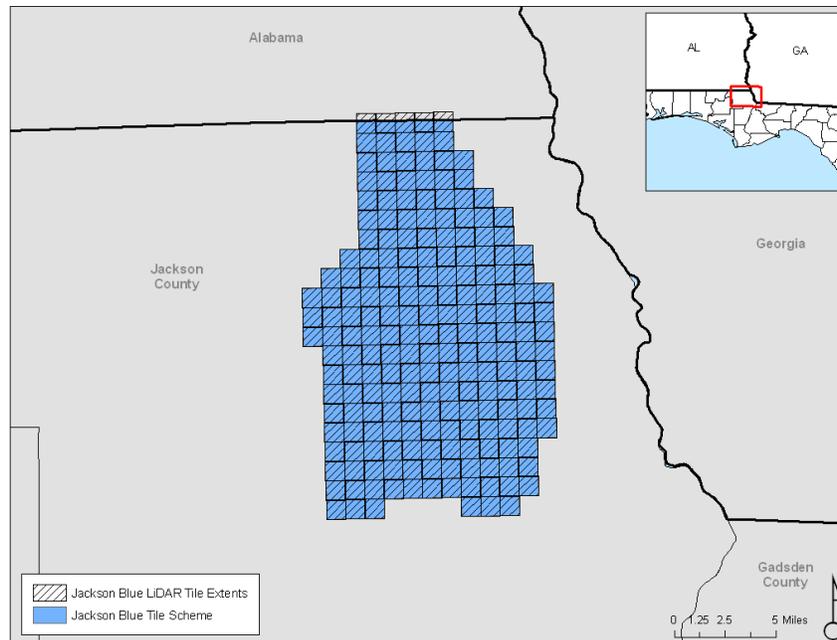
Figure 6 - Delivered LiDAR tiles and extents.

It seems as though all non-ground points were thrown into class 5. Based on our knowledge of the specifications for this project this is incorrect and only canopy points should have been included in this class.

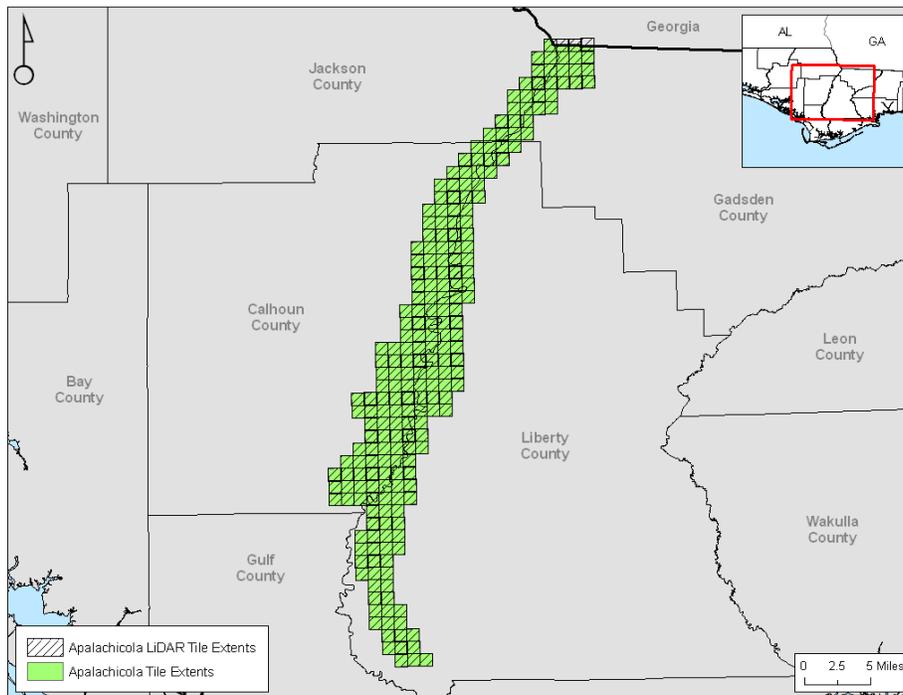
Figure 21 - Delivered LiDAR tiles – extent of the LAS files.

As with the Jackson Blue data, class 5 included all non-ground points instead of only canopy and is in error. Also missing was the flightline data.

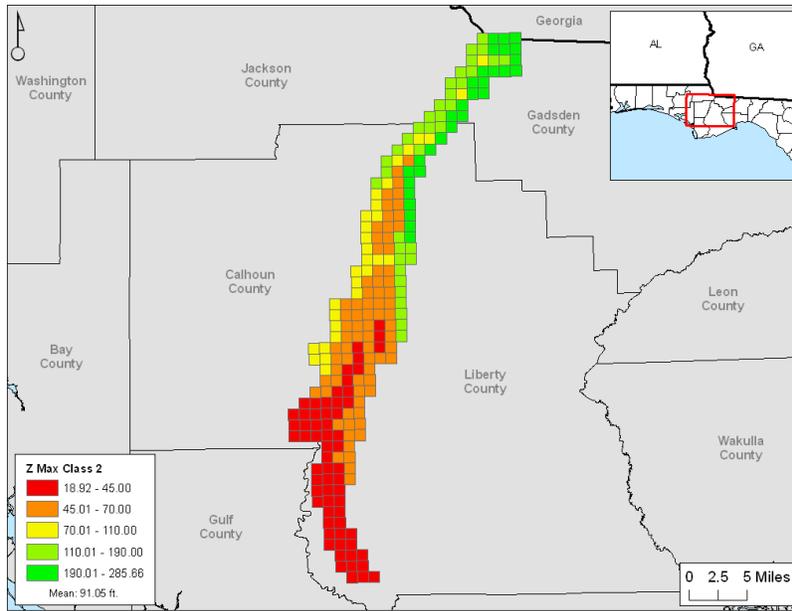
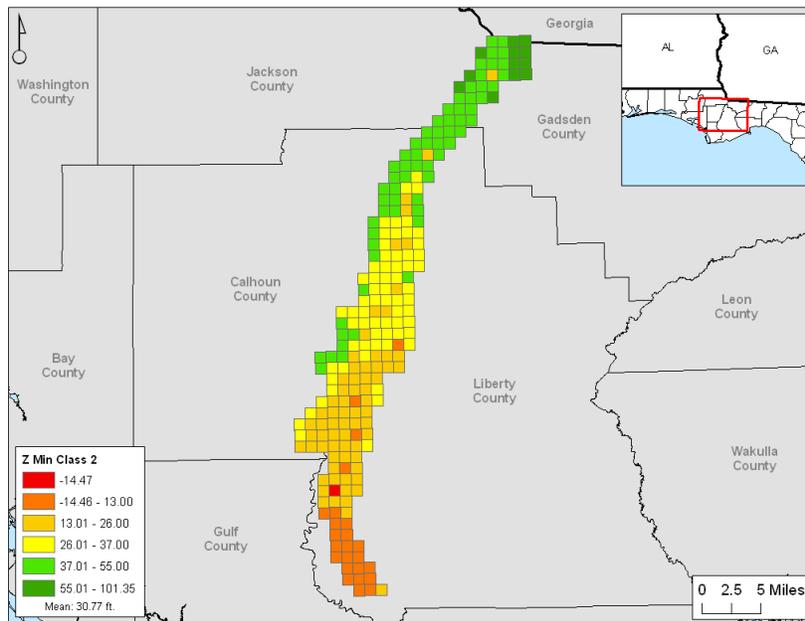
To first identify incorrect elevations, the z-minimum and z-maximum values for the ground class were reviewed. The spatial distributions of these elevations are shown in Figures 23 and 24. Tile number 59046 includes a point with an elevation of -14.47 feet. Upon further investigation of this tile, it was revealed that this point is located in water which frequently causes erroneous return values. Merrick should have removed this point during the processing stage. No other significant anomalies were identified. Considering that the Apalachicola River drains into the Gulf of Mexico, the images of the spatial distribution of the highest and lowest elevations seem to correlate with one another.

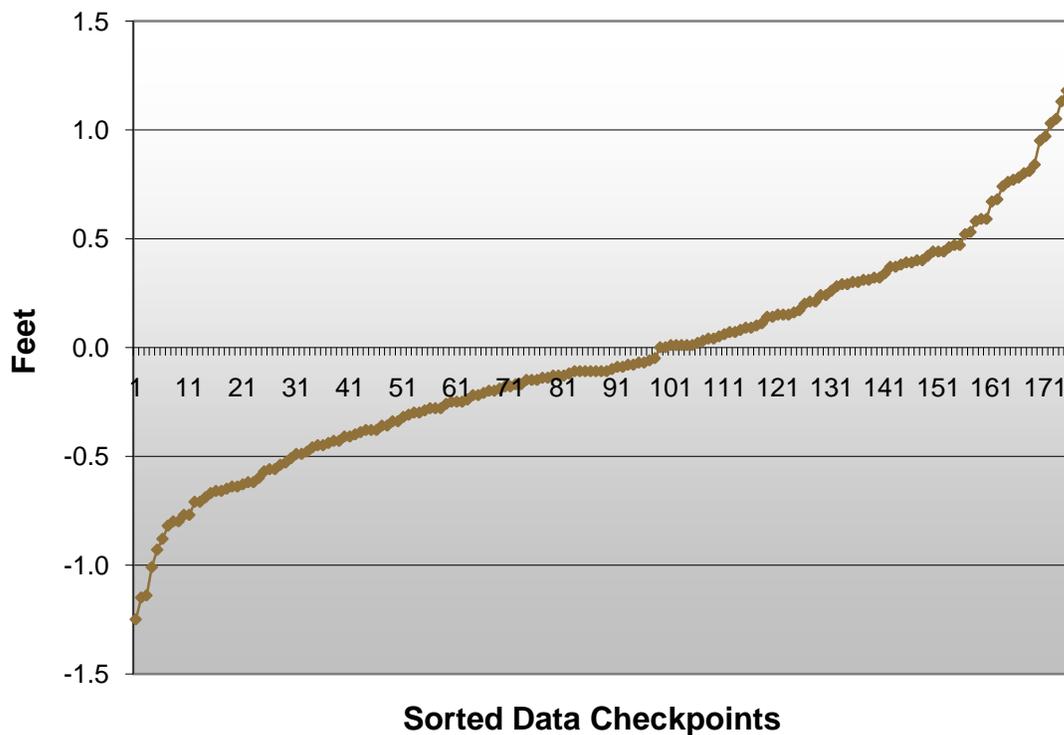
Table 12 - Sorted elevation errors for 176 survey checkpoints.

Table 12 illustrates the distribution of the elevation differences between the LiDAR data and the surveyed points. The elevation deltas are centered around zero which indicates a normal error distribution.

Dewberry's review of the vertical accuracy of the Large Area data confirms Merrick's statement that the dataset meets NSSDA accuracy standards.

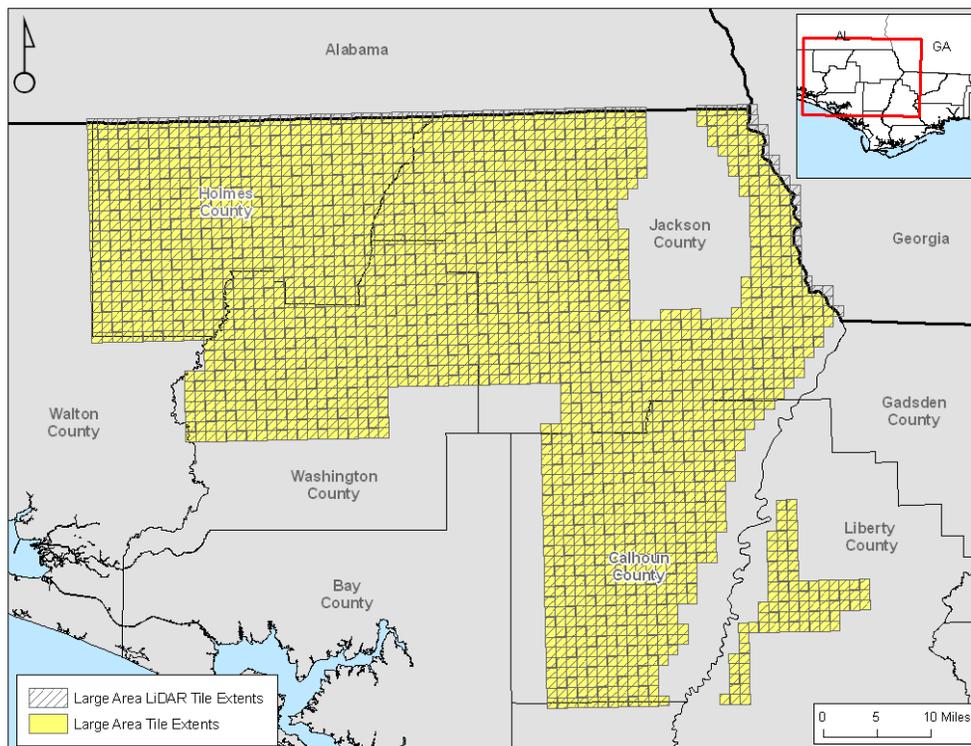
Figure 43 - Delivered LiDAR tiles - extent of LAS files.

A total of 2344 LAS tiles, 2344 DEM rasters in ArcGIS GRID format, and 2344 masspoint shapefiles were delivered by Merrick for the entire project overlapping all the required area (Figure 43). Dewberry verified that the data is in the correct projection and each LAS file includes the following information:

These classes are also incorrect according to NFWFMD specifications of class 2 for ground points and class 5 for canopy.

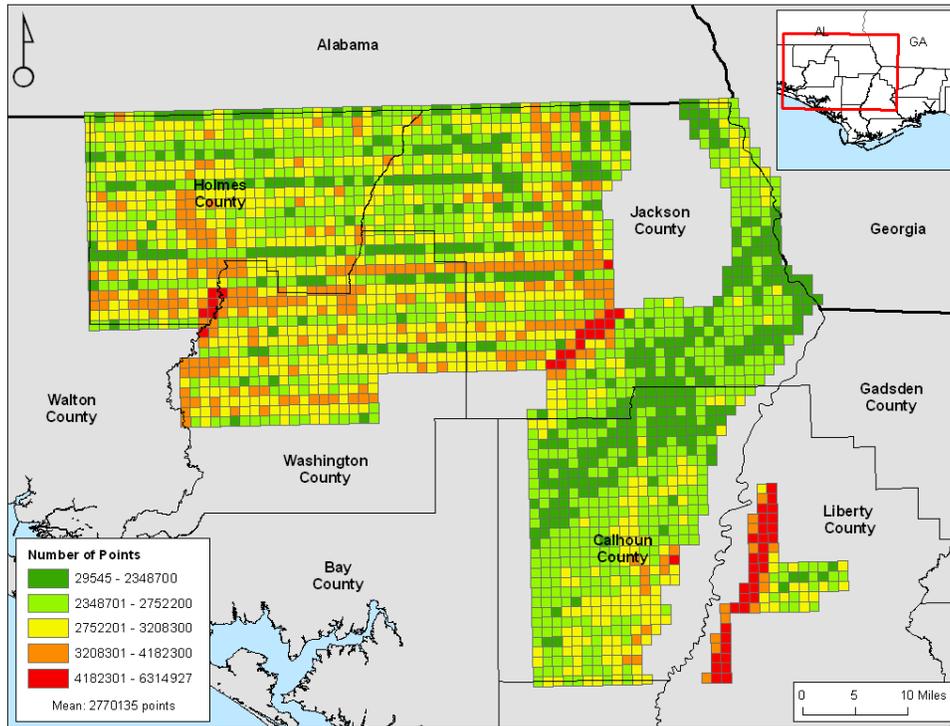
Figure 44 – Number of points per tile.

Each tile was queried to extract the number of LiDAR points and all tiles are within the anticipated size range.

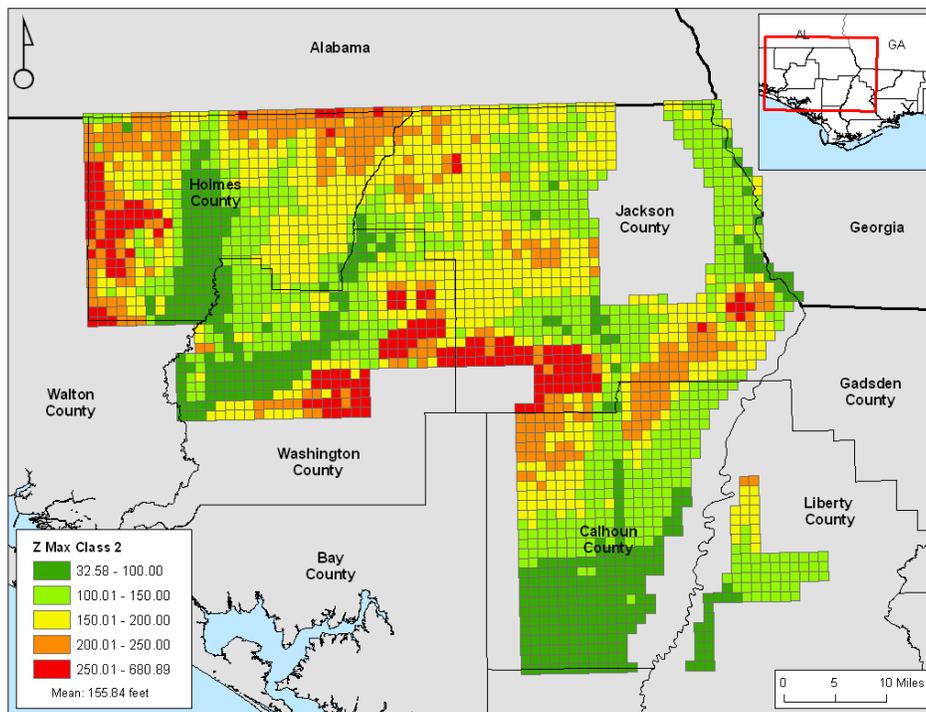
Figure 45 – Tiles classified by highest elevation in feet, class 2.

The first identify incorrect elevations, the z-minimum and z-maximum values for the ground class were reviewed. The spatial distributions of these elevations are shown in Figures 45 and 46. No noticeable anomalies were identified.

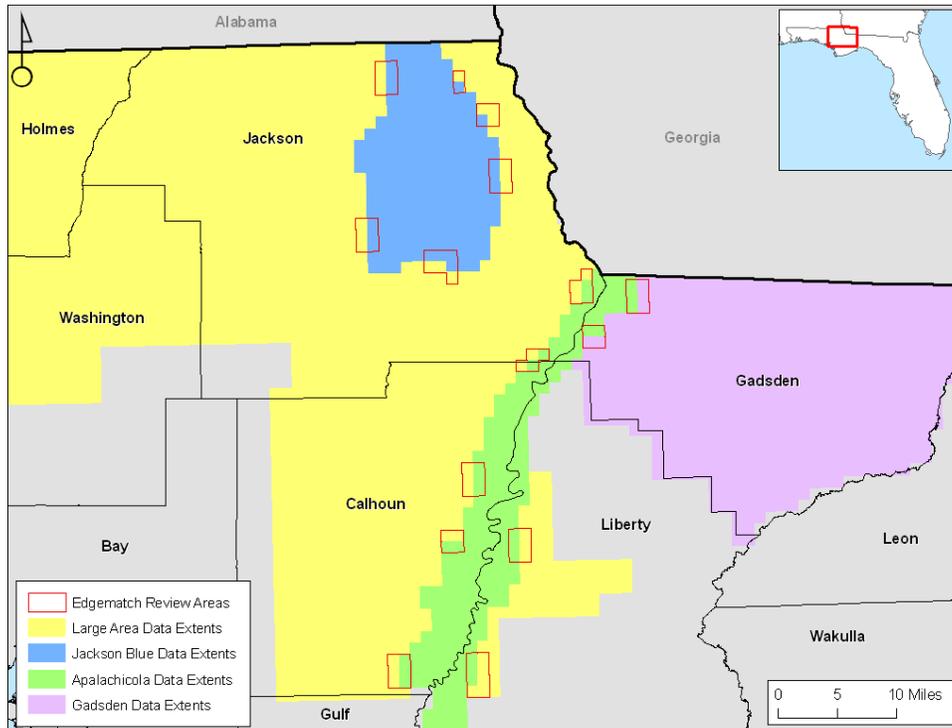
Figure 50 - Areas outlined in red were examined for potential edgematching issues.

Generally speaking, the difference between the datasets was minimal although there are a few things to be aware of when using the data across dataset lines. The biggest differences were seen between the Apalachicola data and the Large Area data and Apalachicola and Gadsden data. As discovered during the quality assessment, the Apalachicola data exhibited much better LiDAR penetration than the Large Area data and the Gadsden data. This could be a result of the time of year that each dataset was flown. The Apalachicola data was captured in March, while the other two datasets were captured in late autumn when it appears that the water levels were higher.
