LiDAR QA/QC
– Quantitative and Qualitative Assessment Report –
Jefferson County FL
May 6, 2008

**Dewberry**
Fairfax, VA

EXECUTIVE SUMMARY

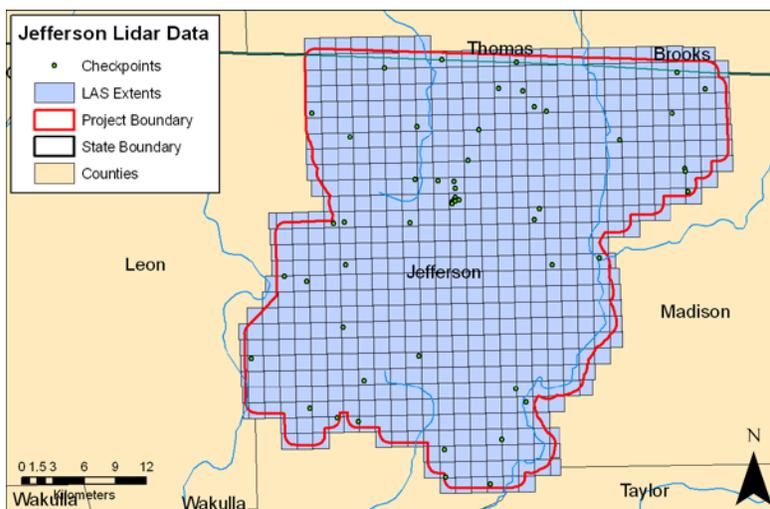
Figure 1 – Check Points for Sanborn Survey

Figure 1 shows the distribution of the checkpoints throughout Jefferson County. All of the checkpoints were within the project boundaries and there is a good distribution of points across the county.

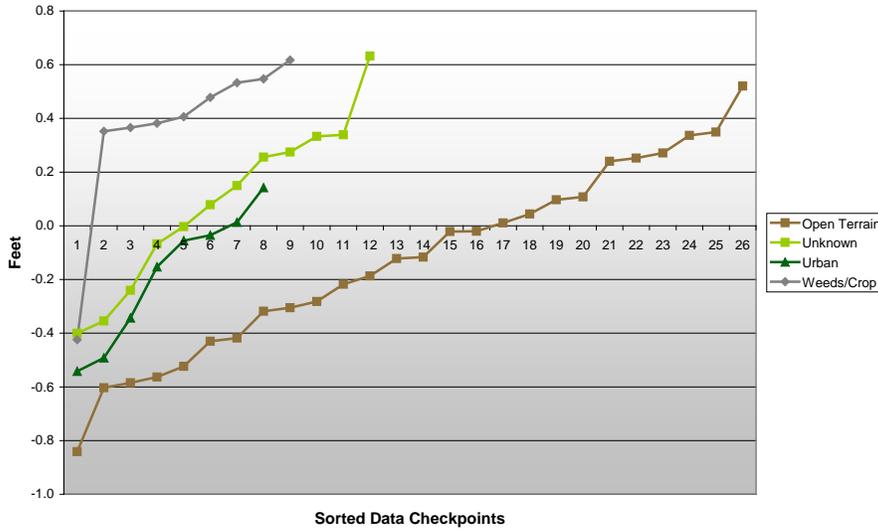
Figure 2 - Sorted checkpoint errors

The statistics computed on the elevation differences between LiDAR and GPS are presented below. Table 1 and Table 2 show the complete results of the Sanborn data set run through the Dewberry RMSE process. The consolidated RMSE for the data set was 0.363 feet which confirms Sanborn results. In addition, both classes Open Terrain (0.366ft compared to 0.492ft) and Vegetation (0.464ft compared to 0.885ft) meet the specifications. The Figure 2 illustrates the distribution of the elevation differences between the LiDAR data and the surveyed points. Open Terrain errors points are well distributed around 0 but the vegetation error points, except for one point, are all positives, indicating that the LiDAR gives higher ground elevation than the actual when vegetation is present; this is a common issue in dense vegetation as the LiDAR beam may not penetrate all the way to the ground.

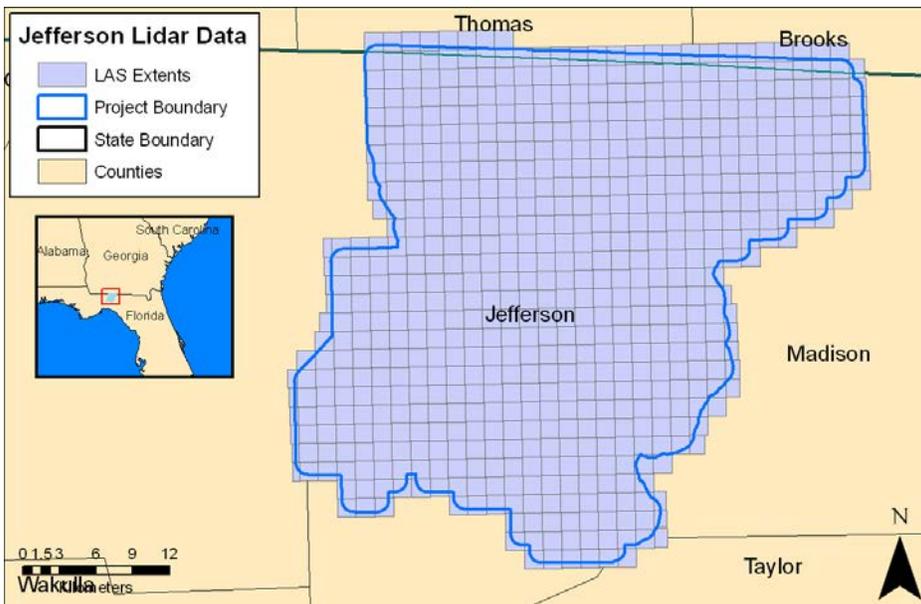
Figure 3 - Delivered LiDAR tiles – extent of the LAS files

A total of 635 LAS tiles and 635 DEM rasters in ArcGIS GRID format were delivered by Sanborn for the entire project overlapping all the required area. The data are tiled using FDEM (Florida Division of Emergency Management) tile scheme, but do not follow the FDEM naming convention. Moreover, this tile grid was originally created in State Plane Florida North, each tile being orthogonal; for this project it was reprojected in UTM 16N (see Figure 4). As a consequence, the tile shape used to divide the dataset is rotated as compared to the state plane coordinate tile scheme. It should be noted that even though the extent shapes (or bounding rectangle in UTM) created from the LAS files will seem to have an overlap, the LiDAR points actually do not overlap. However, the DEM rasters have to be orthogonal in UTM, as a consequence, adjacent DEM will overlap, pixels being duplicated between 2 DEM, this is illustrated in Figure 5. We verified that the overlapping section matches between adjacent DEMs in 5 cases, all the differences were within the expected tolerance.

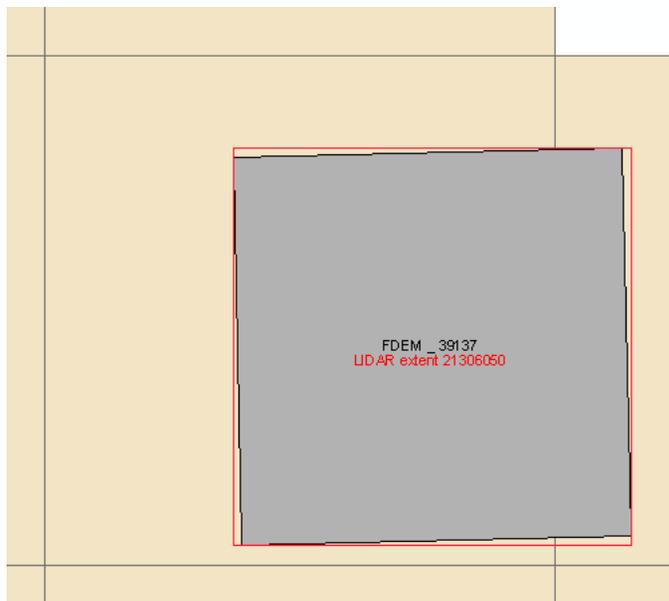
Figure 4 – Tiling scheme illustration

Beige background: tile scheme sent by Sanborn, grey: FDEM tile = location of the LiDAR point; red: corresponding LiDAR extent rectangle (projection used for the display: UTM 16N)

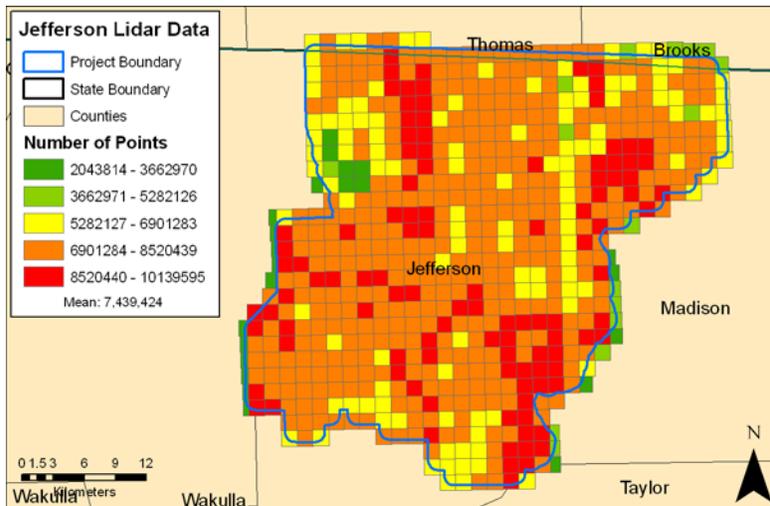
Figure 6 – Number of Points per Tile.

Each tile was queried to extract the number of LiDAR points and all tiles are within the anticipated size range, except for where fewer points are expected (near the project boundary when the tile was truncated) as illustrated in Figure 6. Even though the LiDAR masspoint dataset is not clipped by the boundary polygon, the LiDAR points do not cover the entire tile outside the boundary in some tiles intersecting the boundary, this is especially true on the east-south and west-south sides.

The four tiles shown in green in the northwest quadrant of Figure 6 were examined more closely and we found that there was a large amount of swampy area or water in these tiles. Therefore, the cluster of tiles with few points is normal. Figure 7 illustrates this area.

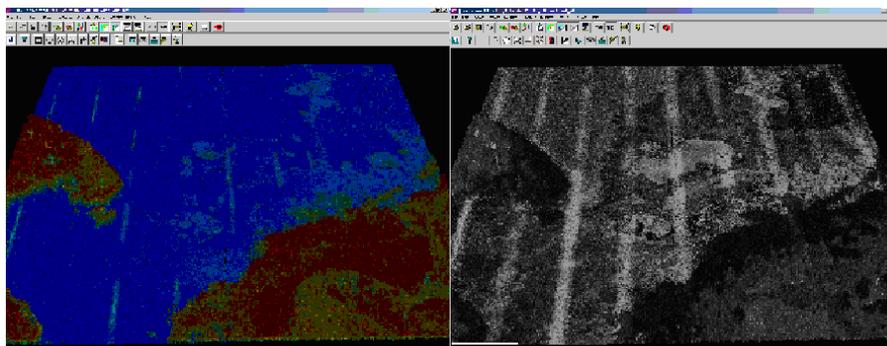
Figure 7 – Tile with less points due to swamp of water

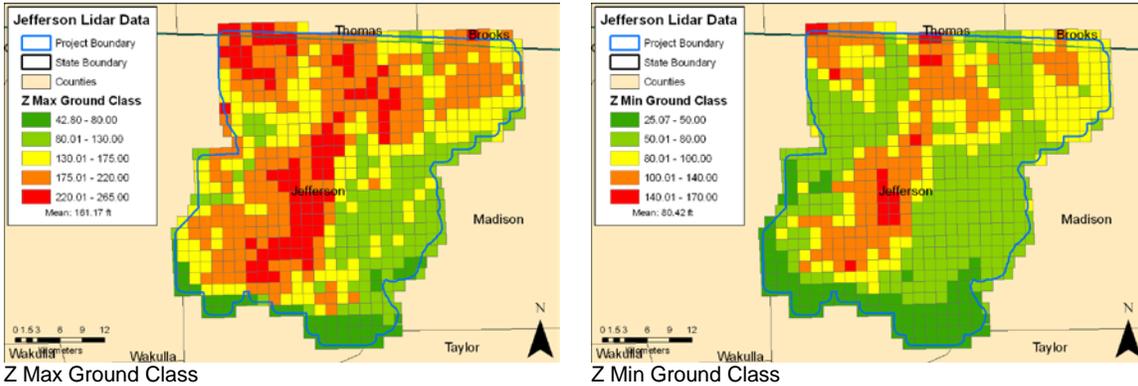
Figure 8 – Max and min elevation statistics per tiles

To first identify incorrect elevations, the z-minimum and z-maximum values for the ground class were reviewed. With maximum values between 40 and 265ft, no noticeable anomalies were identified. Figure 8 shows the spatial distribution of these elevations, following the anticipated terrain topography and the Z Max ground and the Z Min ground seem to correlate with one another.

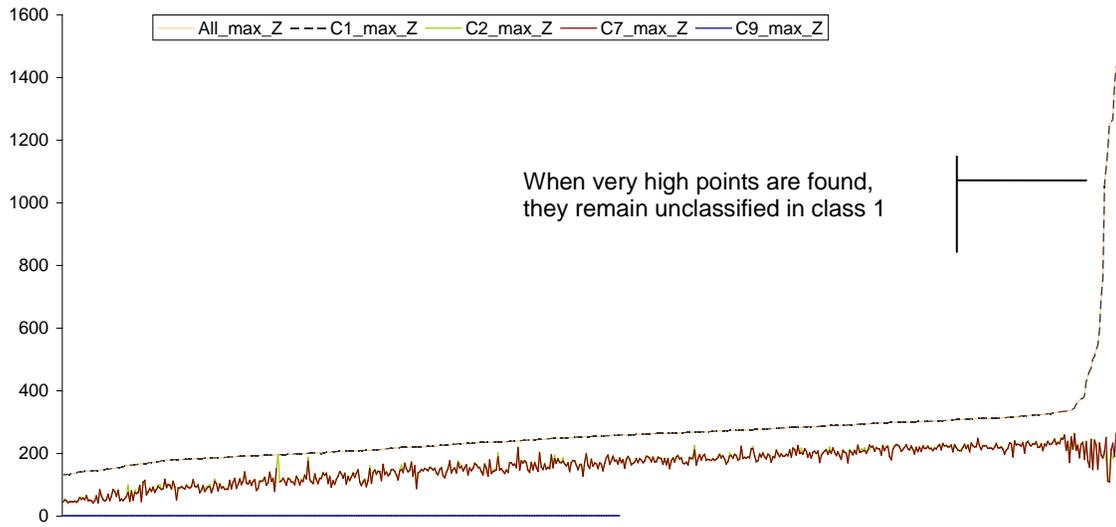
Figure 10 - Maximum elevation in feet for each tile sorted by Max_Z, each class is also plotted separately

Class 7 (Low point - noise) contains the lowest points in the files. These elevations are not necessarily anomalies. Only one tile (21904850) contained an elevation of -3295 feet. It should be noted higher error points (spikes, isolated anomalies) remain in class 1 (Unclassified) as illustrated in Figure 10.

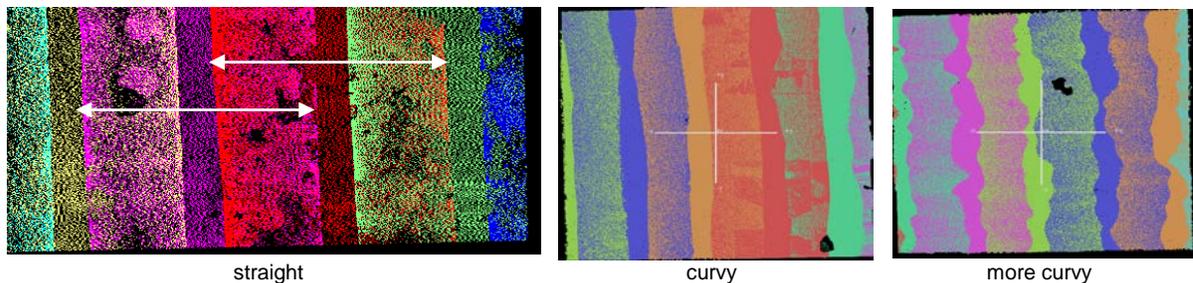
The adjacent flightline overlap seen in the images was 40% (see Figure 16). It represents the actual overlap during acquisition since the flightline edges were not clipped (the zig-zag pattern at the end of each scan line is easily visible). The flightlines are either really straight or curvy, possibly due to windy conditions. Moreover, wind could also be the cause of slight variation in the plane pitch resulting in an apparent “bunching” of the scans as in Figure 17. In this case, it does not compromise the integrity of the data.

When considered over an entire tile, the point density meets the specifications of 0.7m and is even better in overlapping areas. However in the sections where only one pass was acquired, which correspond to the middle of each flightline (nadir), the point spacing may be wider (1.2m along scan, 1 to 1.2m along track at nadir).

Figure 16 – Points displayed by flight line showing 40% overlap, the white arrows show the width of 2 adjacent flightlines
