LiDAR QA/QC

- Quantitative and Qualitative Assessment Report -
Northwest Florida Water Management District
Sanborn Add-on;
Washington, Jackson and Calhoun Counties
September 2, 2008

Dewberry

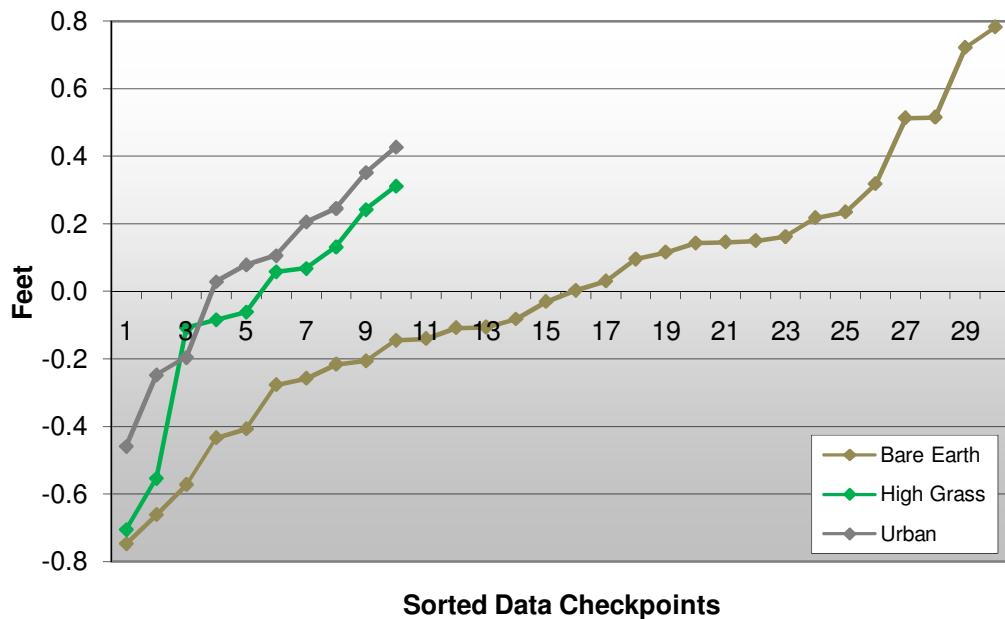
Figure 3 illustrates the distribution of the elevation differences between the LiDAR data and the surveyed points. The bare earth elevation deltas are centered around zero which can also be seen in Table 1 in the mean and median columns. Based on the above testing methodologies this data meets the desired accuracy.

Figure 3 - Sorted elevation errors for 50 survey checkpoints.

Based on the supplied checkpoints, Dewberry's review of the vertical accuracy of the Sanborn LiDAR data confirms that the dataset meets the accuracy requirement as defined by NFWFMD.

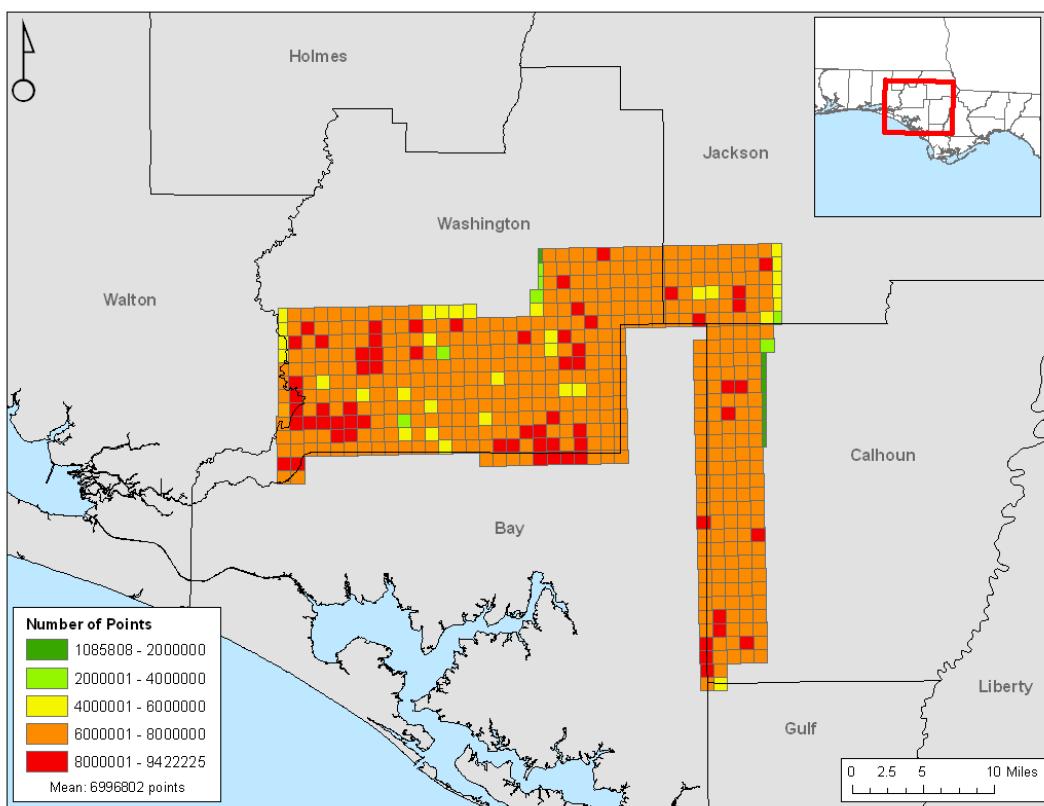
elevations as well as descriptive statistic (mean, median etc), are input to a database for analysis. This allows us to identify any gross errors in the data deliverable through the tabular data but it is also visually mapped. Each tile is queried to extract the number of LiDAR points and all tiles are statistically compared. The data are within the anticipated size range as shown in Figure 5. The green tiles on the edge of the dataset are not full tiles therefore there are less points in them.

Figure 5 - Number of points per tile.

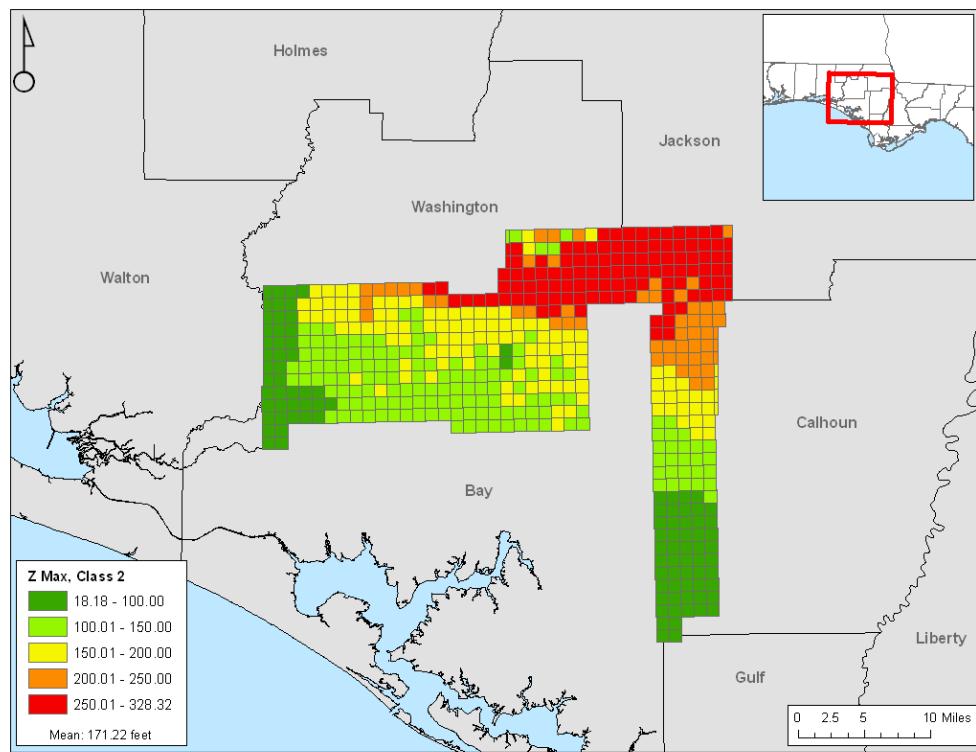
To first identify incorrect elevations, the z-minimum and z-maximum values for the ground class were reviewed. Figure 6 and Figure 7 illustrate the spatial distribution of these elevations. With maximum ground values between 18 and 328 ft, no noticeable anomalies were identified. Considering the natural decrease in elevation towards the coastal areas, the images of the lowest and highest elevations seem to correlate with one another. An additional visual verification is performed by creating a decimated image of the full LiDAR extents. Again this allows us to find missing tiles are data and to aid in identifying gross anomalies (see Figure 8).

Figure 6 - Tiles classified by highest elevation in feet, class 2 (ground).

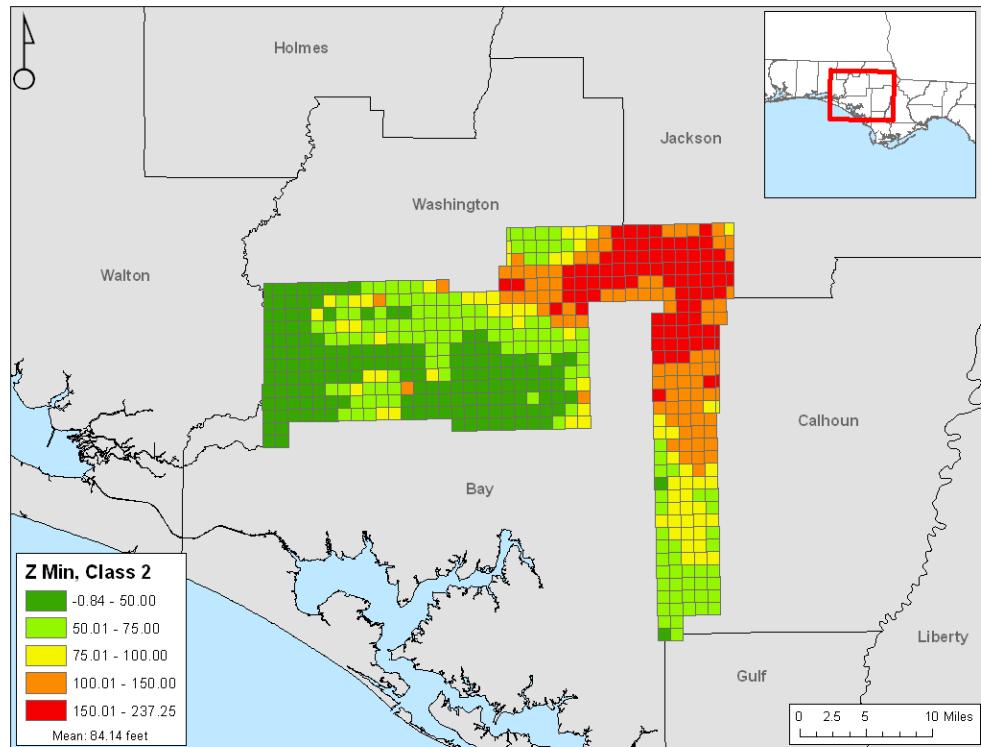
Figure 7 - Tiles classified by lowest elevation, class 2 (ground).

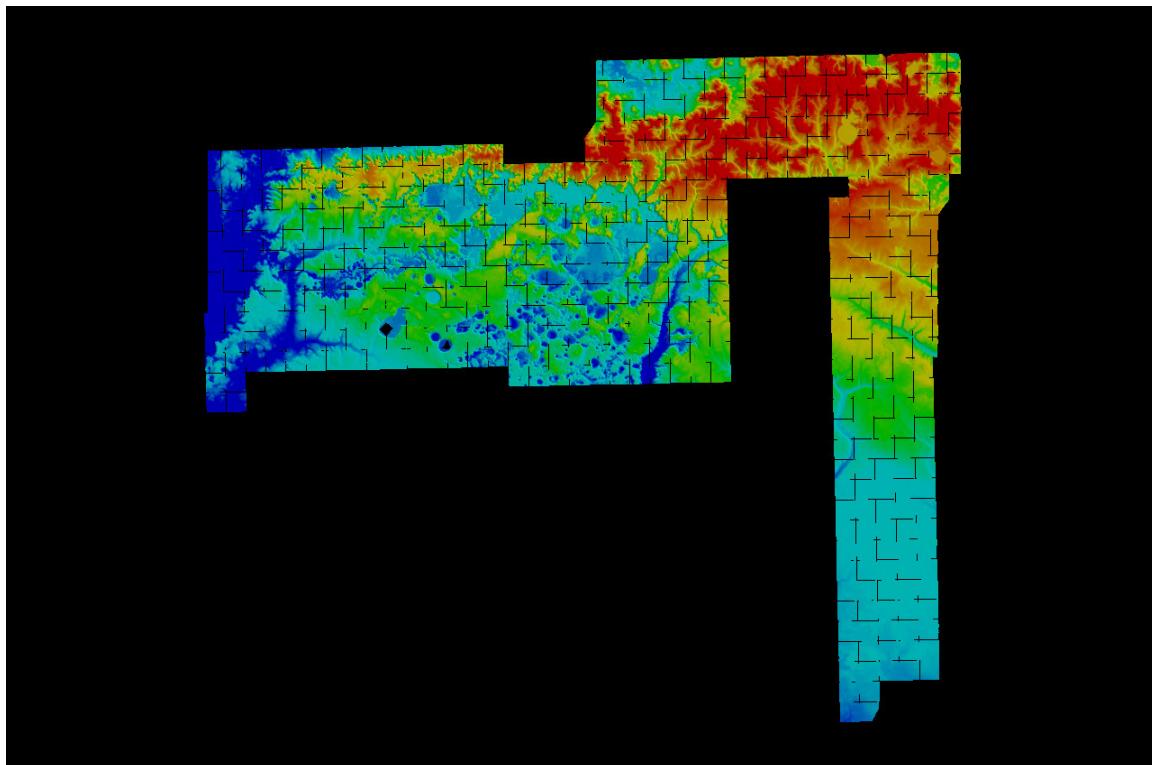
Figure 8 - Decimated image of the full extents of the NWFWM LiDAR Add-on dataset.

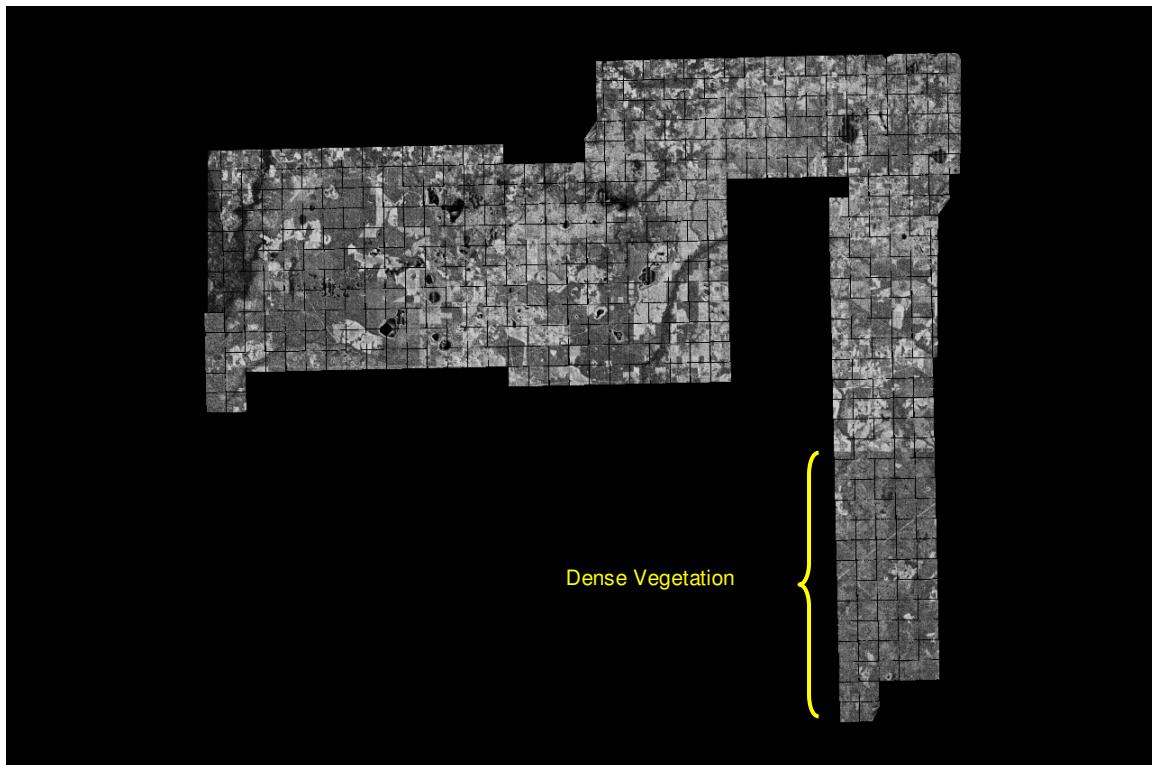
Several patches of sparse data were also found where the LiDAR did not get to the ground. This penetration problem was more pronounced in the southern section of the dataset in western Calhoun County which, as seen in Figure 14, which is characterized by dense vegetation. Figure 12 and Figure 13 display a couple examples of this. Due to the vegetation characteristics and the inability of no other technology achieving the same

Figure 14 - Decimated image of full point cloud LiDAR points with intensity. This image aids in identifying land cover type. Forest areas are depicted by a darker color which reflects less energy of the LiDAR return.

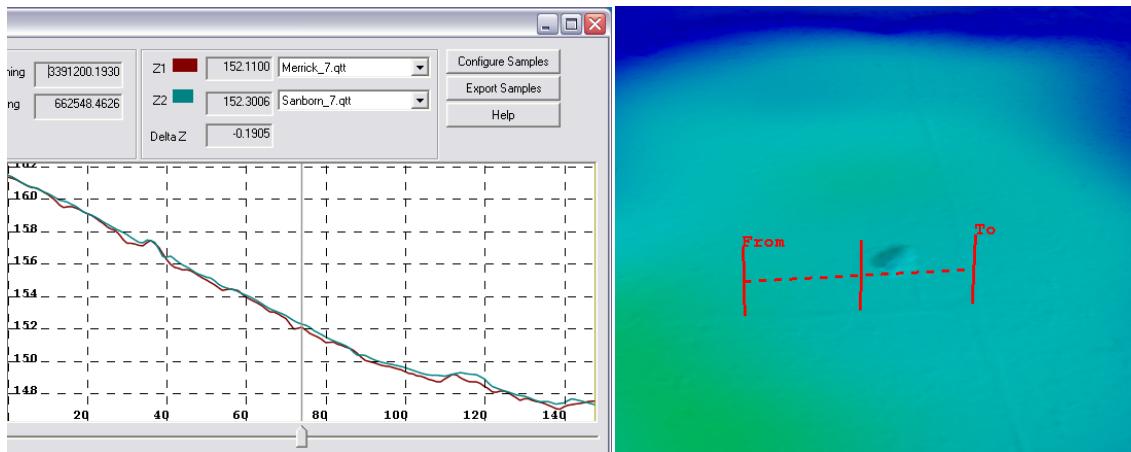
In order to analyze how well the datasets fit to each other, a number of cross sections were drawn in areas of various types of terrain. Dewberry found that for the most part the datasets were within 0.5 feet of each other however there were a few areas where there was almost one foot difference. These areas were located in the southern part of the dataset in western Calhoun County where there is much more vegetation and LiDAR pulses in both datasets had some difficulty in reaching the ground. Figure 16 displays a cross section where the two datasets fit together very well and Figure 17 displays a cross section where the datasets are not as close.

Figure 16 - Tile 17155950. Left is cross section showing small elevation difference of -0.19 ft. along a road. Right is ground model showing the location of the cross section.

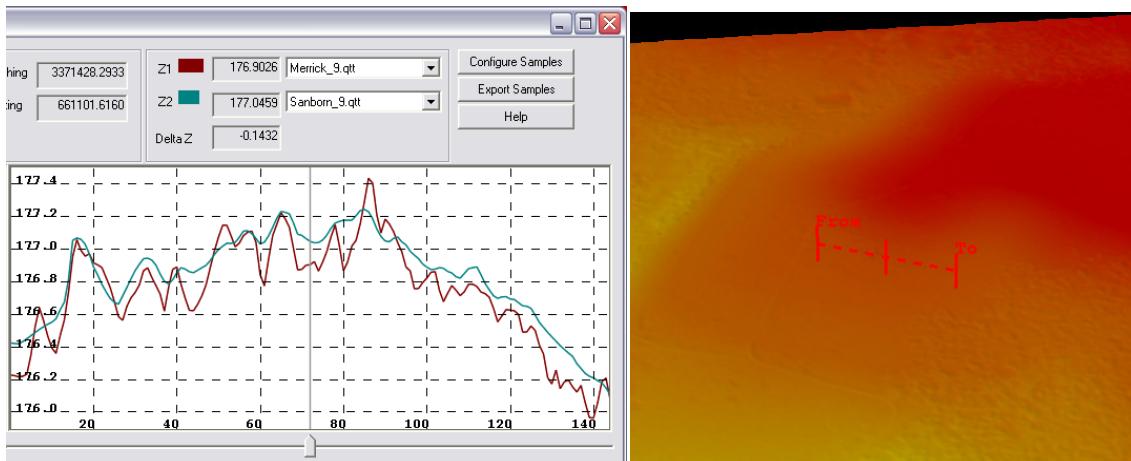
The main qualitative differences between the Merrick data and the Sanborn data had to do with smoothness and penetration. The Sanborn LiDAR data exhibited much smoother data and seemed to be able to penetrate vegetation more easily than the Merrick LiDAR data based on the density images we produced and as illustrated in some of the cross section comparisons (Figure 18 and Figure 19). This does not reflect that one data set is “better” than the other as the ground conditions may have changed between when these datasets were collected.

Figure 18 - Tile 17105300. The blue line is the Sanborn LiDAR data and the red line is the Merrick LiDAR data. The Sanborn data exhibits much smoother terrain than the Merrick at this location.
