LiDAR Quality Assessment Report

New England CMGP SANDY LiDAR

NGTOC 2015-03-30

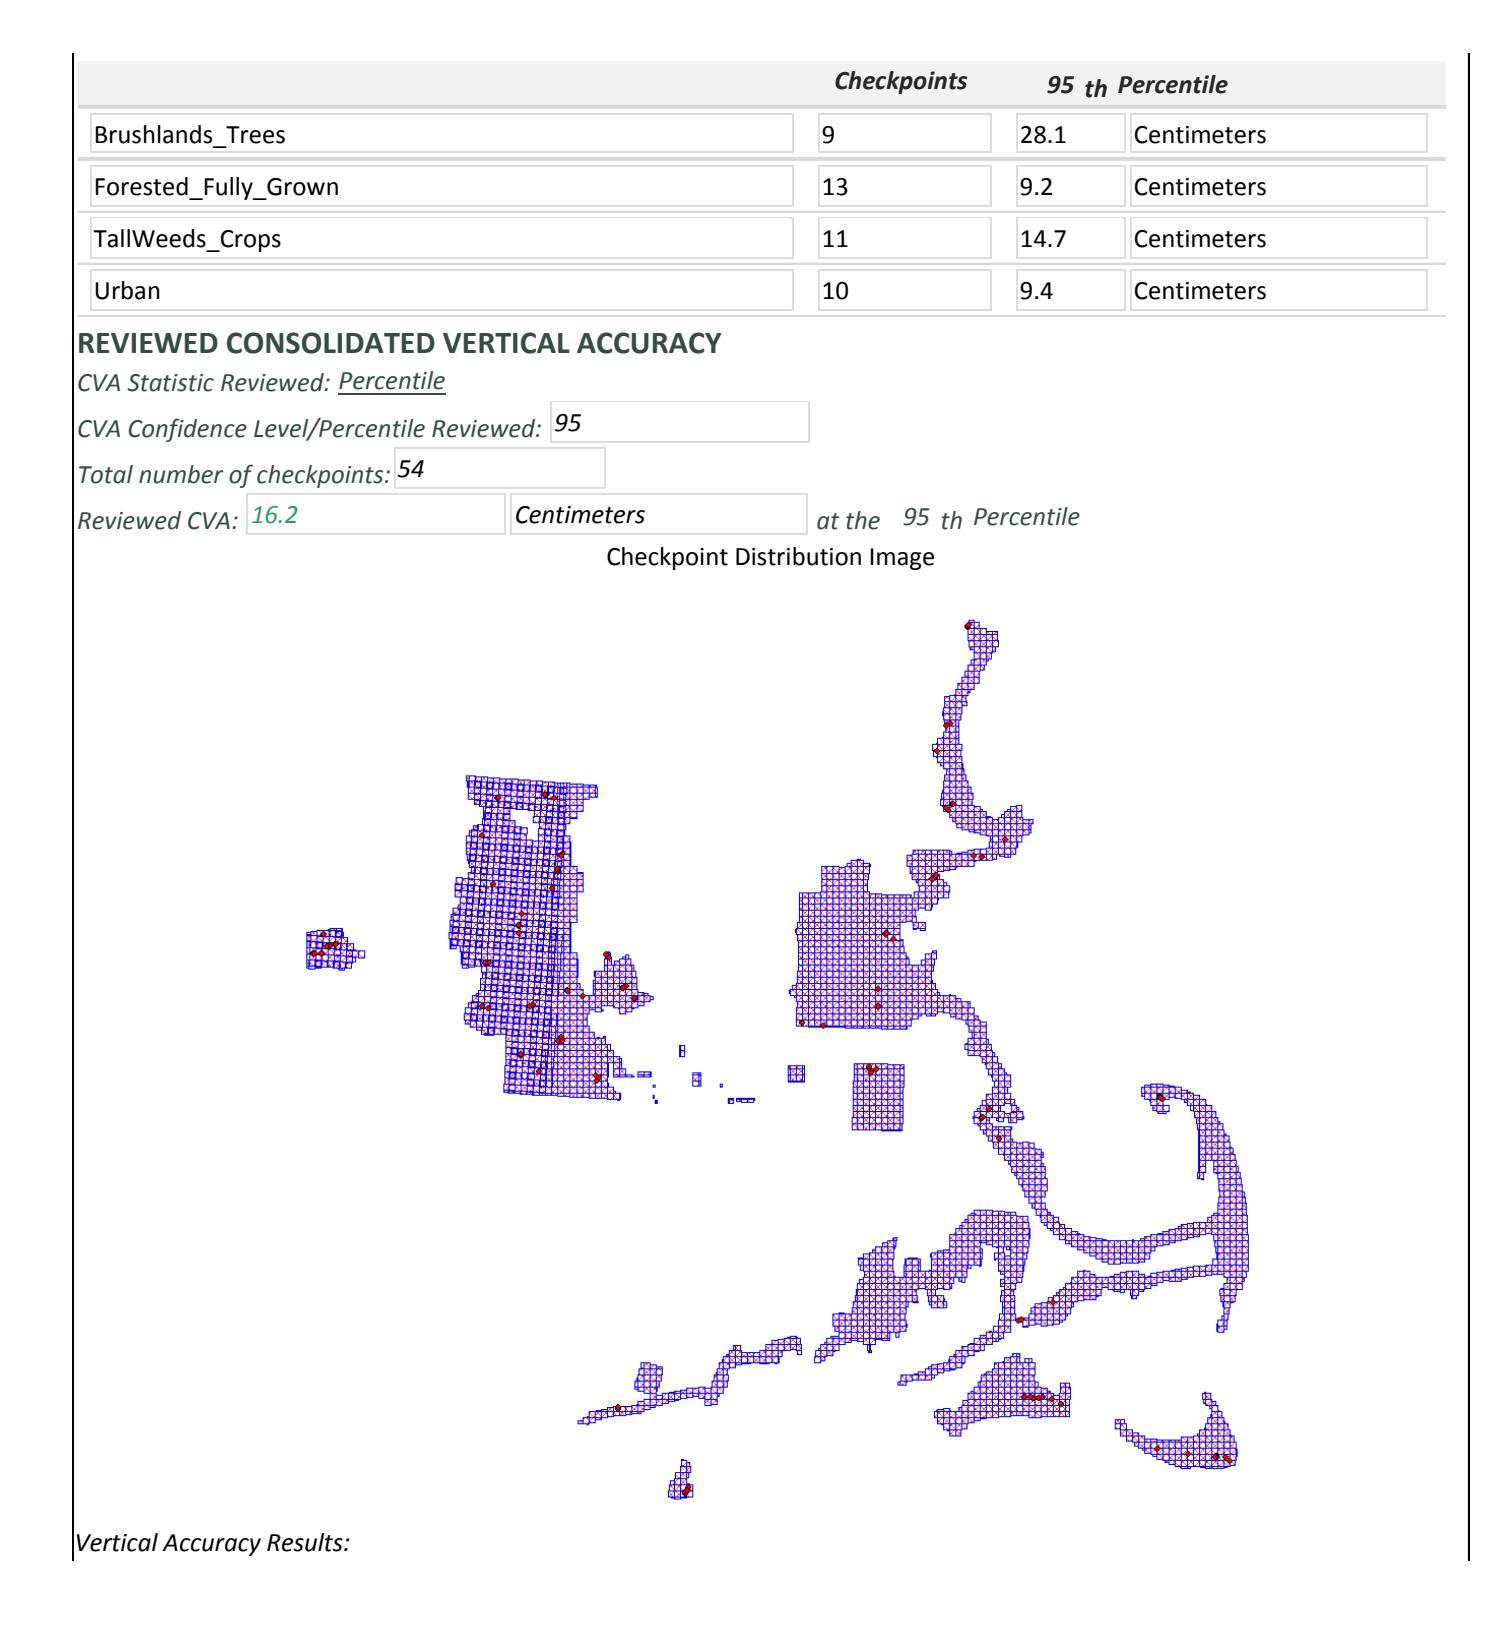
Image chausing the bare earth i								
Image showing the bare earth points against the swath data (shown by classification):								
Additional Reviewed Vertical Accuracy	Vertical	Accuracy v	vill be	assessed once a c	orrected DEM i	s delivered to NGTC	DC.	
Information:	3/26/202	15: Vertica	I Accu	ıracy ran against tl	he swath and D	EM data. For this r	eport.	the
	Swath F\	/A results	werei	ran on the entire p	project area. Fo	or the DEM, the vert	ical a	ccuracy
	was asse	essed per L	JTM zo	one and reported	above. The resu	Its of both UTM18	and L	ITM19 is
	as follow	/s:	-			_		
		Rare Earth	ertical	Accuracy for the DEM	I - UTM18 and UTM	V19 data	CVA	Total Point
	UTM18	8.3	9.4	14.7	28.1	9.2	16.2	54
	UTM19	9.6	10.4	15.3	25.9	29.3	18.9	130
	Required	18.13	26.9	26.9	26.9	26.9	26.9	
				All values	are reported in cr	n		
		Druchler	J /T	a faile the CVA+	ogon for wort -			lowover
	CVA and	Brushiand	a/ i ree	the project and the	egory for vertic	ai accuracy of the L		iowever,

UTM19	Forested F	S IOL I	rown fails the SVA	A category for v	ertical accuracy of t	he DF	M
	However	r, CVA and	FVA c	basses for the proj	ect and the oth	er 3 SVA categories	pass.	
		,	17	1 1

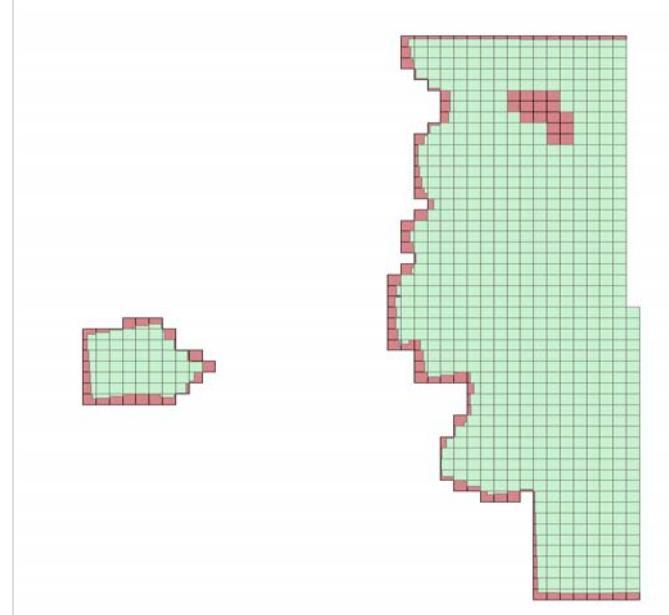
There are 16 .las tiles missing from the upper portion of the project area for UTM18 data. The tile index shows tiles in this location. Are these tiles left out for a purpose?

The coral color represents the Tile Index delivered with the data. The green is the Point Cloud Statistics shapefile for every classified .las tile delivered.

3/26/2015: Contractor sent missing tiles for UTM18 data (16 tiles). Additionally, they sent 5 extra classified .las tiles that were assessed by reviewer for UTM19 data.

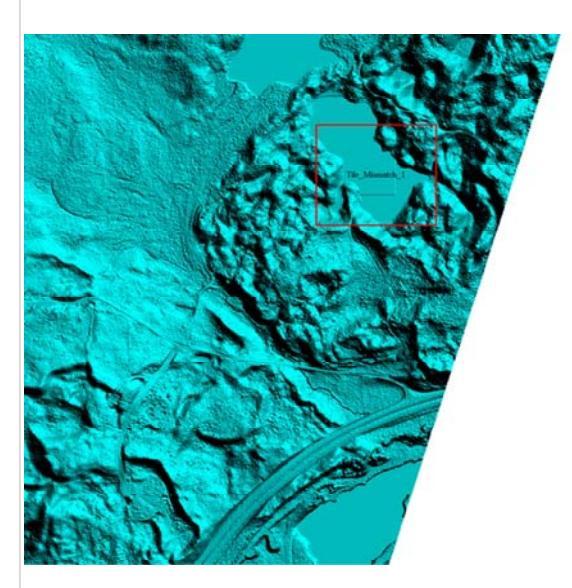
UTM 19 data has a tile edge match error.

*3/26/2015 Contractor corrected issue.

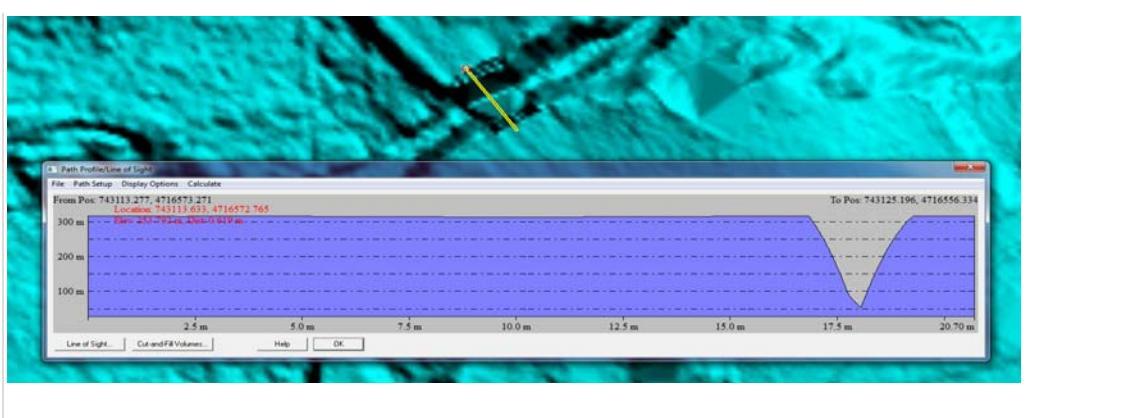
There is a pit at this location in UTM18 data: 42° 33' 47.6171" N, 72° 02' 17.7015" W

*3/26/2015: Contractor corrected issue.

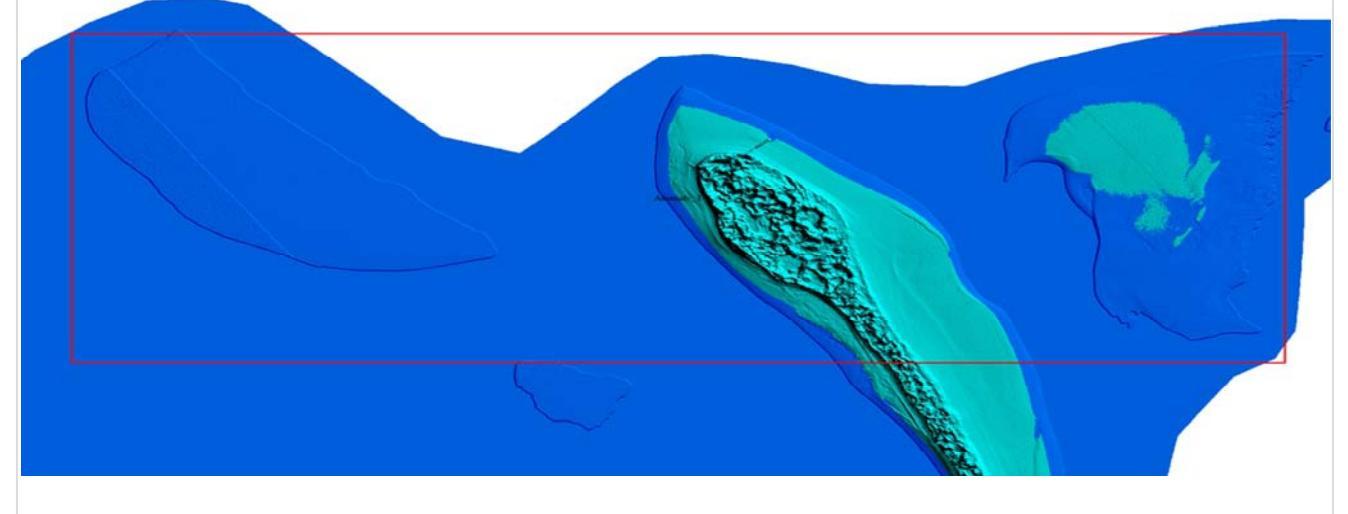
There are several anomalous errors in which there is an elevation change in a pattern running in a NW-SE orientation throughout the UTM19 data. Below is a representative image of what the reviewer is seeing:

2/25/2015: Contractor Response: Offset is due to tidal variation between and within data collections. Best practice was used to eliminate this, but some offset may remain. QA Reviewer accepts these anomalous errors.

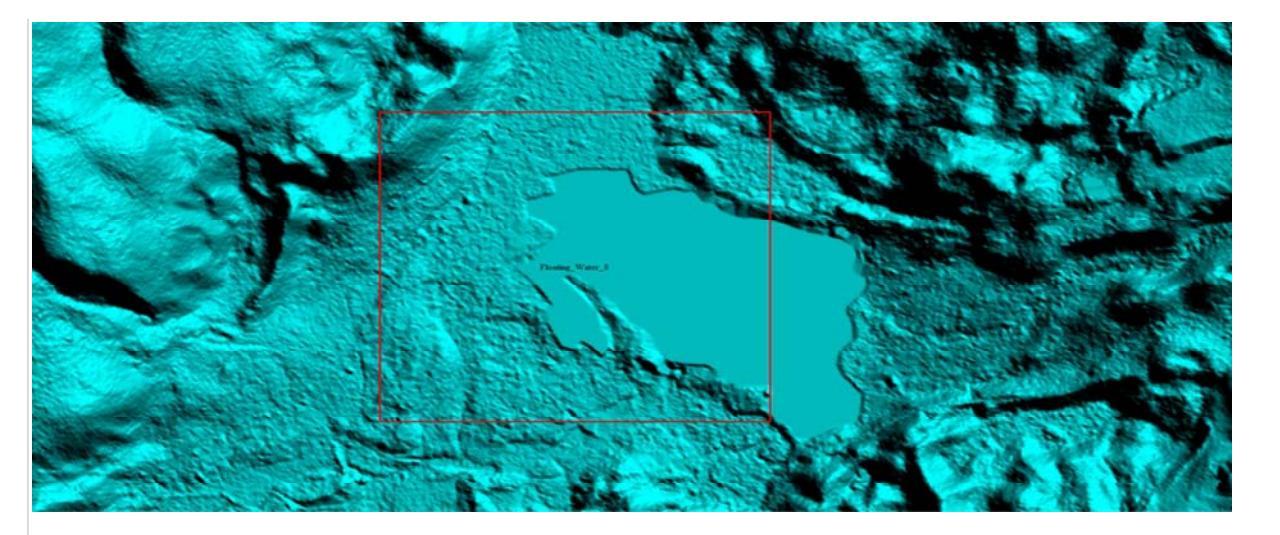
Several lakes have water that is at a higher elevation than the surrounding terrain (Floating_Water errors). Below is a representative image only:

2/25/2015: Contractor fixed floating water issues. For 6 of the errors the contractor responded *elevation change is due to a naturally occurring spillway*. QA Reviewer accepts these errors (Floating_water_3, _4, _6, _7, _8, _9, _11).

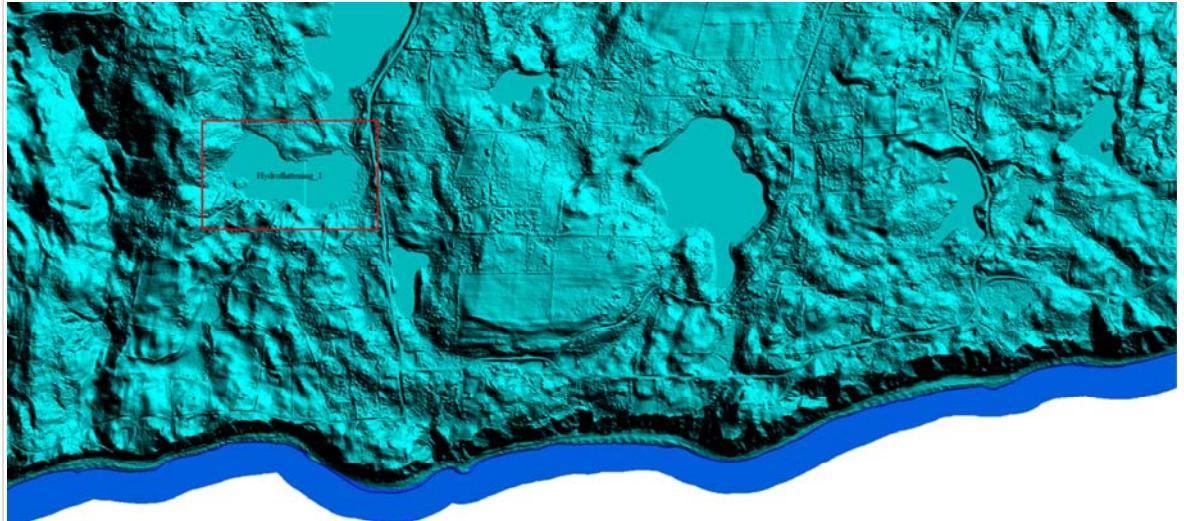
In the UTM19 data there are two errors in which the elevation along the tile edge is different. Below is a representative image:

2/25/2015 Contractor corrected above errors.

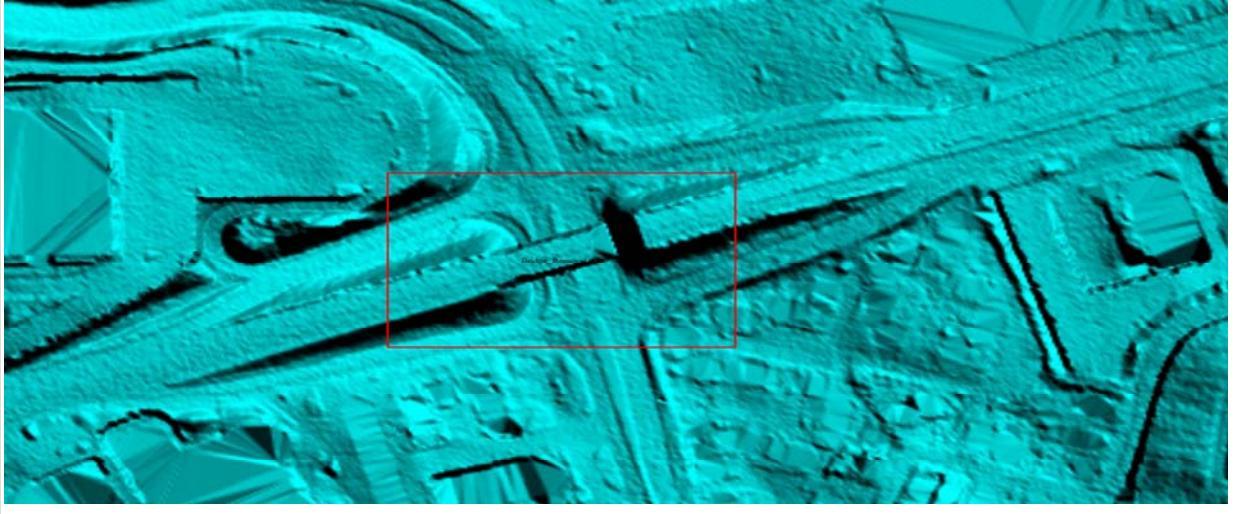
Several errors exist in both UTM18 and UTM19 datasets in which a bridge was not removed or not completely removed in which the flow of water or roadway is blocked. Below is a representative image only. Refer to the error shapefile for all errors of this type.

*3/26/2015: Contractor corrected issues.

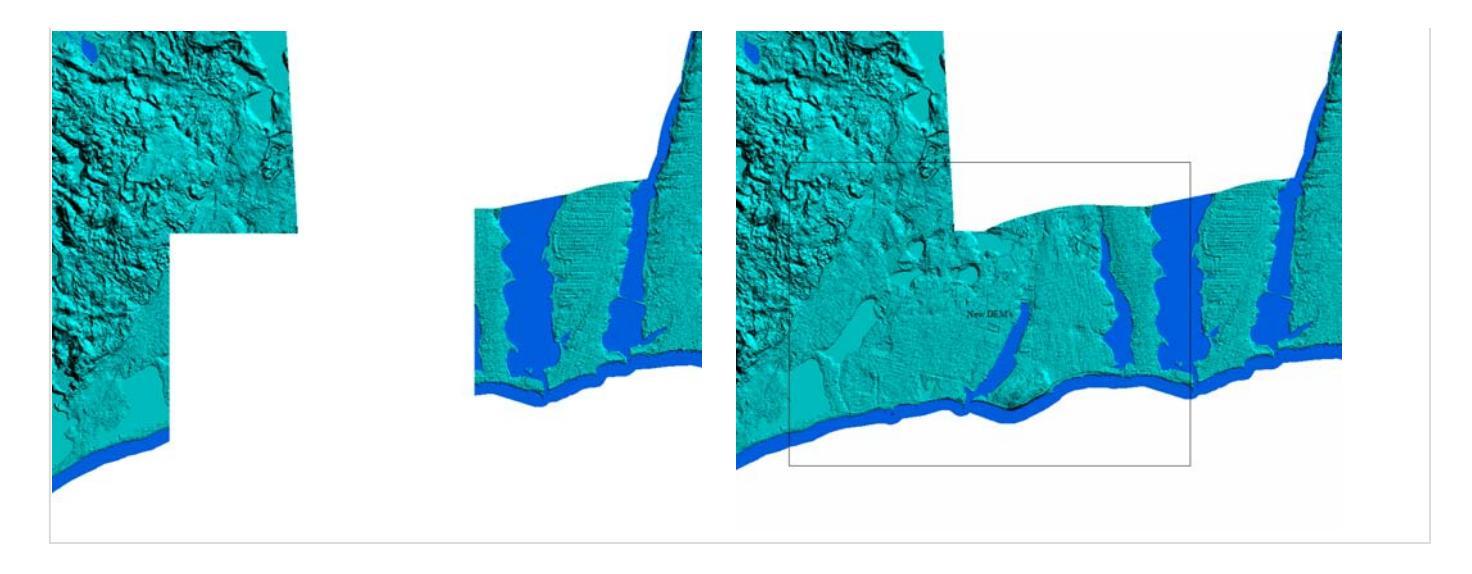
Re-delivery of DEM tiles: UTM 19 DEM had a delivery of 5 additional tiles. QA was done and the tiles are good and will be included in the final acceptance (see image below). Original Delivery: With the additional delivery of 5 tiles:

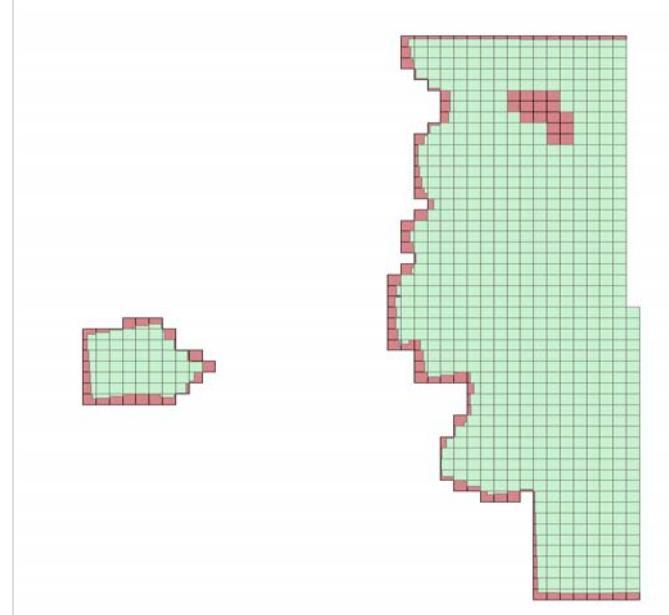
There are 16 .las tiles missing from the upper portion of the project area for UTM18 data. The tile index shows tiles in this location. Are these tiles left out for a purpose?

The coral color represents the Tile Index delivered with the data. The green is the Point Cloud Statistics shapefile for every classified .las tile delivered.

3/26/2015: Contractor sent missing tiles for UTM18 data (16 tiles). Additionally, they sent 5 extra classified .las tiles that were assessed by reviewer for UTM19 data.

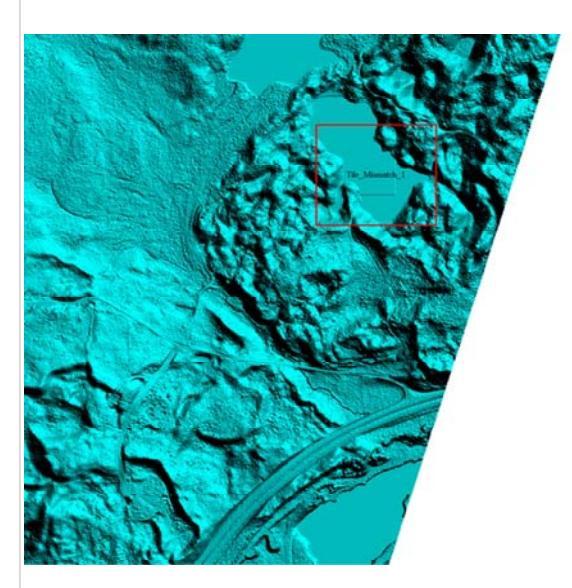
UTM 19 data has a tile edge match error.

*3/26/2015 Contractor corrected issue.

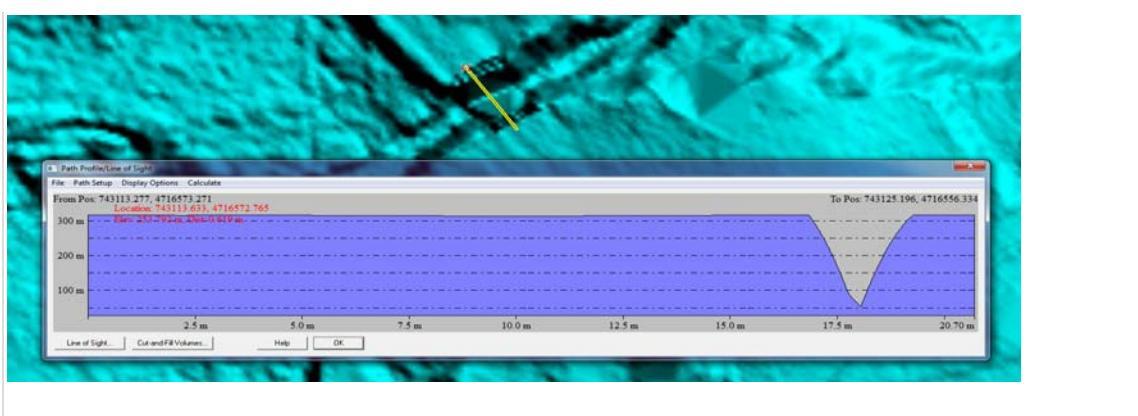
There is a pit at this location in UTM18 data: 42° 33' 47.6171" N, 72° 02' 17.7015" W

*3/26/2015: Contractor corrected issue.

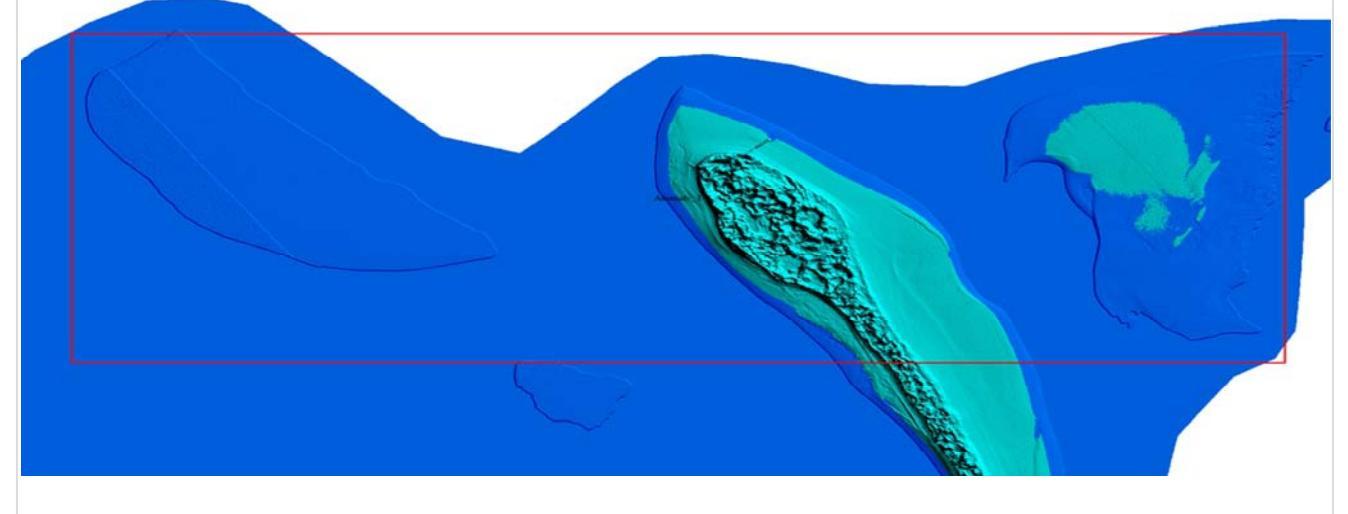
There are several anomalous errors in which there is an elevation change in a pattern running in a NW-SE orientation throughout the UTM19 data. Below is a representative image of what the reviewer is seeing:

2/25/2015: Contractor Response: Offset is due to tidal variation between and within data collections. Best practice was used to eliminate this, but some offset may remain. QA Reviewer accepts these anomalous errors.

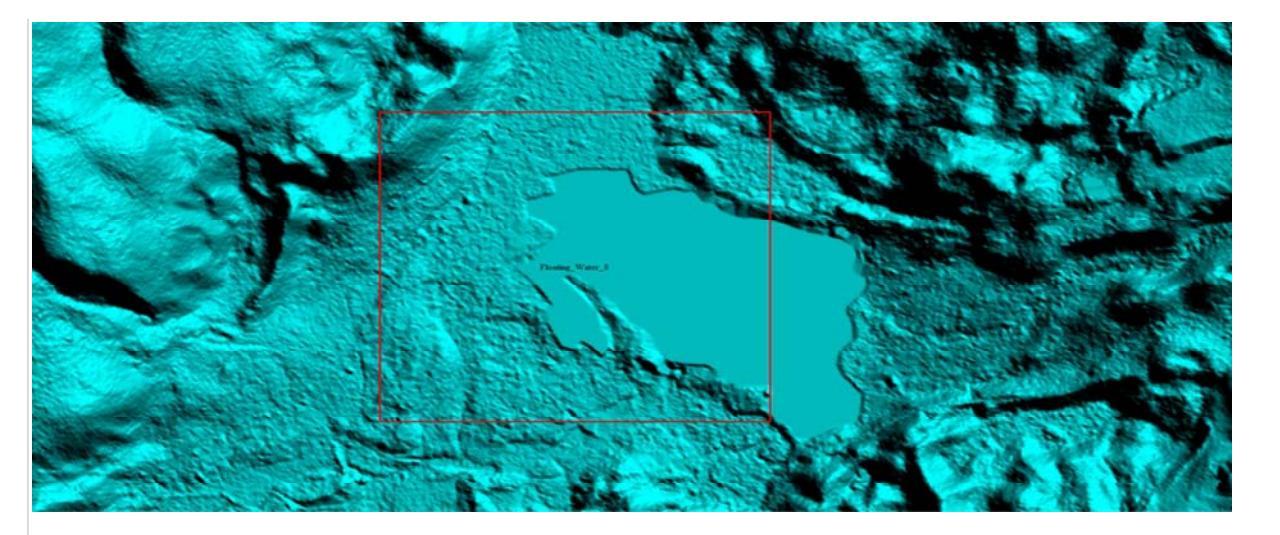
Several lakes have water that is at a higher elevation than the surrounding terrain (Floating_Water errors). Below is a representative image only:

2/25/2015: Contractor fixed floating water issues. For 6 of the errors the contractor responded *elevation change is due to a naturally occurring spillway*. QA Reviewer accepts these errors (Floating_water_3, _4, _6, _7, _8, _9, _11).

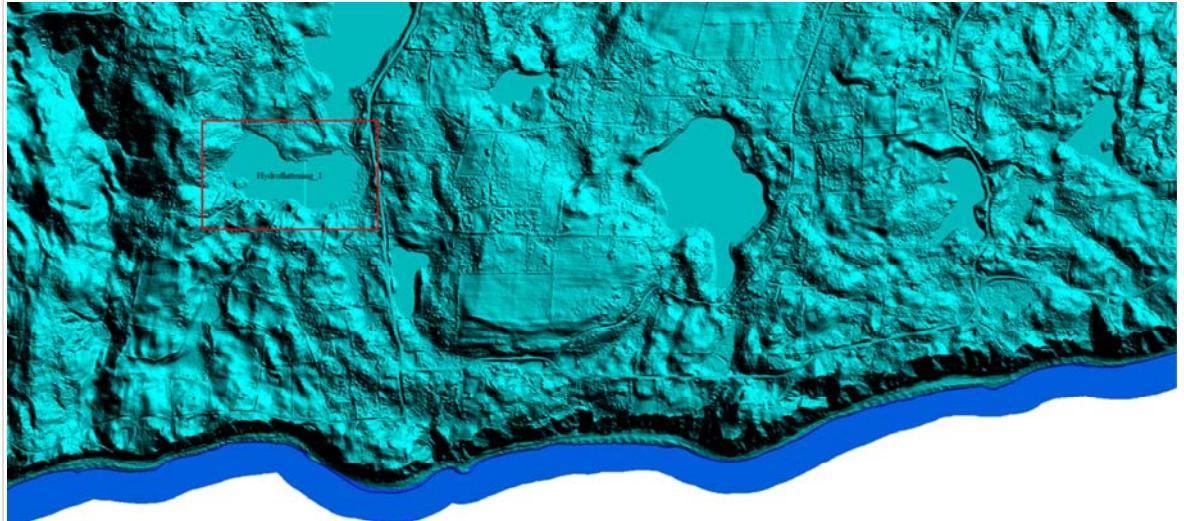
In the UTM19 data there are two errors in which the elevation along the tile edge is different. Below is a representative image:

2/25/2015 Contractor corrected above errors.

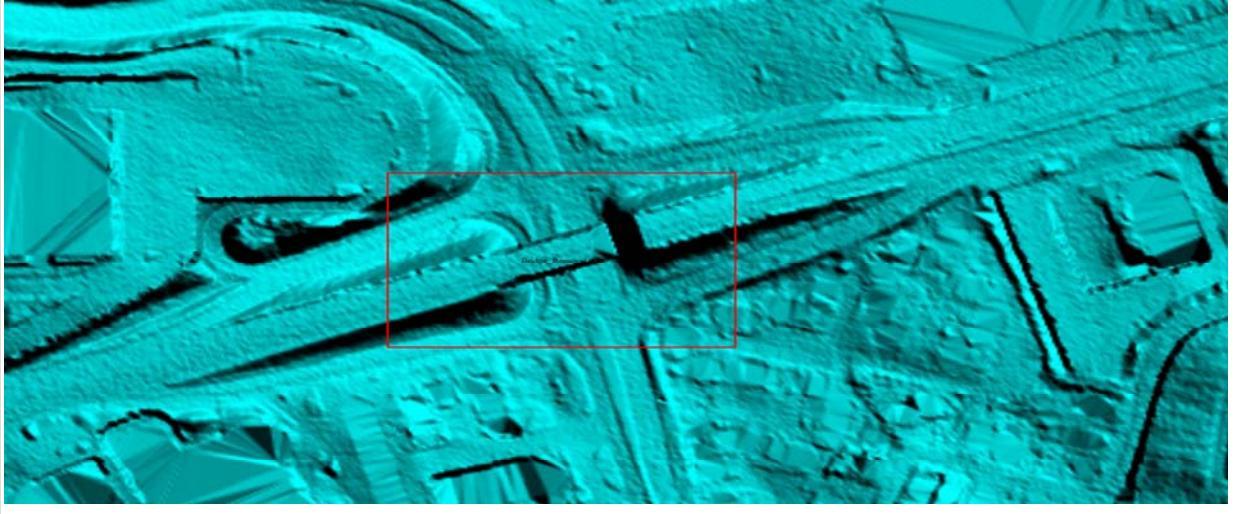
Several errors exist in both UTM18 and UTM19 datasets in which a bridge was not removed or not completely removed in which the flow of water or roadway is blocked. Below is a representative image only. Refer to the error shapefile for all errors of this type.

*3/26/2015: Contractor corrected issues.

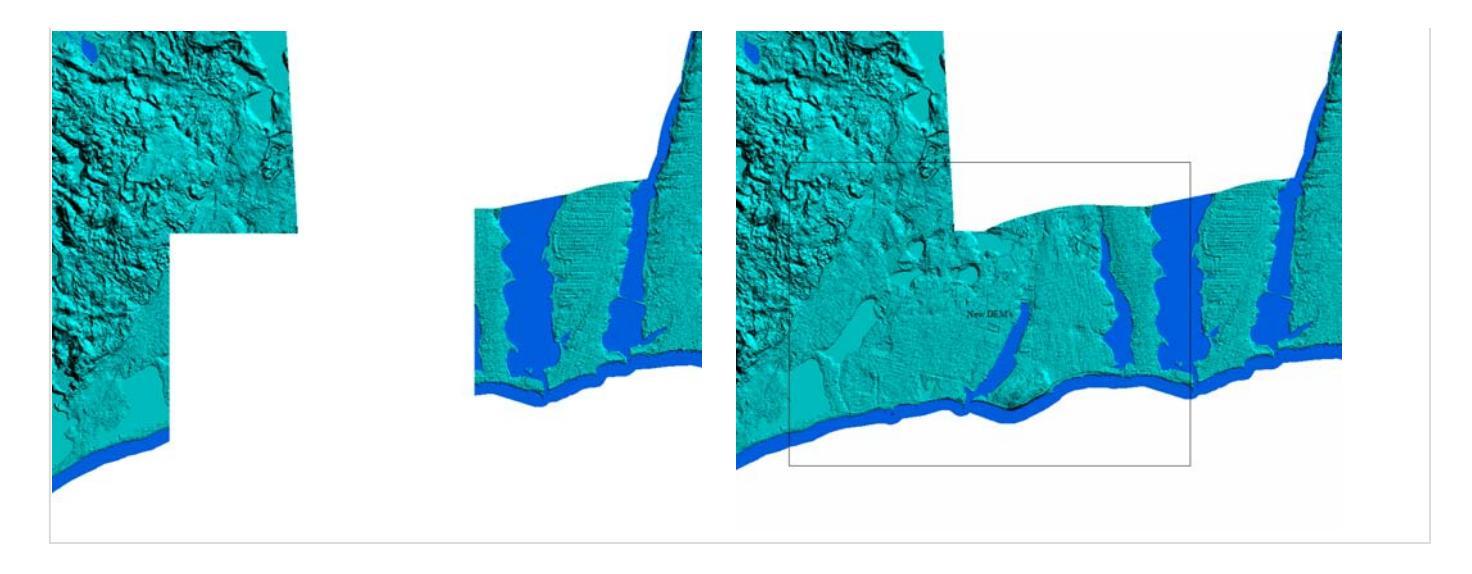
Re-delivery of DEM tiles: UTM 19 DEM had a delivery of 5 additional tiles. QA was done and the tiles are good and will be included in the final acceptance (see image below). **Original Delivery:** With the additional delivery of 5 tiles:
